# Heritage Statement

Marlow House  
107 High Street  
Lindfield  
RH16 2HR

Refs: DM/25/1103 &  
DM/25/1104

September 2025 | Project Ref 10899A

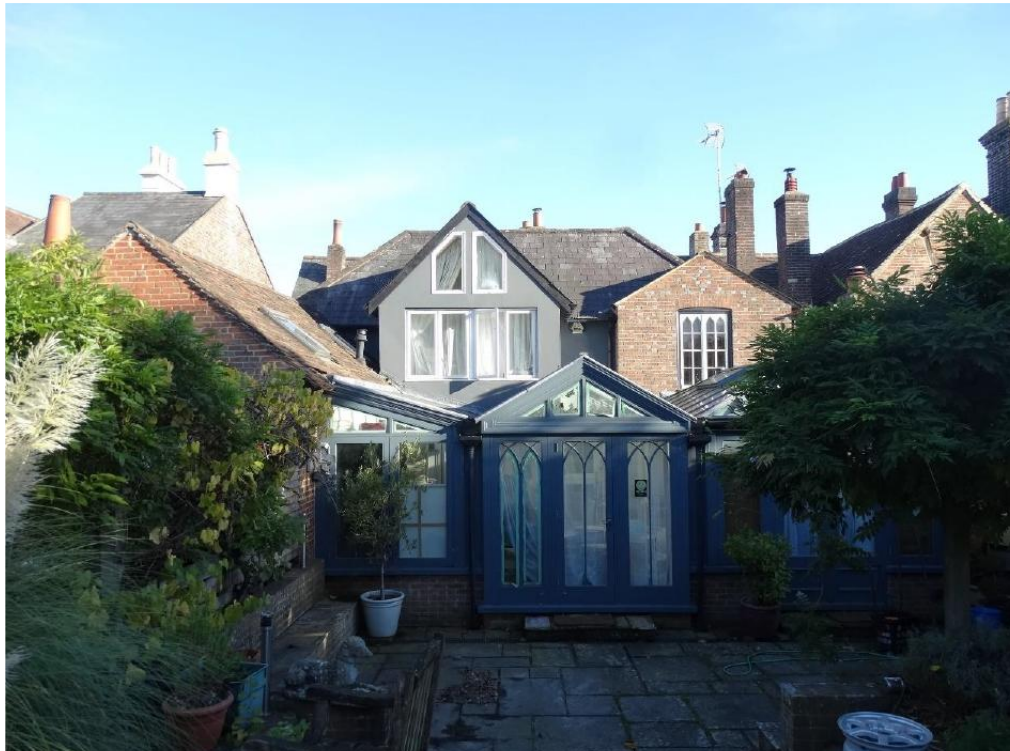
*Figure 7: Marlow House, west elevation, prior to the commencement of the scheme as implemented*

**3.42** The following sequence of OS Maps provides an indication of changes to the building footprint over time, demonstrating remarkably little change until the late 20<sup>th</sup> century. Prior to the implemented scheme, the west (rear) elevation (**Figure 7**) presented a very confused and confusing picture of the listed building. The

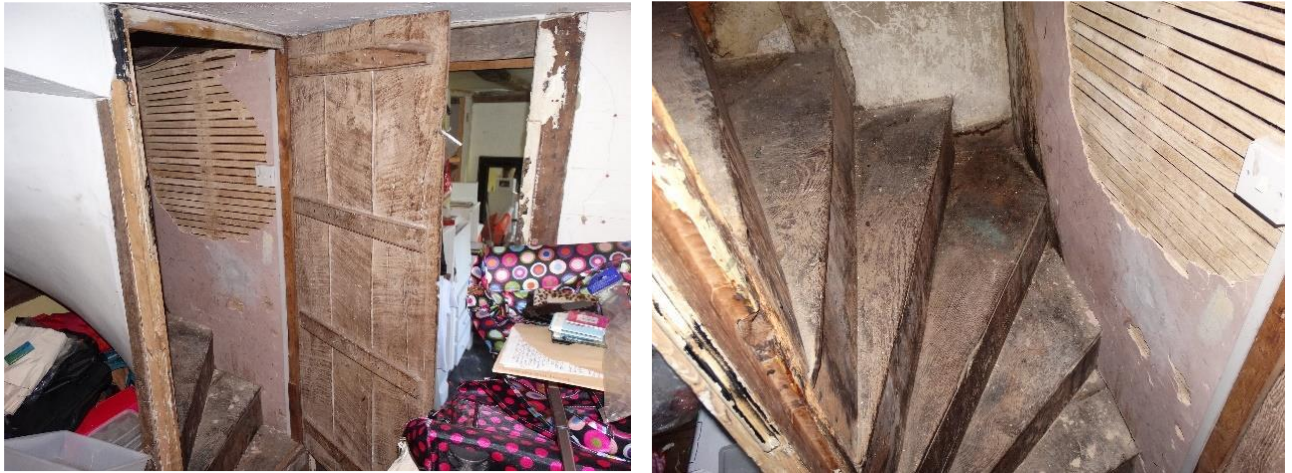
*Figure 11: Views of the 17<sup>th</sup> century upper flight of the corkscrew staircase. Source: Desbruslais Chartered Surveyors Statement of Heritage Significance of 13<sup>th</sup> October 2022*

**3.27** Later phases of stair have been added. The 17<sup>th</sup> century winding stair to the loft rooms are partially complete. The upper part from the landing to the second floor as shown in the images below was complete and shows no serious loss of material apart from wall plaster to the enclosure (**Figure 11**). The latter appears to have been modern gypsum plaster applied to a relatively recent lath system.

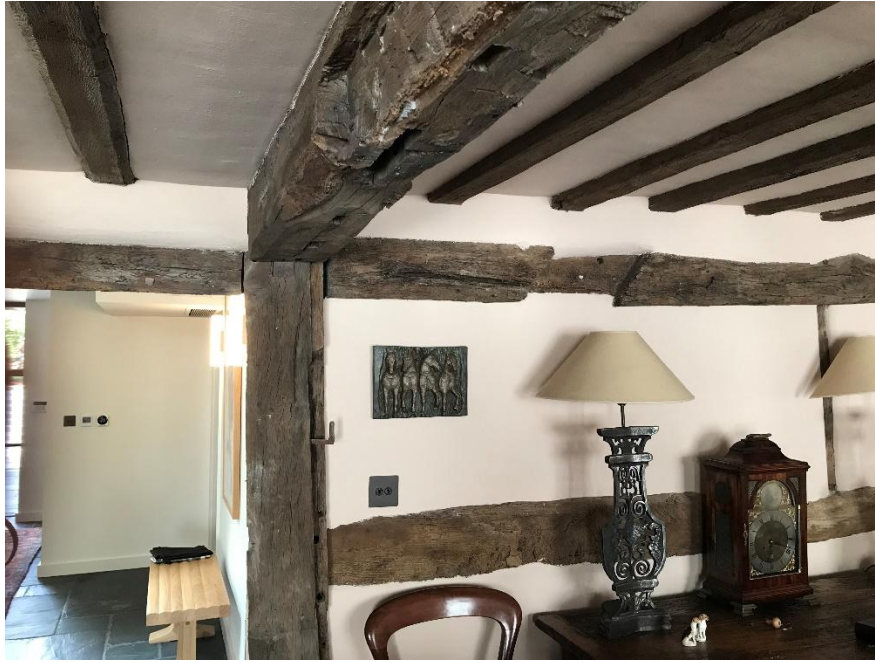
*Figure 12: main E-W ceiling beam to the living room showing the location of an original partition and doorway adjacent to the northwest wall. The timber jamb post is proposed to be reinstated.*

**3.31** The ground floor central room has had much of the original timber lateral partitioning removed at some time in the past, as evident from the exposed mortices to the soffit of ceiling beams in the southern ground floor room and main living room north of the chimney breast (**Figures 12 and 13**). Whilst there is some central support in masonry, the joint where the axial first floor support beam

**3.32** However, the underside of the tie does reveal the design of the partition in this instance, and the doorway at the end into the snug area looks to be in its original position (**Figure 12**).

**5.21** This room was previously partitioned as evidenced by the mortices to the soffit of the main ceiling beam (**Figure 12**). The proposed position of the new partition is on a different alignment but would read as a contemporary intervention of a wholly sympathetic nature that provides much needed amenity within the domestic provision of the house. Since 1987 there have been at least 2 downstairs WCs in the property (*cf.* **Appendix 3**) and there is a strong justification on practical grounds to locate the WC in the proposed location on account of compatibility with historic plan form and layout of the dwelling as a whole. The effect on the listed building as a result of this change would be neutral.

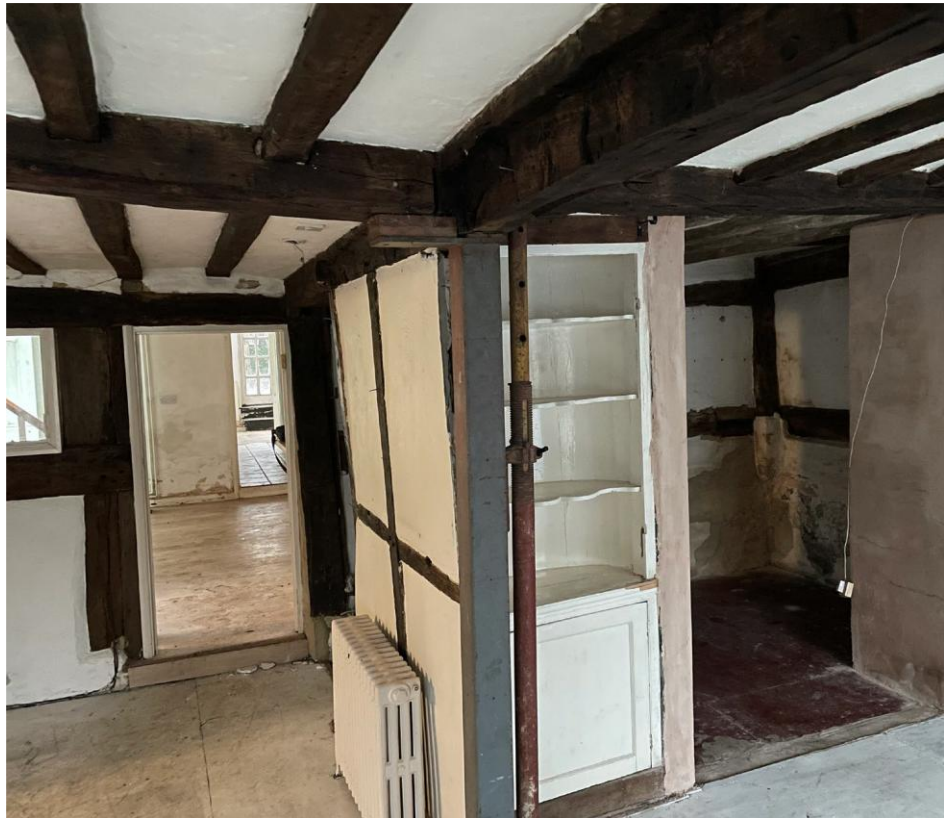
*Figure 14: Central supporting post to main living room. The partitions to the small snug room were of largely modern construction. Source: McCarey Simmonds, Structural Inspection Report of 15<sup>th</sup> March 2023*

crossed the tie is weak and has had to be propped with modern steelwork (**Figure 14**). The existing seasoned oak gunstock post which replaced the improvised support is shown at **Figure 15**.

**5.34** To implement the above repair it was necessary to remove a short section of stud partition which previously enclosed a small snug to the northwest corner of the main parlour (**Figure 14**). The timber studs were of uncertain provenance but the quality of the timber in conjunction with the modern in-fill panelling suggests that the stud partition did not comprise historic fabric, though possibly contemporary with the inserted 19<sup>th</sup> century chimney stack. Some crude 'cutting in' to the main beam (**Figure 12**) also suggests that this partition had been altered to accommodate some fitted joinery or other furniture at the time the partition was added since it lines up squarely with the recessed face of the clearly later cut back section of the main beam.

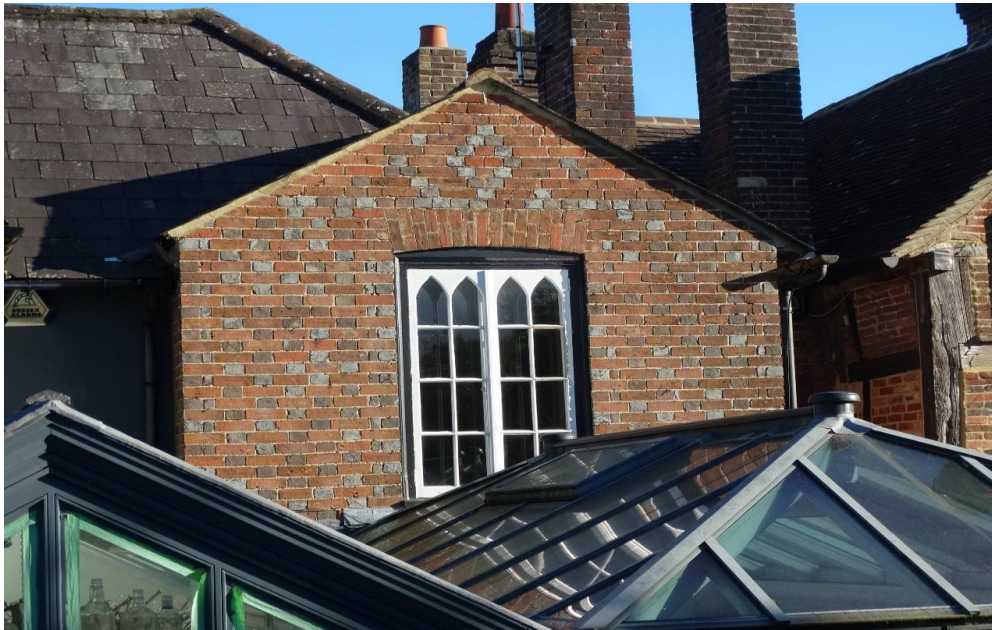
Figure 17: 1830s gabled outrigger with vitrified blue brick header detailing. Source: Desbruslais Chartered Surveyors Statement of Heritage Significance of 13<sup>th</sup> October 2022

- 3.38** The rear projecting two storey extension was added circa 1830. It is fabricated in solid brick masonry in a Flemish bond, showing off blue glazed headers (**Figure 17**).

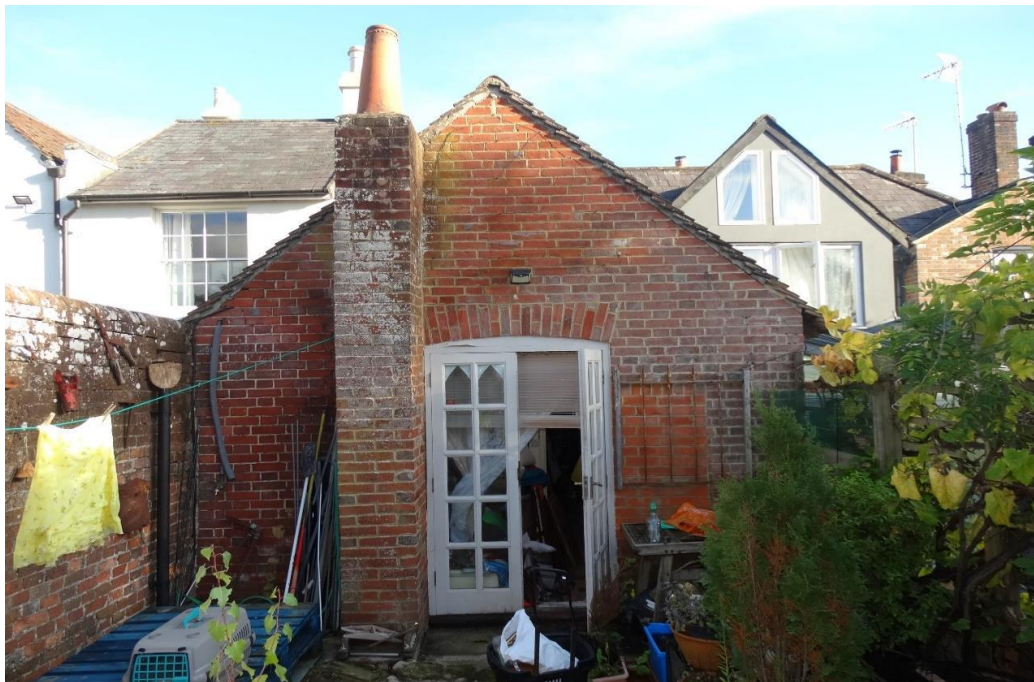
Figure 18: View of the former Bake House from the west prior to dismantling. Source: Desbruslais Chartered Surveyors Statement of Heritage Significance of 13<sup>th</sup> October 2022

- 3.41** A Bake House was also added to the rear, of which only the outer walls remained in situ (**Figure 18**). No internal features survived, and the interior linings and fixtures were wholly modern.

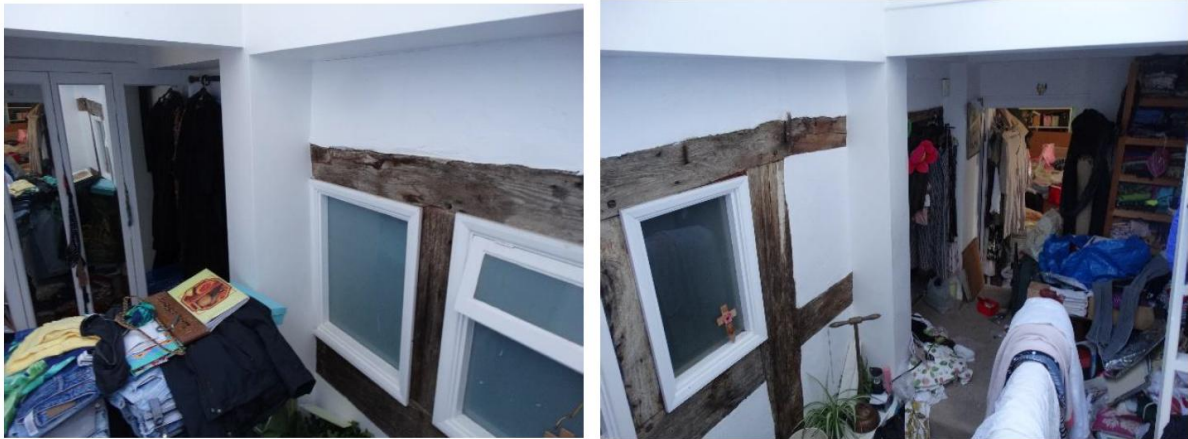
*Figure 29: Box framing to rear (west) wall of the 15<sup>th</sup> century house with internalised modern timber casement windows. Source: Desbruslais Chartered Surveyors Statement of Heritage Significance of 13th October 2022*

- the removal of stud partitions which subdivided the southern ground floor room (making it an uncharacteristic linear open plan) as well as the main parlour to the north of the main chimney breast towards the centre of the original house (**Figures 12 and 13**);
- insertion of modern casement windows to the box framing on the west elevation (**Figure 29**); and,
- insertion of rooflights to various roof slopes, including the main west slope of the 15<sup>th</sup> century building (**Figure 30**).

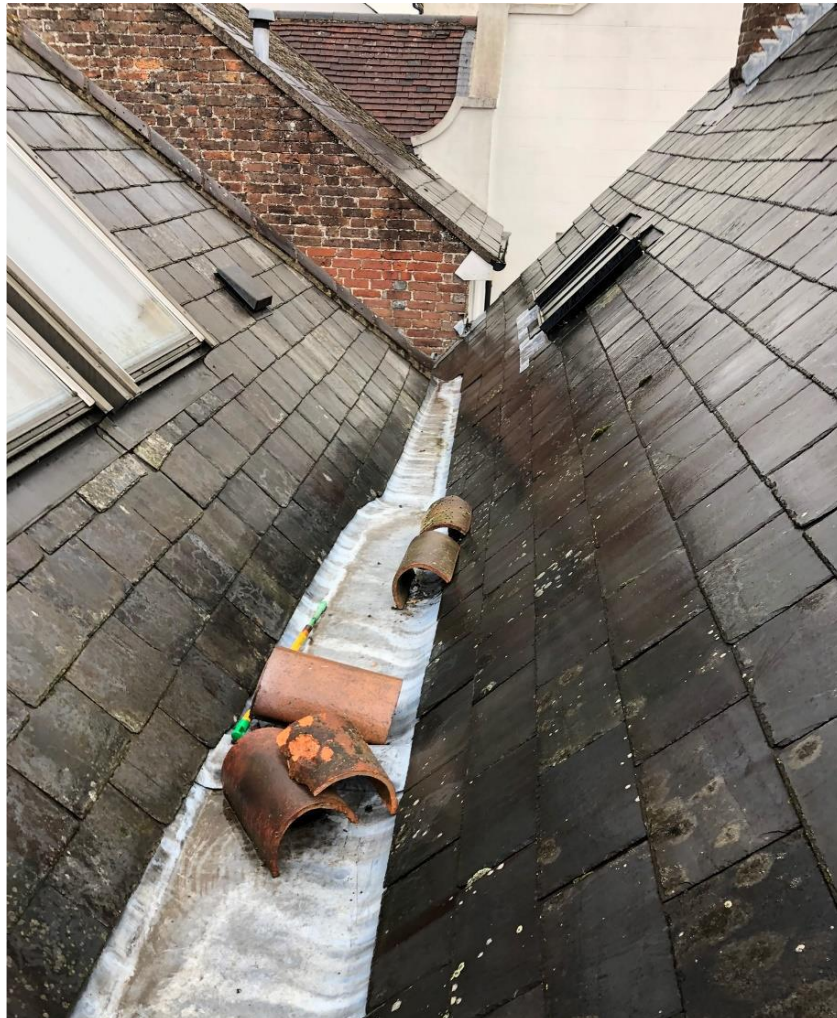
*Figure 30: the rear roof slope to the original 15<sup>th</sup> century building contained no less than 5 rooflights prior to their removal and slating over as part of the implemented scheme. Source: Gould Baxter Survey (October 2022)*

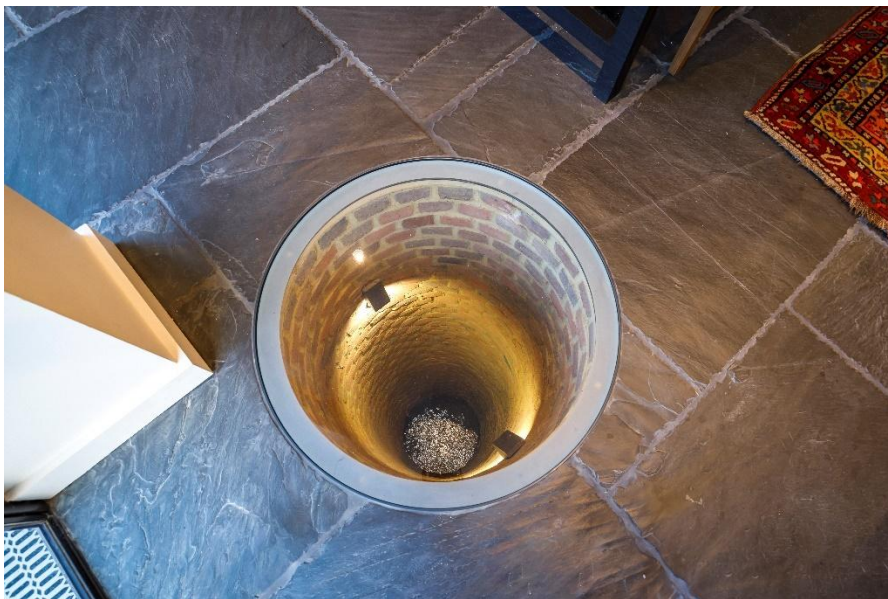
*Figure 31: Rediscovered well shaft (re-lined in handmade brick) and groundwater storage chamber within the kitchen area.*

- 4.16** Where physical evidence remains of changes to the building, and in the surviving historic fabric, there is some archaeological or evidential interest that retains potential for detailed understanding of the development of the building over time. The presence of a well shaft and water storage chamber to the underlying bedrock within the original rear yard (now internalised – **Figure 31**) contributes to the archaeological interest of the Site and also the wider conservation area (see Section 5 below).

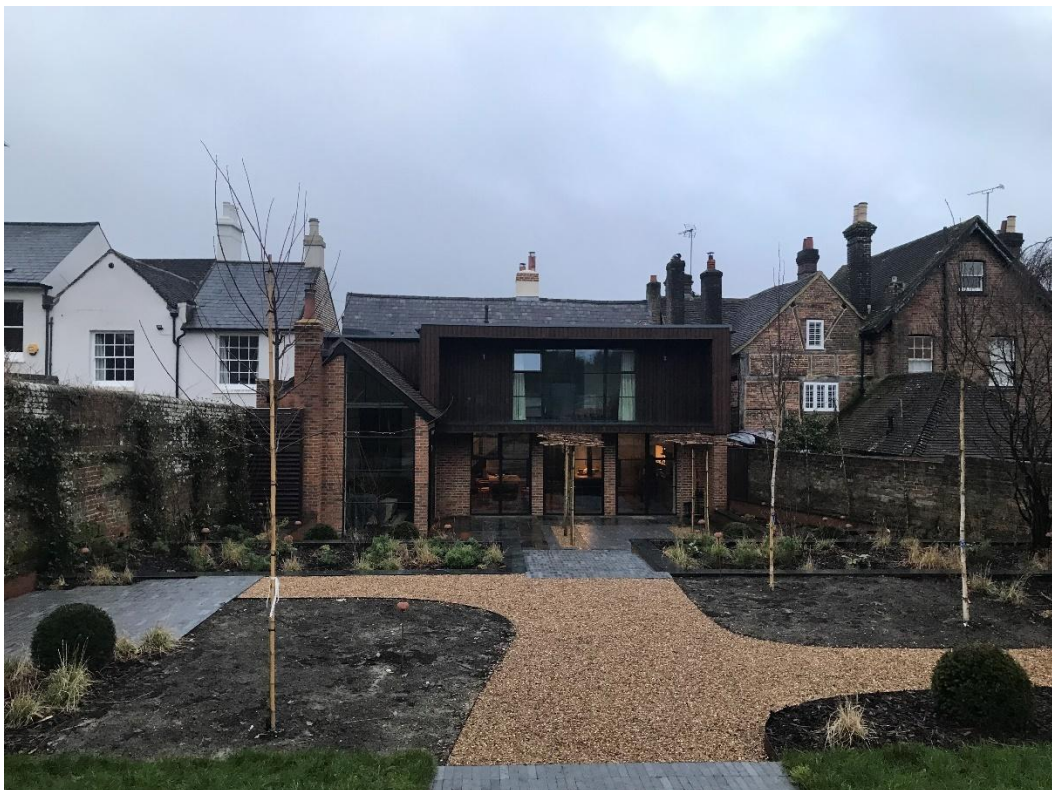
*Figure 32: View of Marlow House from the rear garden (west). Note the prominence of the restored 15<sup>th</sup> century roofscape.*

on the west side of the High Street (**Figure 32**). Many of these buildings are individually listed or otherwise contribute positively to the special character and appearance of the Lindfield Conservation area and common setting of the listed buildings as a coherent historic group, including the adjacent grade II listed buildings at Nos. 105 and 109 High Street.

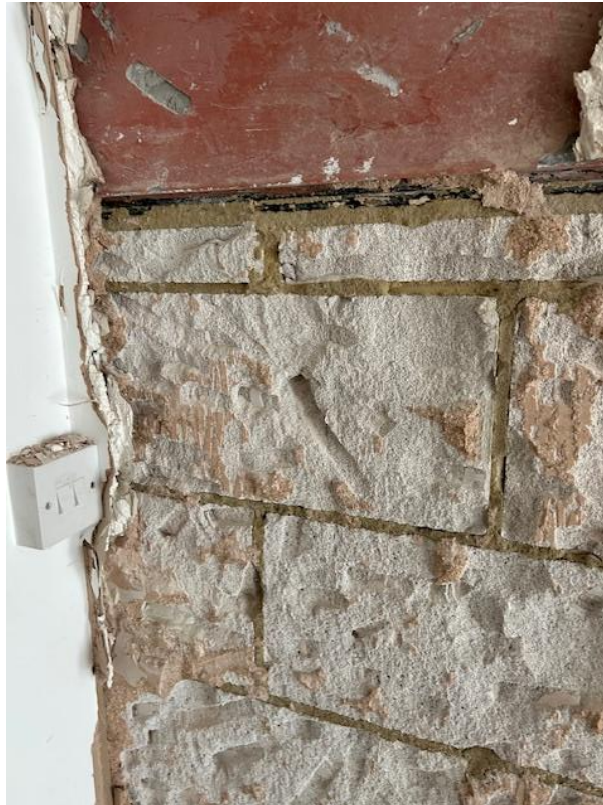
*Figure 35: Blockwork construction underlying the exposed timber stud wall with stonework nogging shown at **Figure 16***

**3.33** One dining room wall which was contrived as a feature wall (**Figure 16**) was subsequently shown to be a cosmetic conceit with the stone 'nogging' applied as a form of cladding to underlying blockwork (cf. **Figure 35**).

- 5.27** This cosmetic stud wall was a legacy of the 20<sup>th</sup> century tea room use. It appears not to have been an original wall or historical feature, as demonstrated by the presence of concrete blockwork within the wall uncovered during its removal (**Figure 35**). The demolition of this partition to create a reveal / recessed cloakroom at the entrance to the ground floor WC improves circulation and layout without harming significance. The impact of this change on the listed building's significance would be a minor heritage benefit as the wall was misleading and interruptive of historic plan form.

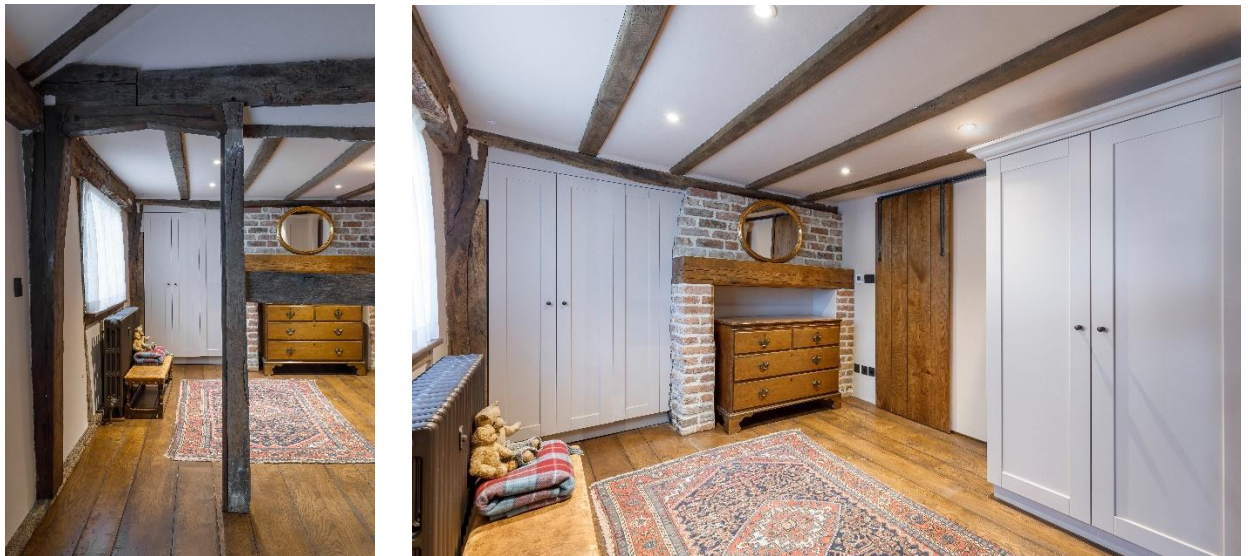
*Figure 36: First floor north bedroom as implemented*

- 5.29** A new partition to create an en-suite bathroom to the north bedroom and removal of modern plasterboard infill from the timber framed spine wall to create a more open plan space (**Figure 36**) has been very sensitively designed with a sliding door to the bathroom and executed to a very high standard. In conjunction with reinstated fireplace / hearth the interpretation of the space is positive and beneficial, resulting in no harm to the listed building's special interest.

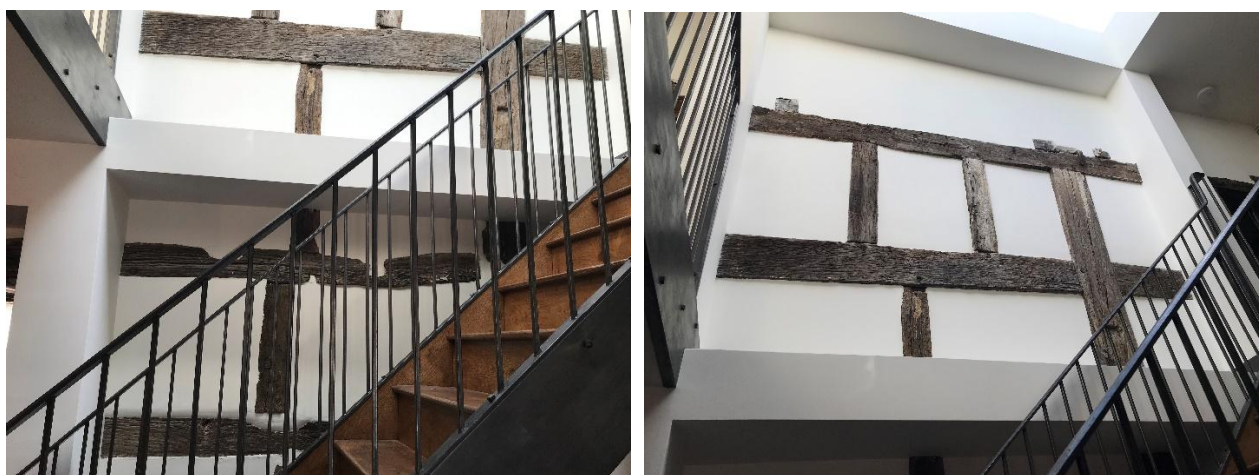
*Figure 37: Box framing to west wall of the 15<sup>th</sup> century house with internal windows infilled with wood wool panels and lime plaster.*

windows would have been in the form of fixed and metal casement lights separated by oak staves or mullions. None of these windows remained in the property prior to the implemented scheme and there is no convincing evidence for their respective positions. The removal of the modern casements and infilling using breathable wood wool boards faced in lime plaster serves to reveal and express the 15<sup>th</sup> century box framing much more clearly and is a significant heritage benefit of the Proposed Scheme (**Figure 37**). This should be weighted accordingly.

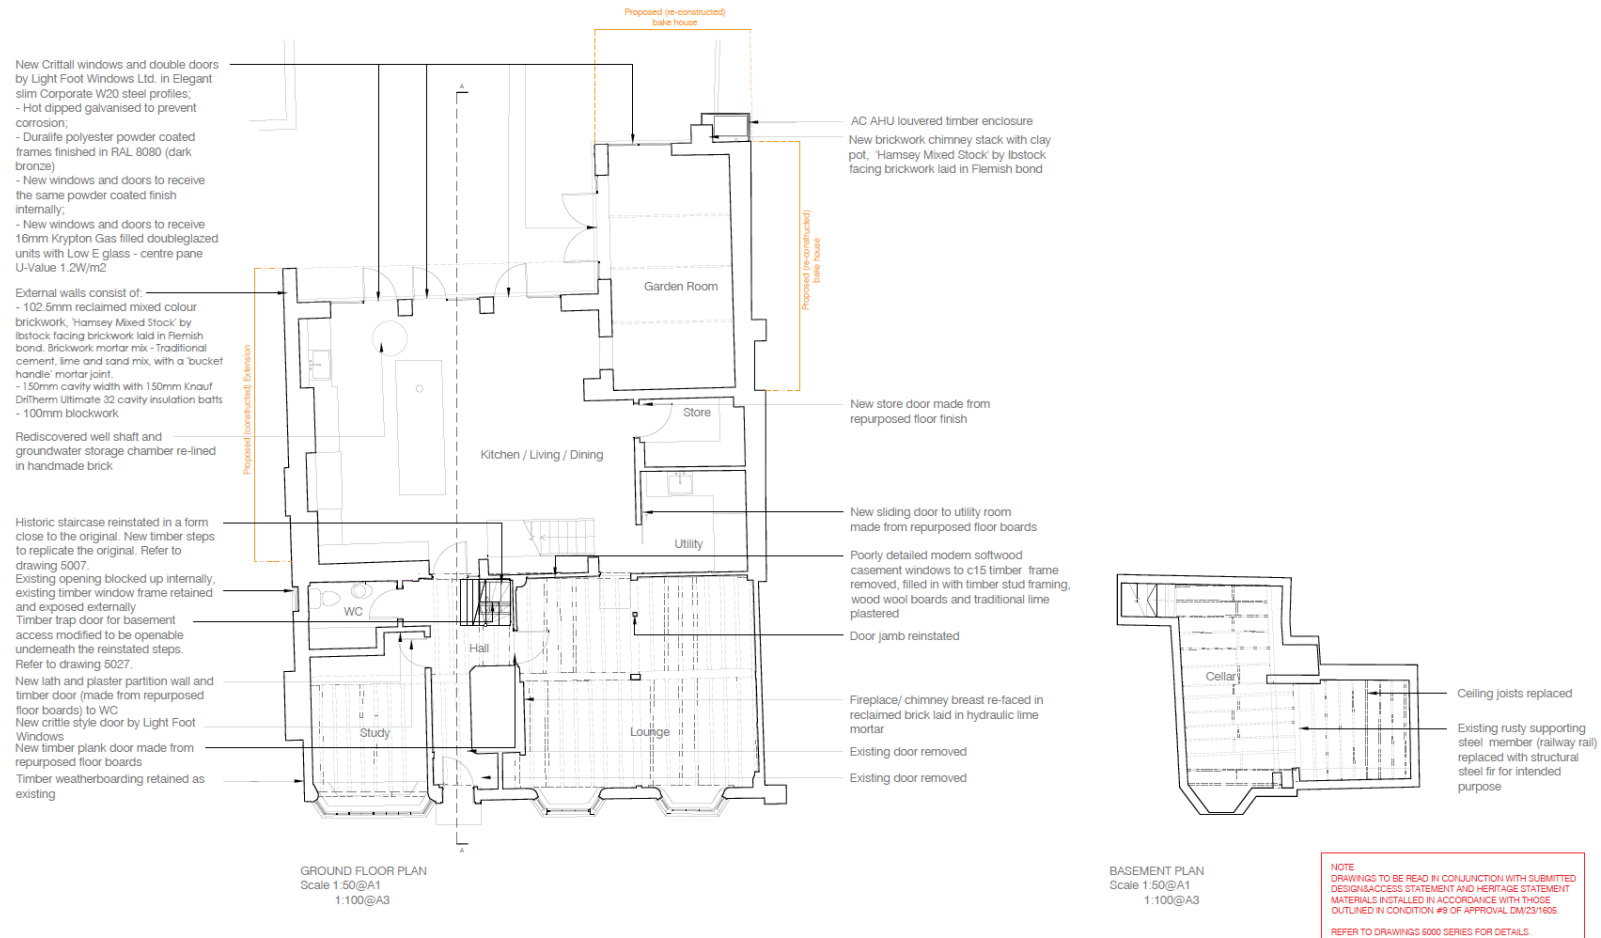
*Proposed Basement and Ground Floor Plan*

21.5mm toughened and laminated clear glass  
balustrade with bespoke fascia brackets and  
50mm projection buttons by South Coast Steel Ltd.

New Crittall windows and double doors by Light  
Foot Windows Ltd. in Elegant slim Corporate  
W20 steel profiles;  
- Hot dipped galvanised to prevent  
corrosion;  
- Duralife polyester powder coated frames  
finished in RAL 8000 (dark bronze)  
- New windows and doors to receive the  
same powder coated finish internally;  
- New windows and doors to receive 16mm  
Krypton Gas filled doubleglazed units with Low E  
glass - centre pane U-Value 1.2W/m<sup>2</sup>

Existing window replaced with new timber sash window

New timber door  
Historic staircase reinstated in a form close to  
the original. Salvaged timber steps to be reused.  
Refer to drawing 5008.  
Opening and existing door to be reinstated and  
locked shut, exposed on both sides

Existing gypsum plaster ceiling removed, new  
vaulted ceiling installed within existing timber  
rafters
