## Foul and Surface Water Drainage Strategy Report

Land at White Lodge, Ockley Lane, Hassocks, Burgess Hill RH15 0BP

Reference **C2755**

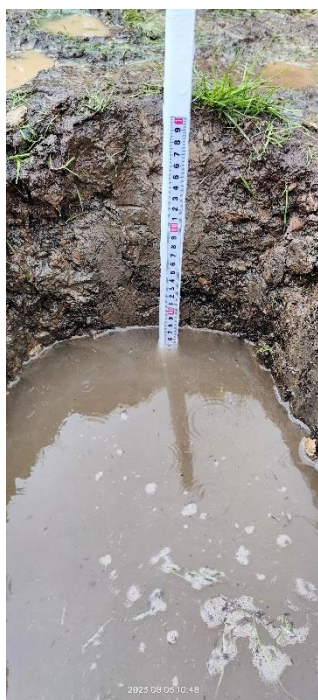
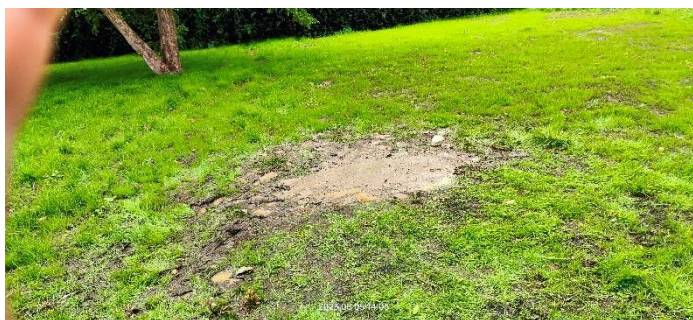
- 2.2.1 An infiltration test was undertaken by CGS Civils Ltd on 4<sup>th</sup> August 2023. The test comprised of the excavation of a trial pit to a depth of 1m which was then rapidly filled with water. It rained during the testing period and the water within the trial pit was noted to rise by approximately 100mm, therefore, the test was considered a failure. The ground was also noted to be waterlogged throughout the day.

Fig 3. Soakaway Test Photographs

- 4.2.1 In order to follow the SuDS hierarchy, the use of soakaways was investigated and an infiltration test was carried out on site. The testing revealed the geology to be made up of thick clay, which was noted to be waterlogged during the rainy day of the test. A trial pit was dug to a depth of 1mbgl and the rapidly filled with water in accordance to BRE365, however, due to the rainy conditions, the water level of the pit was noted to rise approximately 100mm and therefore, the test was considered a failure.

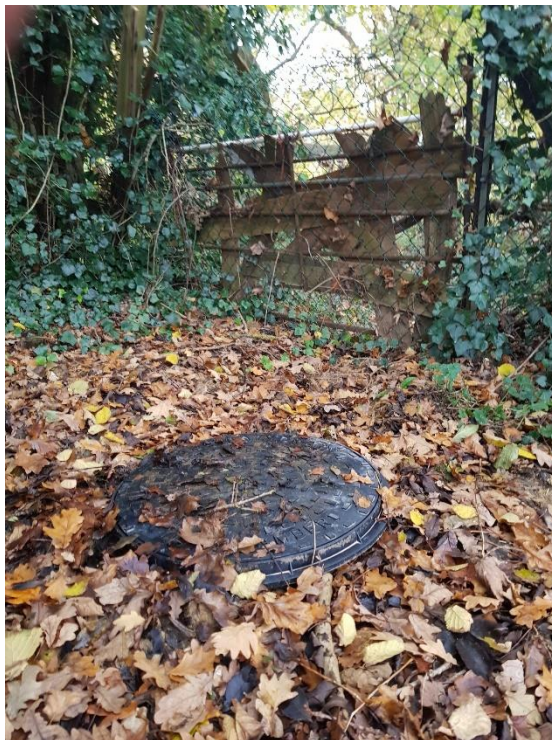
- 3.1.1 As the existing site consists of a tennis court, there is no existing drainage. During the soakaway testing, an existing French drain and chamber was noted on site. It is believed that this drains into the neighbouring property. A CCTV drainage survey should be undertaken in order to confirm the discharge location. The client has confirmed that the existing White Lodge is served by a package treatment plant which discharges into an inspection chamber located in the Southwestern corner of the site.

Fig 4. Existing chamber

- 4.2.2 During the site visit, it was noted that an existing French drain bordered the existing tennis courts and flowed towards the neighbouring property to the west. It was confirmed by the client that a discharge into this chamber will not be suitable for the discharge and there is an alternative chamber located within the southwestern corner of the site which is suitable to discharge the surface water into. This chamber discharges existing treated effluent runoff into a drainage ditch within a neighbouring property. It is therefore proposed that the surface water runoff from the site is to be discharged into this chamber at a restricted rate of 1.0l/s. The hard paved areas are to be constructed from a permeable gravel build up which is to be wrapped in an impermeable geomembrane which will allow it to act as a blanket attenuation tank. It is proposed that a diffuser unit is to be installed within a low point of the sub-base in order to allow all runoff to freely discharge into the sub-base. The storage has been designed to cater for the 1 in 100-year +45% storm.
