**BS5837:2012 TREE SURVEY AND  
ARBORICULTURAL IMPACT ASSESSMENT:  
Lullings Cottage, West Hill, Ardingly, West Sussex  
RH17 6QY**

Our reference: GHA/DS/162320:25a

# Arboricultural Impact Assessment

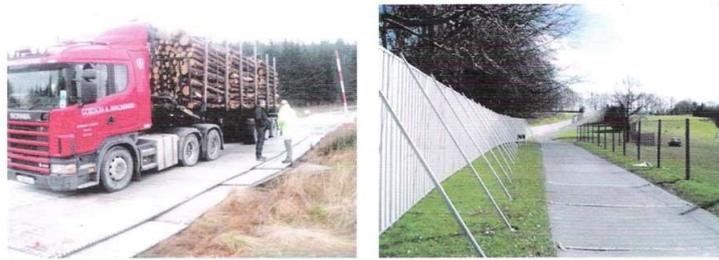
Where heavier vehicular access is required within the RPA, these areas **MUST** be covered using the Eve Trakway system (or a similar product) as shown in the photo below.

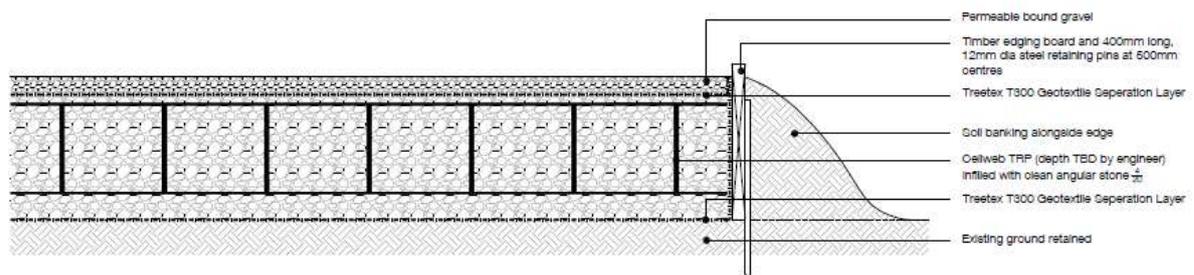
## No dig drive makeup

The sections of the new driveway that are within the RPA's of the retained trees **MUST** be constructed as follows.

- 6.9 Where sections of the new parking are within the RPA of G29 and T32, an “up and over” style construction will be necessary, to ensure that all existing ground levels are retained in their current form, as well as ensuring that satisfactory moisture and oxygen can be obtained from the underlying soil by any tree roots in this area. A design for this proposed access route must be drawn up by a structural engineer, in close co-ordination with the retained arboriculturalist. A preliminary method statement has been included at section 8 of this document.

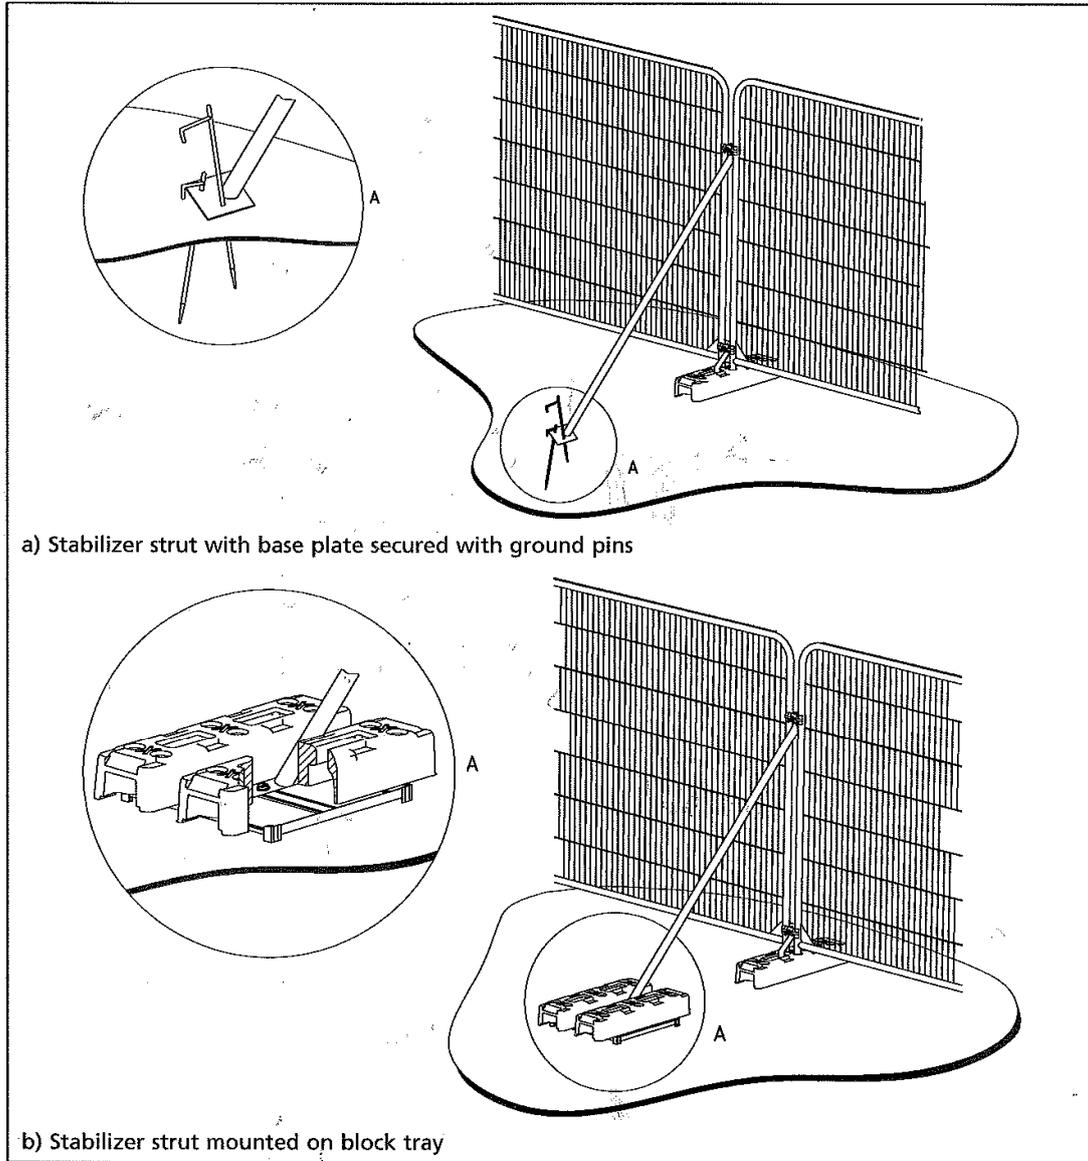
Figure 3 Examples of above-ground stabilizing systems

**Appendix C**  
**TREE FENCING DETAIL**
