**DESIGN & ACCESS STATEMENT**  
**FOR**  
**CONVERSION AND REFURBISHMENT OF**  
**OUTBUILDING FOR ANCILLARY USE**

**OUTBUILDING AT THE OLD BAKERY**  
**65 – 65A HIGH STREET**  
**LINDFIELD**  
**WEST SUSSEX**  
**RH16 2HN**

| REVISION | DATE | STATUS |
|---|---|---|
| B | 15.01.25 | HOUSEHOLDER APPLICATION FOR PLANNING &<br>LISTED BUILDING CONSENT |

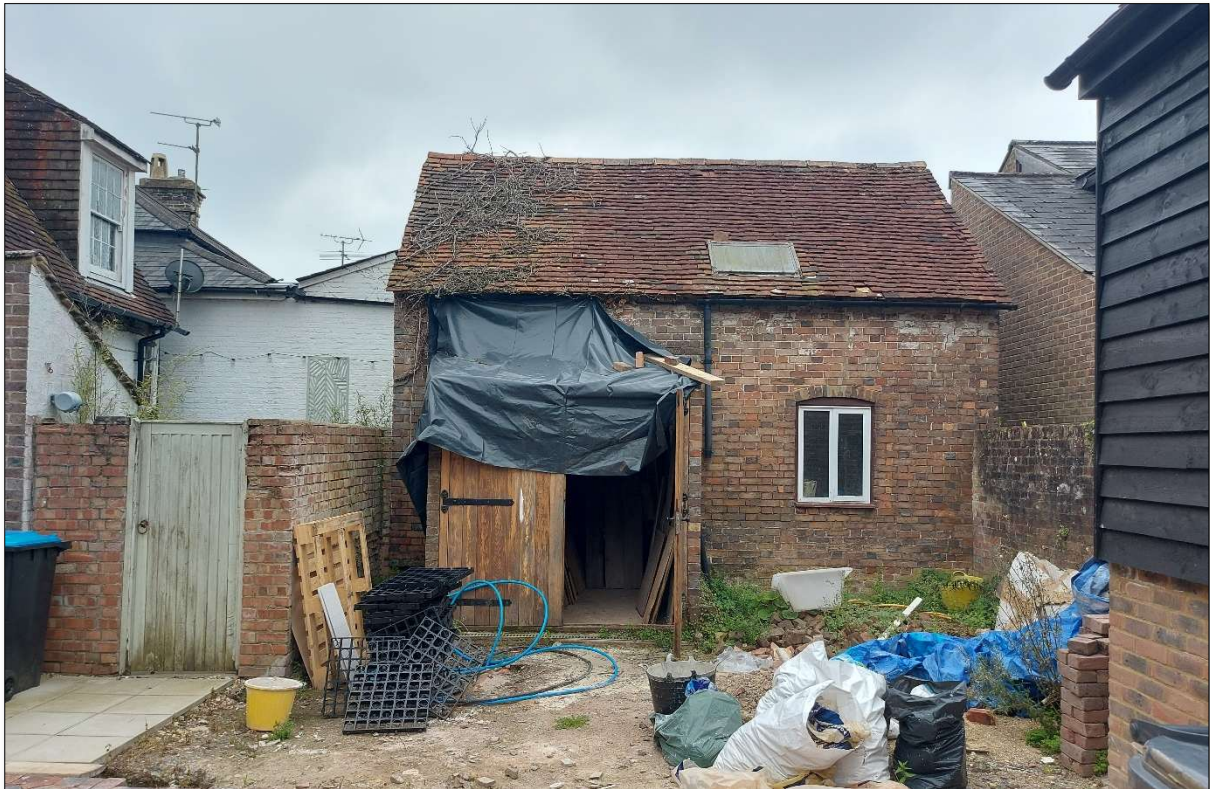
▪ FRONT ELEVATION OF OUTBUILDING

- 3.1 The outbuilding has been extended and modified in the past incorporating a single-skinned brick porch structure with double doors and corrugated metal roof, concrete floor slab, contemporary window and roof window.

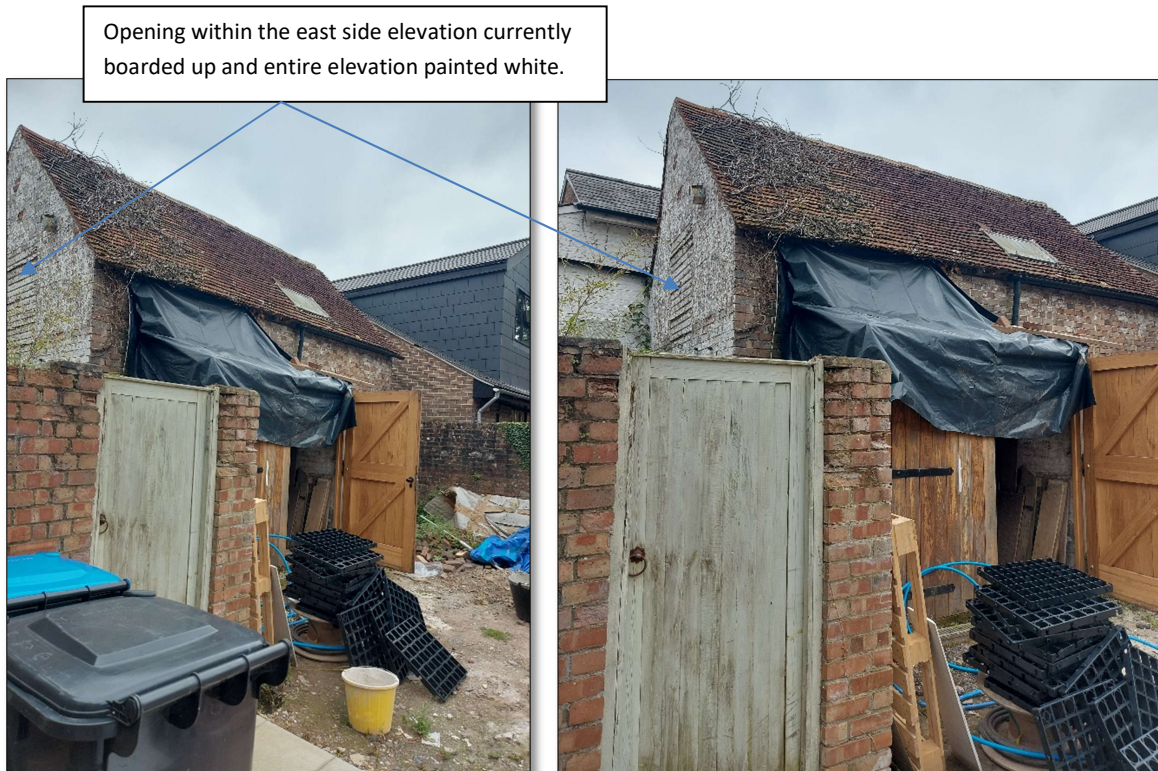
- FRONT & EAST SIDE ELEVATION OF OUTBUILDING. BRICK BOUNDARY WALL AND GATE ACCESS FROM No.63 HIGH STREET & EAST SIDE ELEVATION OF THE LINDFIELD MEDICAL CENTRE.

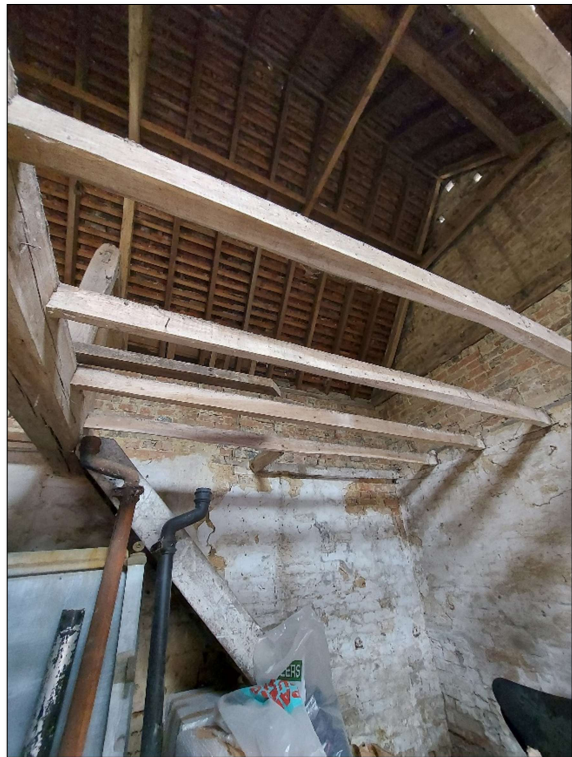
- LEFT: INTERNAL VIEW OF THE WEST FACING GABLE ELEVATION. EXISTING CEILING JOISTS AND VAULTED ROOF.
- RIGHT: INTERNAL VIEW OF THE WEST FACING GABLE ELEVATION AND SOUTH WALL. EXISTING CEILING JOISTS, VAULTED ROOF AND LADDER.

3.9 The brick walls are 225mm thick up to wall plate level and then single-skinned gables.

- 3.10 Timber ceiling joists forming a mezzanine level are built into the gable walls, with cement and fixed to the main timber beam that runs midway across the rear and front elevations.
- 3.11 The mezzanine level is accessed via a timber ladder, with trimmers defining the stair access.
- 3.12 The brick walls are rendered up to the ceiling joist level and exposed brickwork reveals open joists and some localised cracks that require repairs. Unable to inspect condition of wall plate.

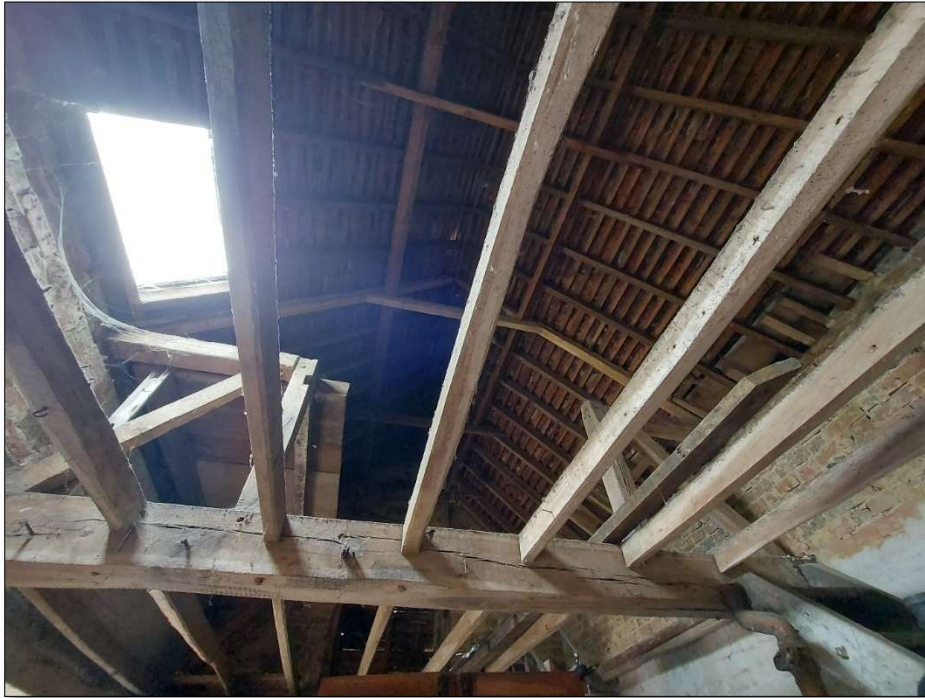
- INTERNAL VIEW FACING EAST SHOWING EXISTING MEZZANINE LEVEL/STRUCTURE AND ROOF WINDOW.

- 4.4.8 Dismantling of the existing roof window, which is in a poor condition, and replacing it with a conservation type roof window to sit flush with the roof line.
