# JUSTIFICATION

## REMOVAL OF INTERNAL CASEMENT WINDOWS

107 HIGH STREET, LINDFIELD, HAYWARDS HEATH, RH16 2HR

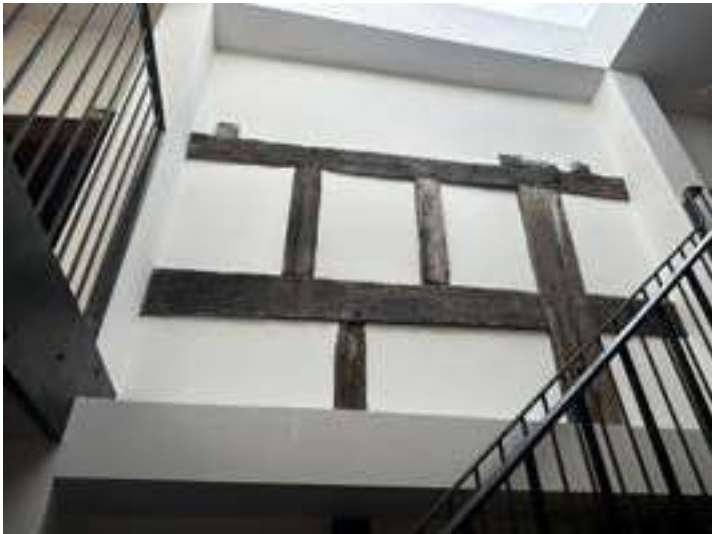
The windows were not original, added in 1990s and poorly detailed. After their removal the openings have been infilled with traditional fibrous wood wool boards faced in lime plaster. This change reveals and expressed the 15th century timber framing, which has been carefully repaired and renovated, which according to the supporting HCUK report is a significant heritage benefit.

Recent photograph of west elevation wall with casement windows removed and openings filled in (first floor)

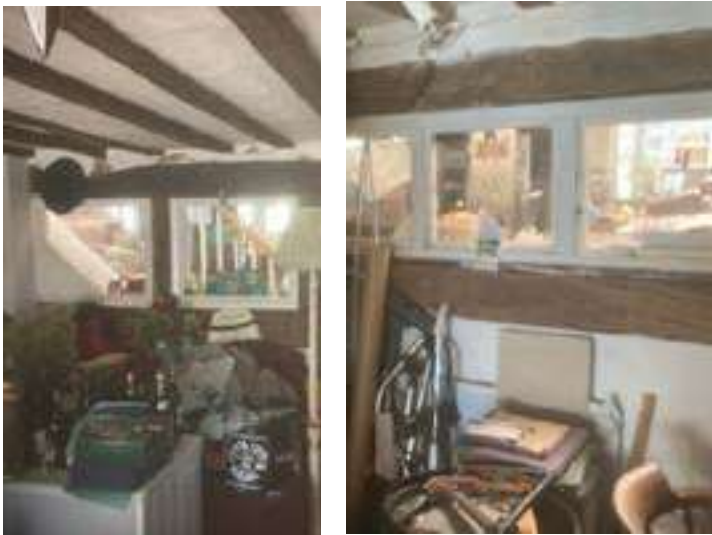
Pre-construction photograph of low quality casement windows, west facade (ground floor)

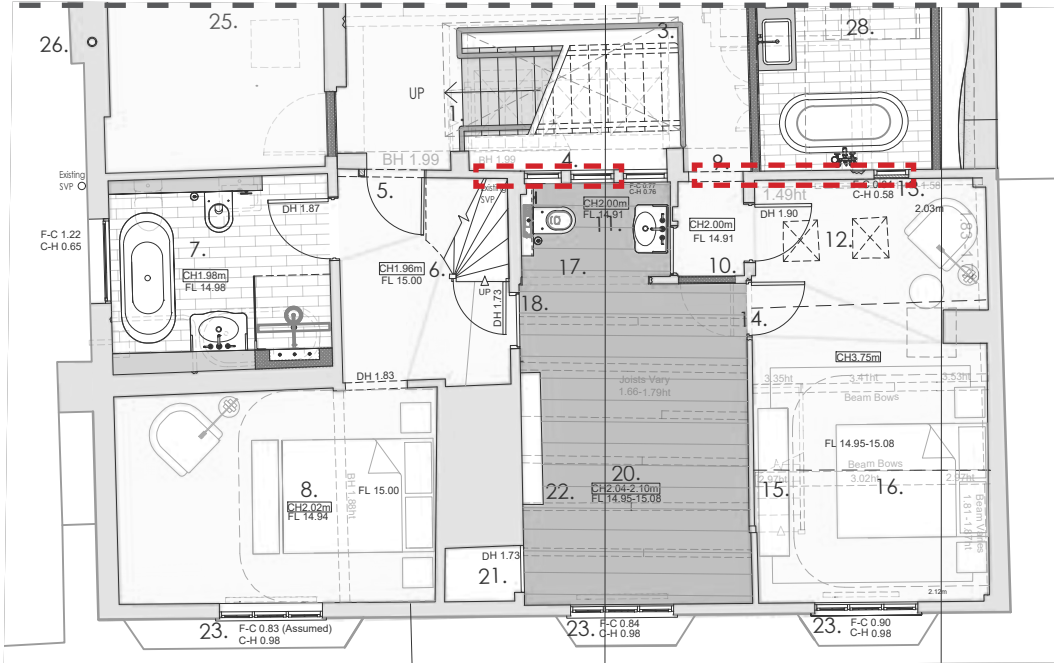
3. Approved first floor plan - submitted drawings under application DM/22/3694 & DM/22/3695 (planning approved)

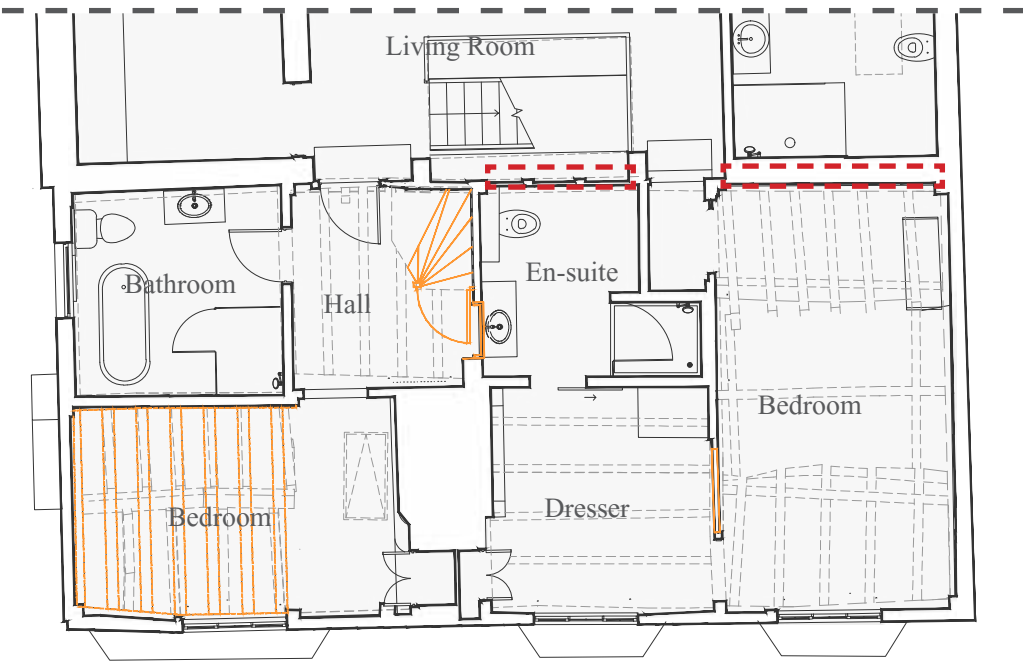
4. Proposed first floor plan

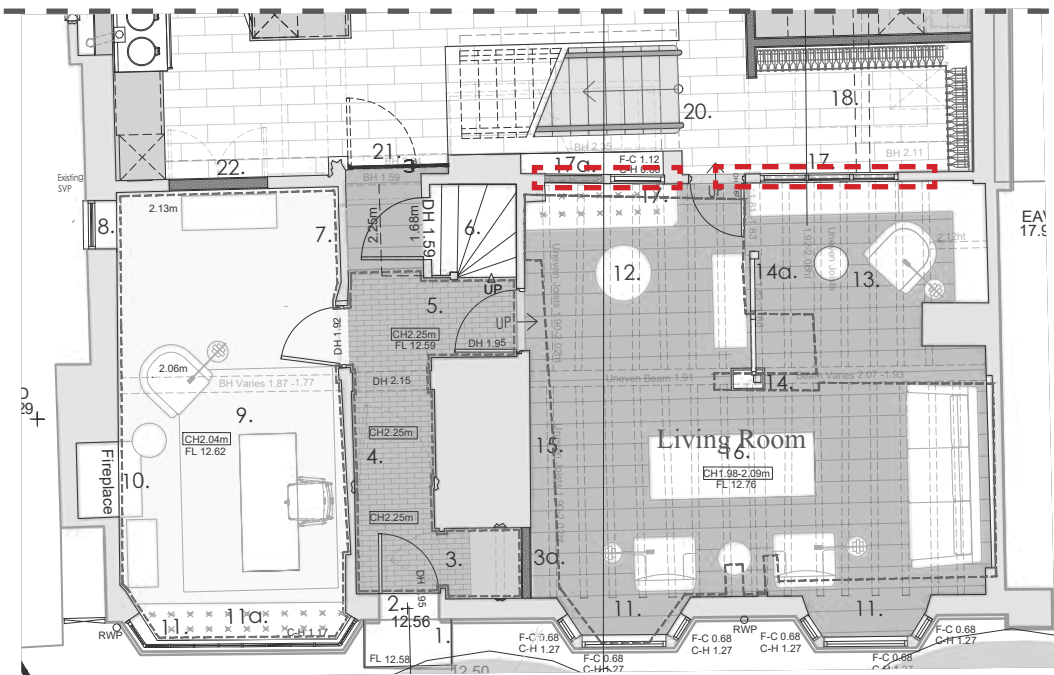
1. Approved ground floor plan - submitted drawings under application DM/22/3694 & DM/22/3695 (planning approved)

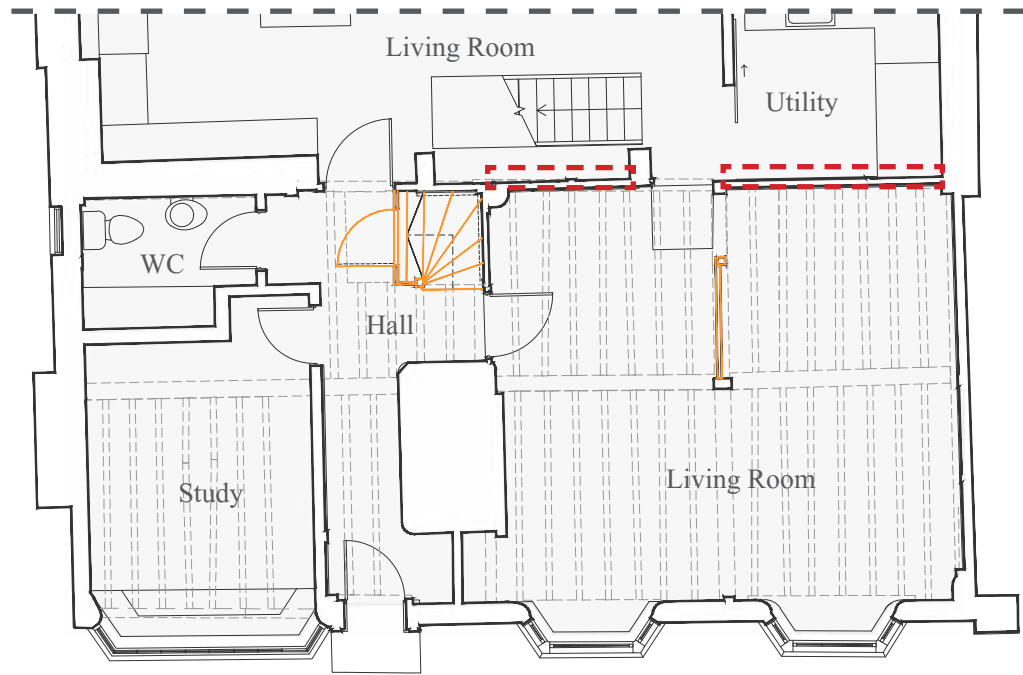
2. Proposed ground floor plan

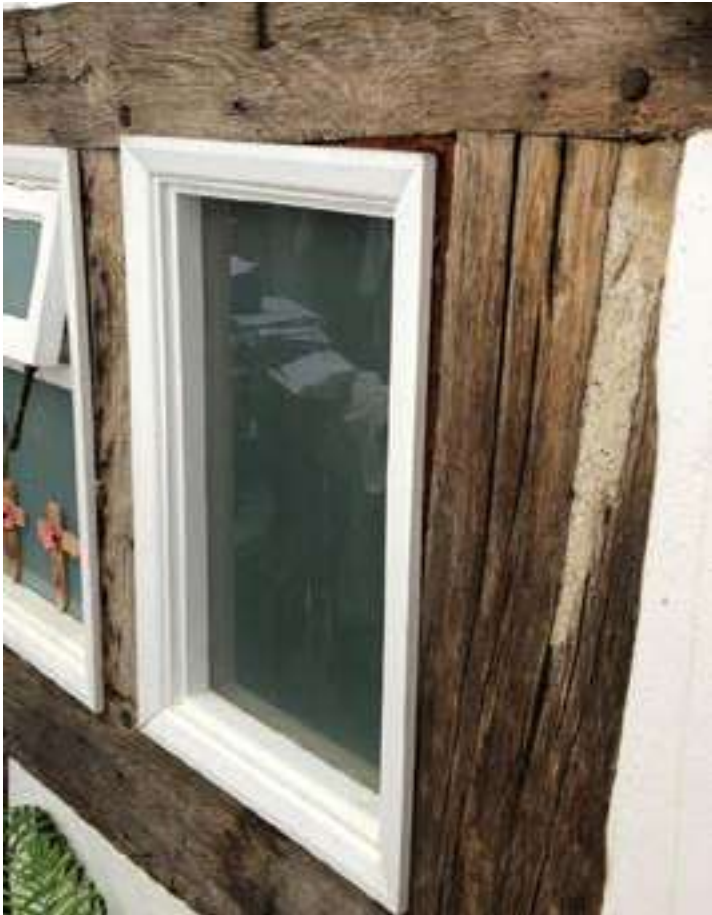
Pre-construction photograph of low quality casement window, west facade (ground floor). Foam around the frame visible.

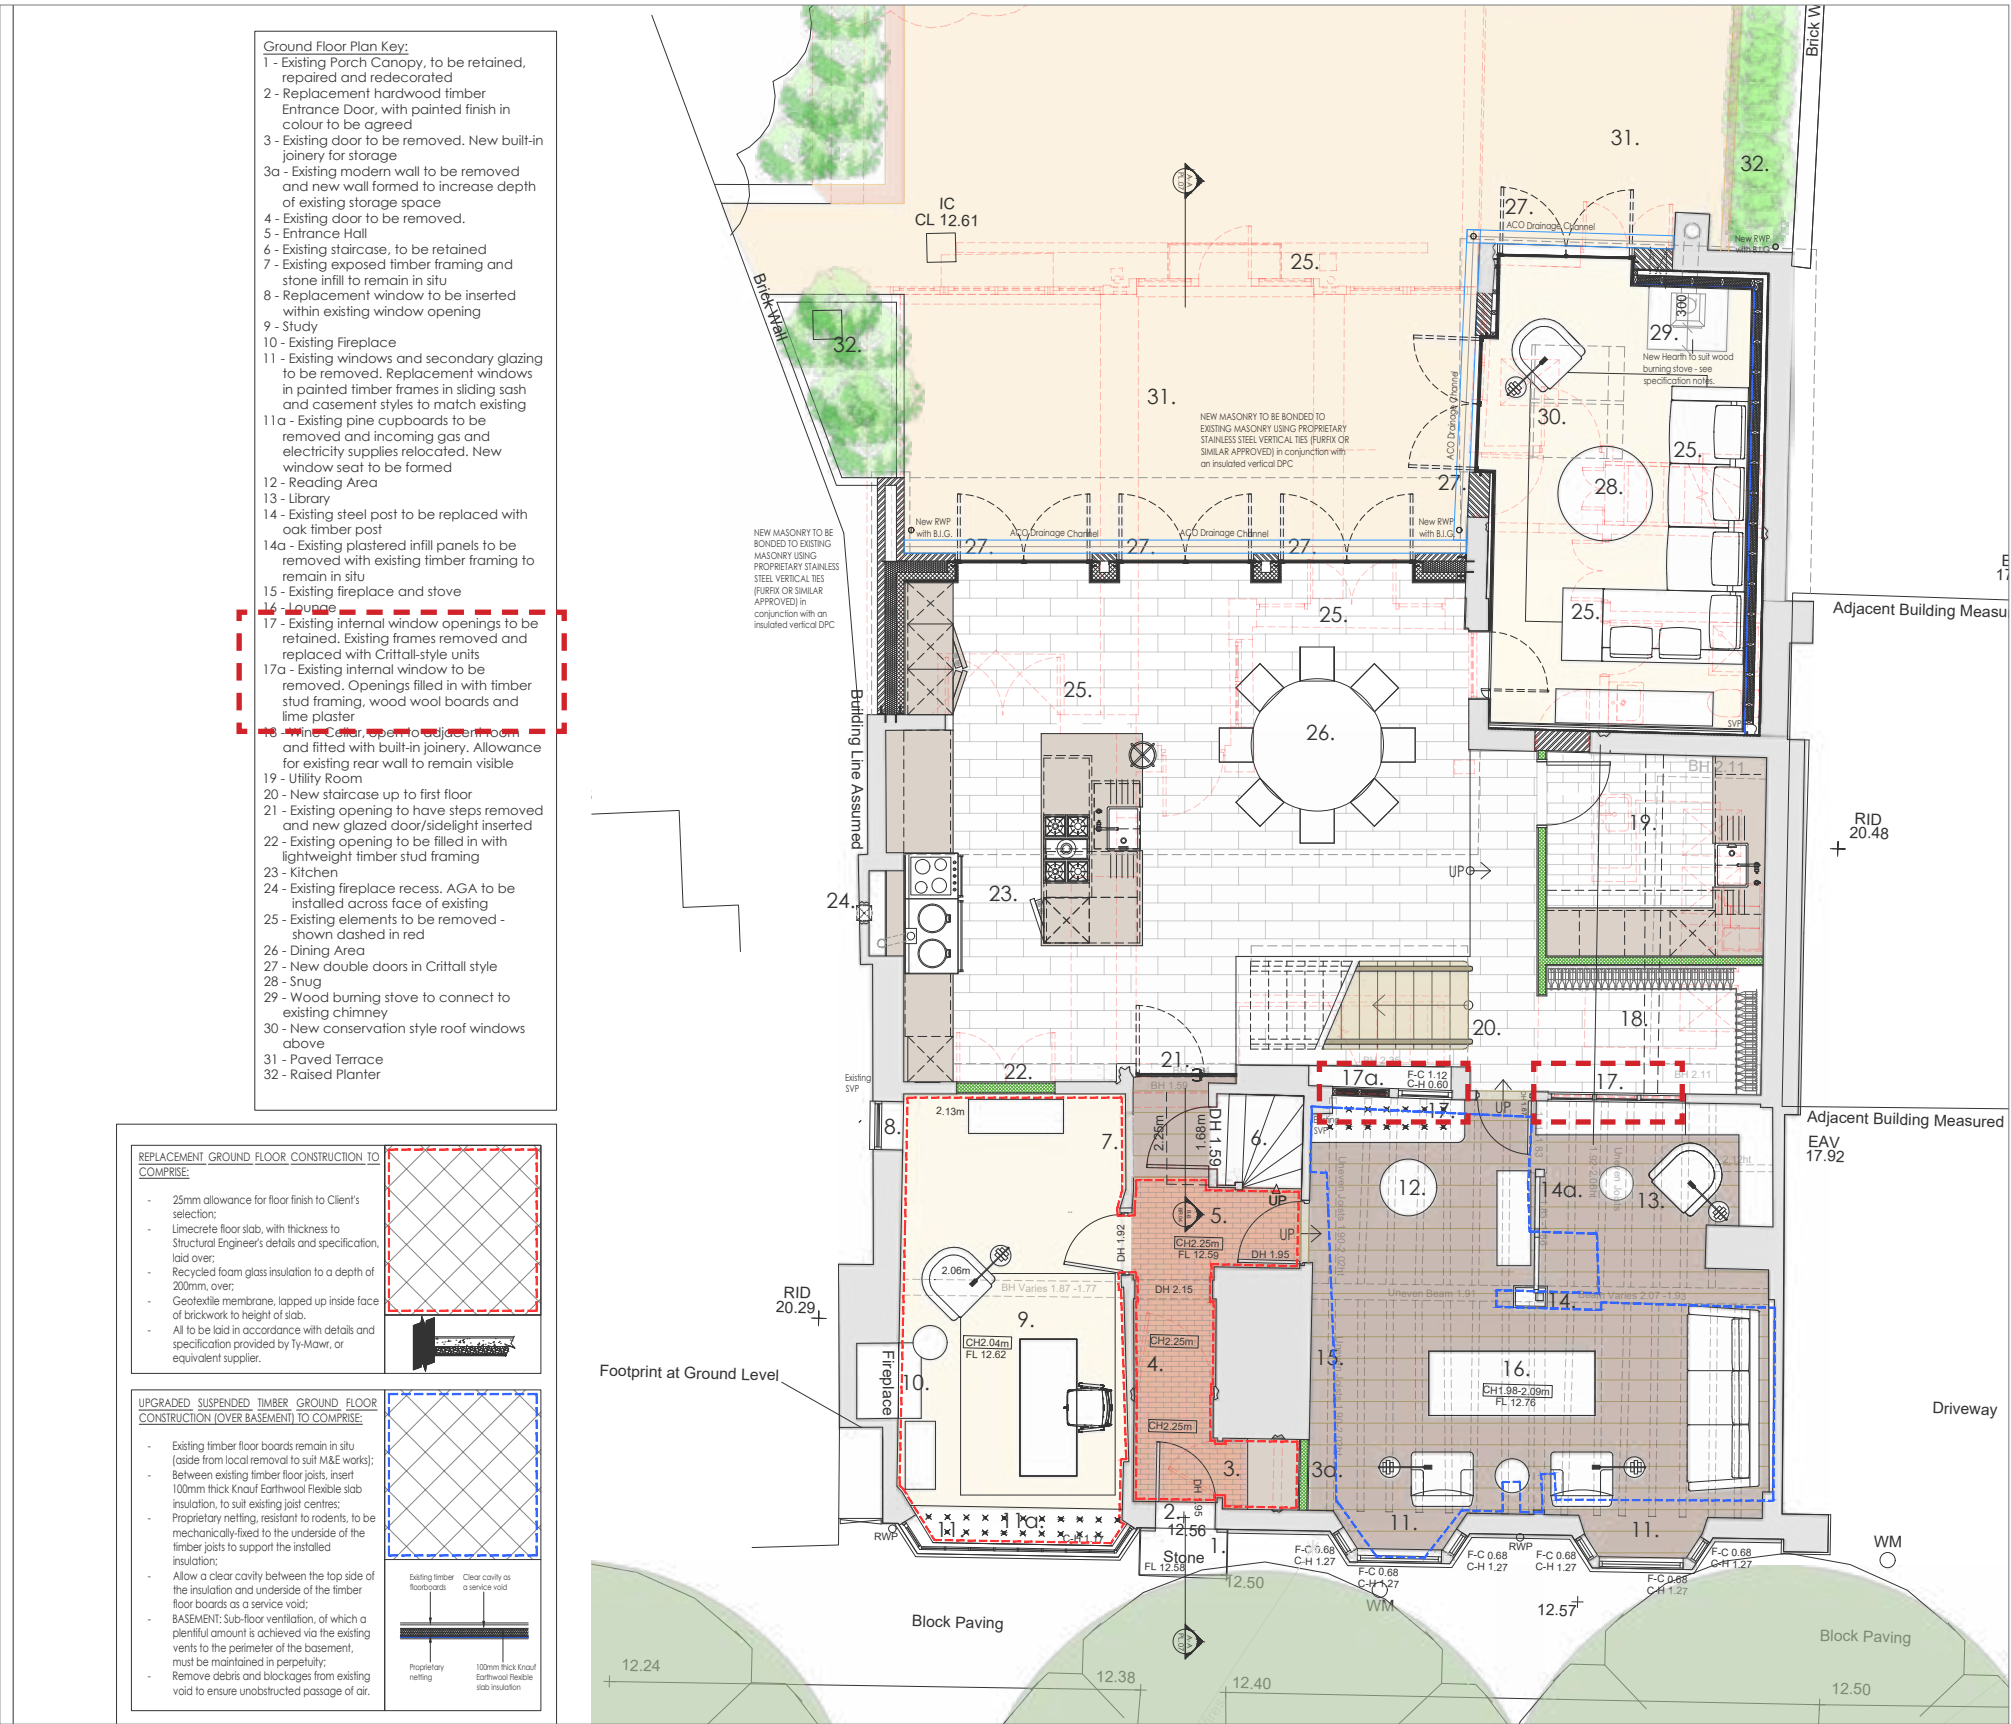
Point 17 of the approved drawing GH342 PL02 Rev B confirms removal of existing casement windows.

Point 17a, relating to the internal opening adjacent to the corkscrew staircase, confirms filling in of the opening with timber stud framing, wood wool boards and lime plaster.

*‘17 - Existing internal window openings to be retained. Existing frames removed and replaced with Crittall-style units*  
*17a - Existing internal window to be removed. Openings filled in with timber stud framing, wood wool boards and lime plaster.’*

Drawing GH342 PL02 Rev B approved drawings under application DM/22/3694 & DM/22/3695

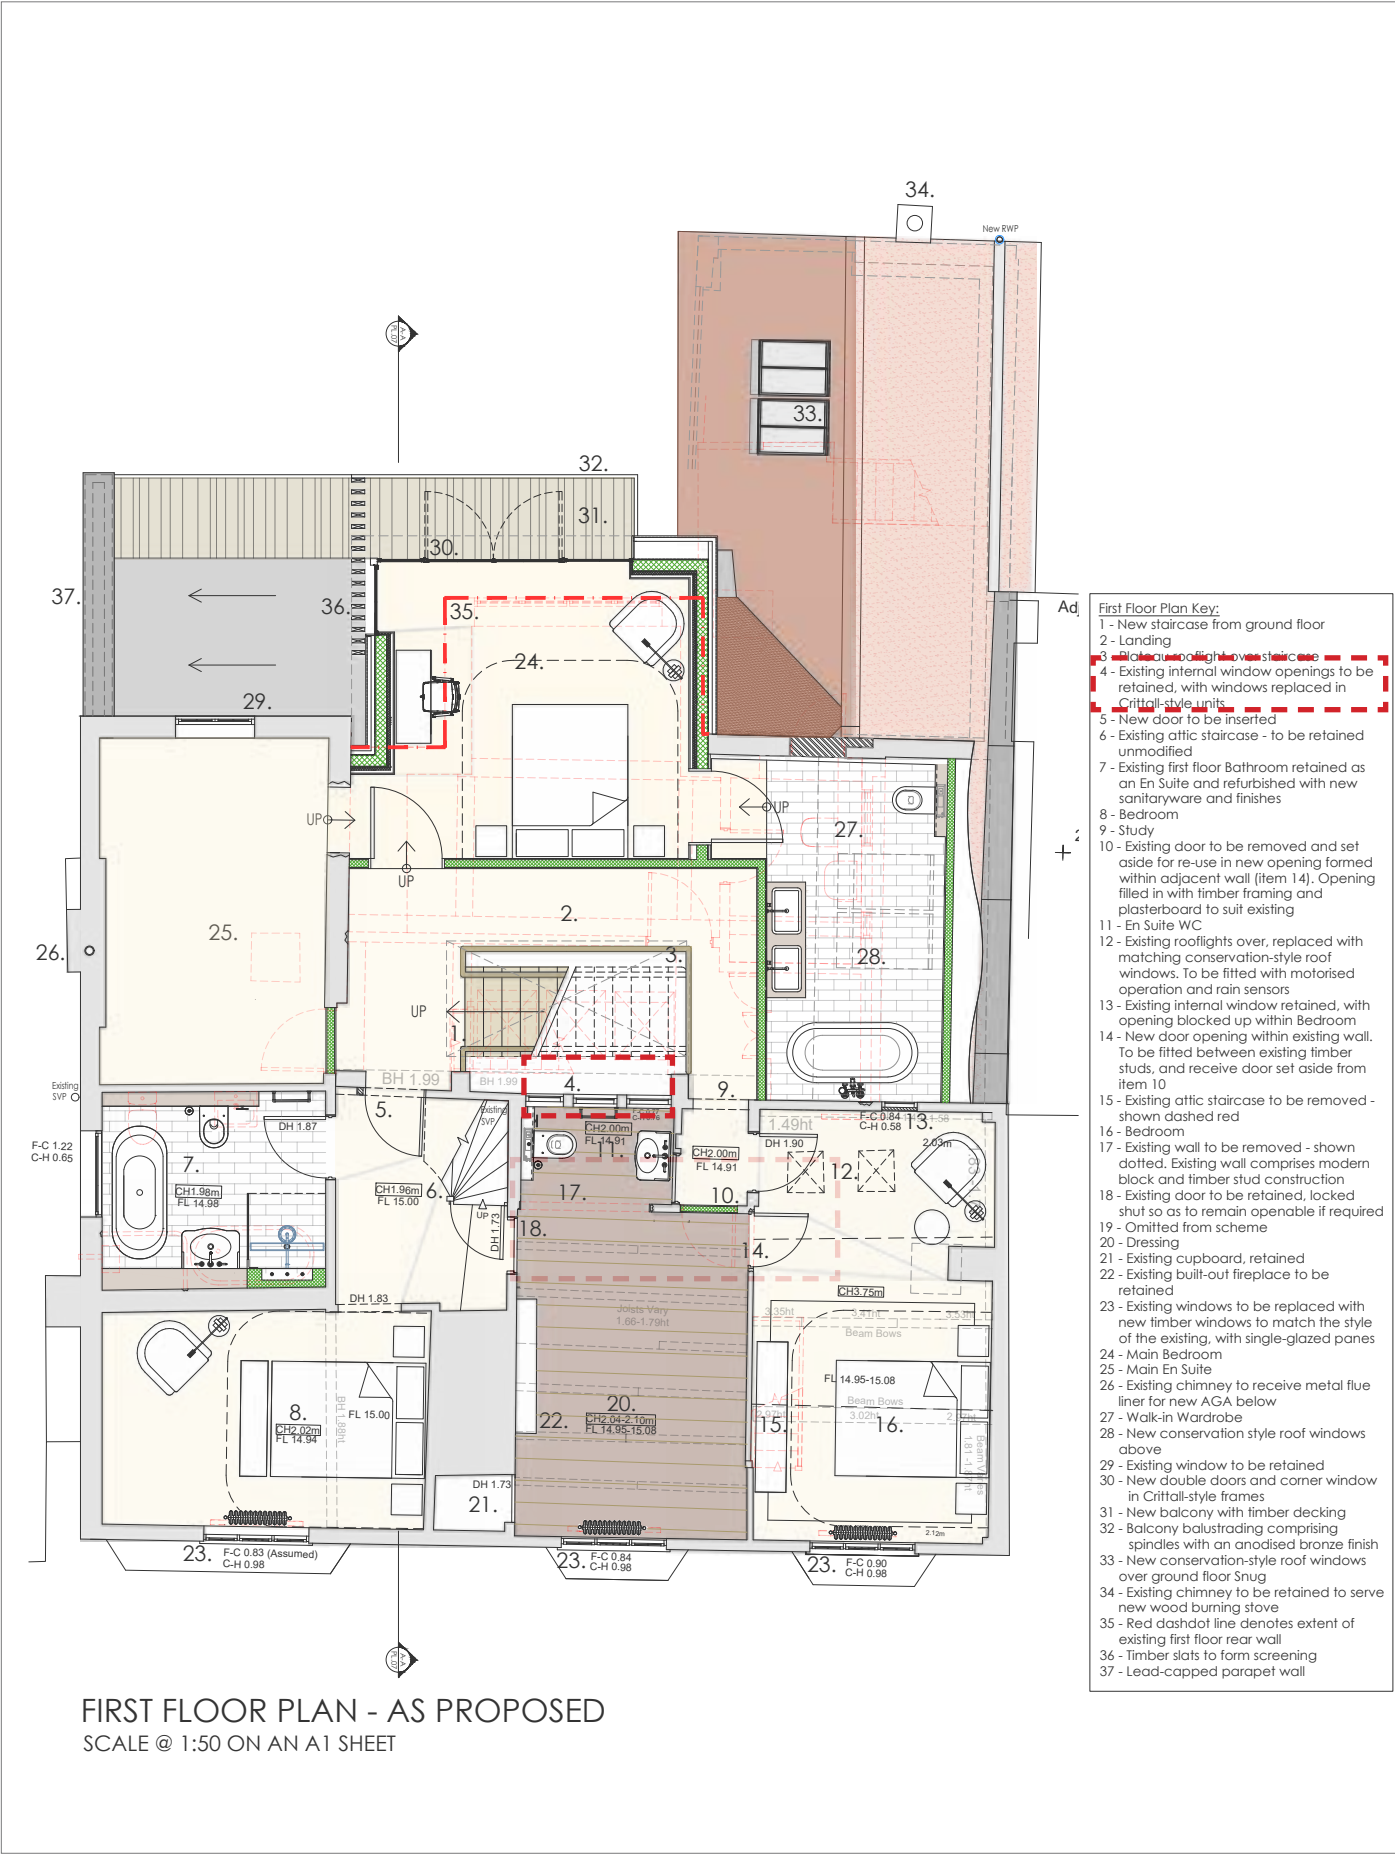
Point 4 of approved drawing GH342 PL03 Rev C confirms removal of existing windows and replacement with crittall-style units. This has been partially implemented by removal of windows. The openings were blocked up with wood wool and lime plaster, which was a more in-keeping solution.

‘4 - Existing internal window openings to be retained, with windows replaced in Crittall-style units’

Drawing GH342 PL03 Rev C approved drawings under application DM/22/3694 & DM/22/3695

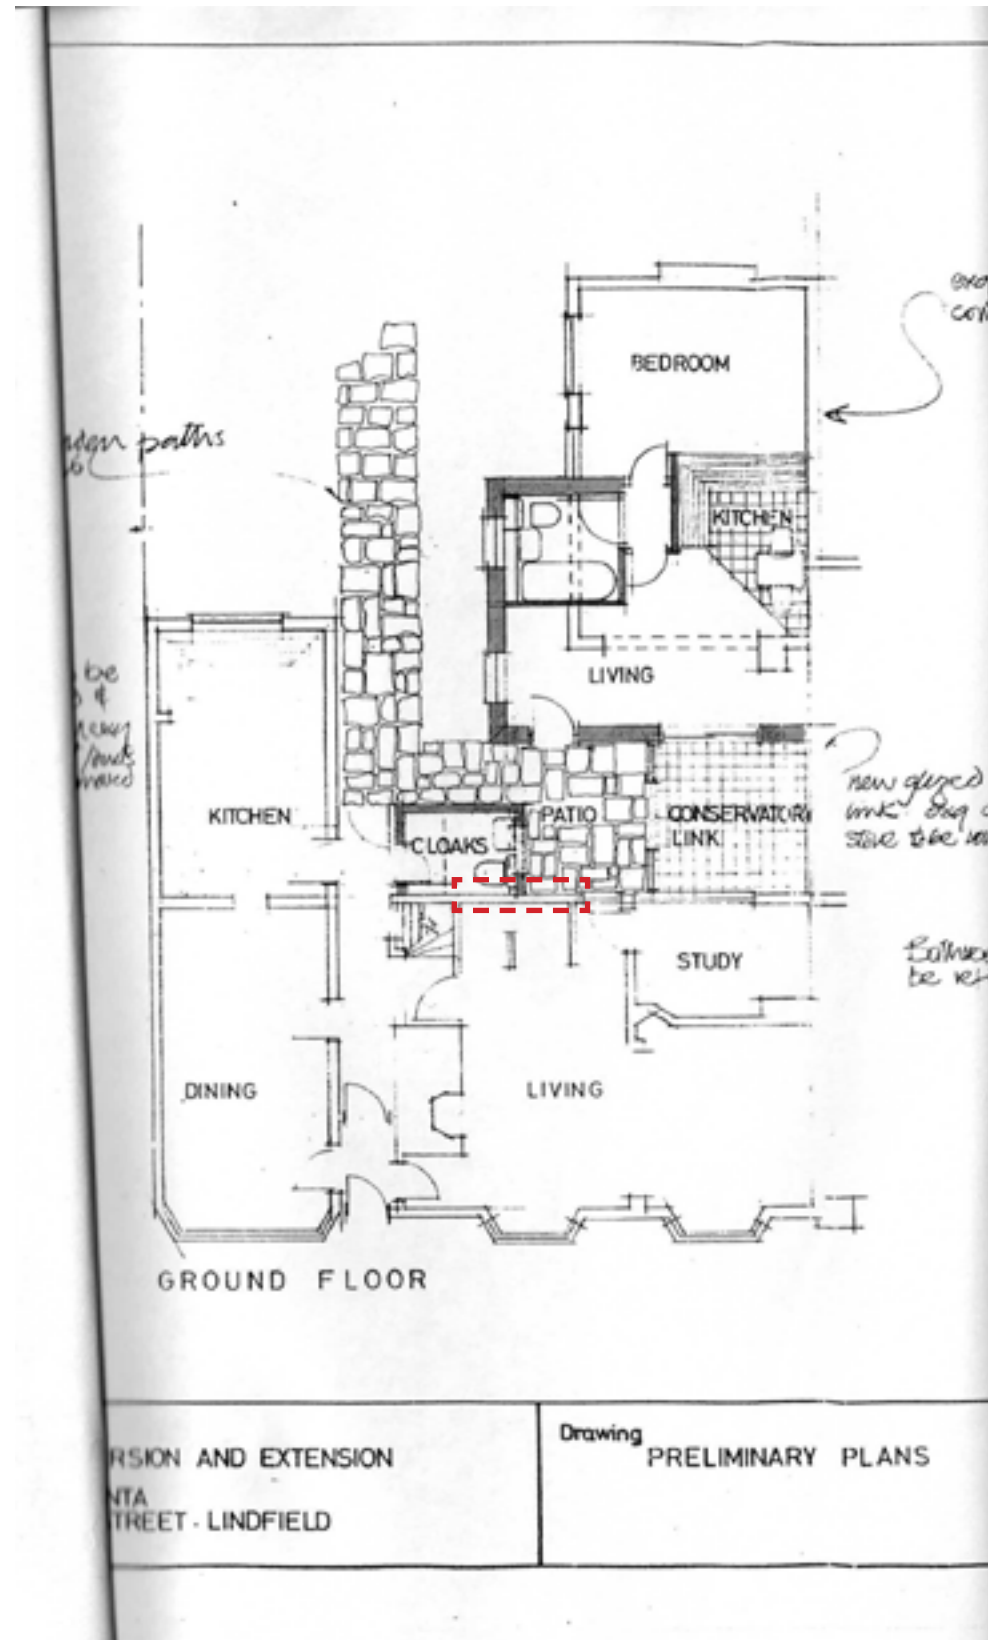
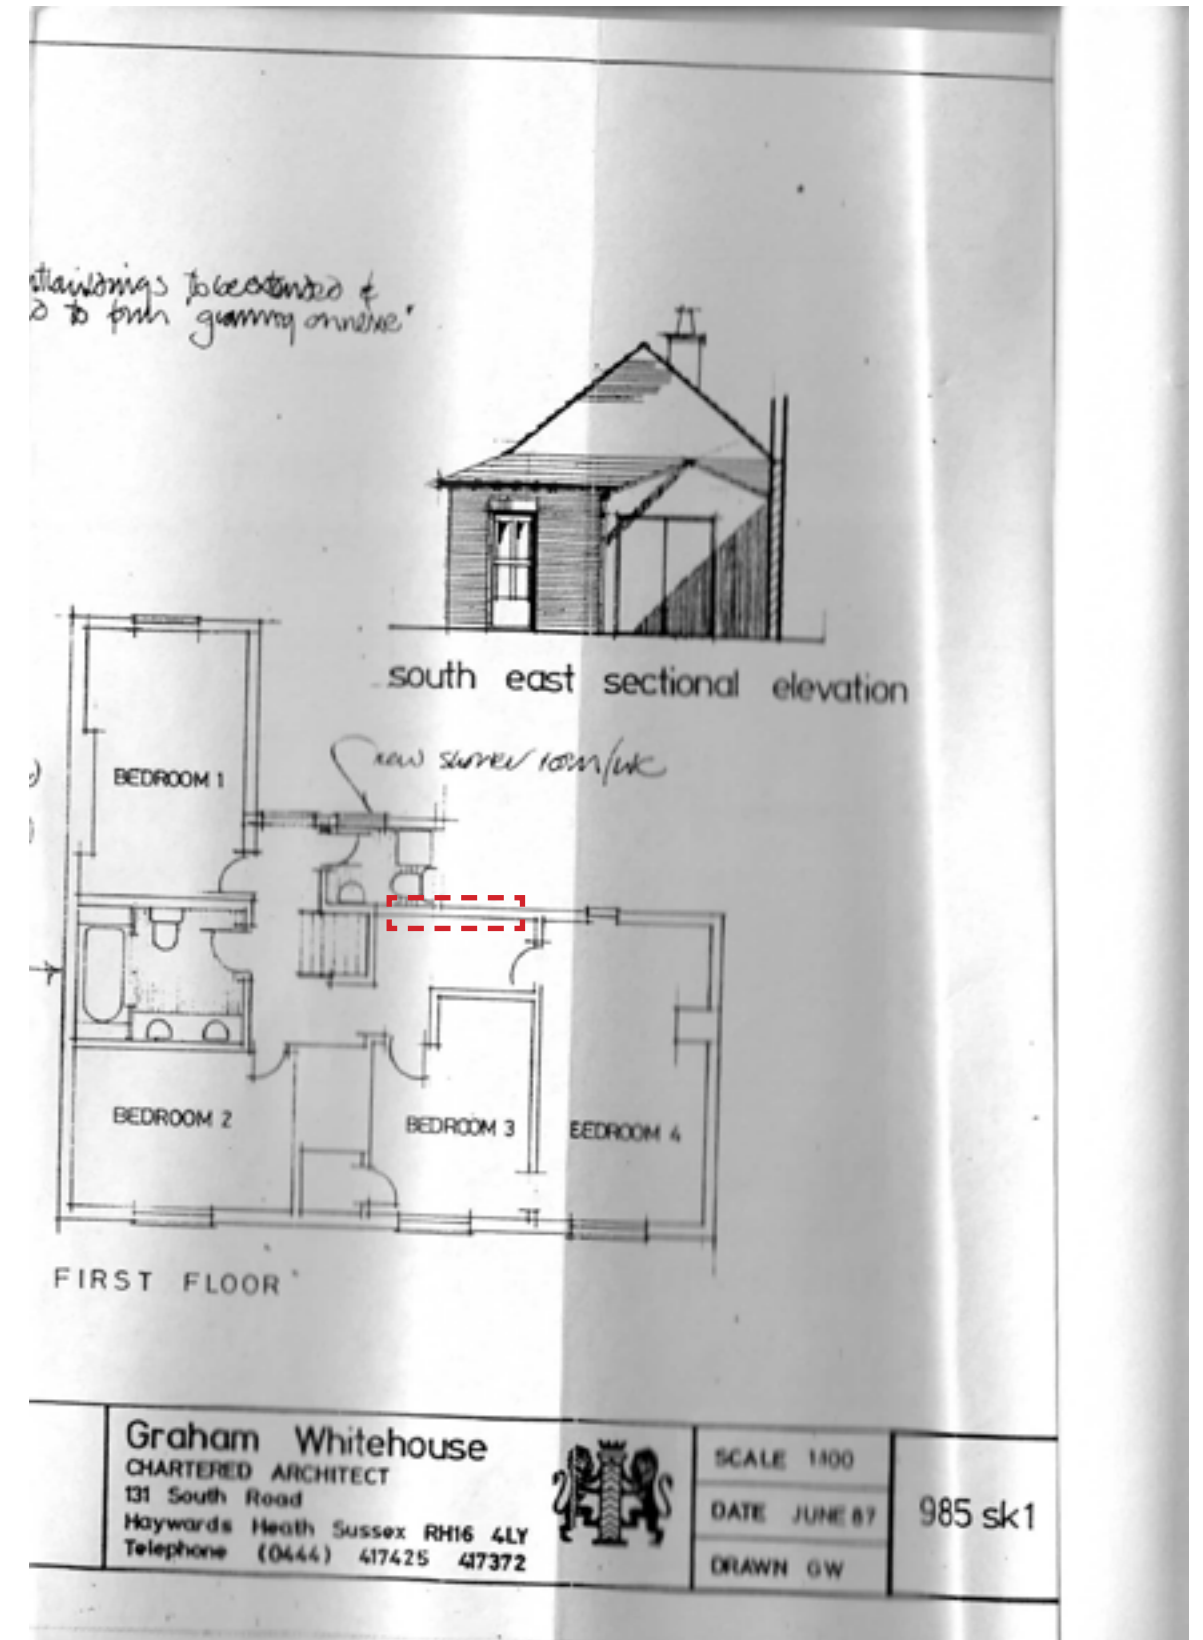
As previously highlighted, the windows do not appear on the oldest accessible floor plans of the building which form part of the planning application LF/064/87 from 1987 and do not appear in any subsequent applications.

Approved drawings under application LF/064/87

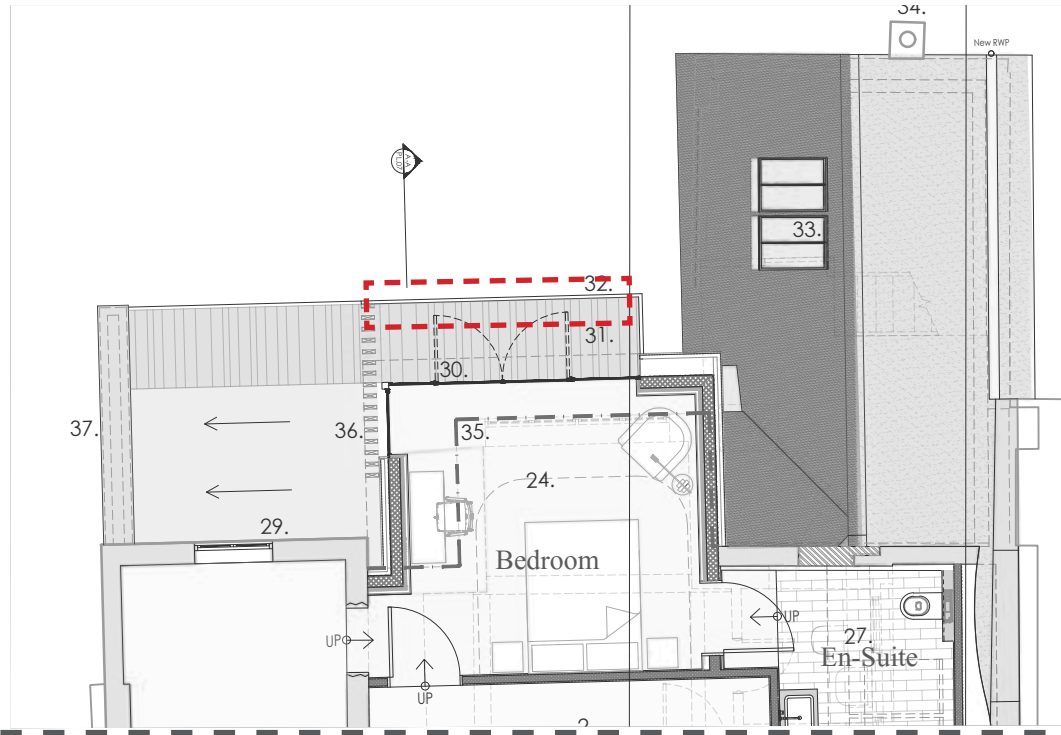
1. Approved first floor plan - submitted drawings under application DM/22/3694 & DM/22/3695 (planning approved)

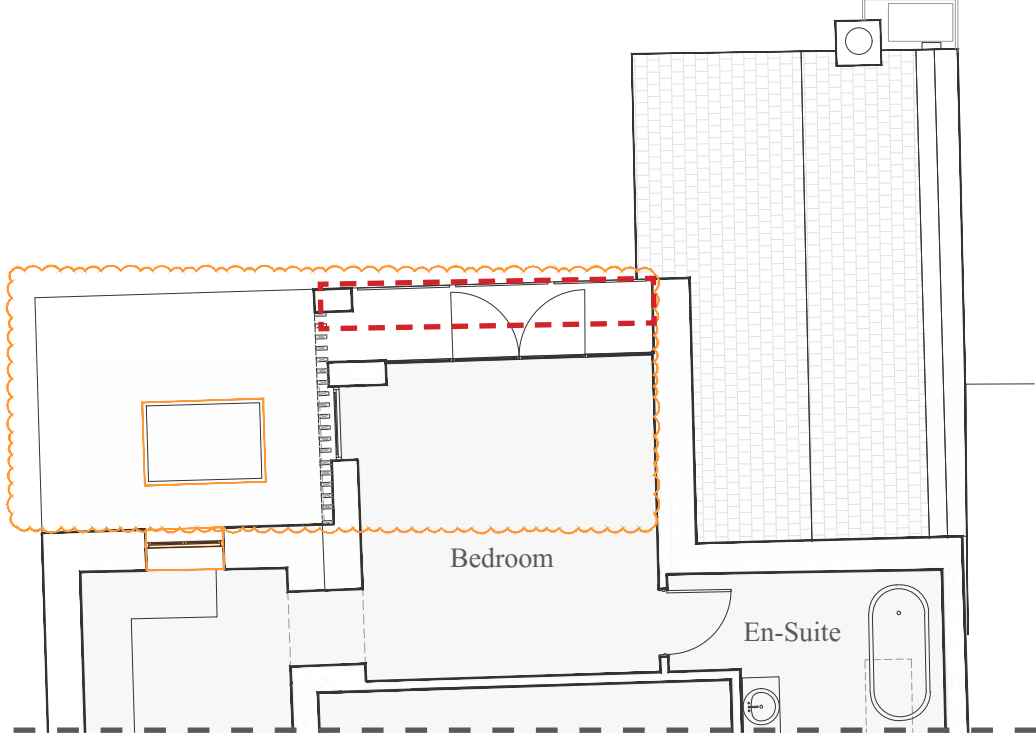
The balustrade to rear terrace has been constructed in deviation to the approved scheme. Due to the increased width of the ‘as-built’ extension the current balustrade has more length. It is proposed that the rear extension will be reconstructed to be in general accordance with the approved scheme, theretofore the length of the balustrade will be closer to what was approved. Its design has been changed from metal rail with balusters to a frameless glazing system.

3 Proposed first floor plan

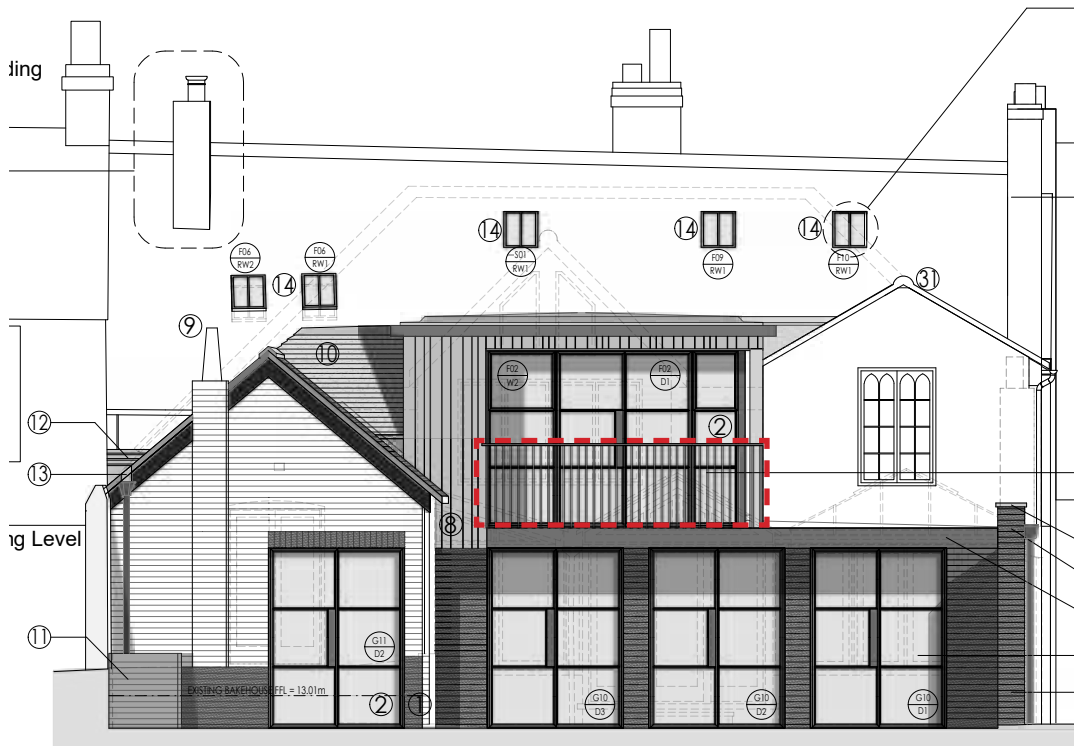
2. Approved scheme rear elevation - submitted under application DM/22/3694 & DM/22/3695 (planning approved)

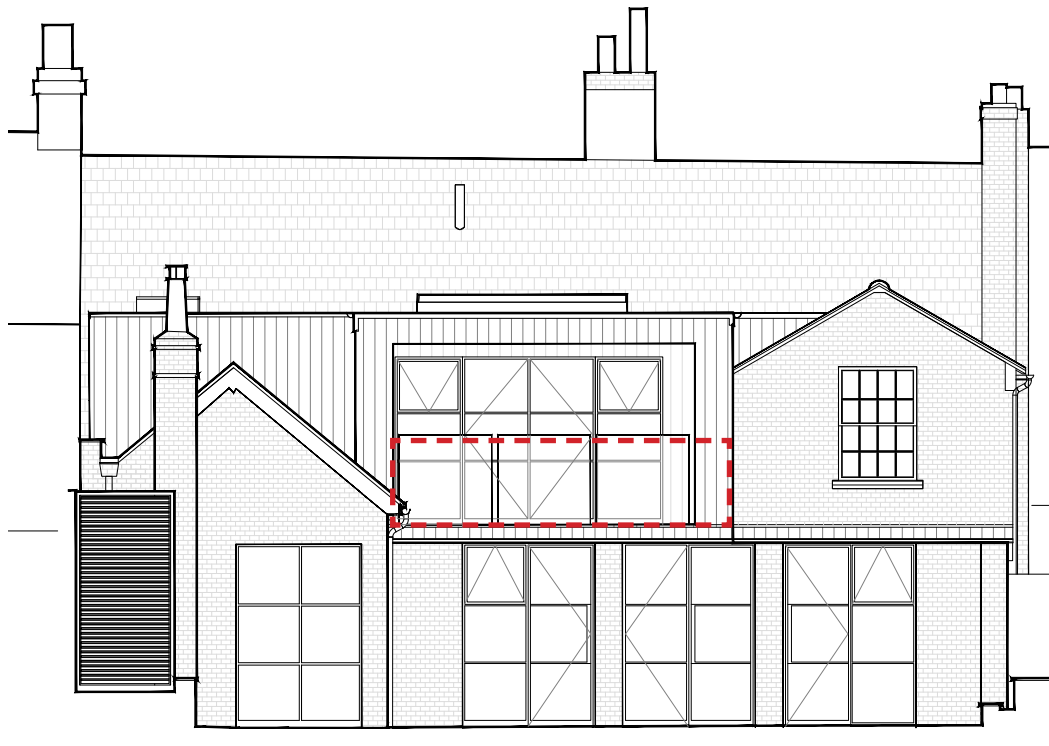
The change to a frameless glazing system is more discreet and visually seamless, reducing the visual obstruction of the overall appearance of the facade, creating less distraction and visual clutter. According to the supporting HCUK Heritage Statement, it is considered to have neutral impact on the significance of the listed building.

4. Proposed rear elevation.

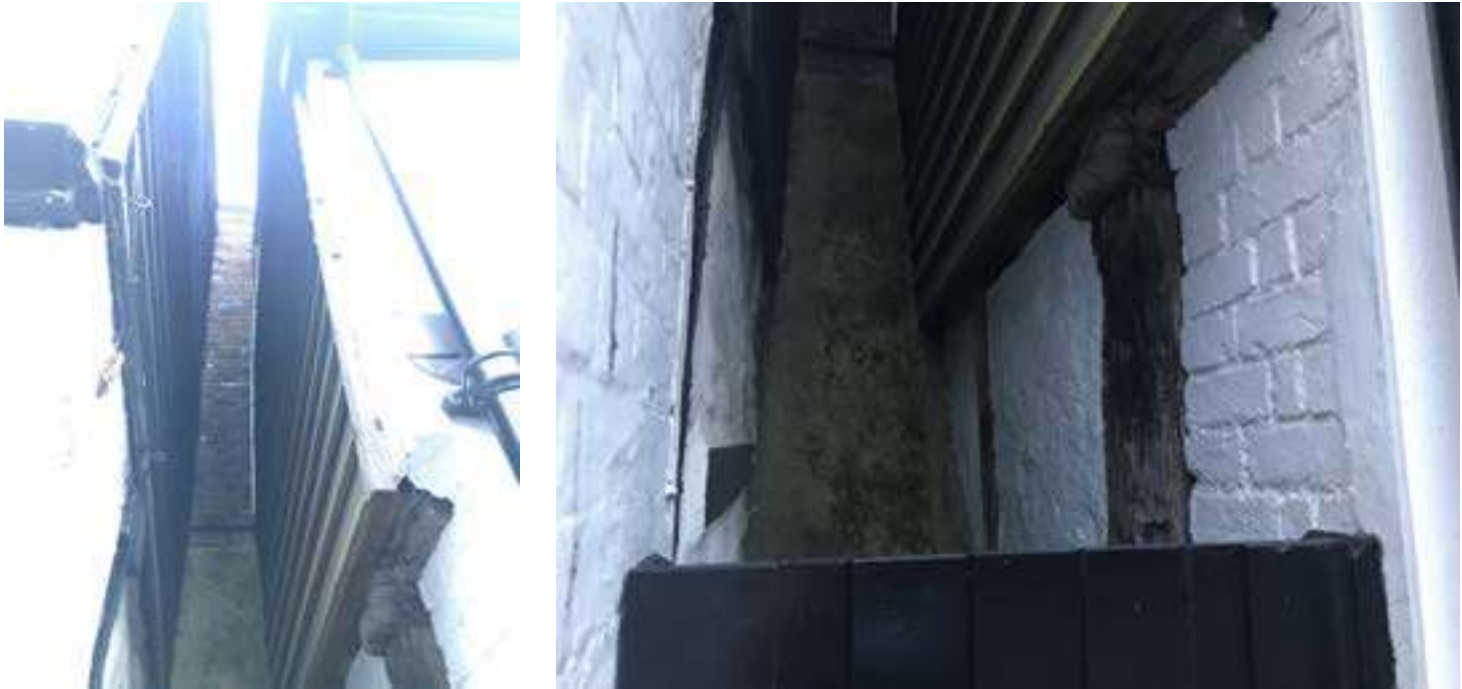
It was approved for the existing timber weatherboarding to the return corner of the front (East) and side (South) elevation to be extended down to ground level.

Leaving it as it is retains the legibility of a possibly truncated timber jetty as well as the exposed timber framing and brick nogging to this return elevation. Under-implementation of this change is preferable in heritage terms.

Recent photographs of timber weatherboarding

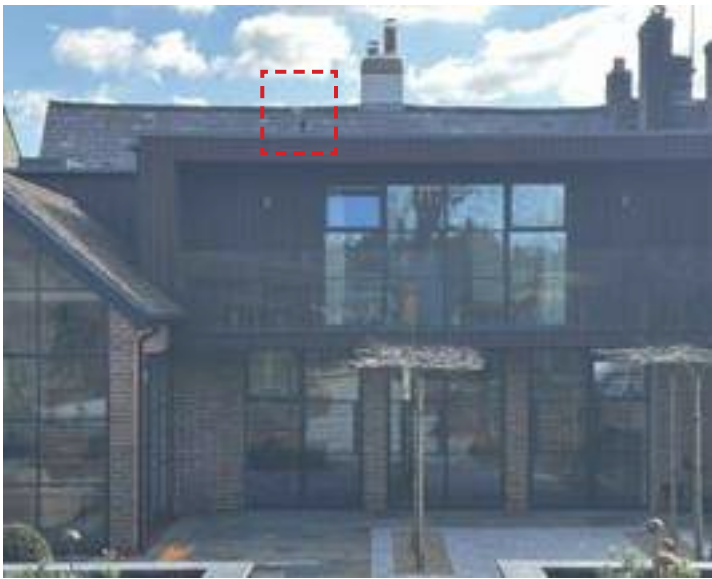
The flue is a 100mm diameter pipe penetrating through the roof with flashing around it to ensure watertightness. It projects up circa 300mm from the face of the roof tiles but not above the main ridge line and is not visible from the front elevation.

Recent photograph capturing the new boiler flue

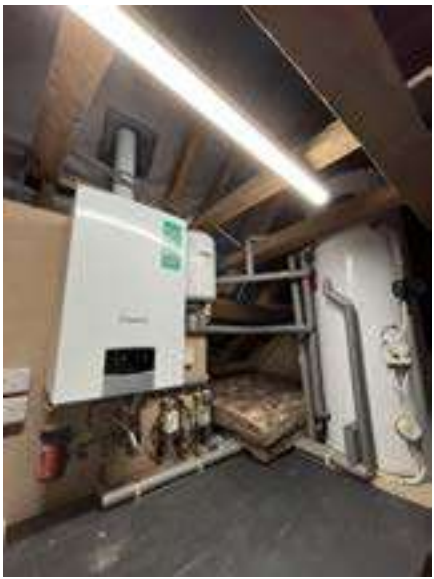
Water cylinder is approx. 600mm diameter and stands on its own supporting timber base spreading the weight over the historic floor joists below.

Recent photograph capturing the new water tank and boiler installed in attic

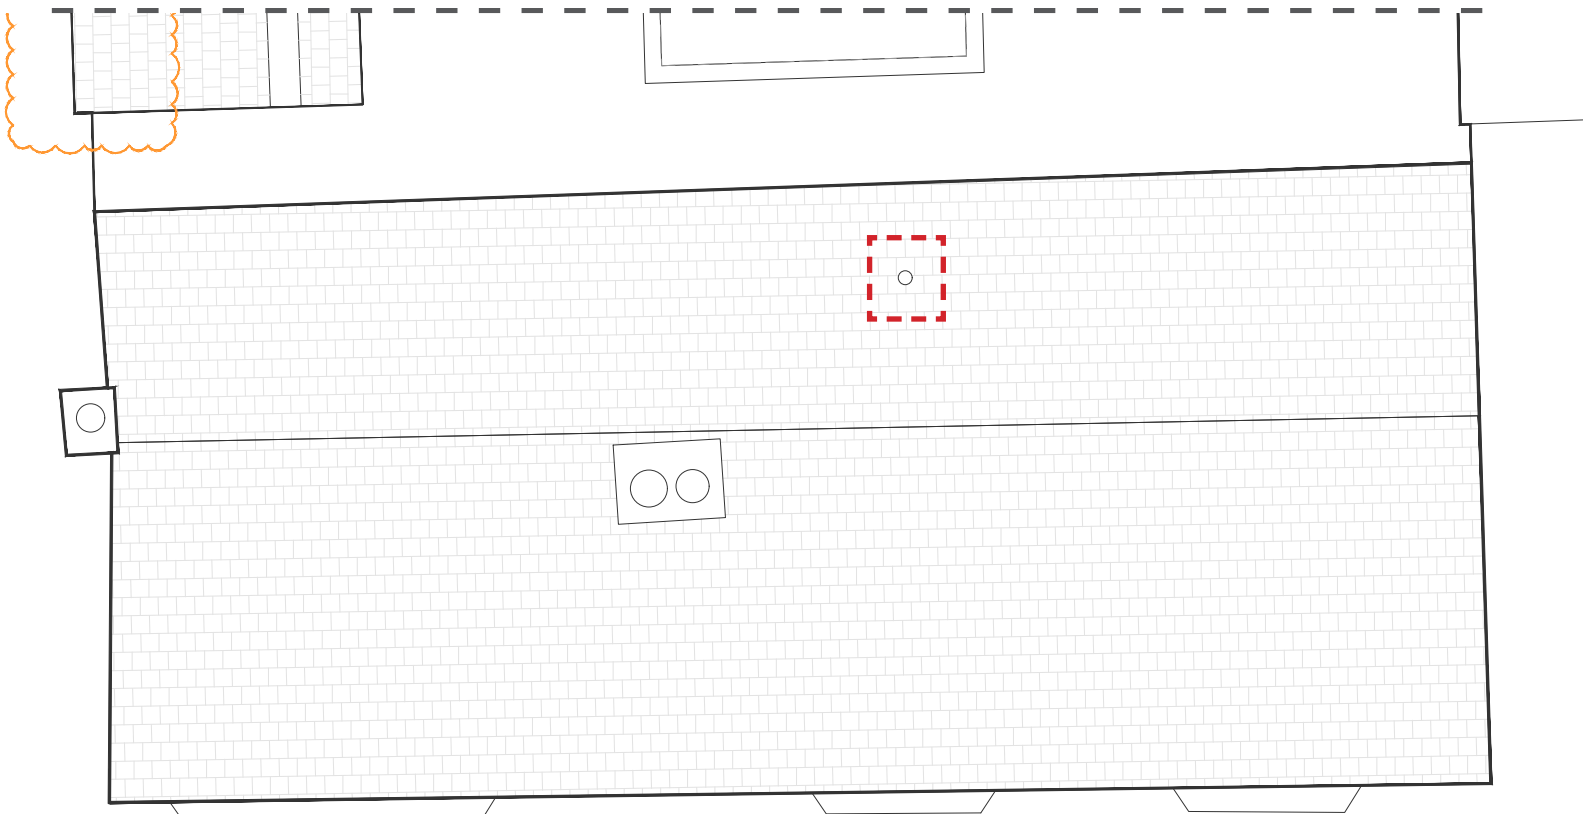
Proposed roof plan

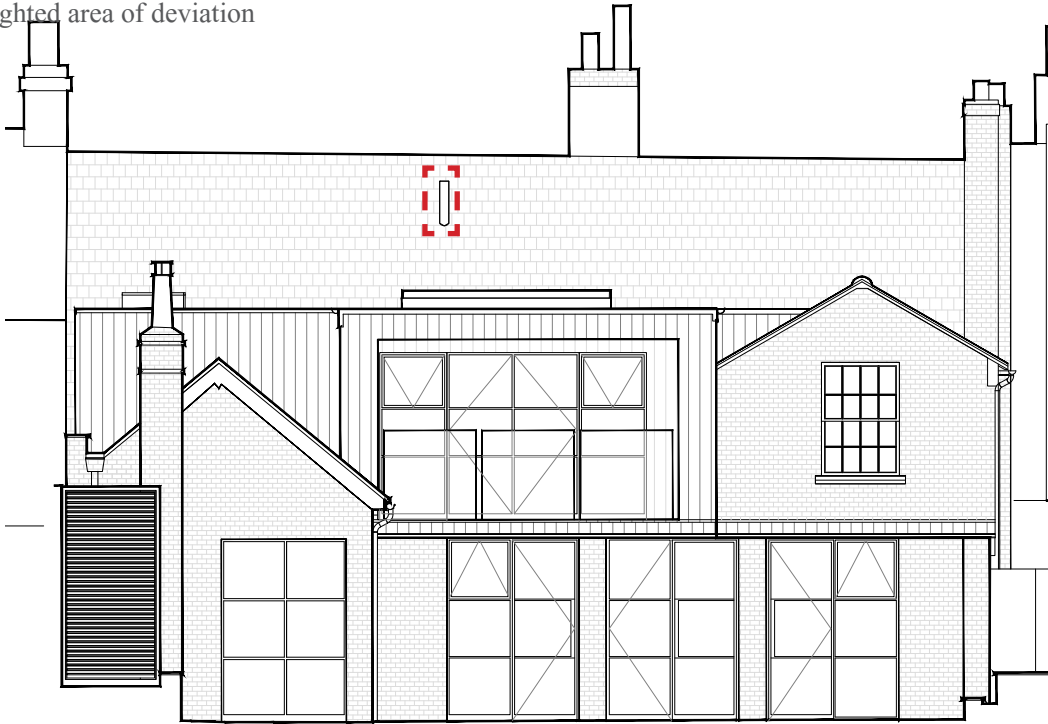
As can be seen from the drawings below, the position of the boiler flue on the rear sloping roof pitch is such that it is not visible from the principal elevation.

Proposed West Elevation

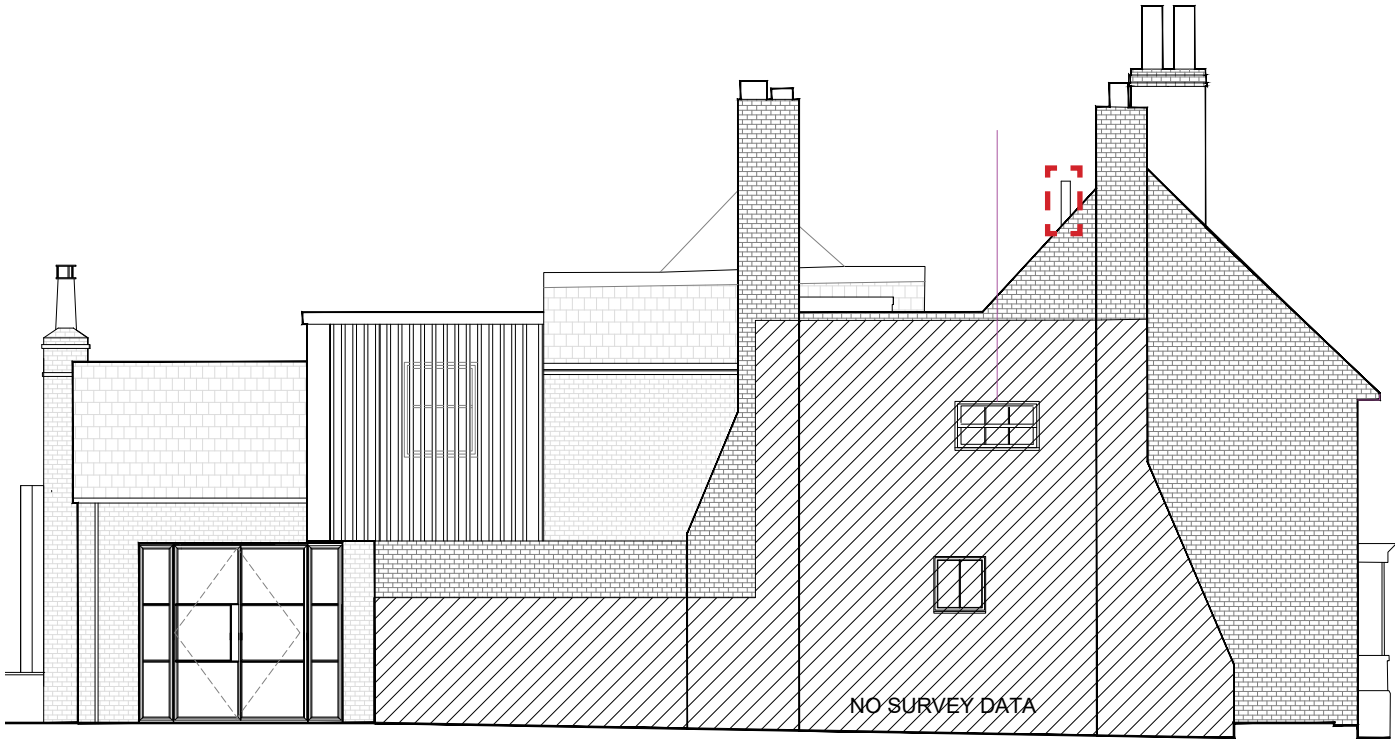
Proposed South Elevation
