# JUSTIFICATION

## REMOVAL OF INTERNAL CASEMENT WINDOWS

107 HIGH STREET, LINDFIELD, HAYWARDS HEATH, RH16 2HR

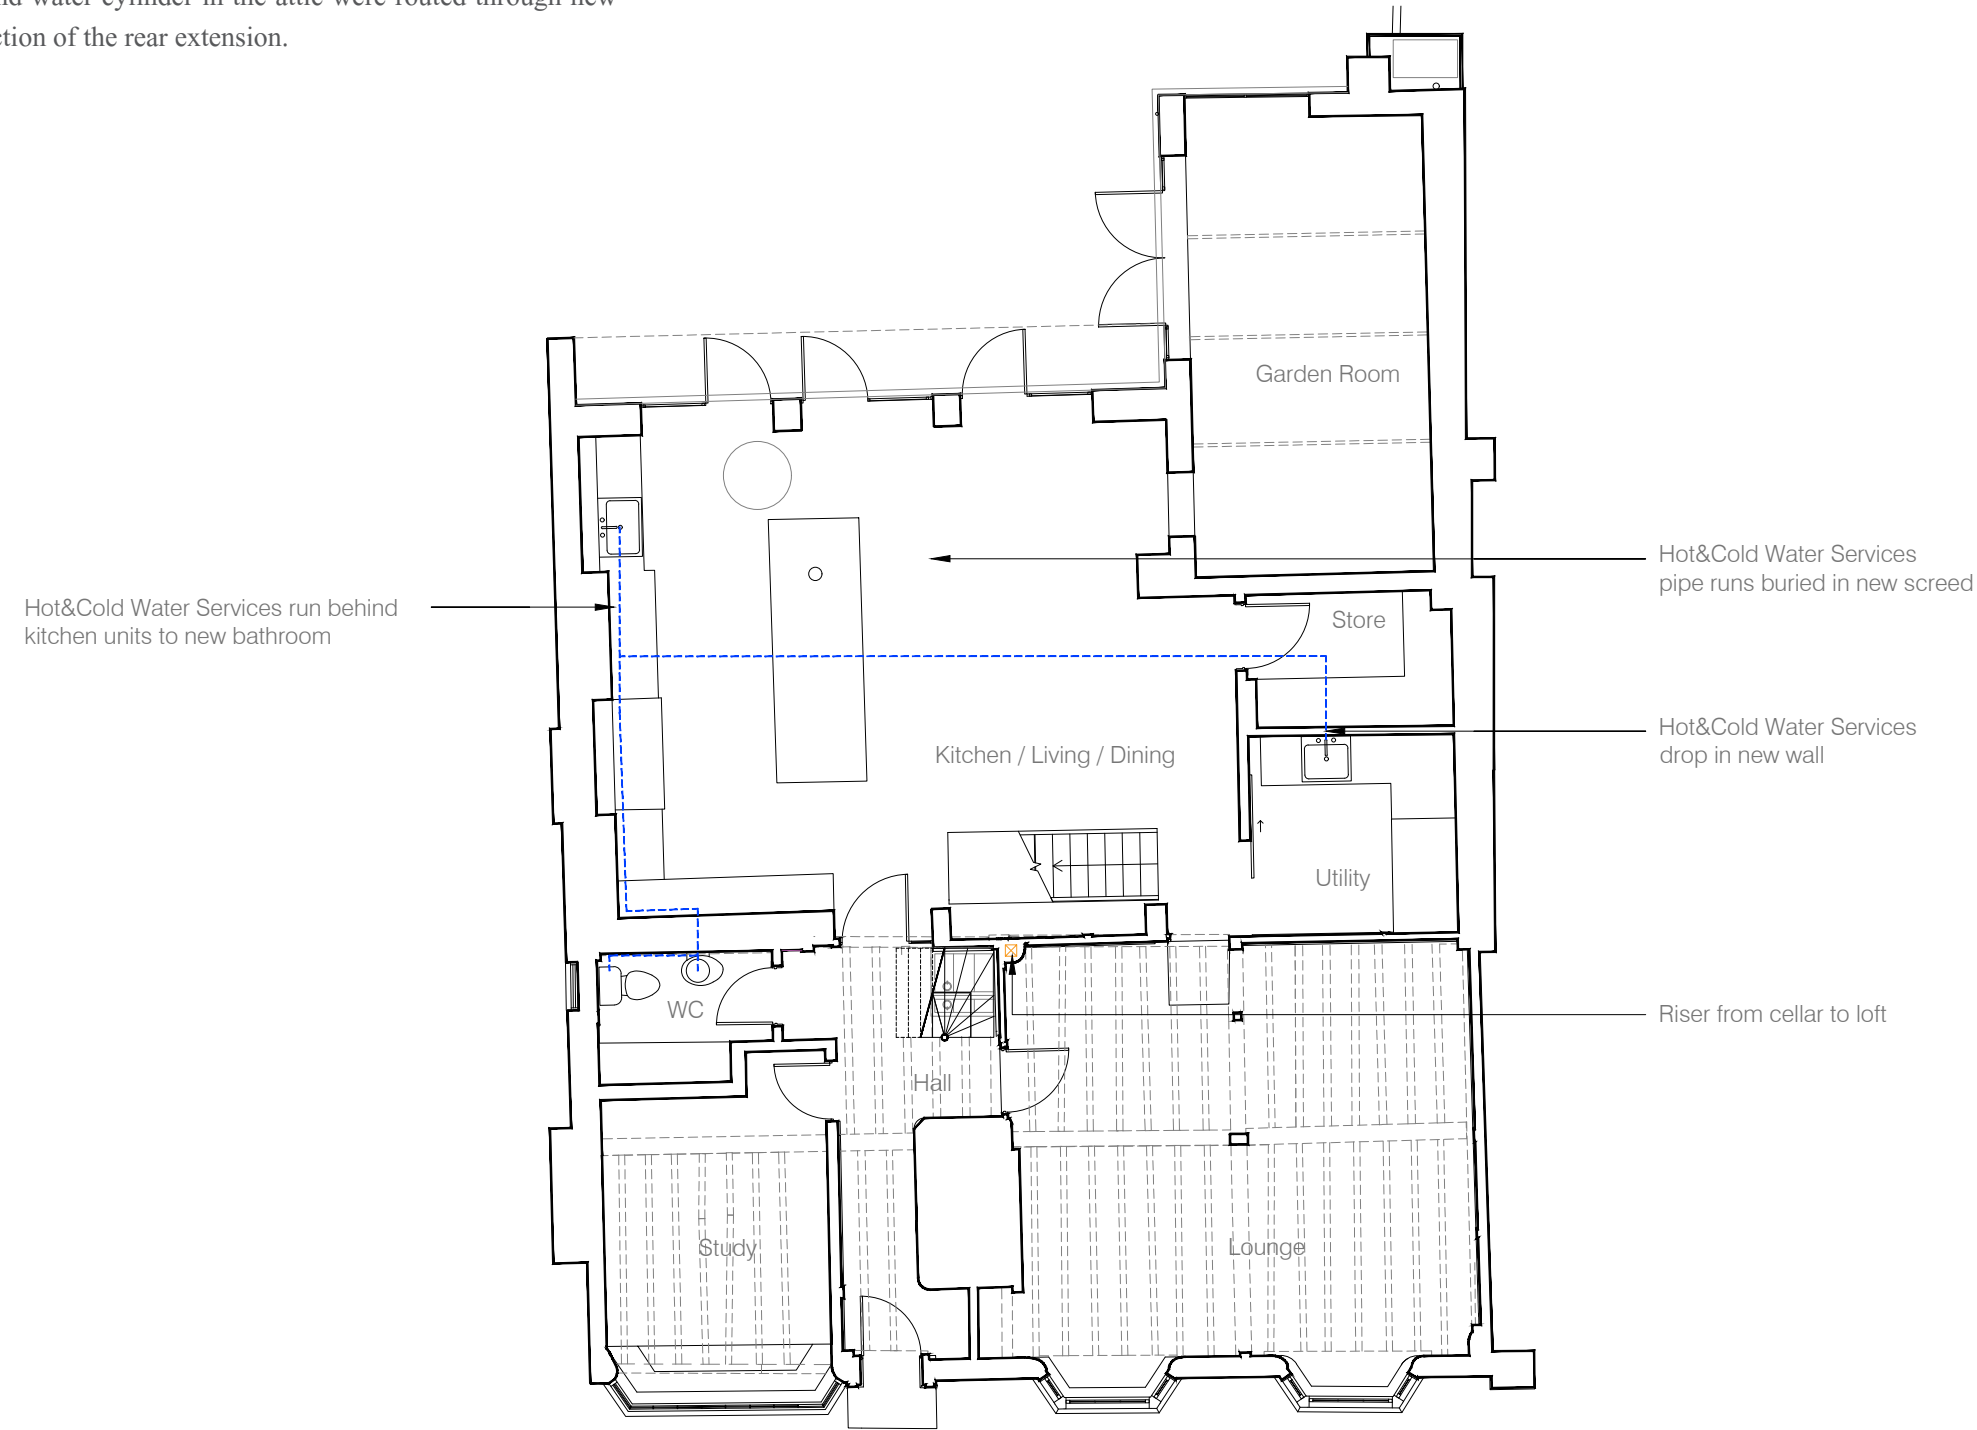
The adjacent diagram illustrates new water pipe runs serving the building.

Where possible existing house service routes were used, minimising impact on the existing building. Pipe runs to new boiler and water cylinder in the attic were routed through new construction of the rear extension.

As-built ground floor plan

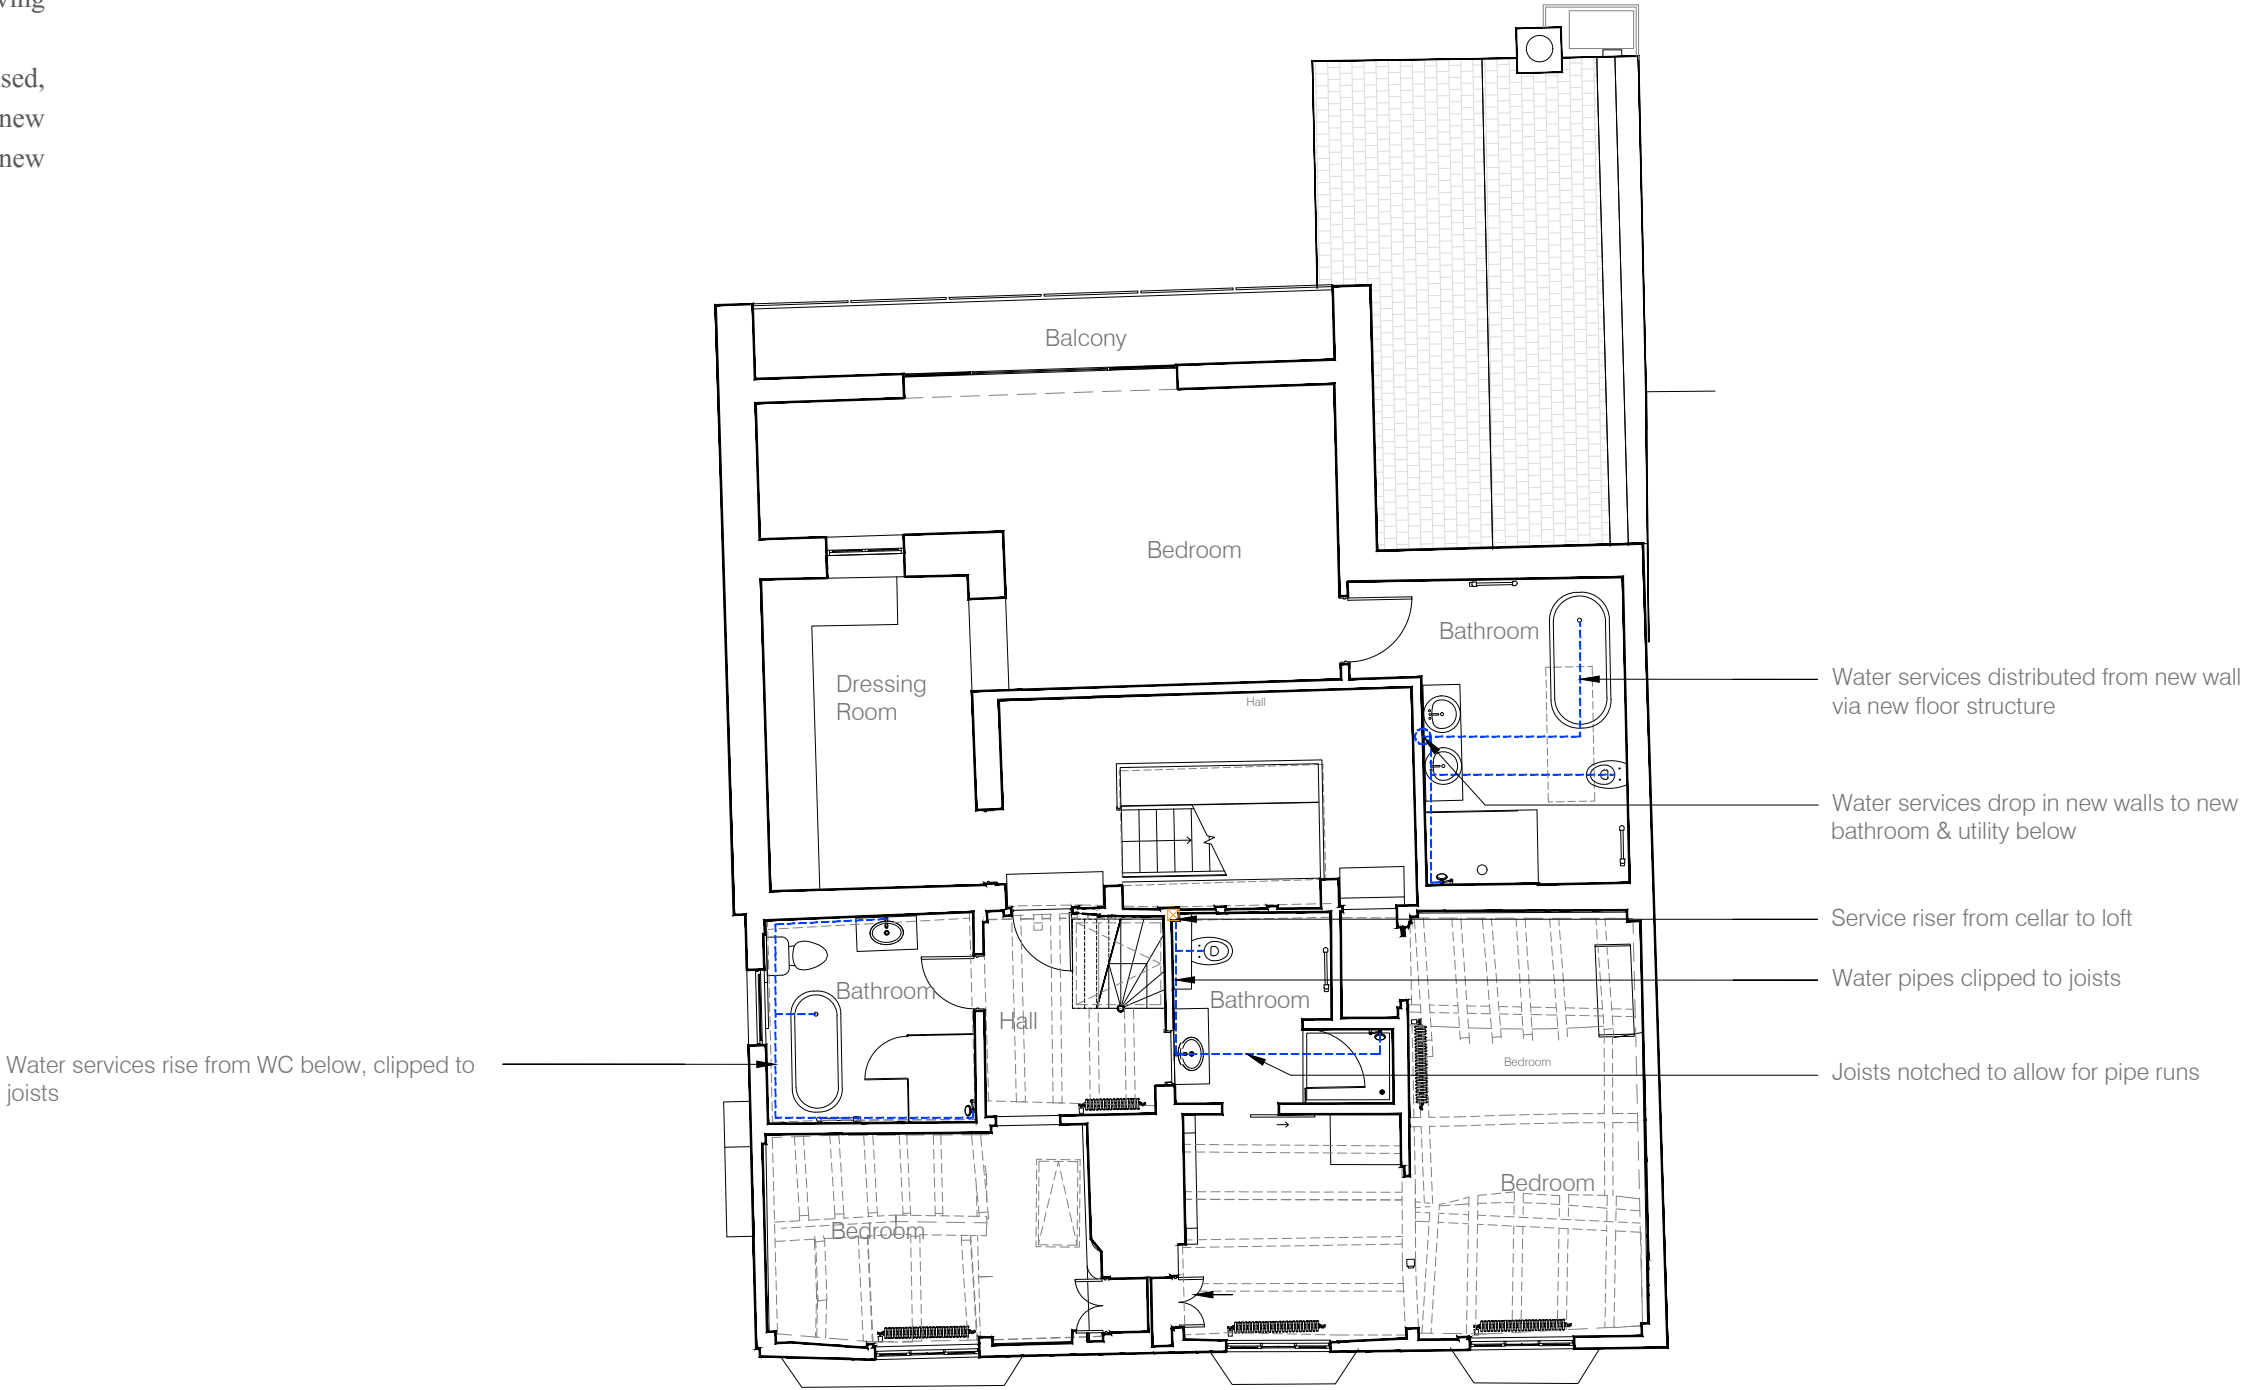
The adjacent diagram illustrates new water pipe runs serving the building.

Where possible existing house service routes were used, minimising impact on the existing building. Pipe runs to new boiler and water cylinder in the attic were routed through new construction of the rear extension.

As-built first floor plan

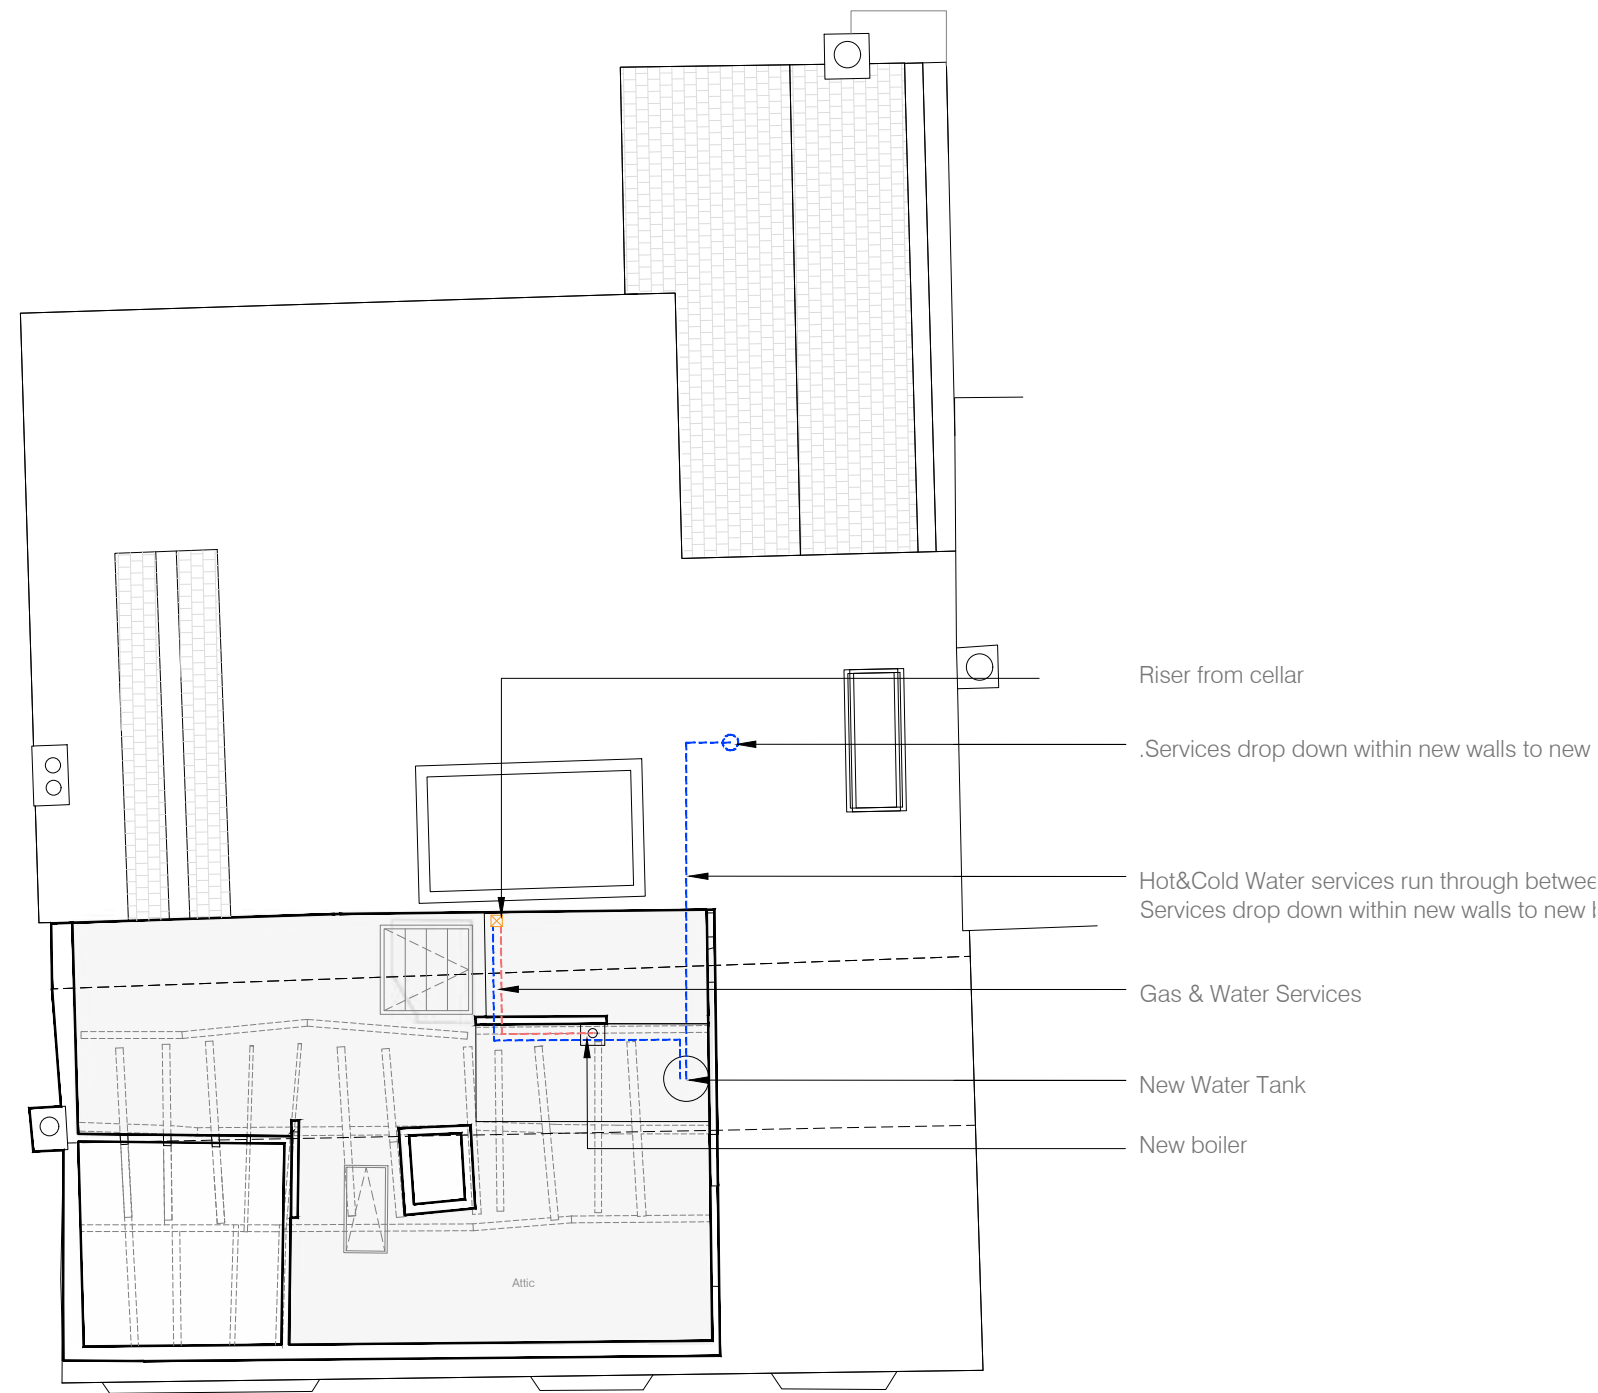
The adjacent diagram illustrates new water pipe runs serving the building.

Where possible existing house service routes were used, minimising impact on the existing building. Pipe runs to new boiler and water cylinder in the attic were routed through new construction of the rear extension.

As-built attic floor plan

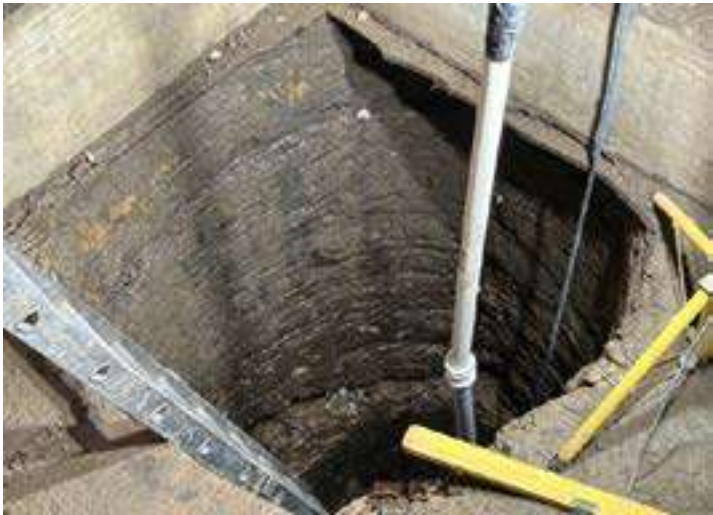
- Survey and safety checks  
Initial inspection of the well shaft: depth, structural stability, water level, possible contaminants. Check for gas accumulation or air quality (old wells can trap gases). Confirmation whether the shaft is stable enough for conservation.

- 2. Clearing & Preparation  
The water from the well was pumped out to reduce water levels to make it as safe and as practicable to undertake construction works as possible. Well was cleaned of debris and silt, any loose stonework linings removed.

Opened well shaft

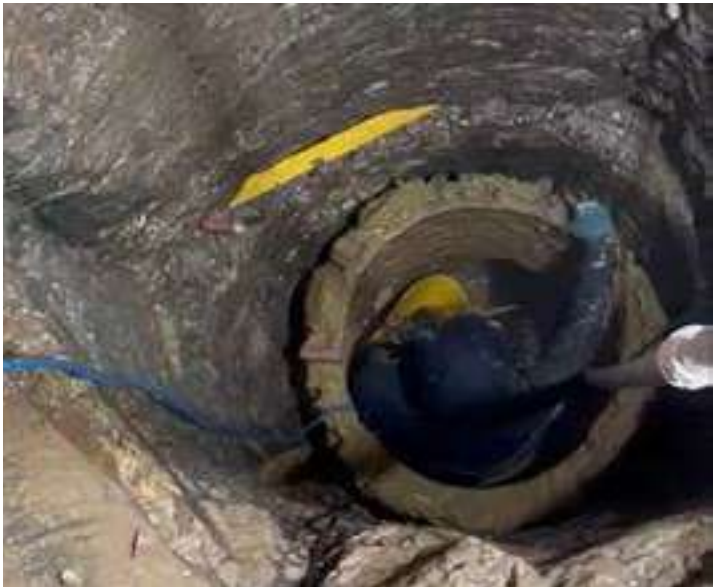
- 3. Relining the shaft  
Shaft relined with the multicoloured Hamsey Mixed Stock brickwork to stabilise the structure, prevent collapse of soil around it, and provide a neat vertical surface. Brick lining laid in lime mortar.

Shaft lining

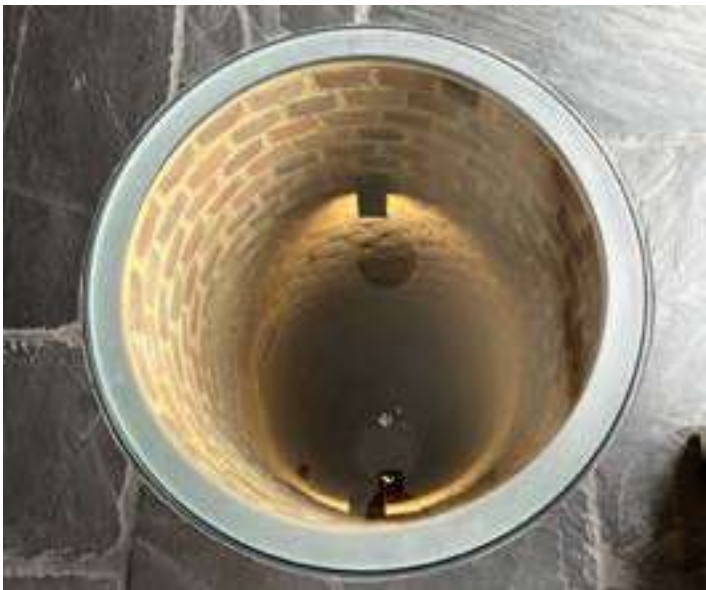
- 5. Structural Cap & Support  
At the top of the shaft, a structural ring was installed to take the load of the glass cover, installed flush on top with new floor finish.

Recent photograph of the well with glass enclosure

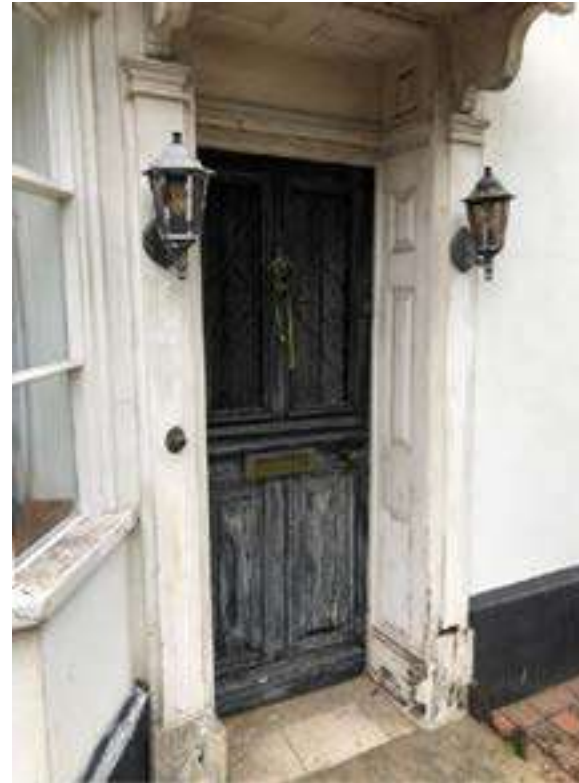
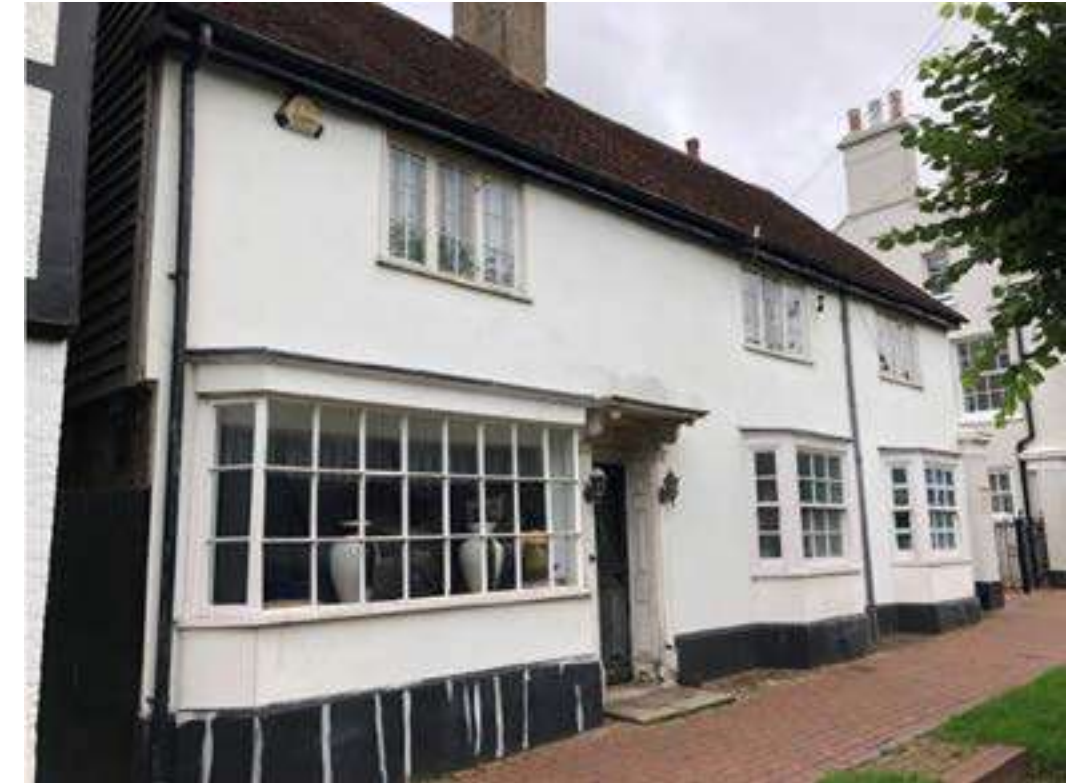
Photographs of front elevation before restoration works

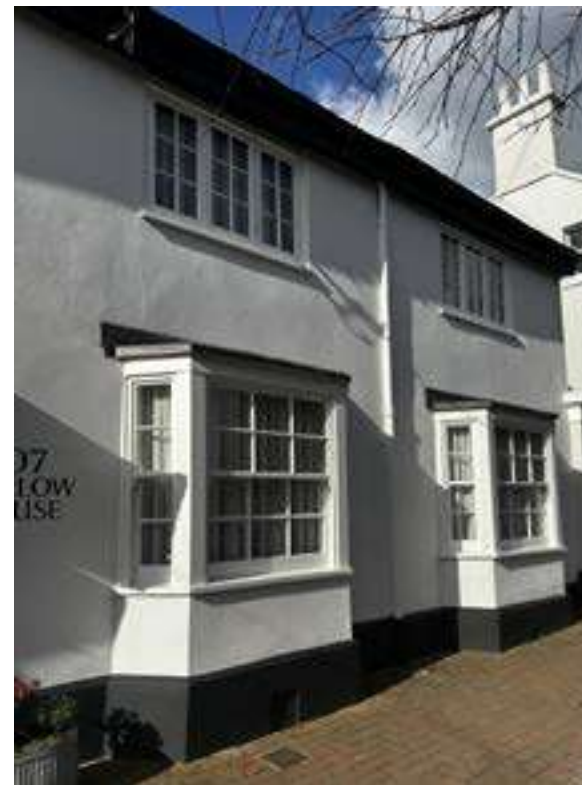
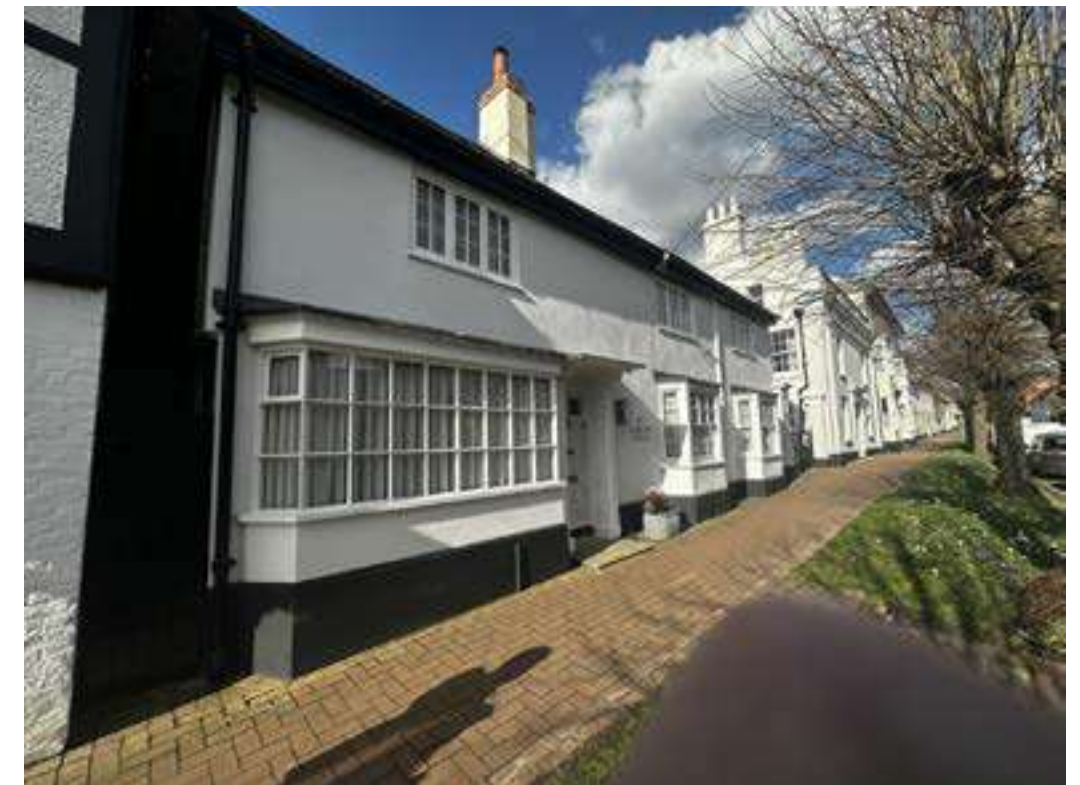
The Applicant restored the front elevation to return it to its original grandeur, delivering a clear heritage benefit. All windows and doors were meticulously replicated to match the original, which had deteriorated, and the front door surround was also faithfully reproduced. This is a heritage benefit and

Photographs of front elevation after restoration works

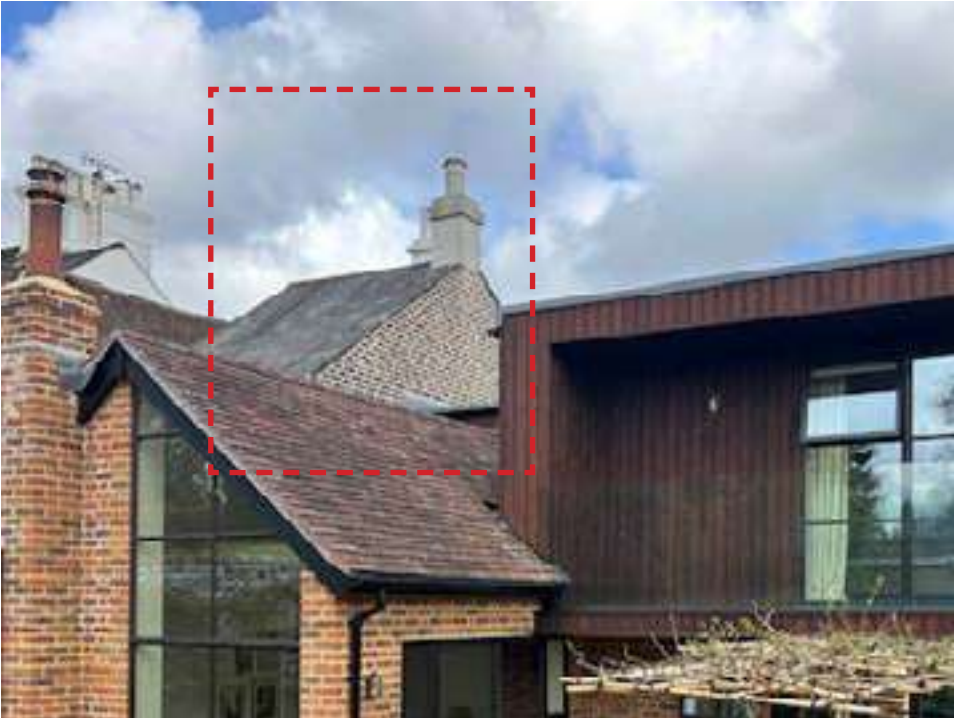
This work was carried out using lime mortar, rejuvenating the now more exposed brickwork façade, improving the fabric quality of the adjacent listed building, ensuring its longevity for years to come.

109 High Street south gable wall re-pointed in lime mortar

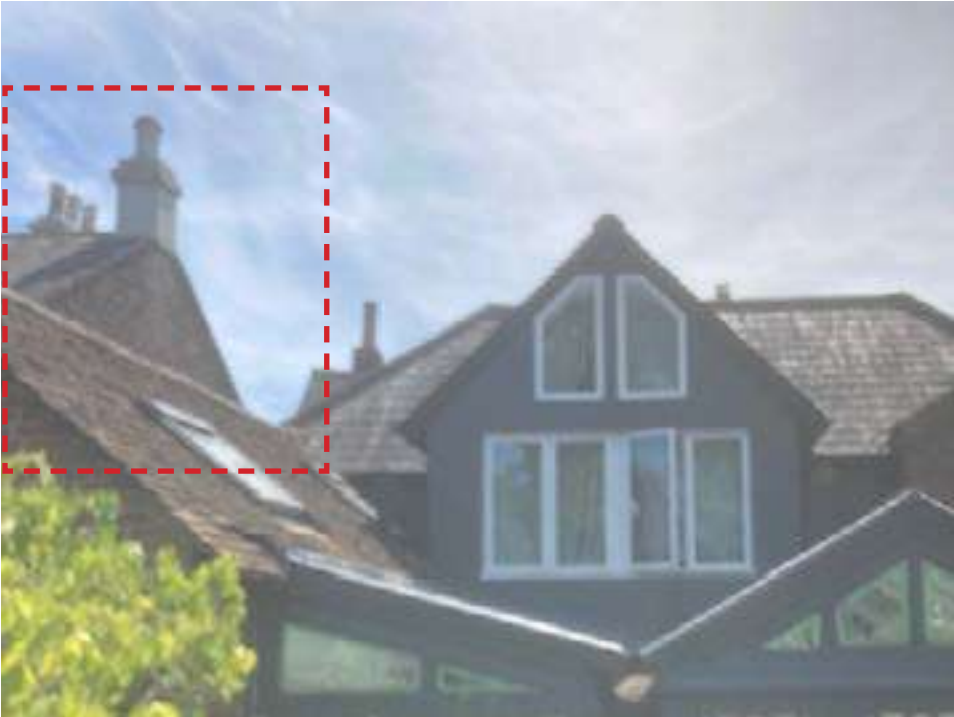
109 High Street south gable wall before re-pointing

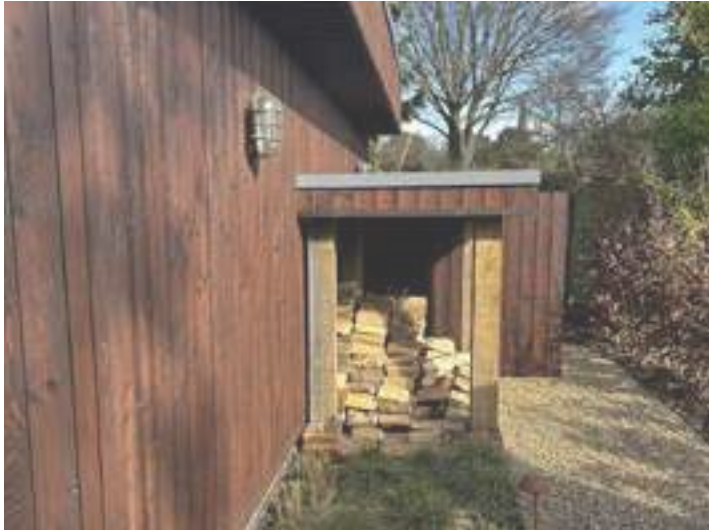
The garage has been constructed with minor variation to the approved scheme - the approved log store was constructed lower and in shifted location (centre of the elevation instead of side).

Current photograph- garage

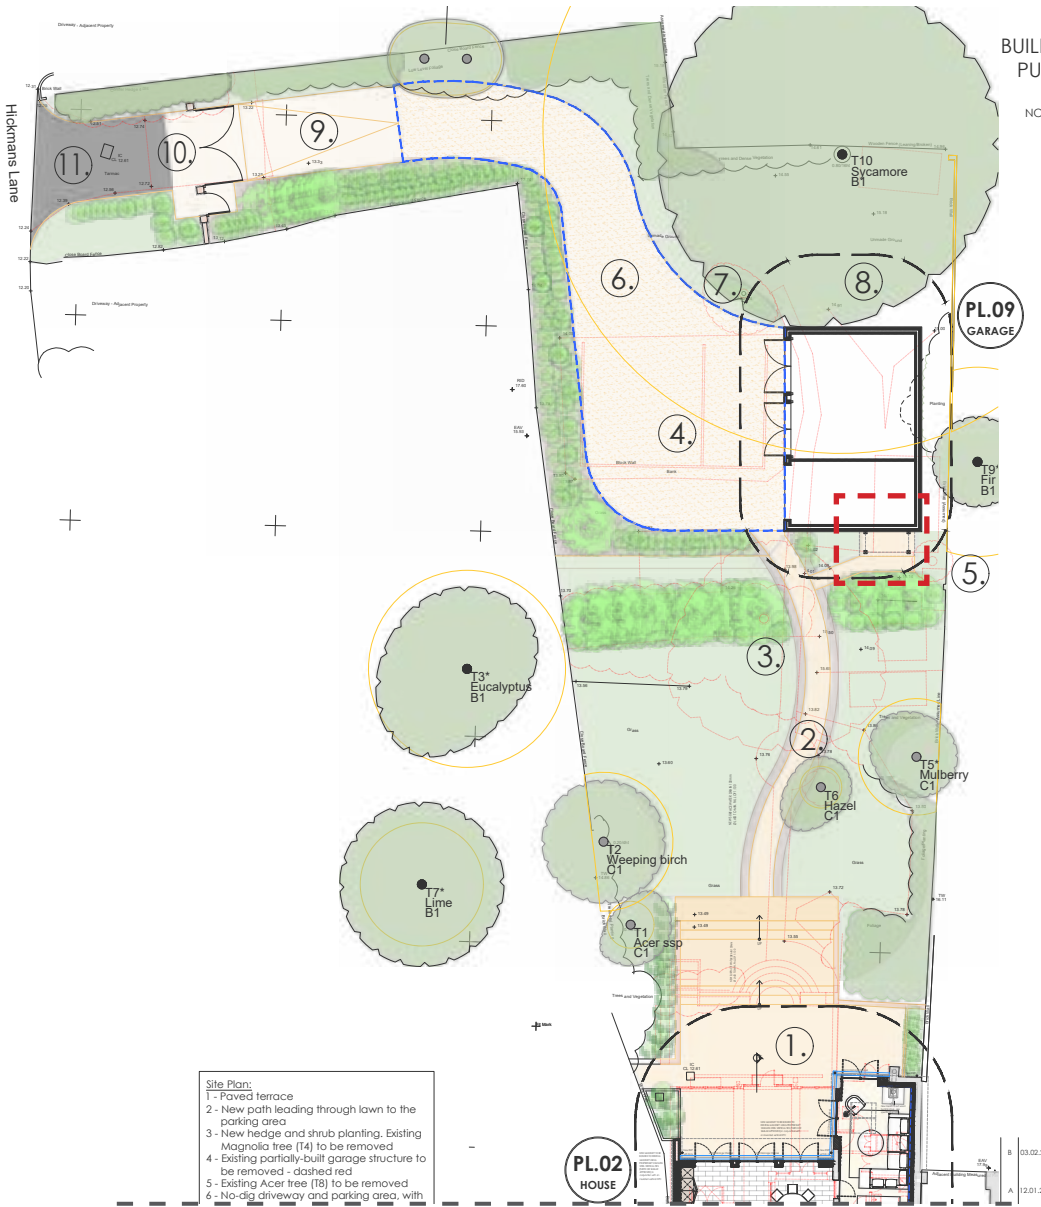
1. Approved Site Plan - submitted drawings under application DM/22/3694 & DM/22/3695 (planning approved).

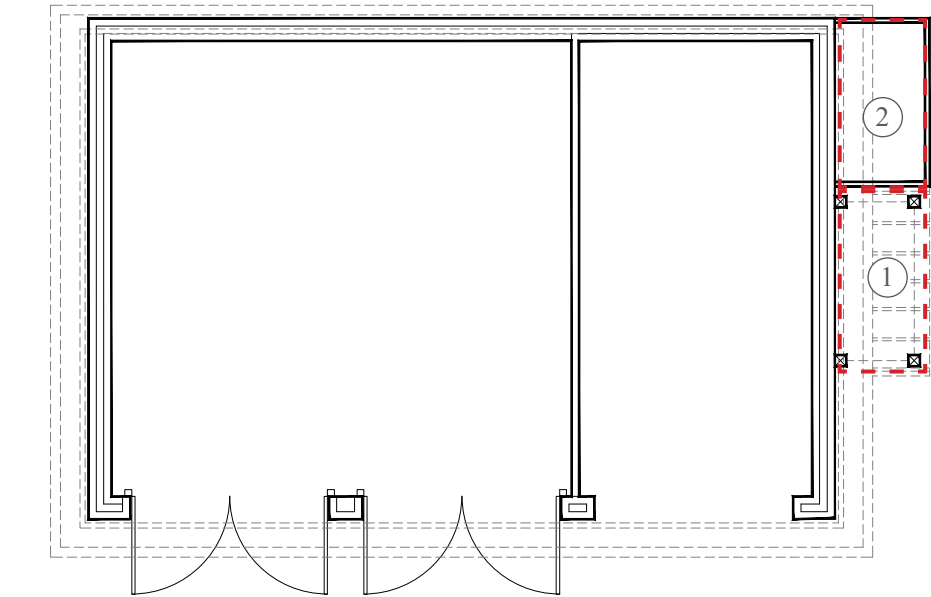
2. Proposed Garage Drawings

- Highlighted area of deviation
- 1 Timber log store
- 2 Irrigation tank enclosure
