# Heritage Statement

Marlow House  
107 High Street  
Lindfield  
RH16 2HR

June 2026 | Project Ref 10899A

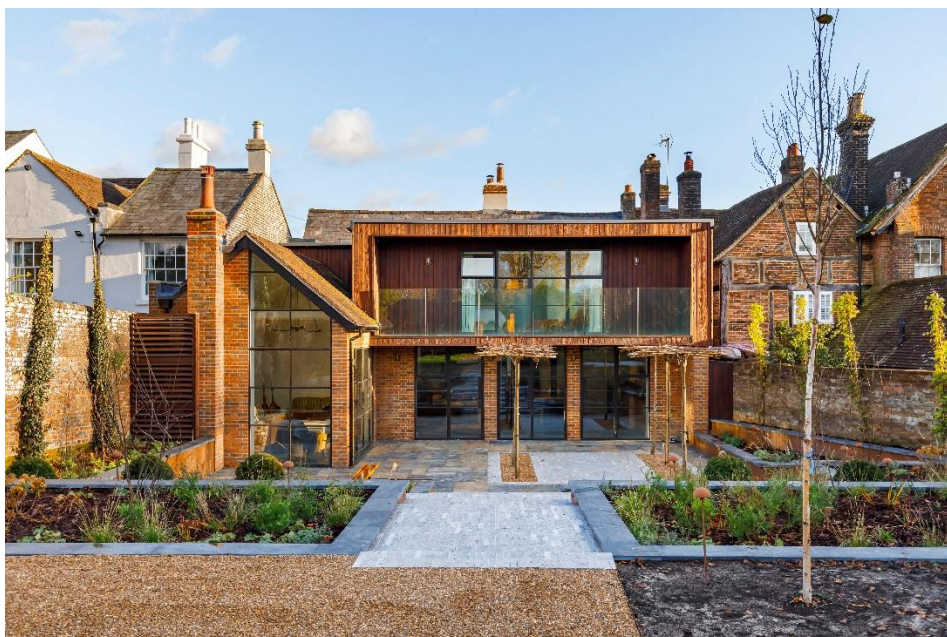
*Figure 6: Marlow House, west elevation, as existing*

**1.6** Marlow House, previously known as the Araminta Tea House (**Figures 5–6**), has been subject to works of extension, alteration and demolition which part implements a scheme approved under DM/22/3694 & DM/22/3695. However, the scheme as implemented is not in accordance with the approved plans as established through correspondence with MSDC in January 2025.

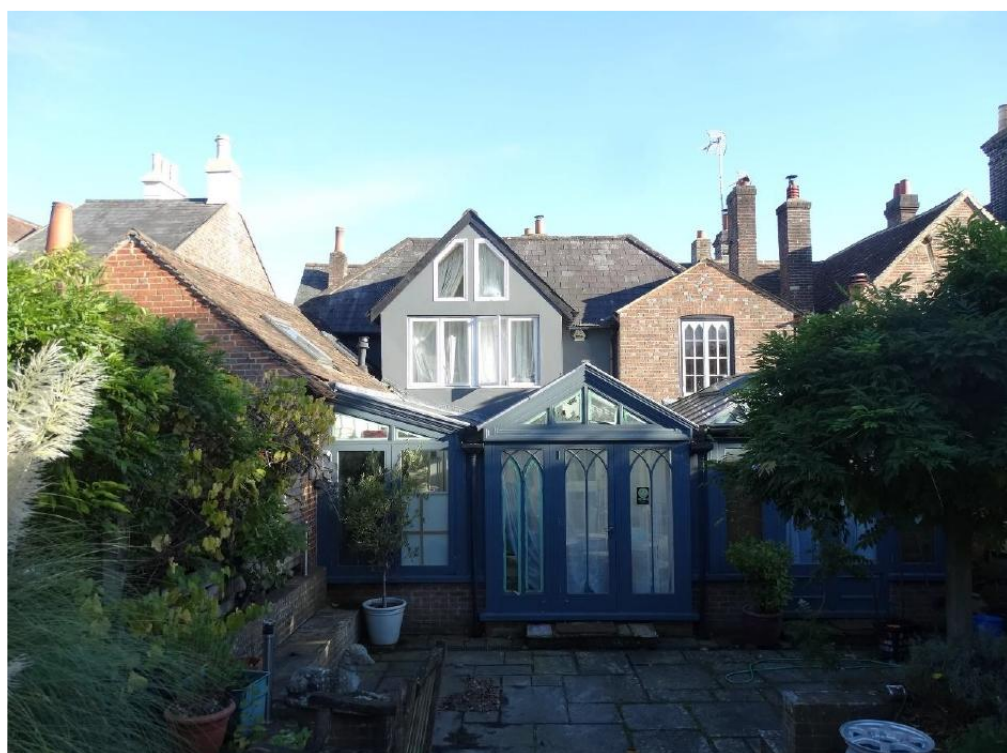
*Figure 7: Marlow House, west elevation, prior to the commencement of the scheme as implemented*

**3.44** The following sequence of OS Maps provides an indication of changes to the building footprint over time, demonstrating remarkably little change until the late 20<sup>th</sup> century. Prior to the implemented scheme, the west (rear) elevation (**Figure 7**) presented a very confused and confusing picture of the listed building. The jumble of gabled bays, roofs and lean-to extensions jostled for attention and did little to reveal or reinforce the building's special interest, as described in Section 4 below.

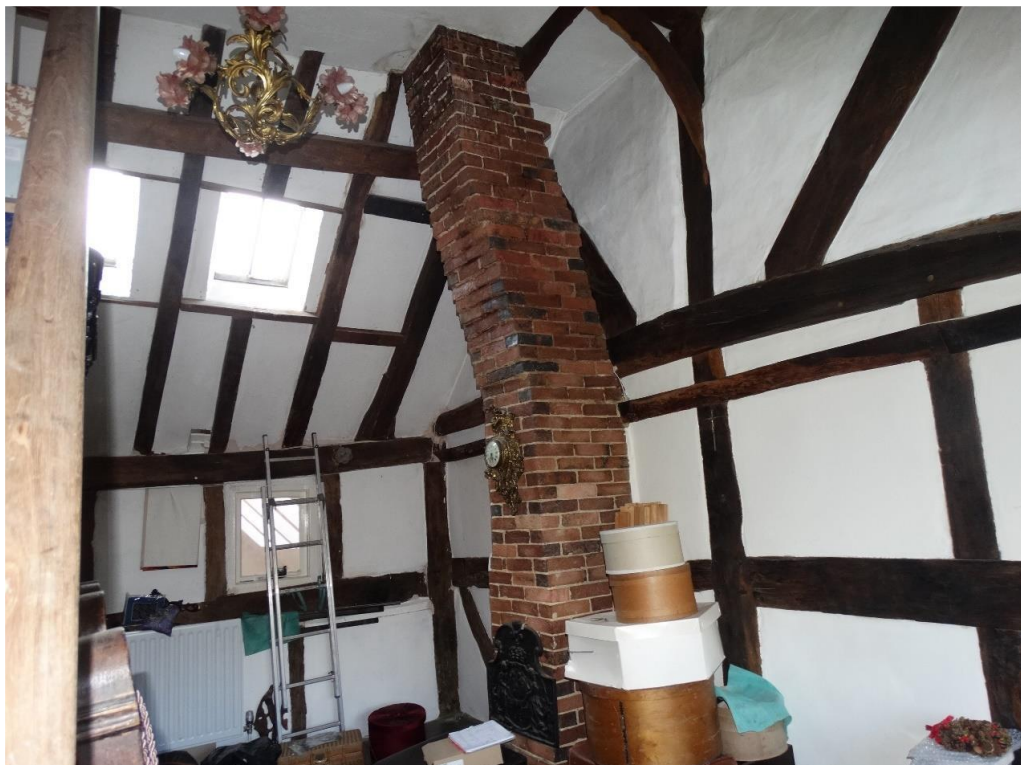
*Figure 9: 19<sup>th</sup> century brick stack adjacent to the north wall of the 15<sup>th</sup> century house prior to its removal. Source: Desbruslais Chartered Surveyors Statement of Heritage Significance of 13<sup>th</sup> October 2022*

**3.22** It is not known when this was carried out. However, this is presumably well after the early 19<sup>th</sup> century brick stack was inserted through the space (**Figure 9**).

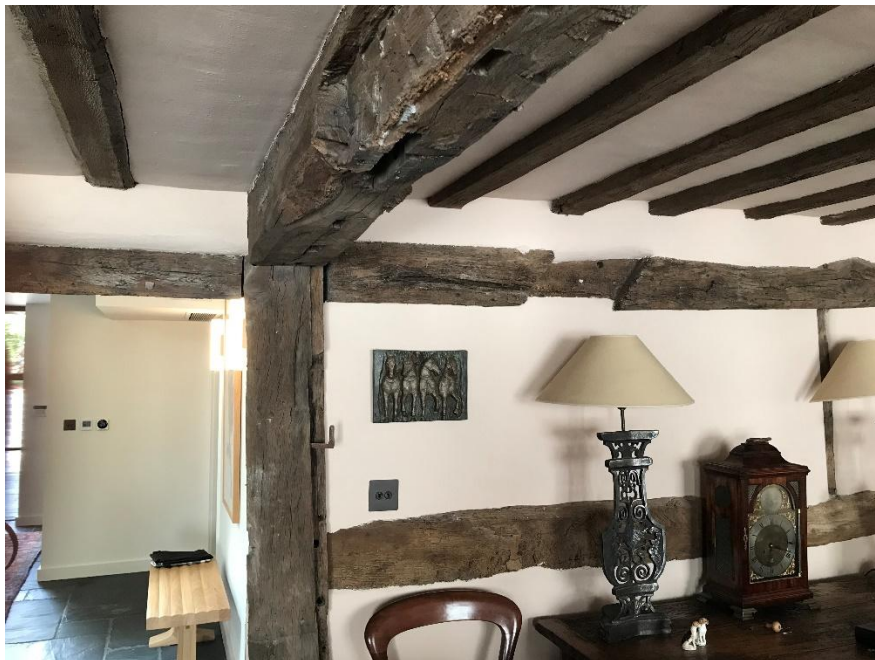
*Figure 12: main E-W ceiling beam to the living room showing the location of an original partition and doorway adjacent to the northwest wall. The timber jamb post and stud partition is proposed to be reinstated.*

**3.32** The ground floor central room has had much of the original timber lateral partitioning removed at some time in the past, as evident from the exposed mortices to the soffit of ceiling beams in the southern ground floor room and main living room north of the chimney breast (**Figures 12** and **13**). Whilst there is some central support in masonry, the joint where the axial first floor support beam crossed the tie is weak and has had to be propped with modern steelwork (**Figure 14**). The existing seasoned oak gunstock post which replaced the improvised support is shown at **Figure 15**.

**3.33** However, the underside of the tie does reveal the design of the partition in this instance, and the doorway at the end into the snug area looks to be in its original position (**Figure 12**).

- the removal of stud partitions which subdivided the southern ground floor room (making it an uncharacteristic linear open plan) as well as the main parlour to the north of the main chimney breast towards the centre of the original house (**Figures 12 and 13**);
- insertion of softwood casement windows and French Doors with faux gothic detailing to the 1830s rear range and Bake House respectively (**Figures 17 and 18**). Earlier plans from 1982, 1987 and 1996 found at **Appendix 4** clearly show there were no window openings to this part of the wall at first floor level;

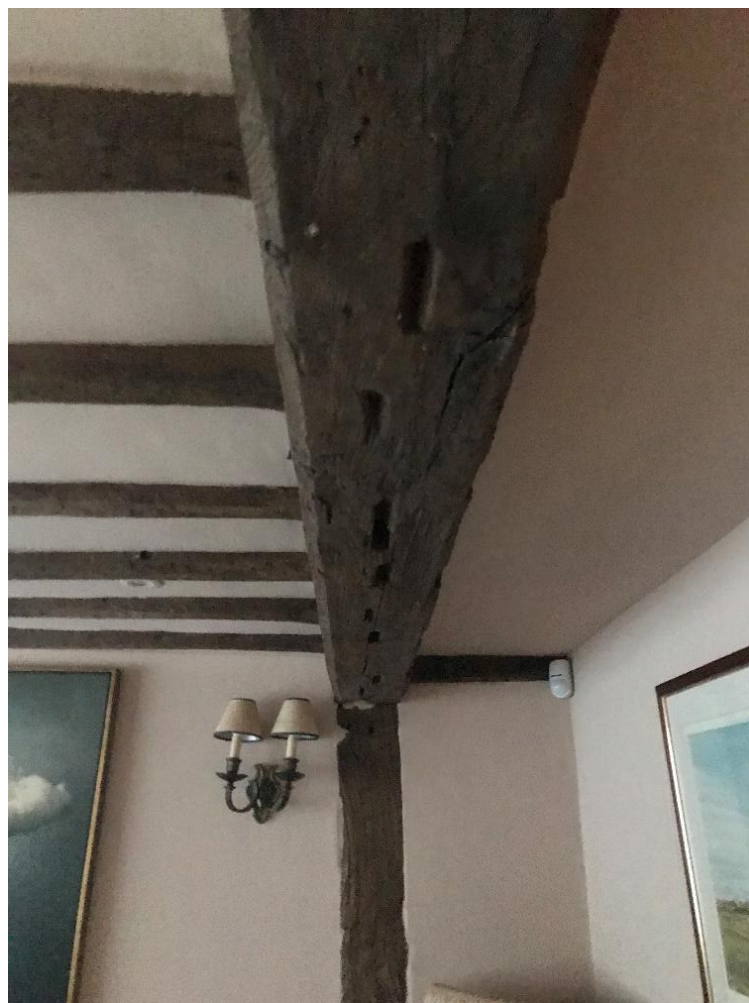
*Figure 13: N-S ceiling beam to the former dining room to the south bay with mortices indicative of historic partitioning within this space.*

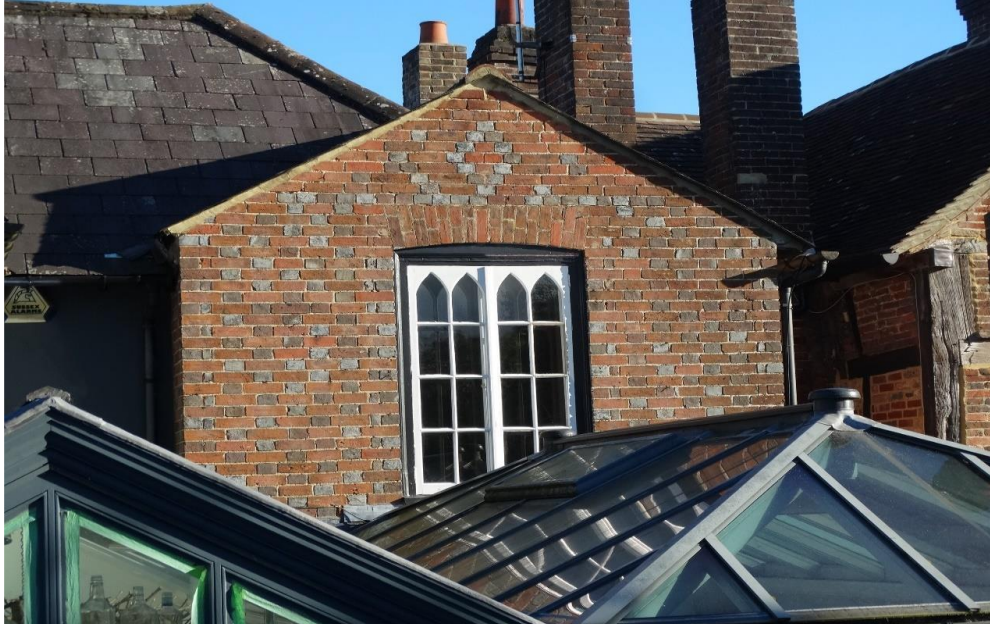
*Figure 17: 1830s gabled outrigger with vitrified blue brick header detailing. N.B. the double casement window is mid C20 with inserted softwood spandrels suggesting a gothic pointed arch head. The original windows was likely an eight-over-eight vertical sliding hardwood sash. Source: Desbruslais Chartered Surveyors Statement of Heritage Significance of 13<sup>th</sup> October 2022*

**3.40** The rear projecting two storey extension was added circa 1830. It is fabricated in solid brick masonry in a Flemish bond, showing off blue glazed headers (**Figure 17**). The gable features a modern softwood casement window with storm proof beading to the middle stiles and faux gothic spandrels to the upper lights. The original window was most probably a vertical sliding sash judging from the retained window frame joinery which indicate the presence of sash boxes.

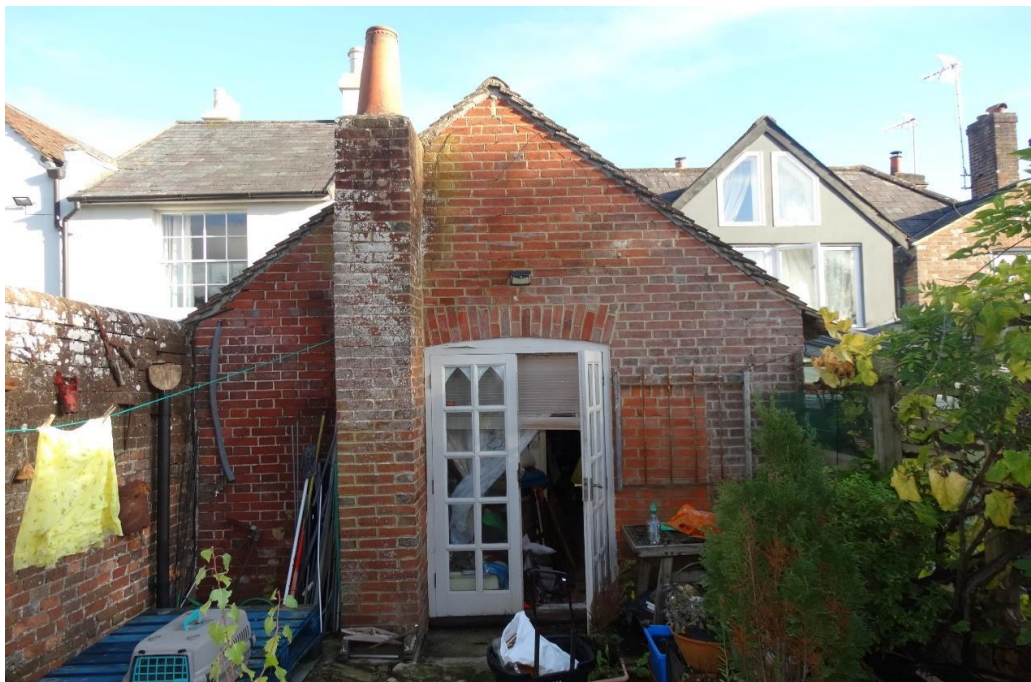
*Figure 18: View of the former Bake House from the west prior to dismantling. Source: Desbruslais Chartered Surveyors Statement of Heritage Significance of 13<sup>th</sup> October 2022*

**3.43** A Bake House was also added to the rear, of which only the outer walls remained in situ (**Figure 18**). The apex of the gable appears to have been rebuilt in stretcher bond. No internal features survived, and the interior linings and fixtures were

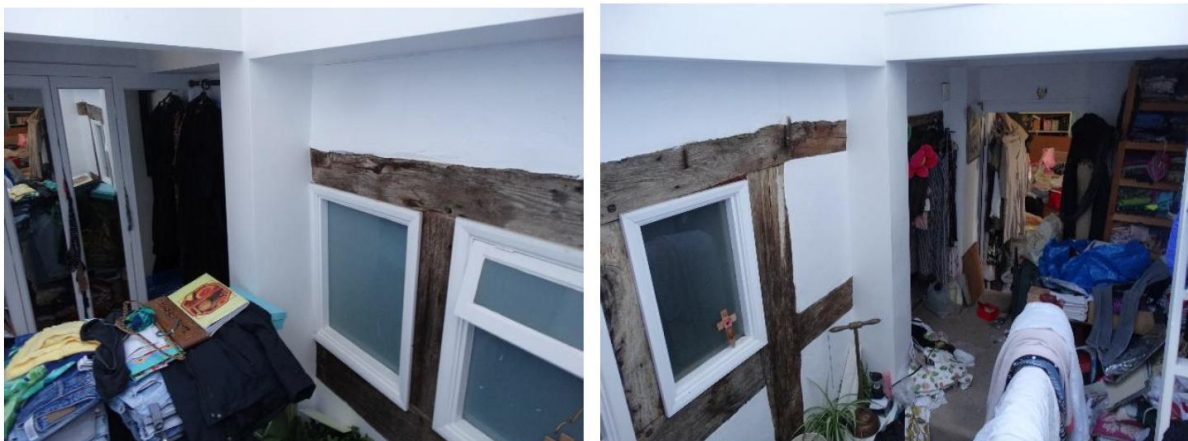
*Figure 29: Box framing to rear (west) wall of the 15<sup>th</sup> century house with internalised modern timber casement windows. Source: Desbruslais Chartered Surveyors Statement of Heritage Significance of 13th October 2022*

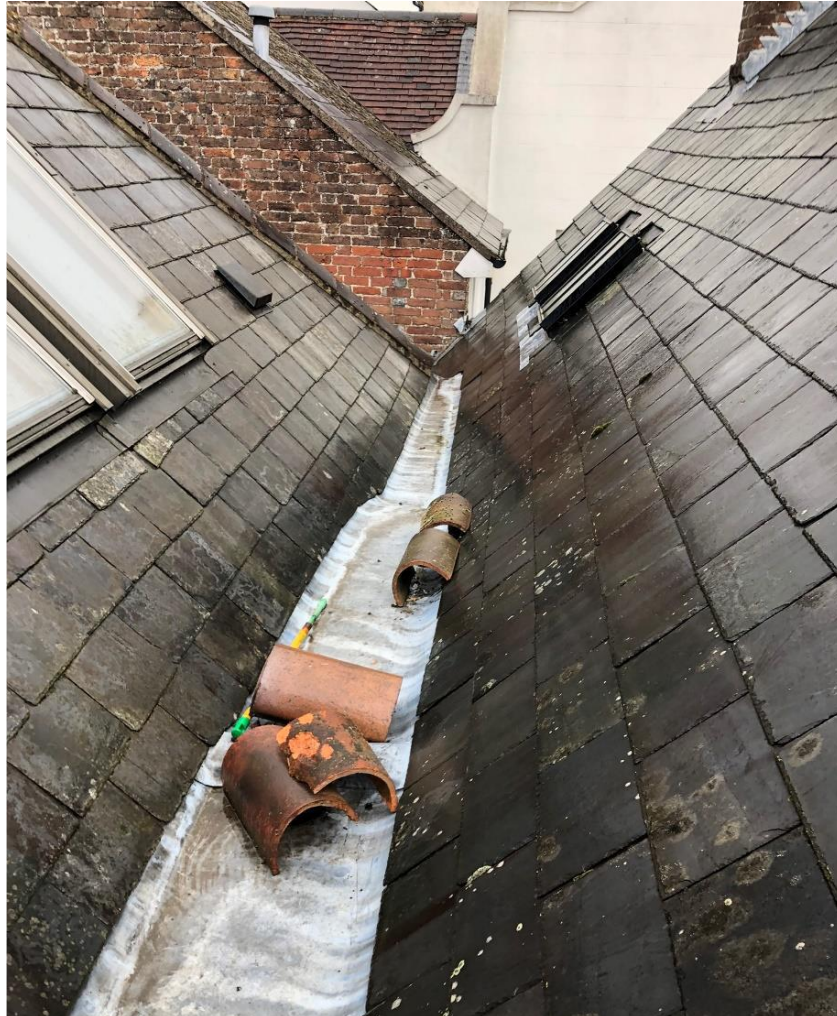
*Figure 30: the rear roof slope to the original 15<sup>th</sup> century building contained no less than 5 rooflights prior to their removal and slating over as part of the implemented scheme. Source: Gould Baxter Survey (October 2022)*

- Blocking of access via the 17<sup>th</sup> century staircase between ground and first and first to attic levels, making this feature entirely redundant in terms of historic circulation and accessibility (**Figure 11**);
- Blocking of an original door between the north bedroom and proposed en-suite which older plans from 1982, 1987 and 1996 (see **Appendix 4**) confirm was an original opening. A historic hinge was uncovered in the removal of modern plasterboard from this opening (see **Figure 38**);
- insertion of modern casement windows to the box framing on the west elevation (**Figure 29**); and,
- insertion of rooflights to various roof slopes, including the main west slope of the 15<sup>th</sup> century building (**Figure 30**) and south slope of the Bake House (**Figure 31**).

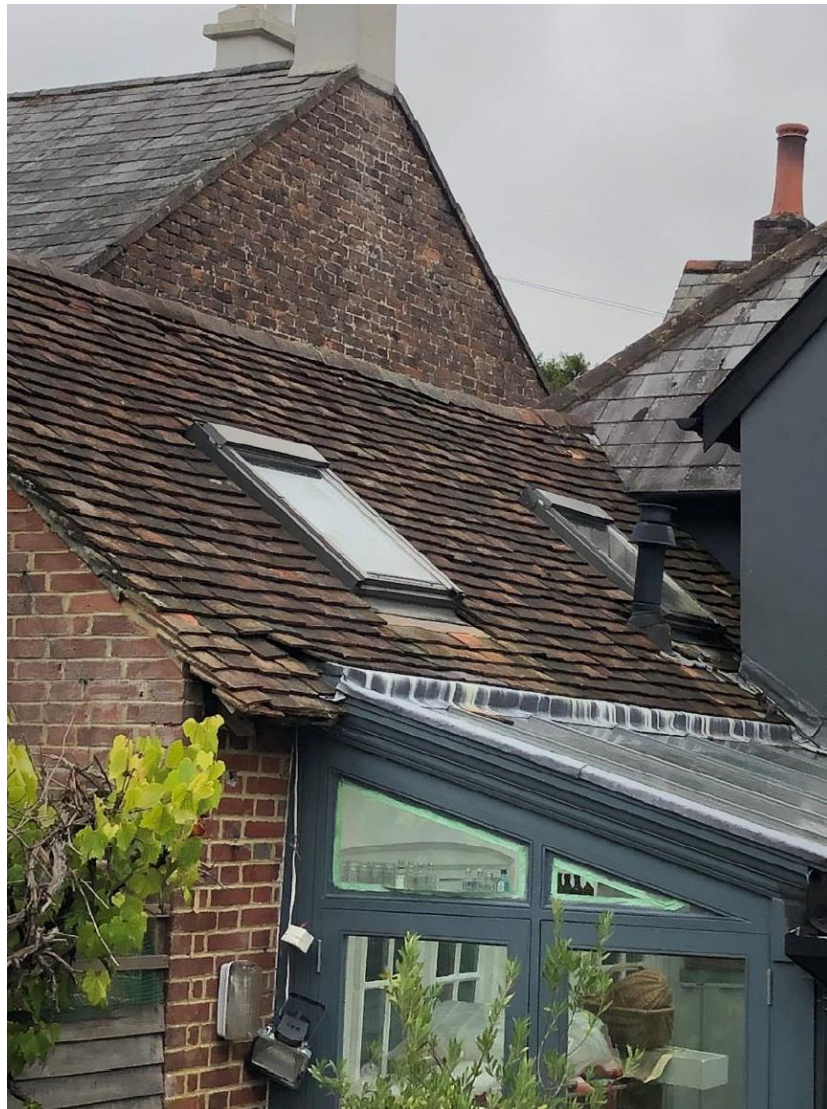
*Figure 31: Bake House roof (south slope) as seen in 2022 with 2 no. modern Velux rooflights.  
Source: Gould Baxter Condition Report*

- 1.11** The rebuilt Bake House is to be retained though the full height glazed break in the west elevation (as built) is amended to correspond to the size of the approved window opening, with Crittall windows adjusted accordingly. The Bake House (as re-built) also differs from the approved scheme in that the rooflights to the Bake House roof were omitted, these having been intended to replace two large Velux rooflights (*cf.* **Figure 31**).<sup>4</sup>

wholly modern. In 2022 the Bake House had a pair of large Velux rooflights to the south roof slope (see **Figure 31**).

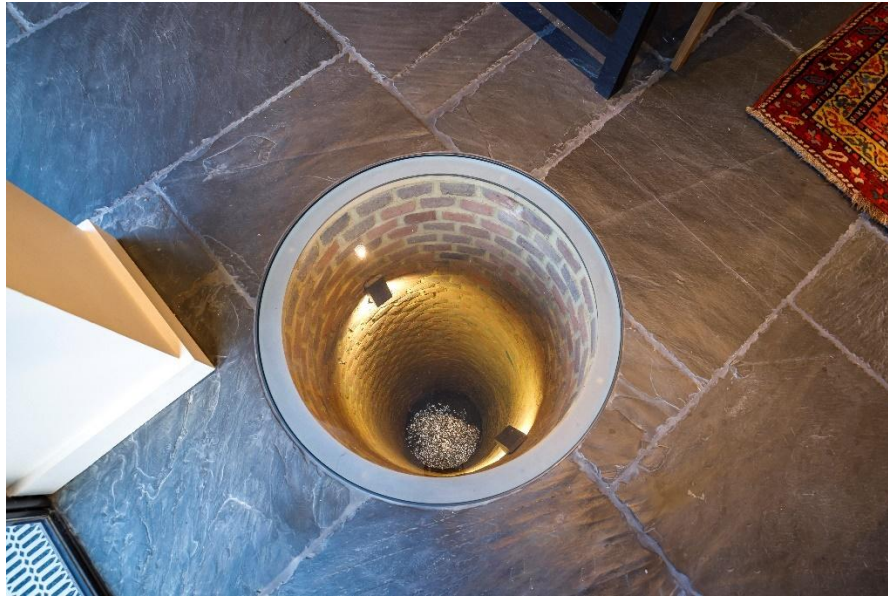
*Figure 32: Rediscovered well shaft (re-lined in handmade brick) and groundwater storage chamber within the kitchen area. See DAS for images of well as revealed and during construction phase*

- 4.16** Where physical evidence remains of changes to the building, and in the surviving historic fabric, there is some archaeological or evidential interest that retains potential for detailed understanding of the development of the building over time. The presence of a well shaft and water storage chamber to the underlying bedrock

within the original rear yard (now internalised – **Figure 32**) contributes to the archaeological interest of the Site and also the wider conservation area (see Section 5 below).

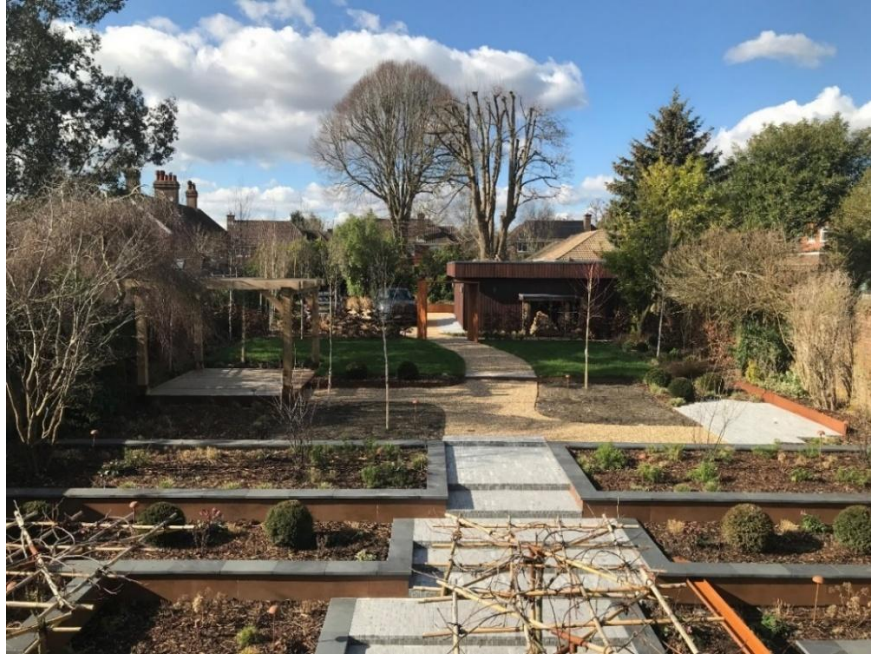
*Figure 35: View west from first floor bedroom window across the rear garden towards the garage (built as approved with lowered height log store).*

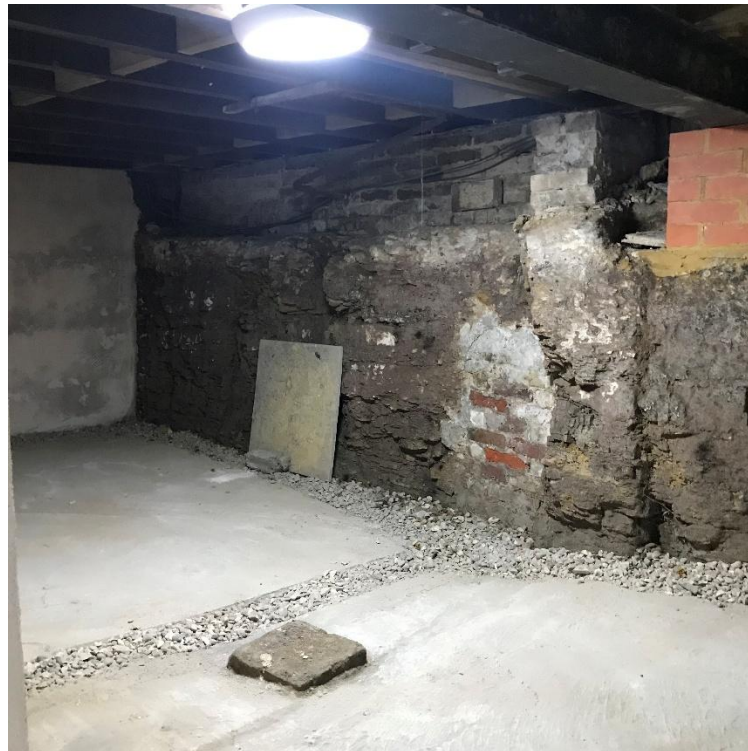
*Figure 36: Renewed steel beam with new nogging and joists at basement level. The pre-existing concrete floor has been augmented by a French drain and brick walls coated with breathable hydraulic lime render to regulate the damp.*

- 5.22** An under-engineered steel beam (comprising a railway line steel) has been replaced with an appropriately specified rolled steel joist (**Figure 36**). Some modern softwood joists renewed in better quality timber. These works comprise a minor heritage benefit due to enhanced structural stability which contributes towards securing the building's long term conservation.

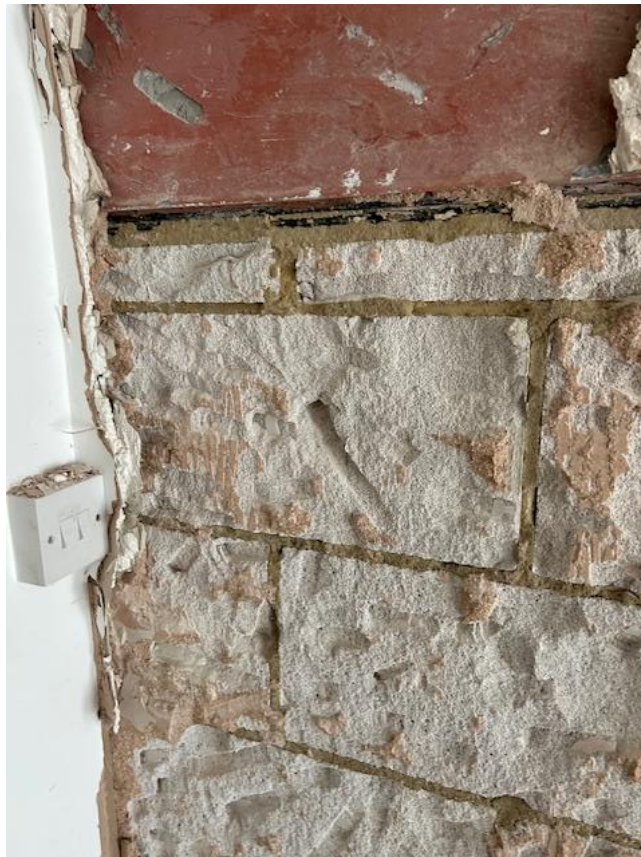
*Figure 37: Blockwork construction underlying the cosmetic 'timber stud' wall with stonework nogging shown at **Figure 16***

**3.34** One dining room wall which was contrived as a feature wall (**Figure 16**) was subsequently shown to be a cosmetic conceit with the stone 'nogging' applied as a form of cladding to underlying blockwork (cf. **Figure 37**).

**5.30** This cosmetic stud wall was a legacy of the 20<sup>th</sup> century tea room use. It appears not to have been an original wall or historical feature, as demonstrated by the presence of concrete blockwork within the wall uncovered during its removal (**Figure 37**). The demolition of this partition to create a reveal / recessed cloakroom at the entrance to the ground floor WC improves circulation and layout without harming significance. The impact of this change on the listed building's significance would be a minor heritage benefit as the wall was misleading and interruptive of historic plan form.

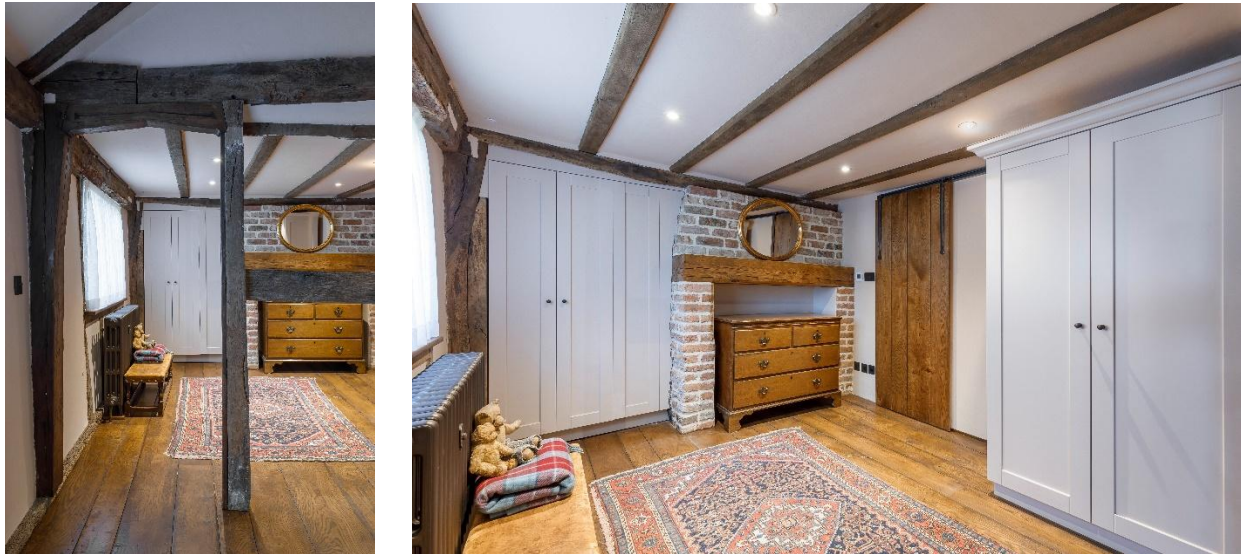
*Figure 38: First floor north bedroom as implemented*

- 5.32** A new partition to create an en-suite bathroom to the north bedroom is proposed in conjunction with the reinstatement of lime plaster infill panels to the historic spine to delineate the originally separate rooms as distinct spaces. The new bathroom partition has been sensitively designed with a sliding door and executed to a high standard (**Figure 38**) and merely follows the line of a historic, but possibly later, partition shown on plans dating back to 1982 and 1987 which projected as far east as the chimney breast. In conjunction with reinstated fireplace / hearth the interpretation of the space is positive and beneficial, resulting in no harm to the listed building's special interest. Furthermore, the reinstatement of the historic door opening to the east end of the partition (**Figure 38**) and which was to remain sealed under the approved scheme, reinforces historic plan form is a notable heritage benefit of the Proposed Scheme. An old iron hinge was uncovered when the modern plasterboard seal was removed, providing clear evidence of this historic opening which is now integral to the building's contemporary domestic plan form.

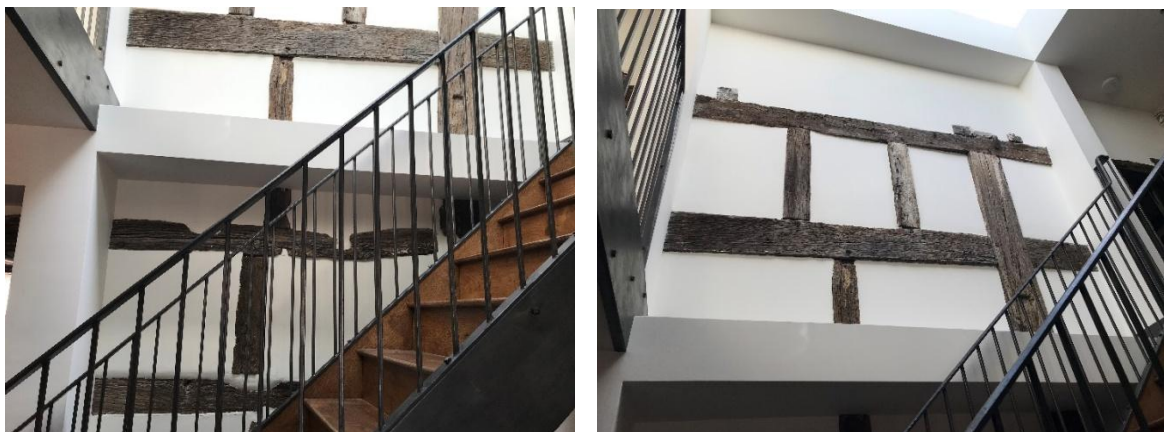
*Figure 39: Box framing to west wall of the 15<sup>th</sup> century house with internal windows infilled with wood wool panels and lime plaster.*

**5.36** The original window openings to the west wall of the house have long since disappeared. These modern windows do not represent the original window openings, the position of which is a matter of considerable conjecture. Approved drawings from 1982, 1987 and 1996 (see **Appendix 3**) all indicate that there were no windows in this rear elevation, the modern casements dating from after 1999. Any original windows would have been in the form of fixed and metal casement lights separated by oak staves or mullions. None of these windows remained in the property prior to the implemented scheme and there is no convincing evidence for their respective positions. The removal of the modern casements and infilling using breathable wood wool boards faced in lime plaster reverts to the pre-2000 baseline and serves to reveal and express the 15<sup>th</sup> century box framing much more clearly and is a significant heritage benefit of the Proposed Scheme (**Figure 39**). This should be weighted accordingly.

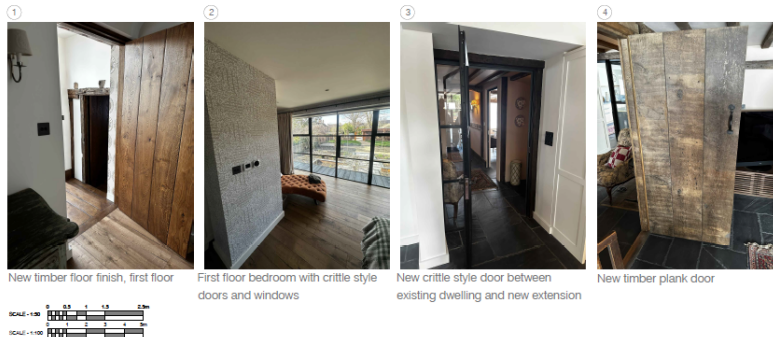
## Proposed Section A-A

- Hot dipped galvanised to prevent corrosion;
- Duralife polyester powder coated frames finished in RAL 8080 (dark bronze)
- New windows and doors to receive the same powder coated finish internally;
- New windows and doors to receive 16mm Krypton Gas filled doubleglazed units with Low E glass - centre pane U-Value 1.2W/m<sup>2</sup>

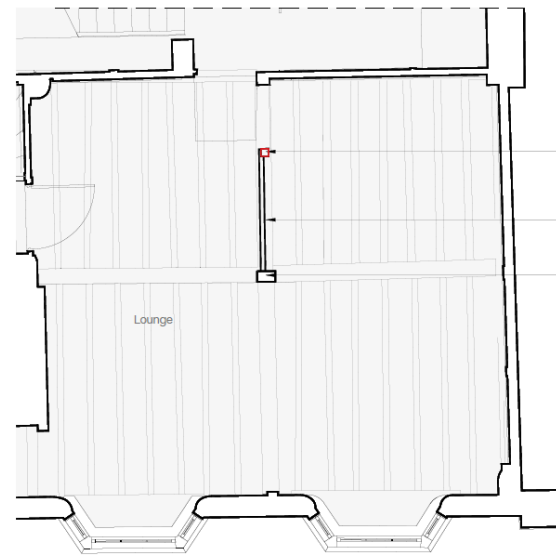
Proposed Scheme  
Ground Floor Plan  
Scale 1:25@A1, 1:50@A3

Previously removed door jamb to be reinstated to make legible an original stud partition which was heavily altered in the 20th century.

Historic horizontal timber frame member to be reinstated, secured to the post for stability

Existing timber gunstock post

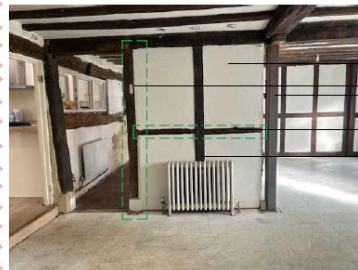
Internal lounge wall prior to changes.

- Plaster panel infills removed
- Historic door jamb to be reinstated
- Steel post previously replaced with timber gunstock post
- Historic horizontal timber frame member to be reinstated, secured to the post for stability
- Non-original decorative wall fillet element previously removed
