68 & 70 Keymer Road, Hassocks

Flood Risk Assessment

Project No.	1592
Revision	B [Changes Highlighted]
Date	05th March 2024
Client	Planning Issues Ltd
Prepared	R Leever
Checked	J Blyth
Authorised	C Yalden
File Ref.	P:\1592 68 & 70 Keymer Road, Hassocks\C Documents\Reports\1592 68 & 70 Keymer Road, Hassocks - Flood Risk Assessment (Initial Issue - 30.11.2023).docx

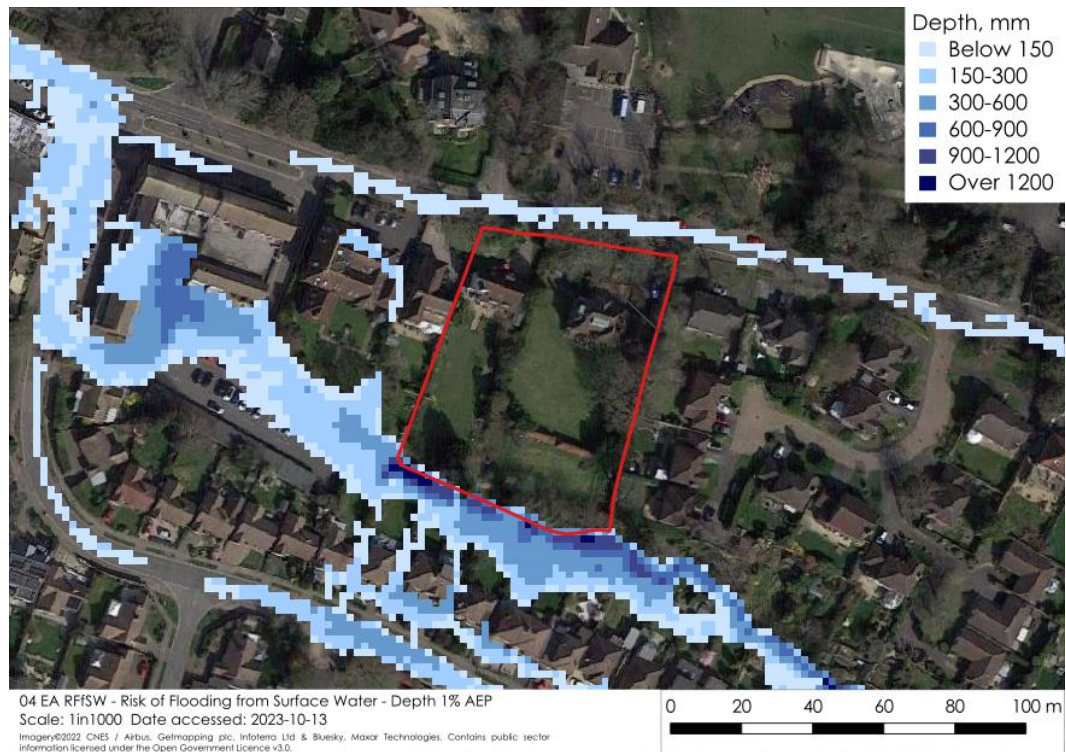
Figure 2.2A – EA Flooding from Surface Water (Depths) 1in100

2.12 The EA's 'Flooding from Surface Water' map has been reproduced as Figures 2.2A and 2.2B and show the depth of surface water flooding in the 1 in 100 and 1 in 1000 AEP events respectively.

2.15 Surface water flooding risk is also present in the highway along the northern boundary. In a 1 in 100-year event, this takes the form of isolated linear pooling. In a 1 in 1,000-year event, it is more connected to wider surface water flow routes in the local area but does not exceed 0.15 m in depth and should remain passable by vehicular traffic.

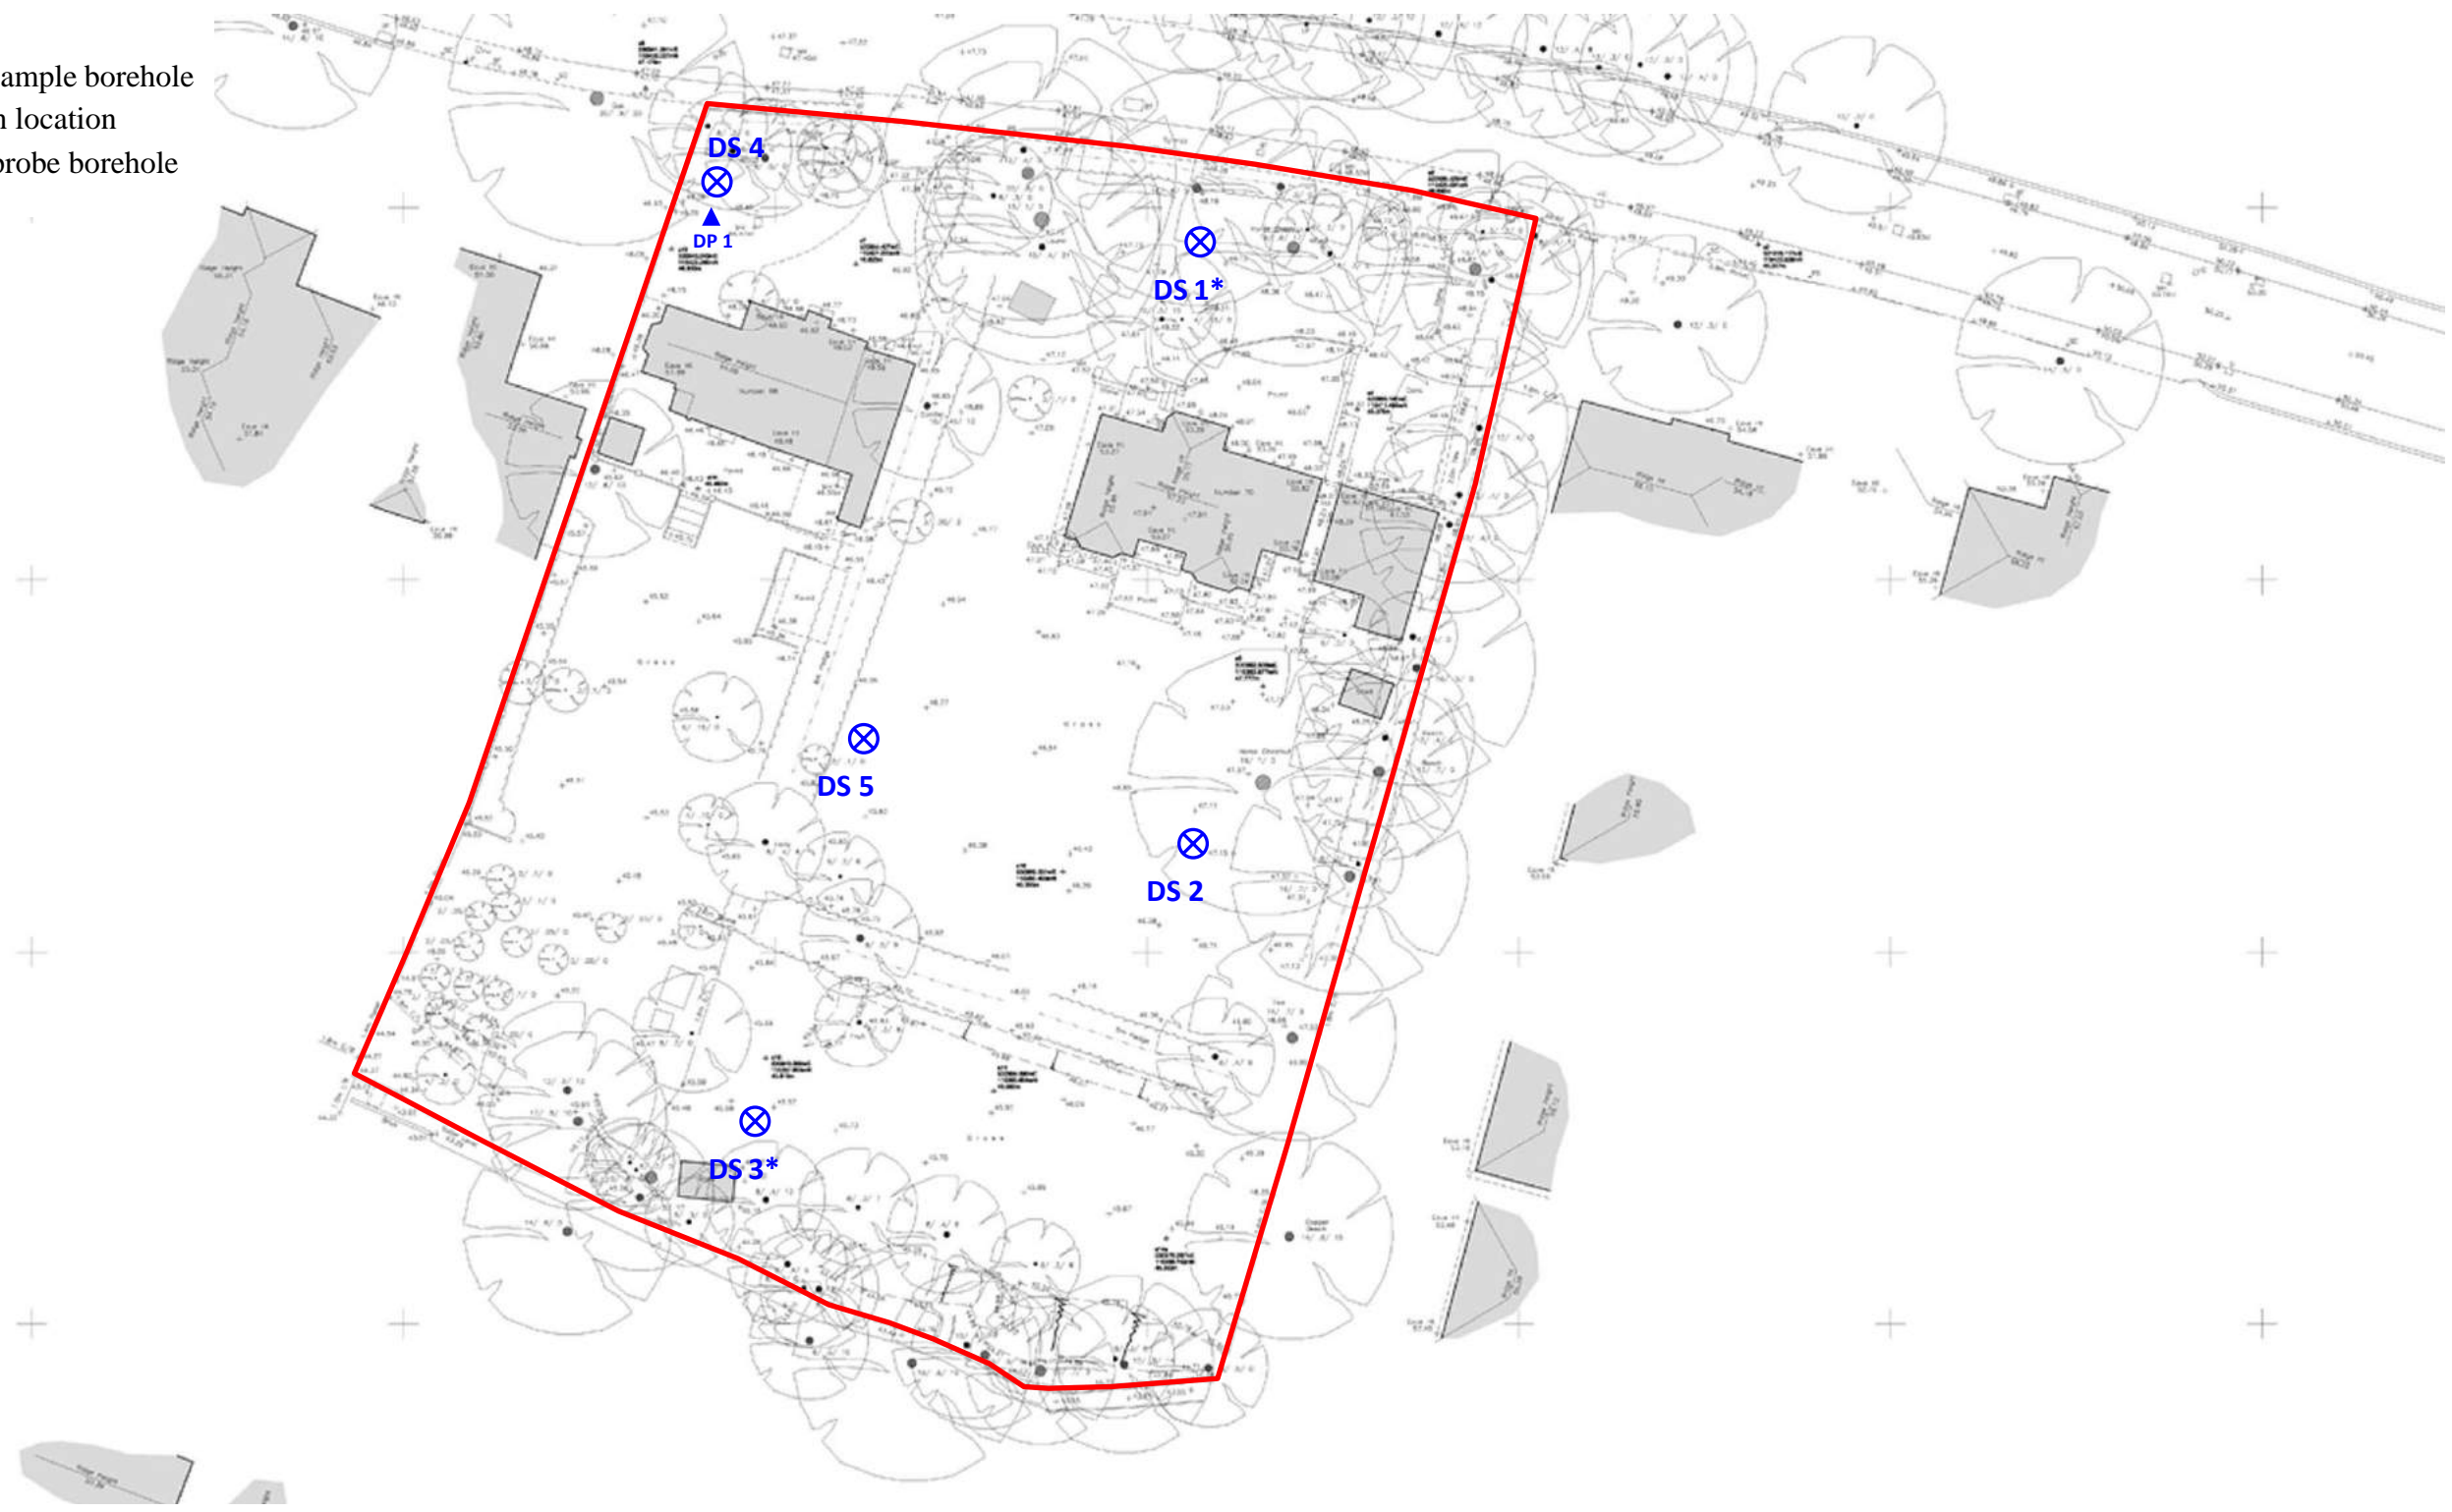
EXPLORATORY HOLE LOCATION PLAN

- ⊗ Dynamic sample borehole
- * Installation location
- ▲ Dynamic probe borehole

Scale 1:500

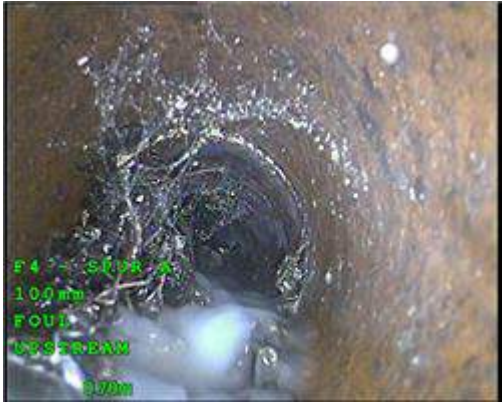
Pos	Video Ref	Code	Description	Image
00.00m		MH	Start node type, manhole F4	
00.00m	0:00:00	WL	Water level: 5% Height/Diameter	
00.40m	0:00:02	R	Roots - Severity 3 TAP ROOTS	Image Provided - Ref: 5_2

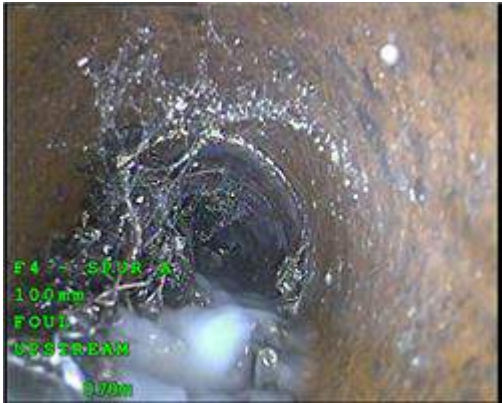
00.70m	0:00:09	R	Roots - Severity 3 MASS ROOTS	Image Provided - Ref: 5_3
