## Planning Statement - Design & Access Statement

Park Centre, 60 Park Rd, Burgess Hill RH15 8ET

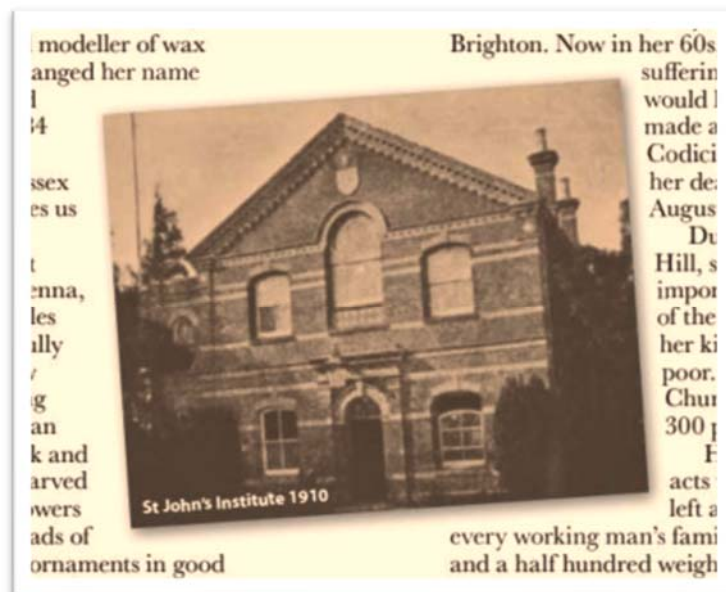
Image of Park Centre from 1910 from article *Emily Temple: Burgess Hill Benefactress*.  
Full article available at <https://parkcentre.org.uk>

The existing front elevations is at the moment a mix with rendered area for the pediment and painted brickwork underneath. We were hoping to be able to bring back the existing brick aspect of the front elevation as shown in a picture from 1910 attached above, however this is not possible, as per explanation below:

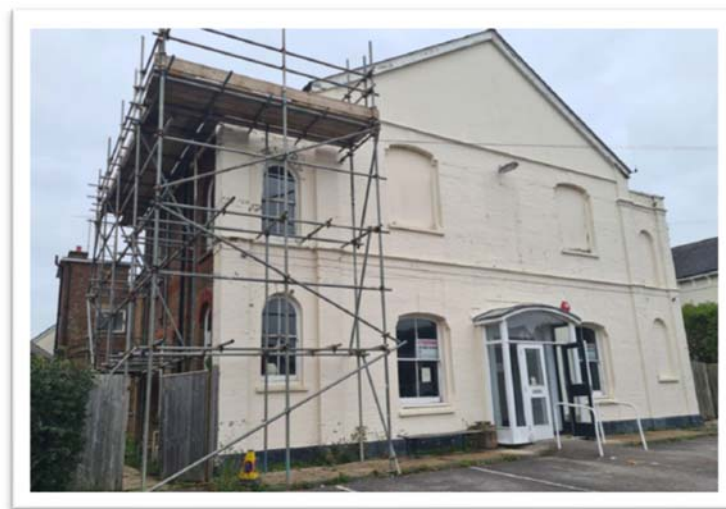
Image showing the current appearance of Park Centre

The front elevation has undergone several modifications throughout the 20th century. The original portico was demolished and replaced with a painted timber and glass porch featuring a felt roof. Two first-floor windows on the front elevation have been boarded up with plywood as well as many of the windows on the side elevations. The entire front elevation has been painted white, and wall-mounted lighting has been installed above the front door. The front pediment has been filled with what appears to be render. The right side of the front elevation was extended to mirror the left side of the elevation and a lift was installed behind which is now out-of-use. An original large central window on the front elevation above the main entrance has been lost.

The side elevations remain unpainted, preserving the original brickwork, lintels, and cornice details.

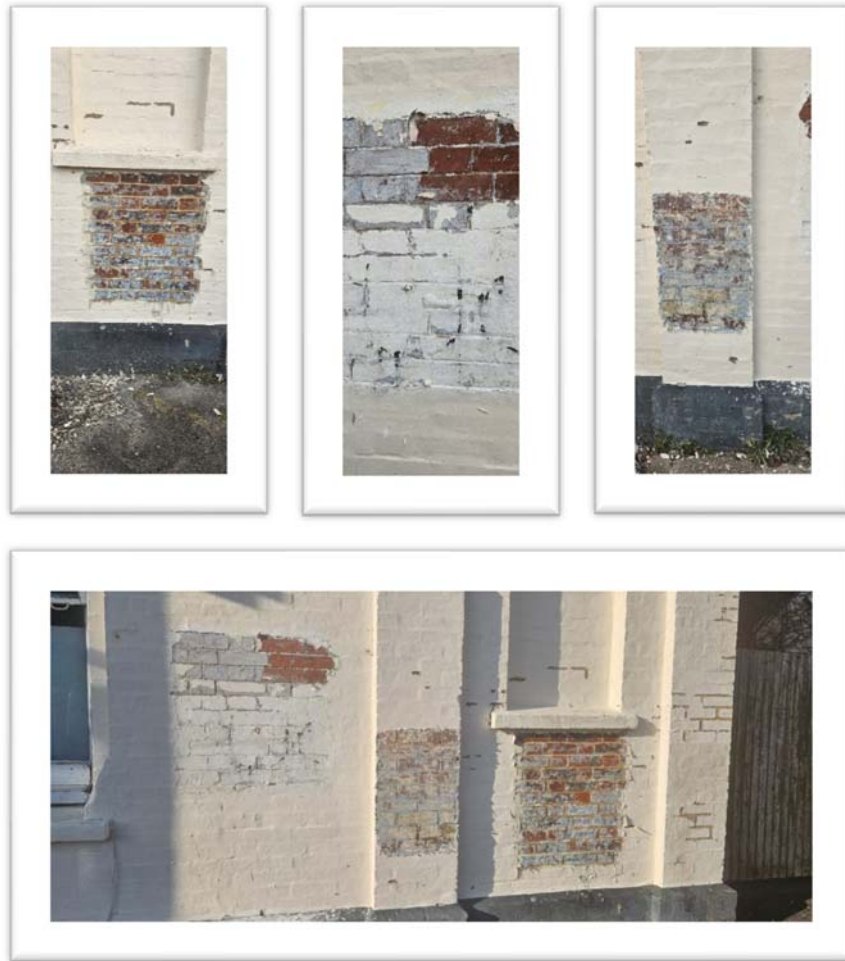
We complemented this investigation with the pictures below to illustrate the above.

“The contractor attempted several chemical cleaning methods before resorting to sanding, but unfortunately, none were effective. It appears that the elevation has been repeatedly painted over the past 60 years (according to local residents' accounts), and using a gentler method than sandblasting has proven unsuccessful in removing the paint.

Concerning the overall condition of the original elevation, we are particularly concerned about the state of the gable end. As shown in the attached picture, this area was rendered some years ago, and attempting to reveal the brick here will likely cause significant damage to the underlying structure. It is possible that the gable end may need to be rebuilt entirely.

Additionally, upon revealing the existing brickwork, we observed that a different type of brick was used for the front extension (on the right side when facing the building). The mortar used here is also a different thickness and in cement compared to the original building, which is thinner and in lime. This contrast in materials may create an awkward visual disparity if this section is left as part of the same elevation.

We also noted that the original blue band brick on the existing elevation has lost much of its colour and contrast, which now stands out in relation to the surrounding brickwork.”

Therefore, we are opting for a natural lime render finish to the front elevation, with ashlar lines to match next door. This will give a uniform and qualitative finish to the building, using natural materials.
