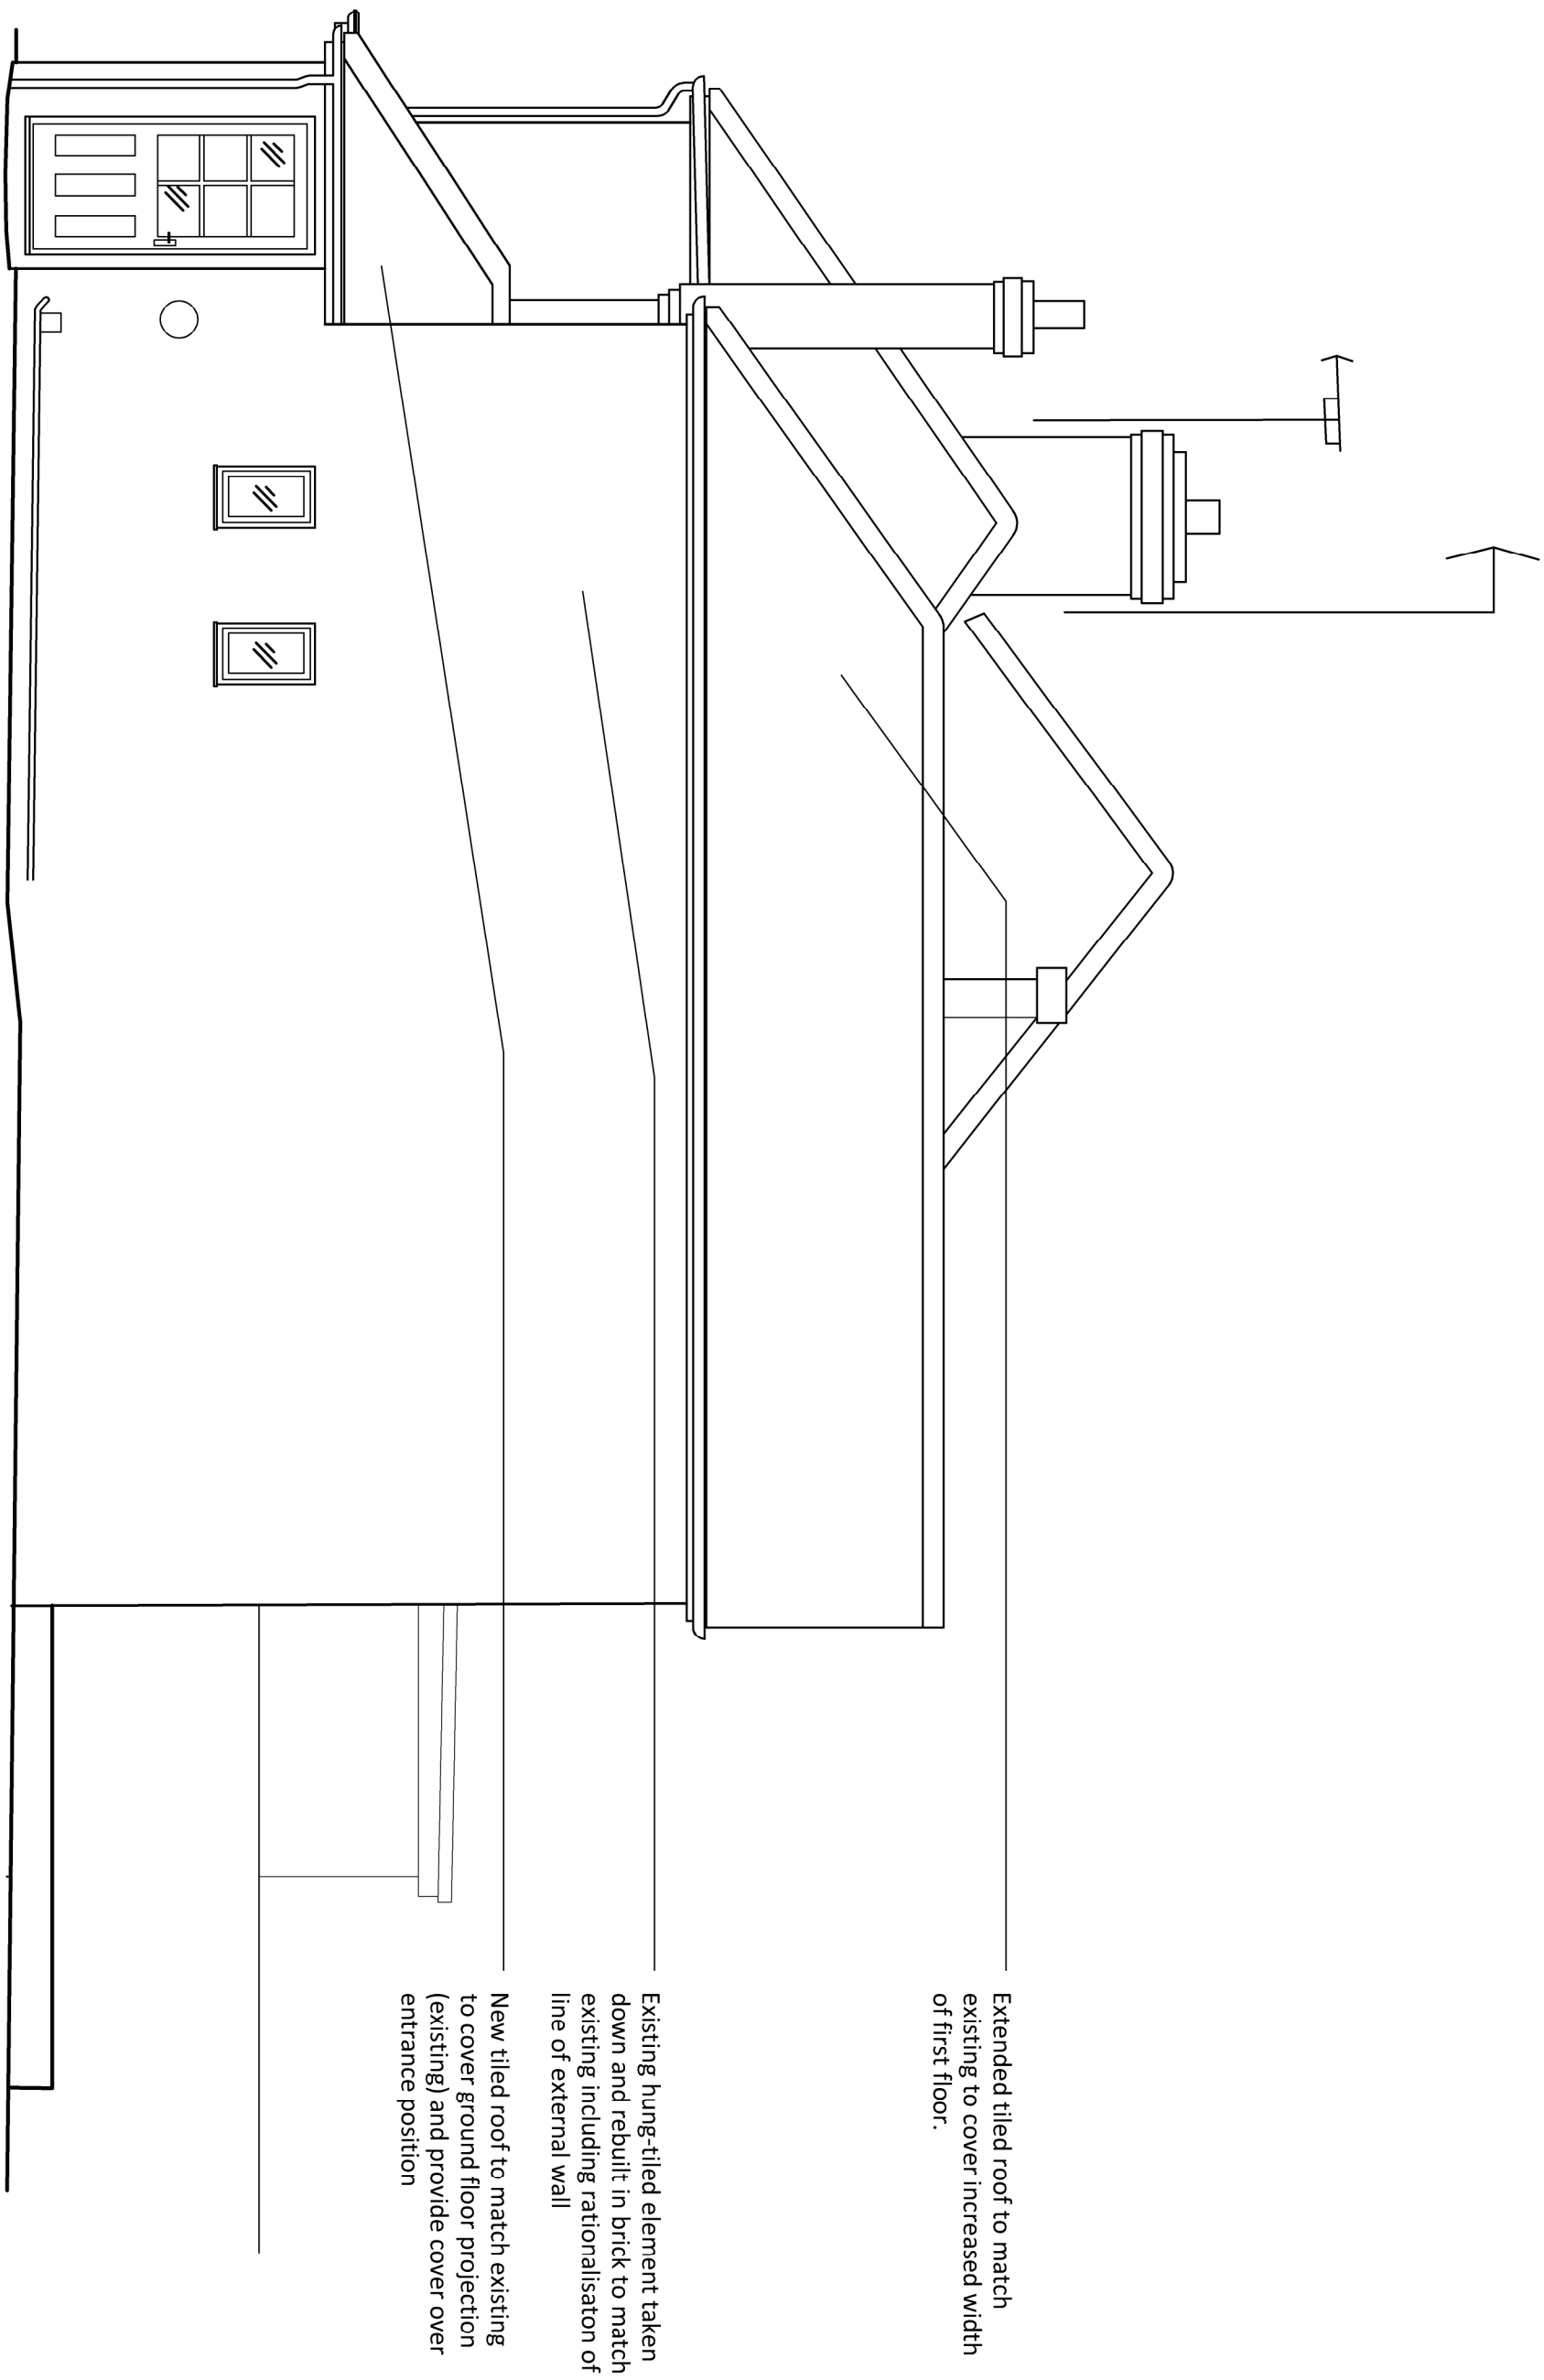
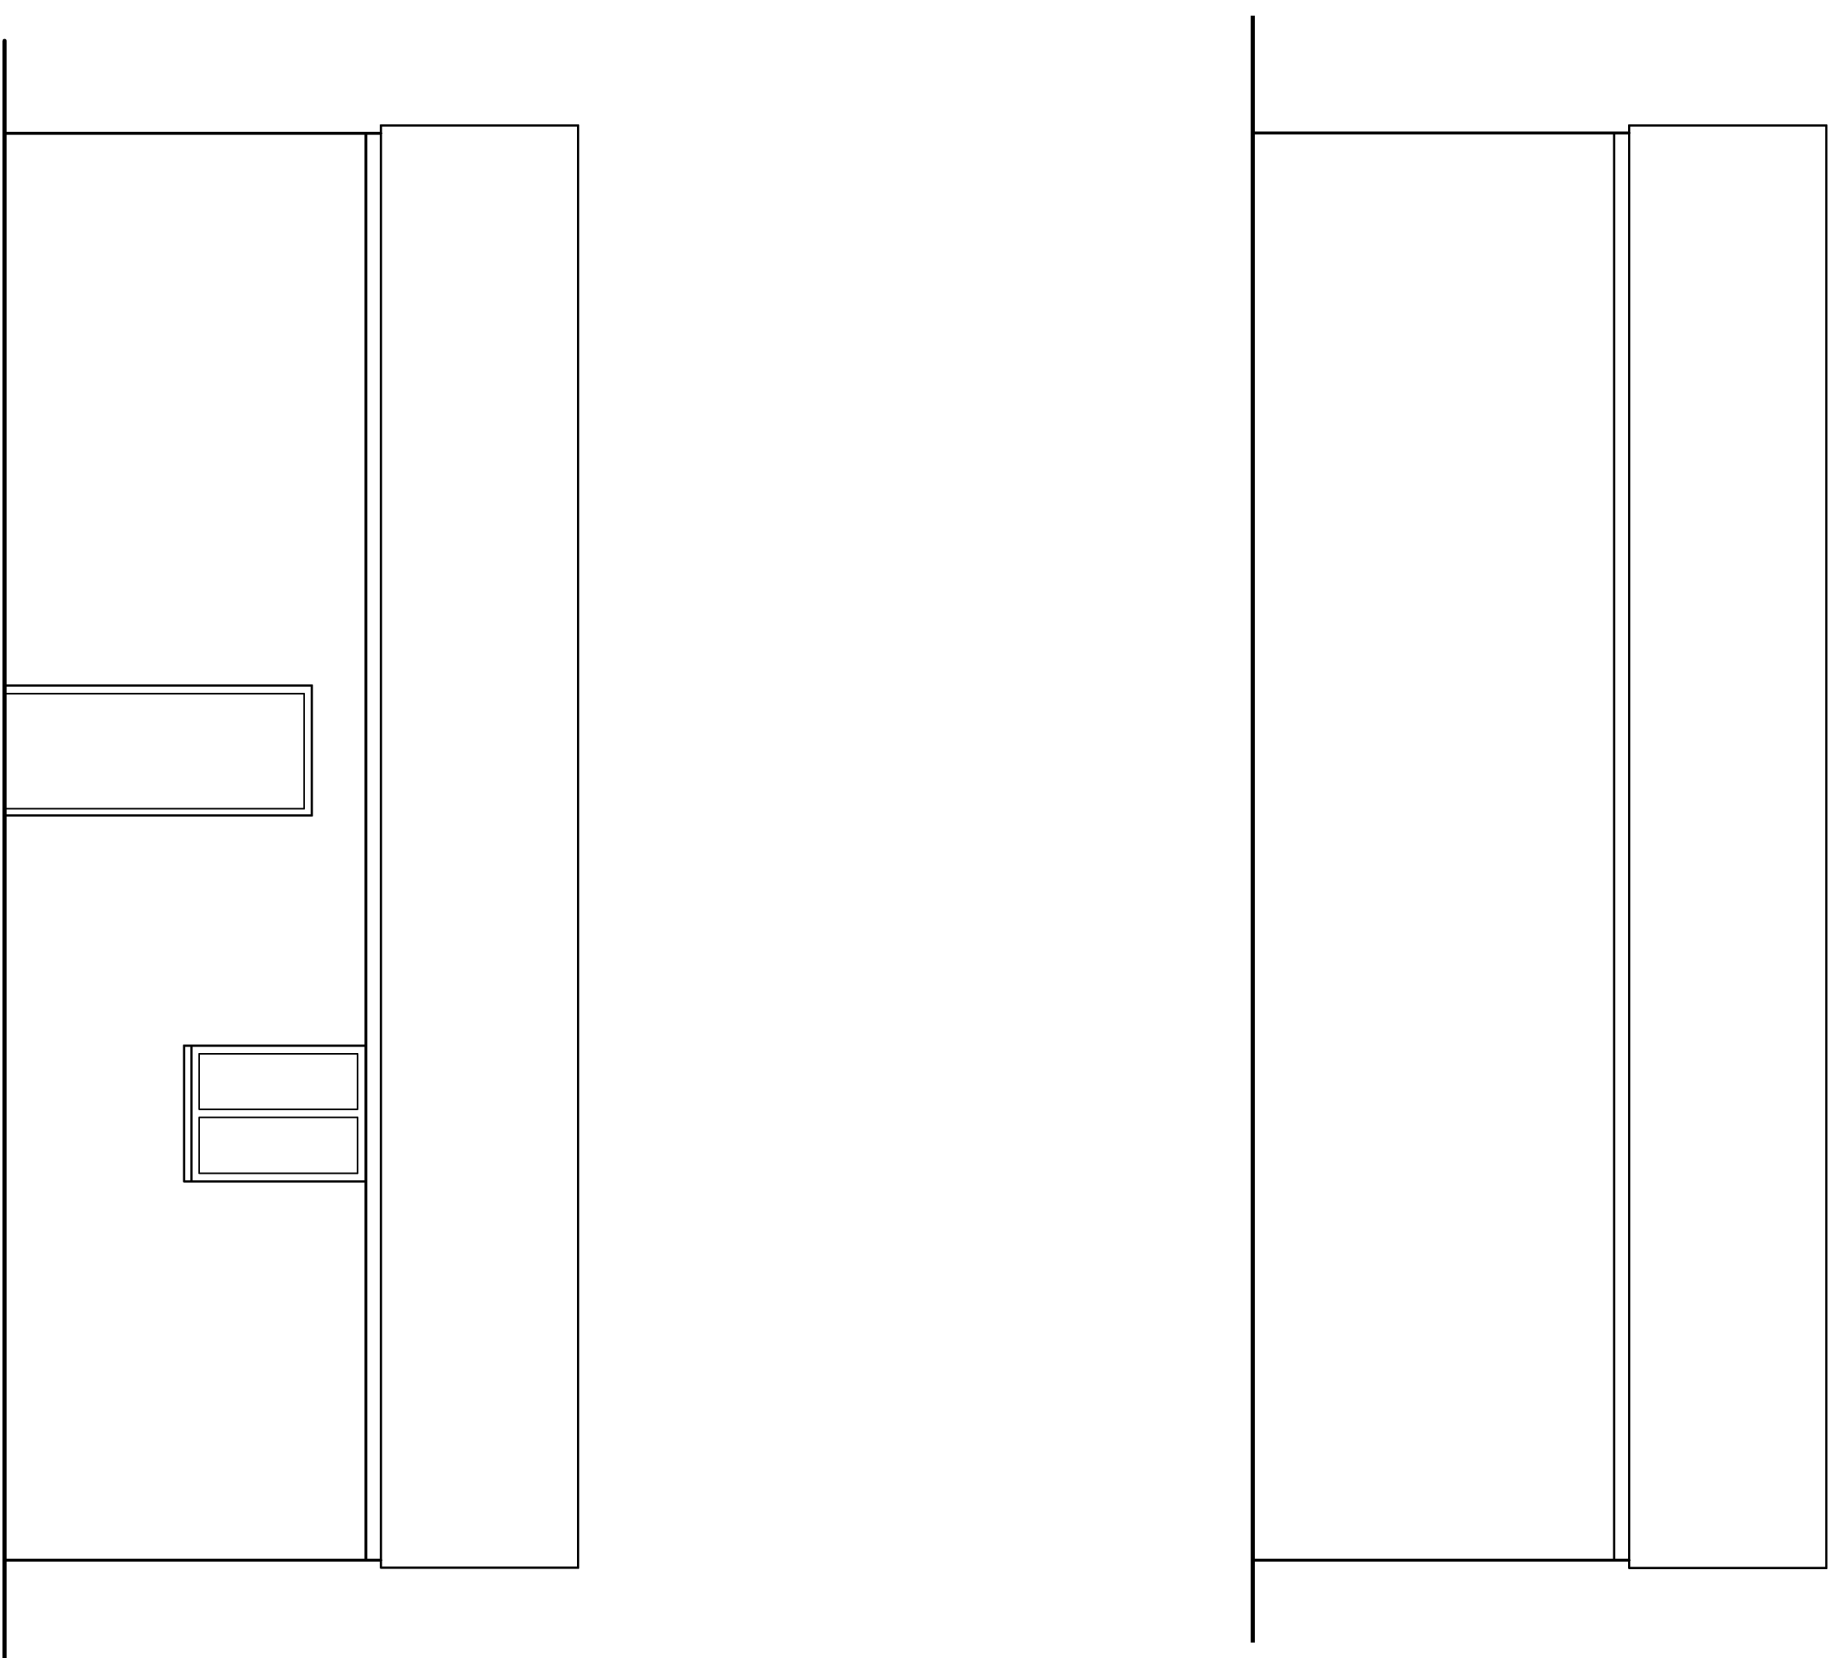
Existing hung-tiled element taken down and rebuilt in brick to match existing including rationalisation of line of external wall

New tiled roof to match existing to cover ground floor projection (existing) and provide cover over entrance position
