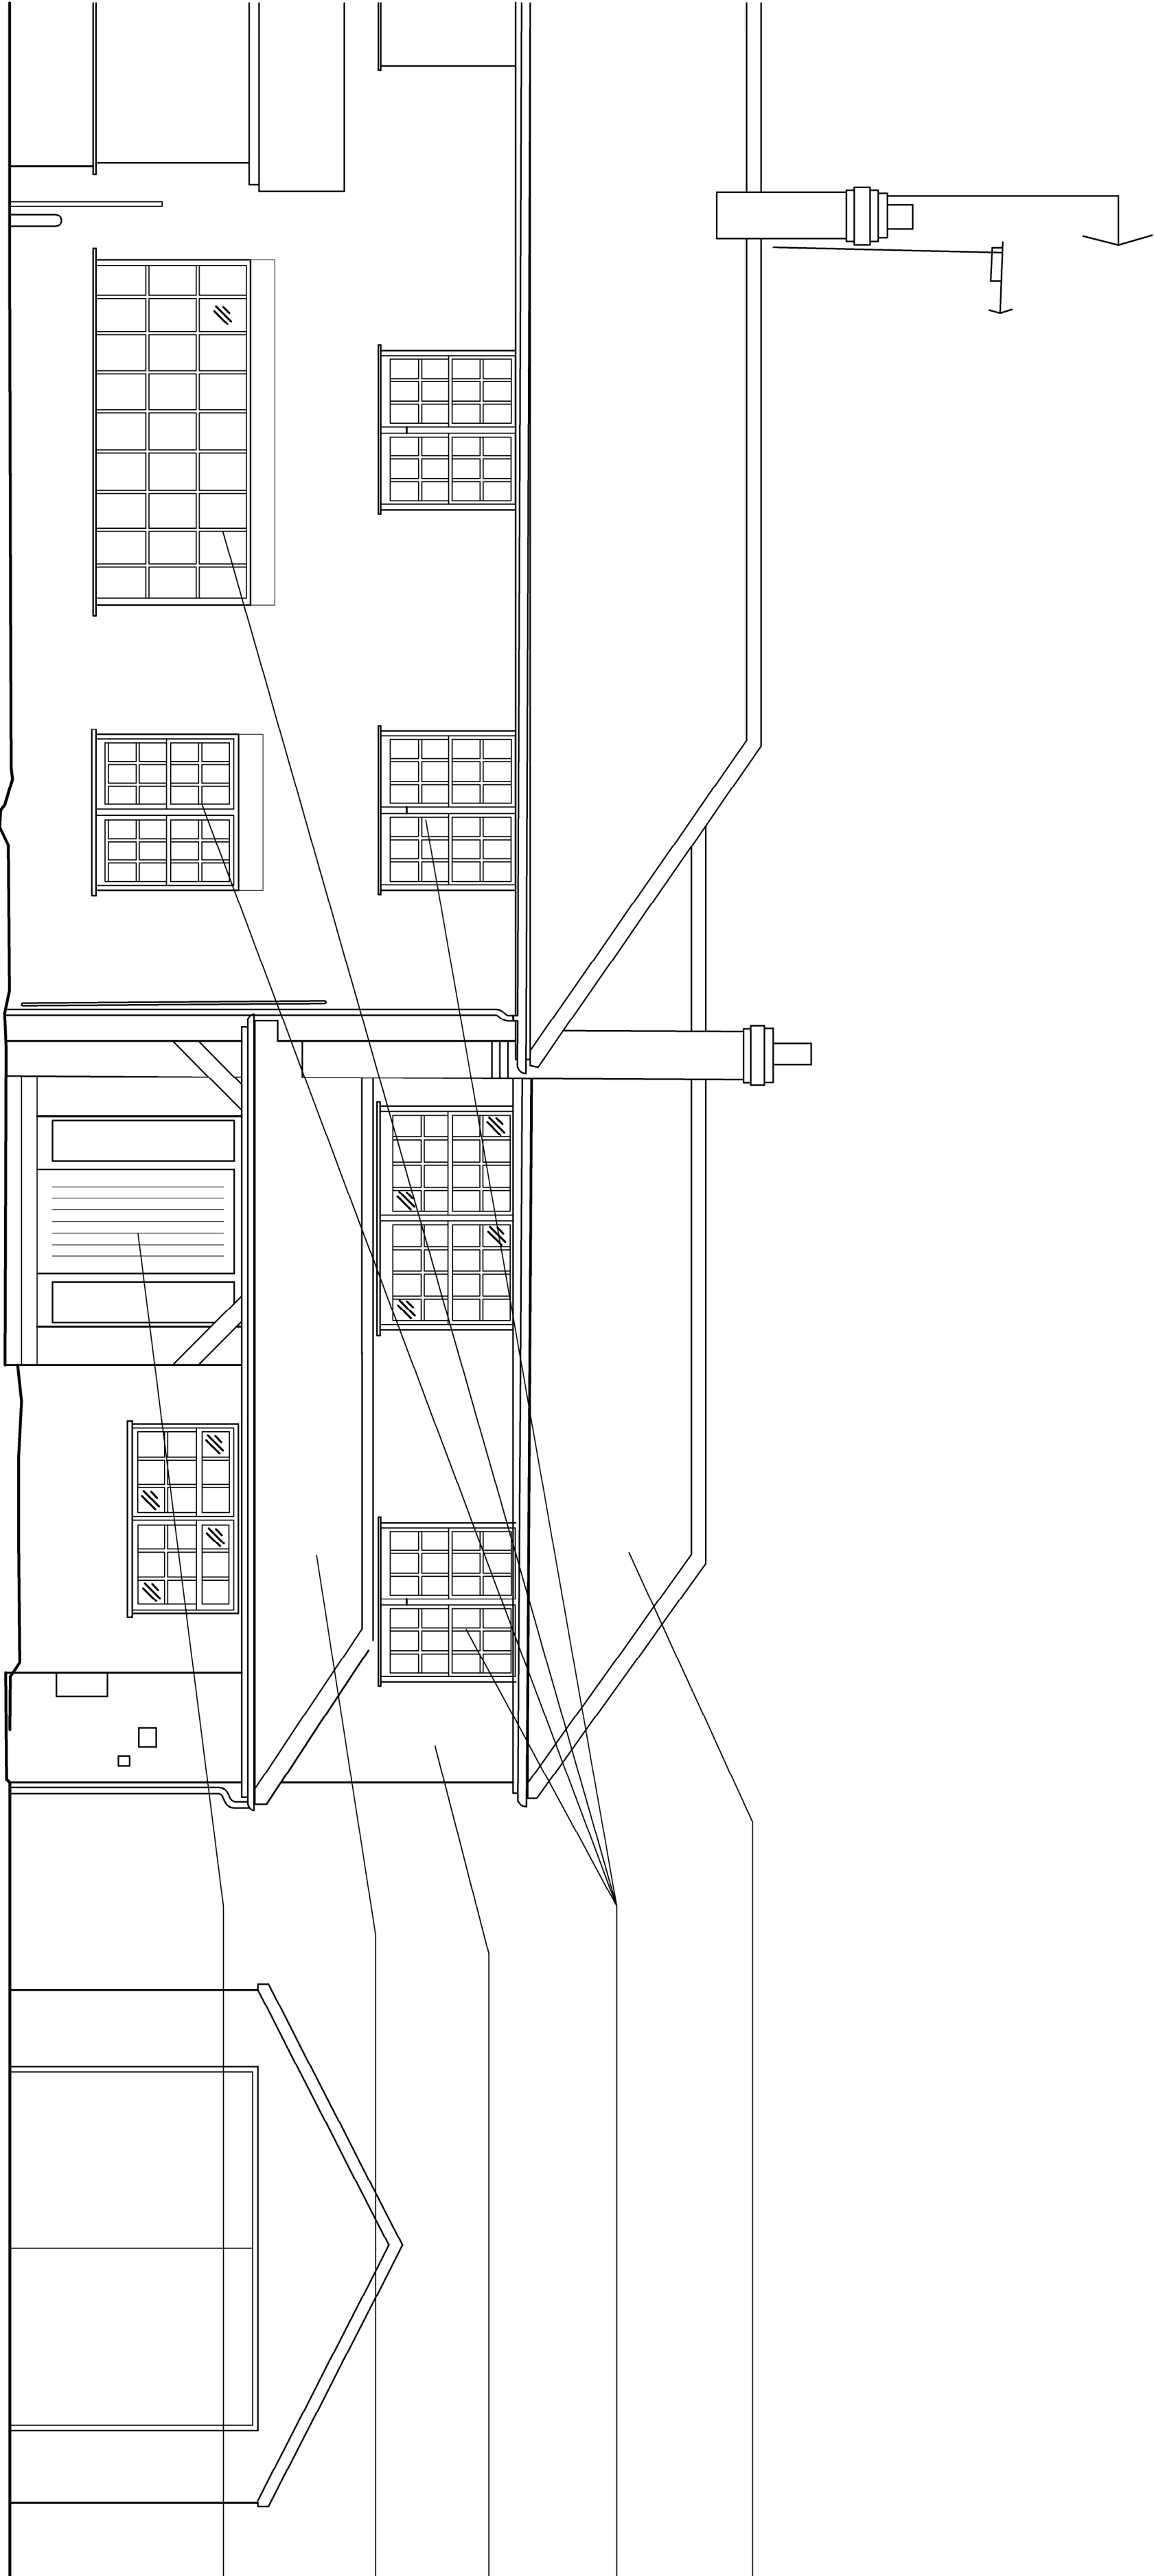
Extended tiled roof to match existing to cover increased width of first floor.

New window to match the existing

Existing hung-tiled element taken down and rebuilt in brick to match existing including rationalisation of line of external wall

New tiled roof to match existing to cover ground floor projection (existing) and provide cover over entrance position

New entrance door and window set in revised location to improve sense of arrival
