## **St Wilfrid's Church, Church Road, Haywards Heath, West Sussex**

### **Heritage Statement**

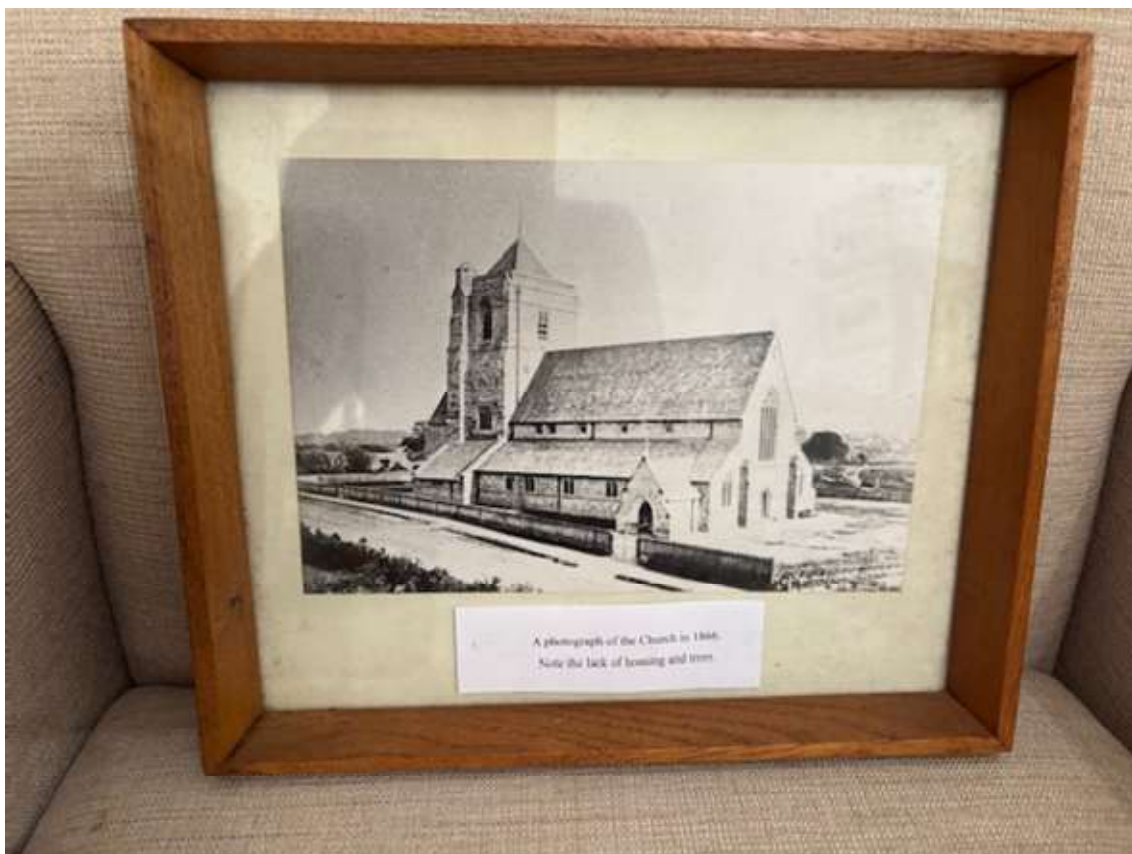
*Photograph of the north side of the church in 1866*

The church is constructed from local stone from Birch Green and features a distinctive low, spired, tiled tower. The church stands on the highest point in Haywards Heath, approximately 300 feet above sea level.

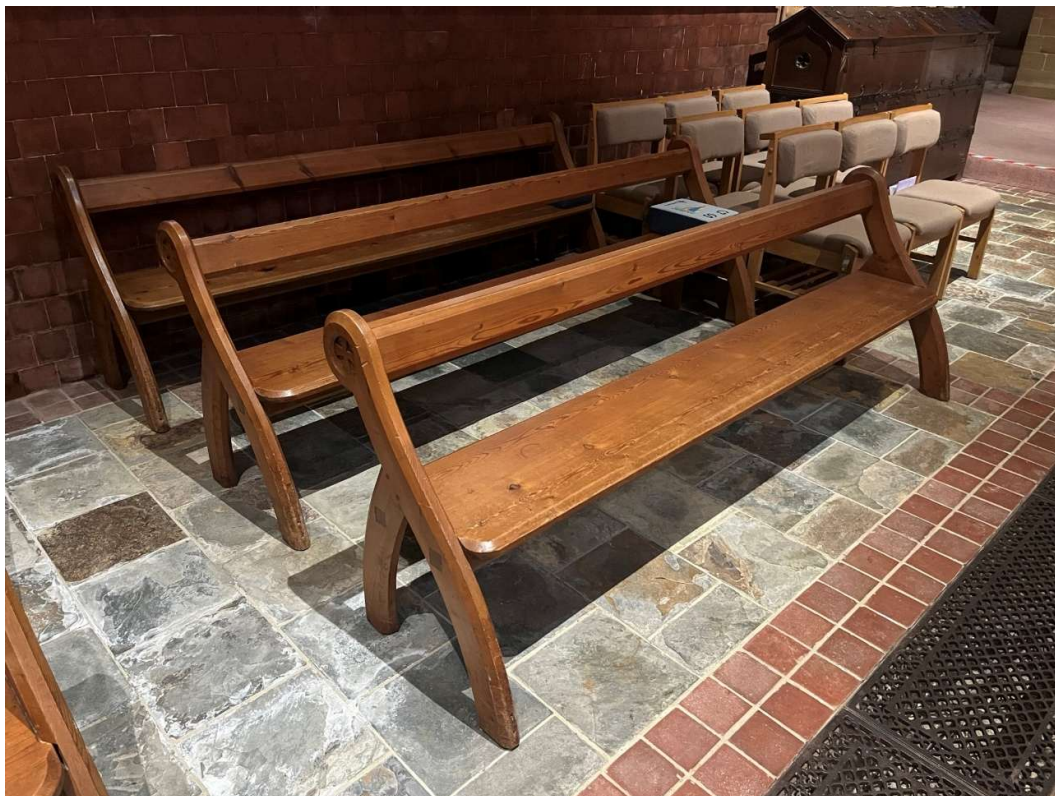
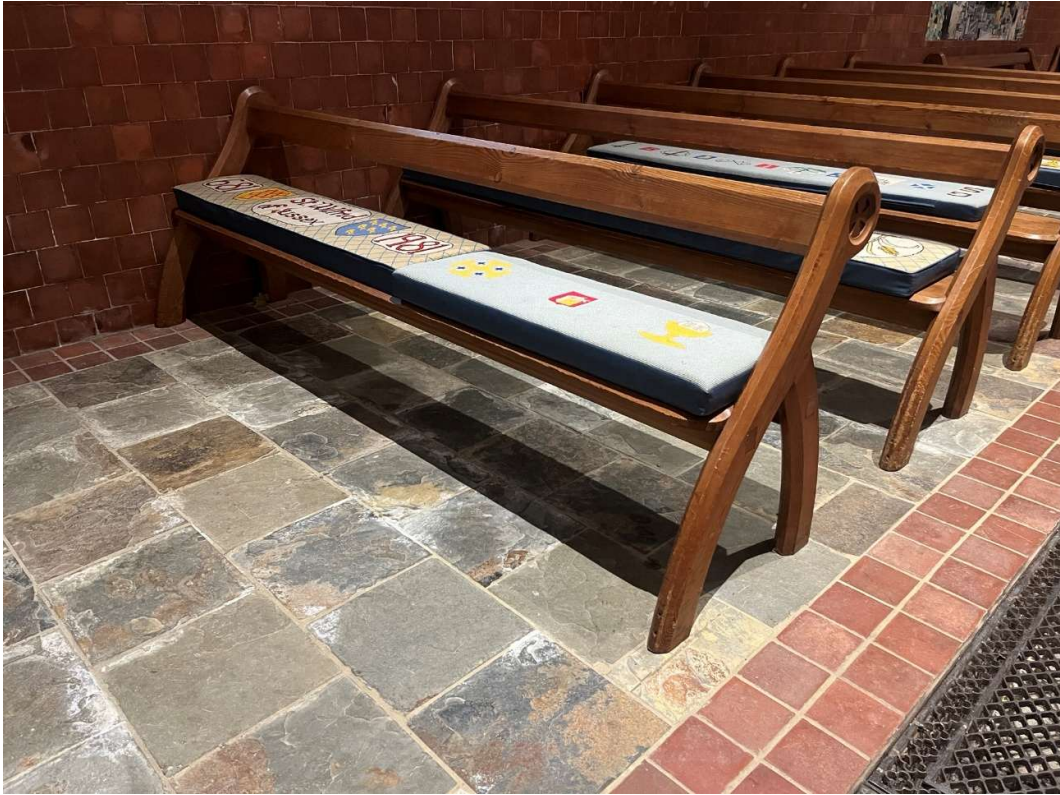
**Pews:**

The pews are late Victorian (1890) and are now placed in the north and south aisles. Removal of 12 pews would enable the church to be flexible, providing space to facilitate small group fellowship and enhance the activity space for the young and their families coming to the church. The rest of the Victorian pews in the church will be retained.
