## Heritage Statement & Impact Assessment Wykehurst House, nr Bolney RH17 5QQ

**Prepared by Stickland Wright Ltd for:** Michael and Sarah Blencowe

**Job No:** 25041B

**Revision:** B

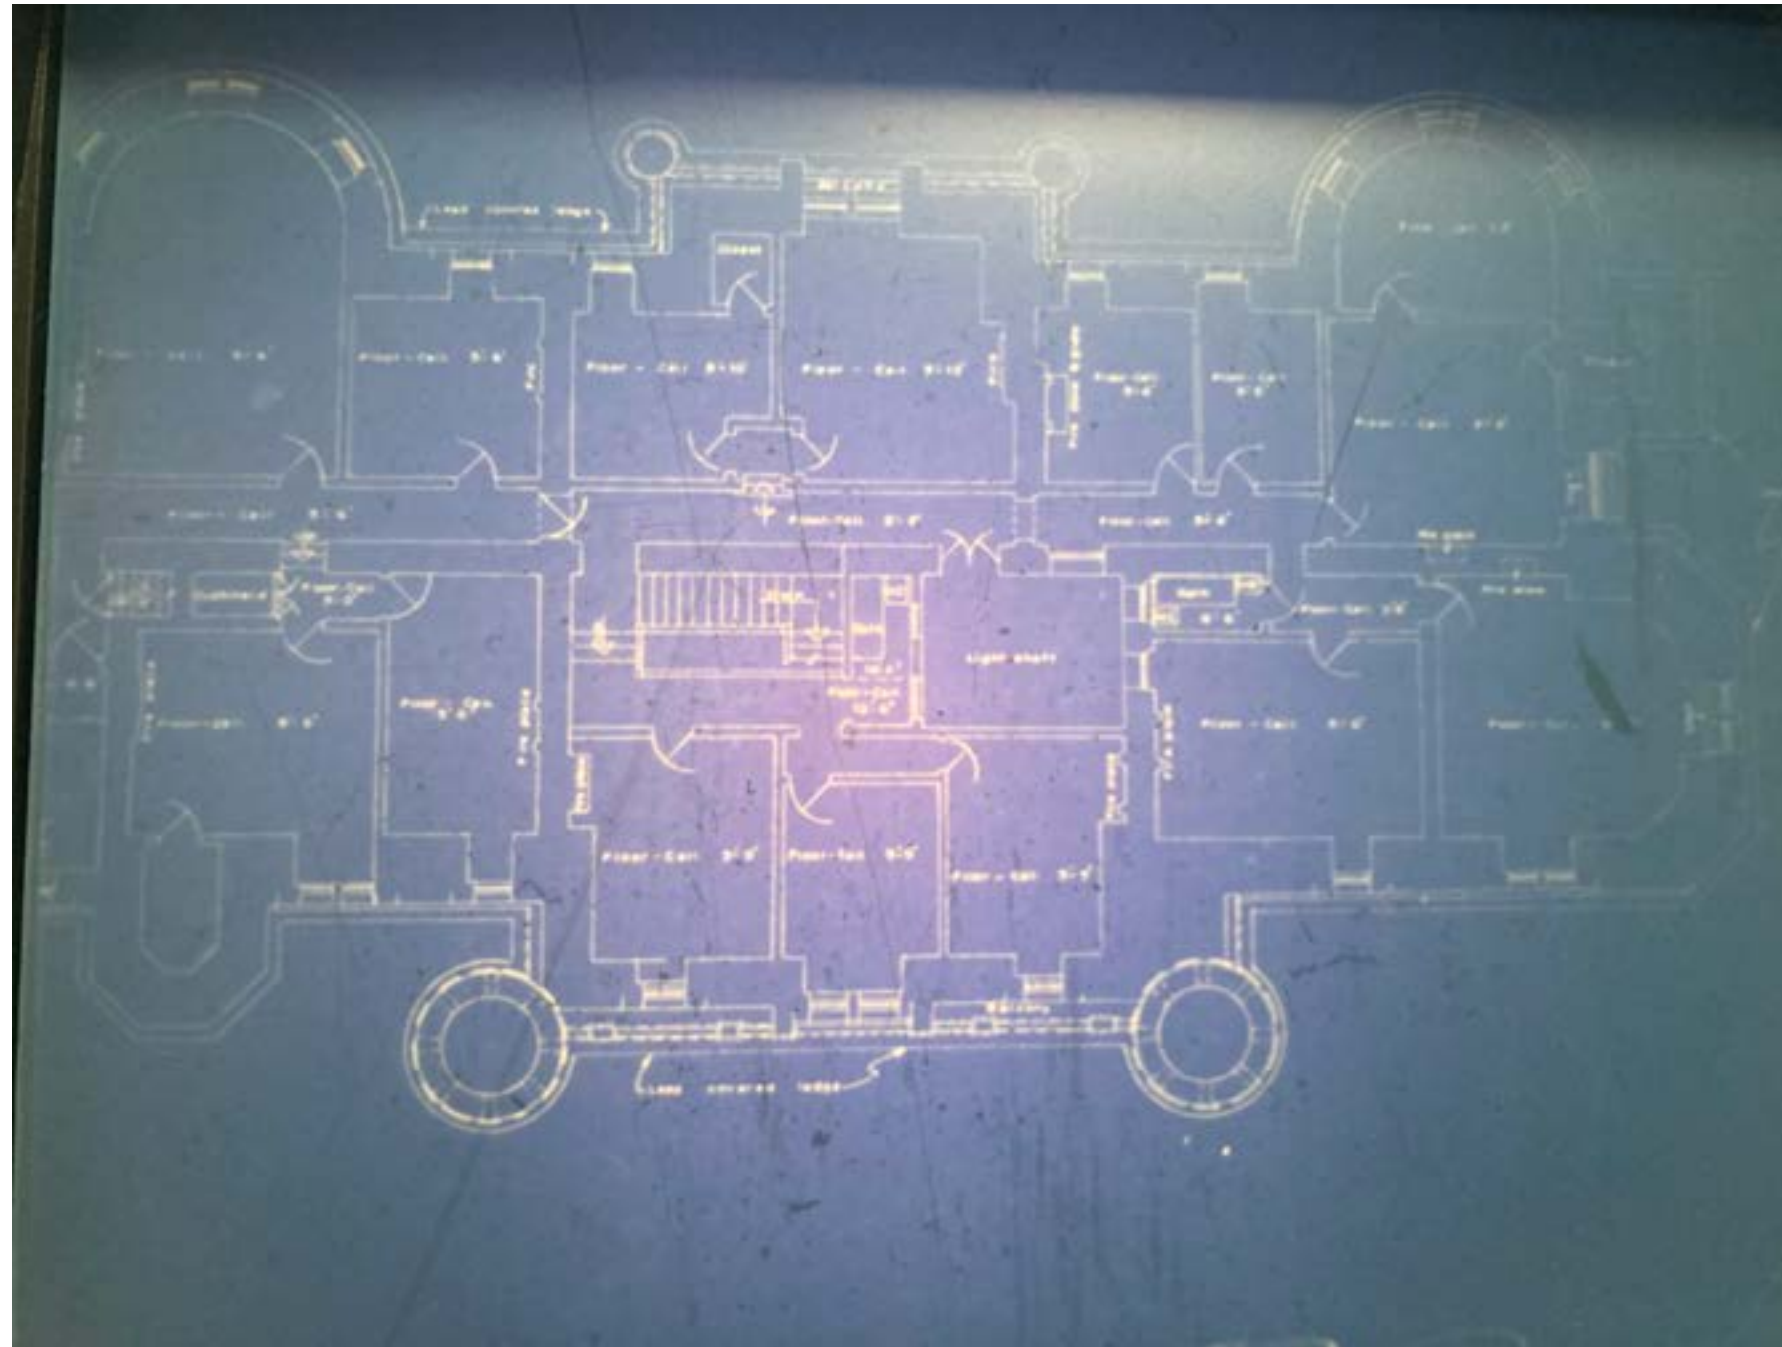
**Figure VI.01**

*Copy of drawing - author unknown.  
2nd floor plan - assumed original layout.*
