FOR PLANNING  
PURPOSES ONLY

NOT FOR CONSTRUCTION

TO BE READ IN CONJUNCTION WITH  
STRUCTURAL ENGINEER'S DRAWINGS,  
DETAILS AND SPECIFICATIONS

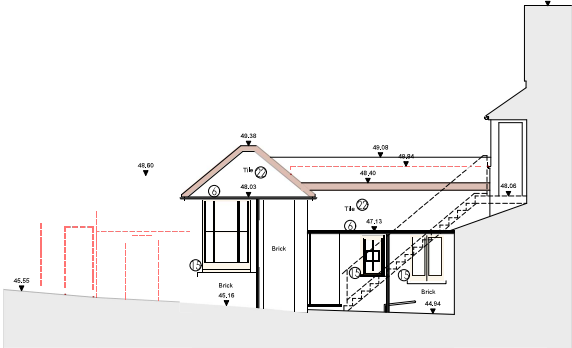
- Elevation Key:**
- Red dashed lines denote demolitions
  - Solid red/white hatch denotes re-bedded ridge tiles
- Existing timber barge boards to be repaired and repainted in white to match the existing

- Existing sliding sash window to be repaired and upgraded, with new double-glazed panes and draught seals to be installed. To be painted white to match the existing

- Existing bay window and roof over to be repaired and upgraded - new double-glazed panes and draught seals to be installed, replacement ship-lap timber cladding boards, and replacement lead roof. All joinery painted white to match the existing

- Existing casement window to be repaired and upgraded, with new double-glazed panes and draught seals to be installed. To be painted white to match the existing

- Existing cast iron rainwater goods to be removed, and replaced with new cast metal rainwater goods with a black powder-coated finish
  - Existing plastic rainwater goods to be removed, and replaced with new black plastic rainwater goods

- Existing timber fascia and soffit boards to be repaired and repainted in white to match the existing
  - Existing casement window to be repaired and upgraded, with new double-glazed panes and draught seals to be installed. To be painted white to match the existing

- Existing metal framed windows to be repaired and repainted. Existing double-glazed panes to be retained. All existing timber sub-frames/brackets to be repaired and repainted in white to match the existing

- New lead valley to be formed between existing (currently concealed) lead roof and boundary wall
  - Existing sliding sash window to be repaired and upgraded, with new double-glazed panes and draught seals to be installed. To be painted white to match the existing

- Existing cast iron SVP to be replaced with new cast metal pipe with a black powder-coated finish. Pipe to be fitted with a lead-lined cowl to prevent vermin ingress

- Existing dormer window to be repaired and upgraded - new double-glazed panes and draught seals to be installed, existing chest wall cladding removed, and replacement lead cladding. All joinery painted white to match the existing

- Existing timber windows to be repaired and repainted in white to match existing
  - Iron chimney stack backwork and remove vegetation growth
  - Iron downspout/ventilator (that overhanging details with Code 4 lead flashings

- Iron downspout/ventilator and allow for localised repainting. In line motor to be replaced in Code 4 lead with traditional mastic seal details
  - Painted metal roof sheeting with a dark powder-coated finish, to replace existing chicken sheets

- Existing timber cladding to be repaired and repainted to match the timber joinery elsewhere
  - Repairs to existing lead roofs, with sloped tiles re-bedded, and missing tiles replaced (to match existing)
