## **Planning Statement - Design & Access Statement**

REV4 - 10 07 2025

### **Park Centre, 60 Park Rd, Burgess Hill RH15 8ET**

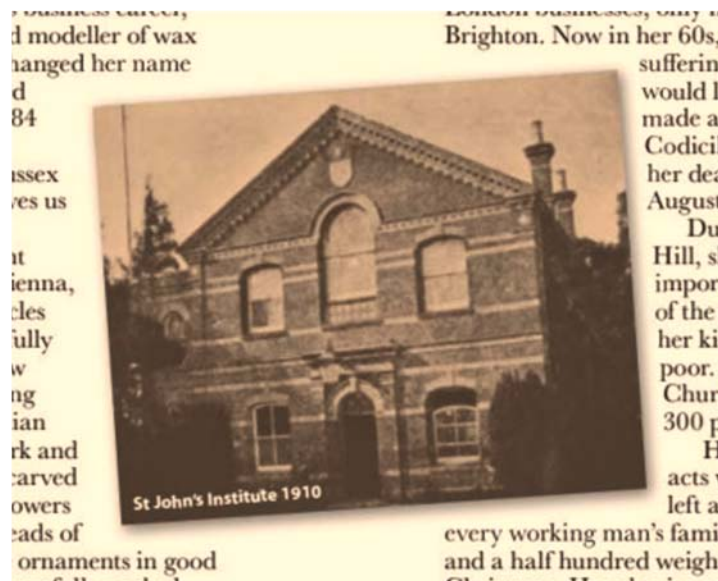
Image of Park Centre from 1910 from article *Emily Temple: Burgess Hill Benefactress*.

The existing front elevations is at the moment a mix with rendered area for the pediment and painted brickwork underneath. We were hoping to be able to bring back the existing brick aspect of the front elevation as shown in a picture from 1910 attached above, however this is not possible, as per explanation below:

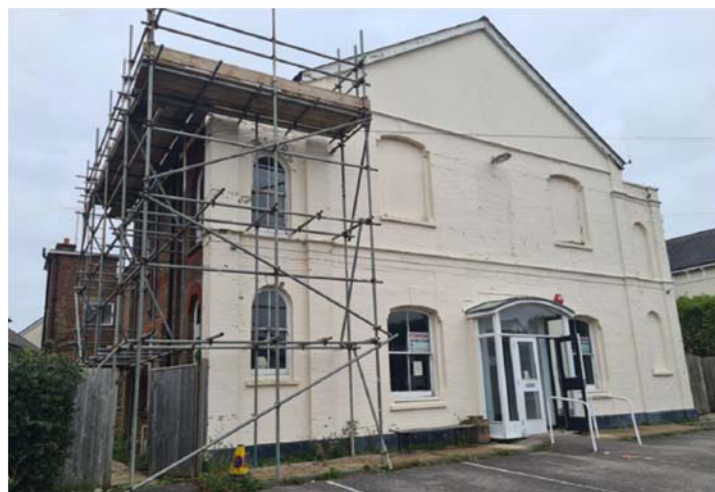
Image showing the current appearance of Park Centre

porch featuring a felt roof. Two first-floor windows on the front elevation have been boarded up with plywood as well as many of the windows on the side elevations. The entire front elevation has been painted white, and wall-mounted lighting has been installed above the front door. The front pediment has been filled with what appears to be render. The right side of the front elevation was extended to mirror the left side of the elevation and a lift was installed behind which is now out-of-use. An original large central window on the front elevation above the main entrance has been lost.

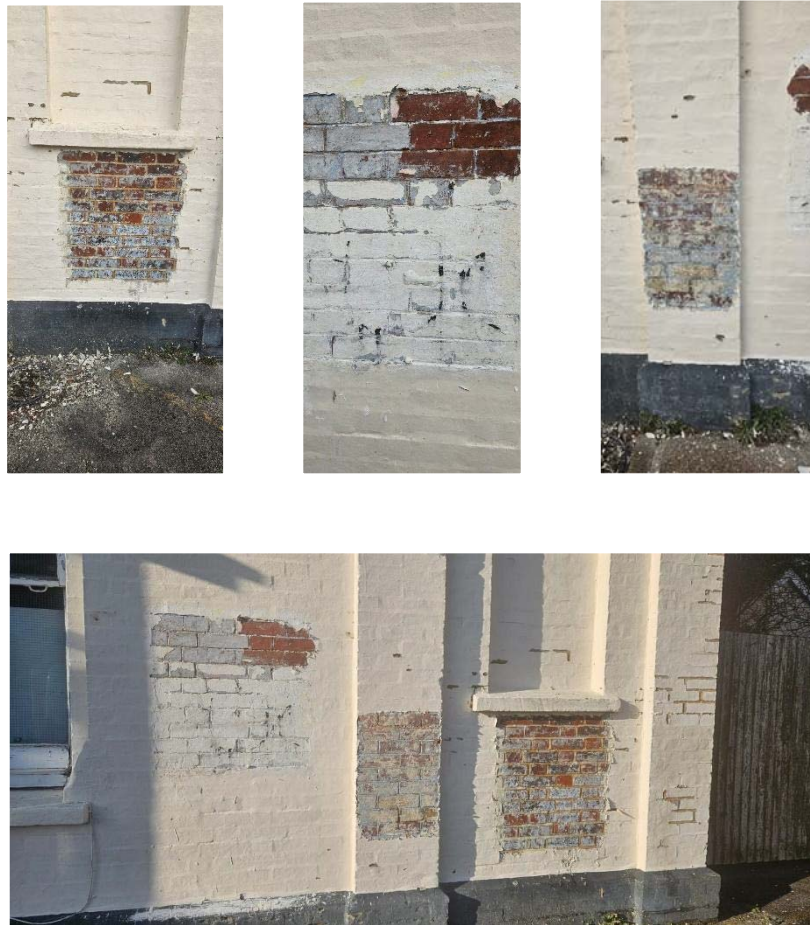
We complemented this investigation with the pictures below to illustrate the above.

“The contractor attempted several chemical cleaning methods before resorting to sanding, but unfortunately, none were effective. It appears that the elevation has been repeatedly painted over the past 60 years (according to local residents' accounts), and using a gentler method than sandblasting has proven unsuccessful in removing the paint.

Concerning the overall condition of the original elevation, we are particularly concerned about the state of the gable end. As shown in the attached picture, this area was rendered some years ago, and attempting to reveal the brick here will likely cause significant damage to the underlying structure. It is possible that the gable end may need to be rebuilt entirely.

Additionally, upon revealing the existing brickwork, we observed that a different type of brick was used for the front extension (on the right side when facing the building). The mortar used here is also a different thickness and in cement compared to the original building, which is thinner and in lime. This contrast in materials may create an awkward visual disparity if this section is left as part of the same elevation.

We also noted that the original blue band brick on the existing elevation has lost much of its colour and contrast, which now stands out in relation to the surrounding brickwork.”

Therefore, we are opting for a natural lime render finish to the front elevation, with ashlar lines to match next door. This will give a uniform and qualitative finish to the building, using natural materials.
