# Arboricultural Method Statement (Construction Phase)

Meadow Bank House, Turners Hill Road

Date of Report: 08/09/26

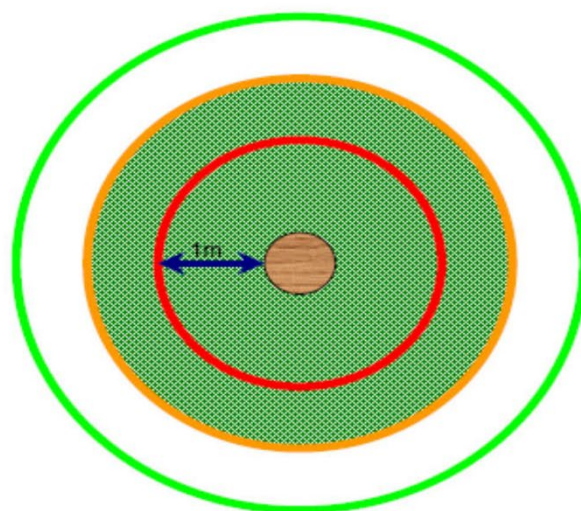
TREE PROTECTION ZONE

**PROHIBITED ZONE – 1m from trunk.** Excavations of any kind must not be undertaken within this zone unless full consultation with Local Authority Tree Officer is undertaken. Materials, plant and spoil must not be stored within this zone.

**PRECAUTIONARY ZONE – 4 x tree circumference.** Where excavations must be undertaken within this zone the use of mechanical excavation plant should be prohibited. Precautions should be undertaken to protect any exposed roots. Materials, plant and spoil should not be stored within this zone. Consult with Local Authority Tree Officer if in any doubt.

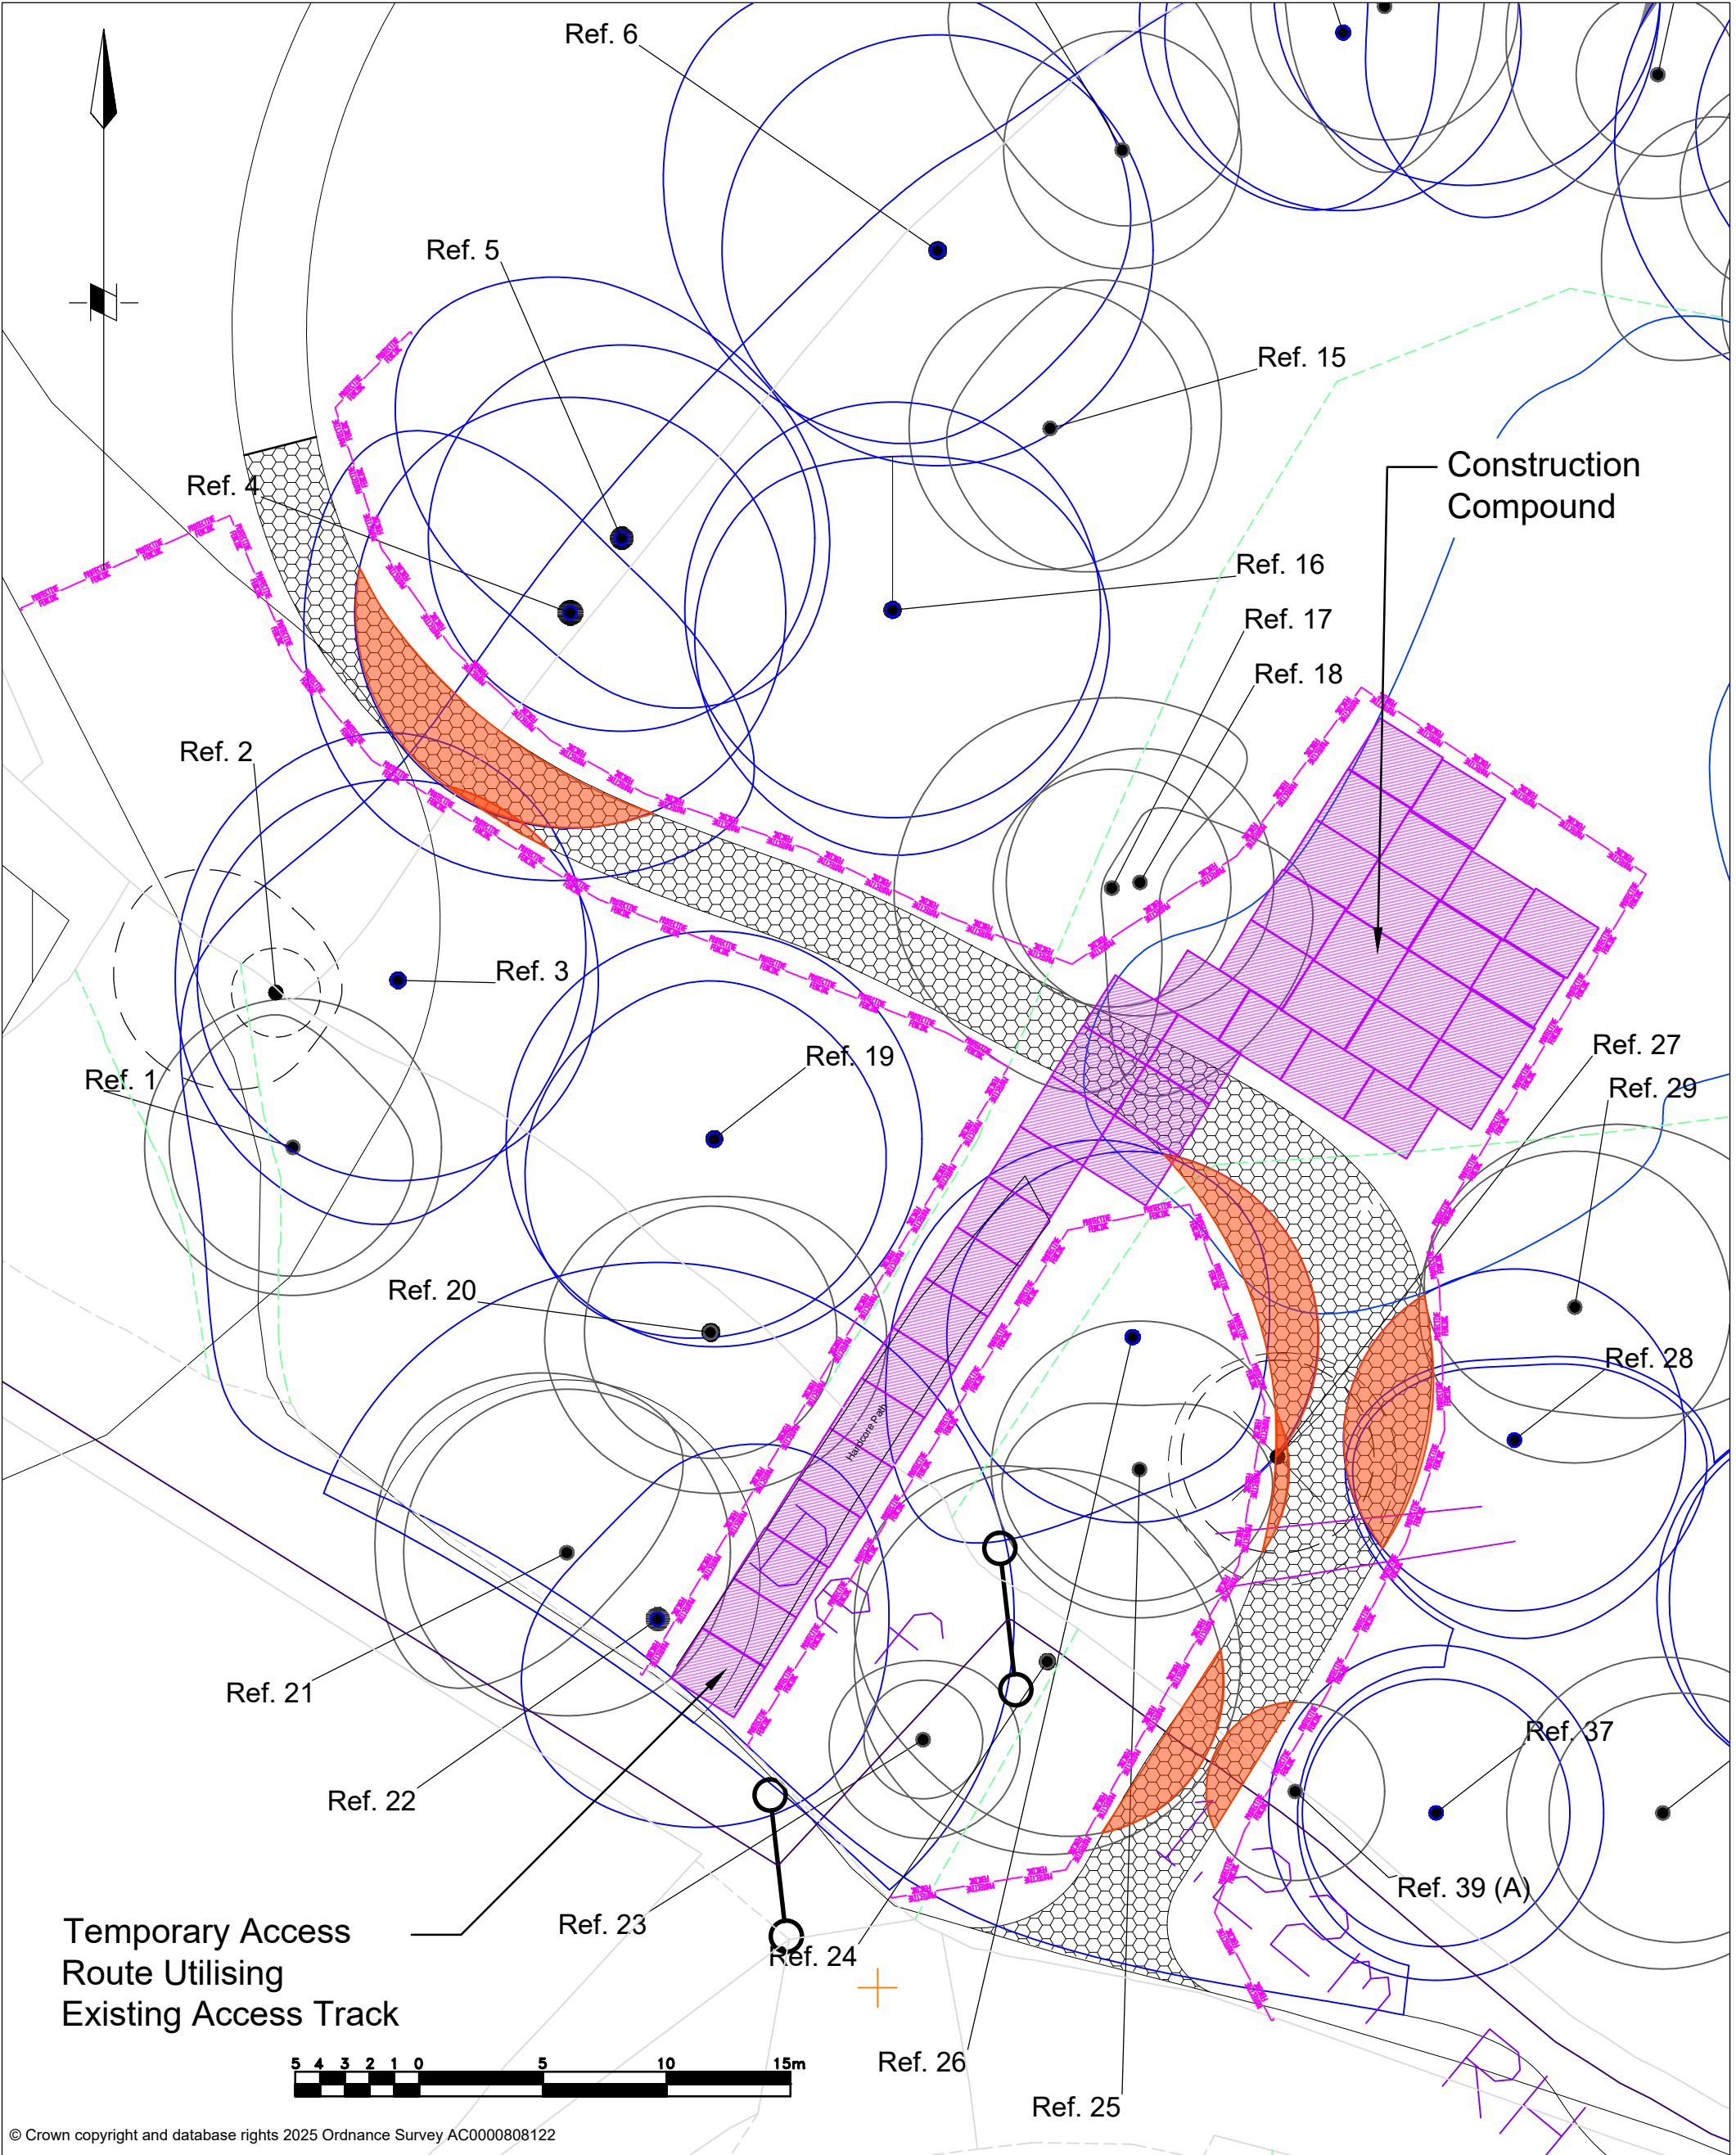
| no. | revision | date | by | check |
|---|---|---|---|---|
| | | FLA-FEN-D1-T-001 | | |

Drawings FLA-FEN-D1-T-001 & 002

- c) Installation of Tree protection fencing and exclusion signage to BS 5837:2012 "Trees in relation to design, demolition and construction – Recommendations", or another agreed approach, shall be used to clearly identify the Construction Exclusion Zone (CEZ) identified on FLA Tree Protection Plan (TPP) FLA-FEN-D1-T-001

- 2.2 An assessment of the site's tree stock has been undertaken, and the trees to be retained are clearly shown within the SJA Tree Survey SJA MSP 22287-011. A calculation has been made of the soil volume required to support their survival. This is represented by the Root Protection Area (RPA), shown by the BS 5837:2012 tree category-coloured circles around the retained trees on the plan FLA-FEN-D1-T-001.

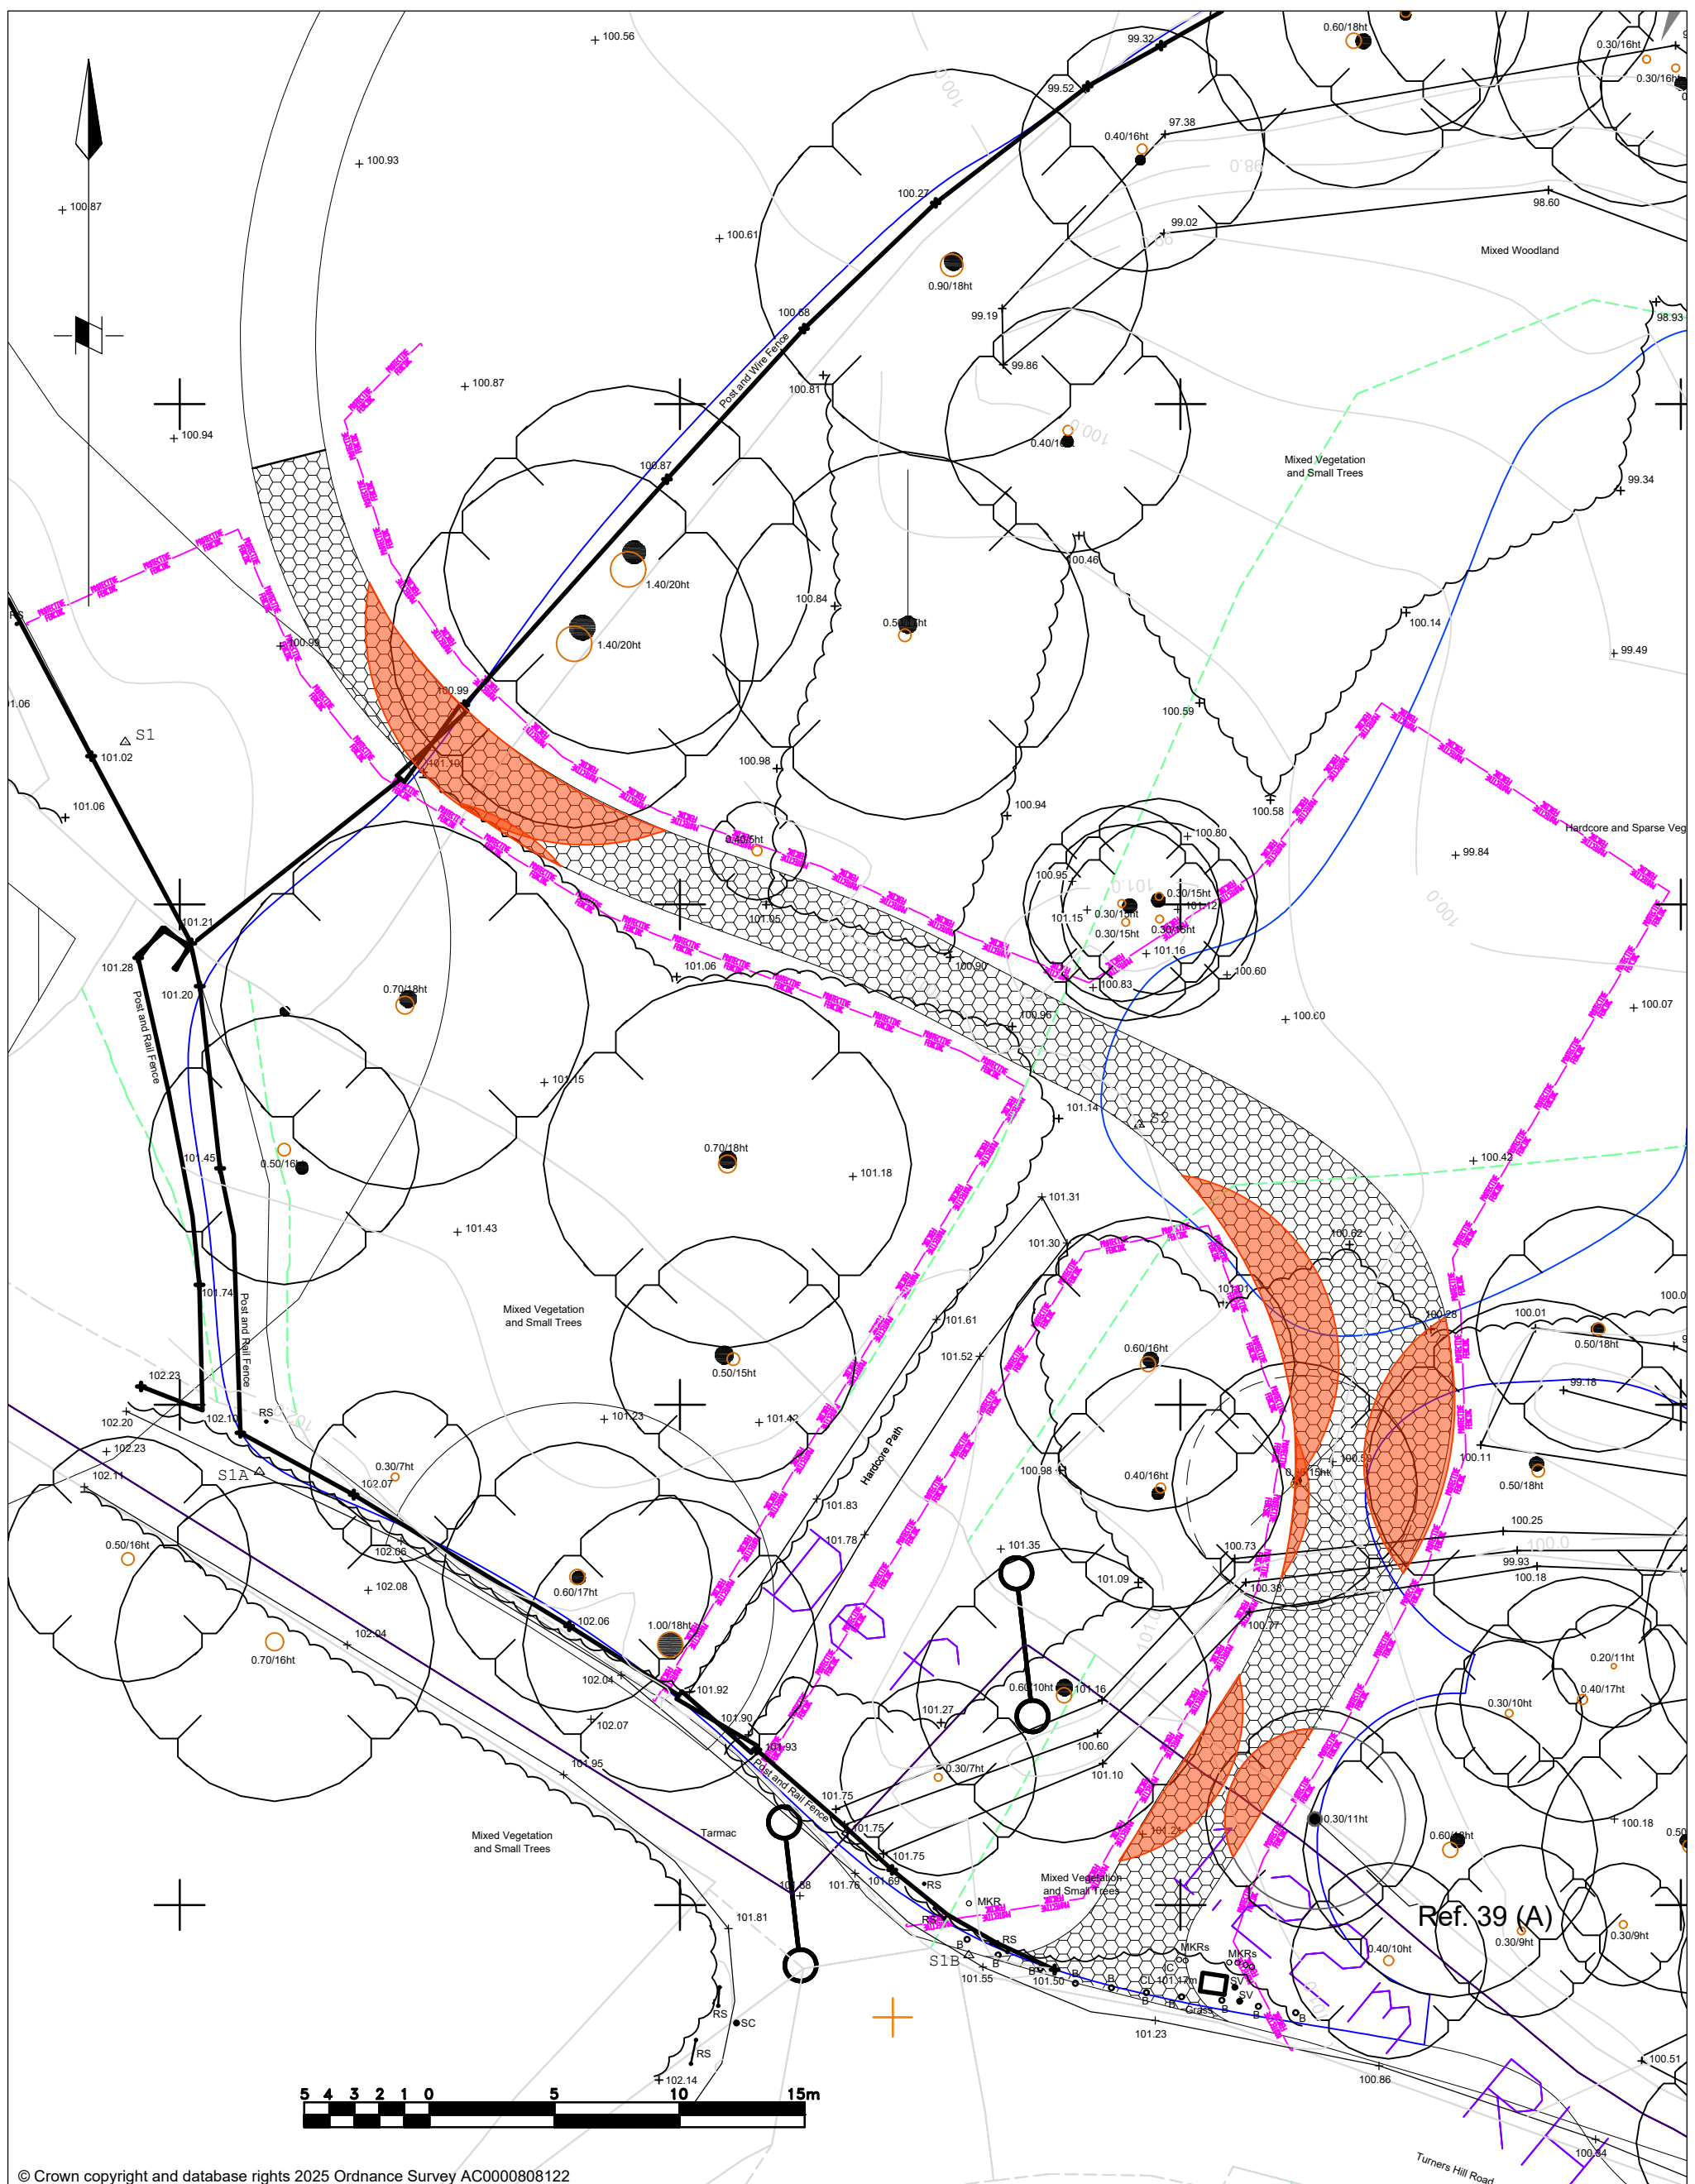
| | | <p>status</p> <p><b>PLANNING</b></p> | | <p>Tree Protection Plan (TPP 2)<br/>Construction Phase<br/>Topographic Survey &amp; Temporary Fencing</p> | | | | |
