# Burgess Hill Town Fc

Stadia AGP

TITLE  
Burgess Hill Town Fc  
Stadia AGP  
Spillage Comparison

PROJECT  
SSL3402

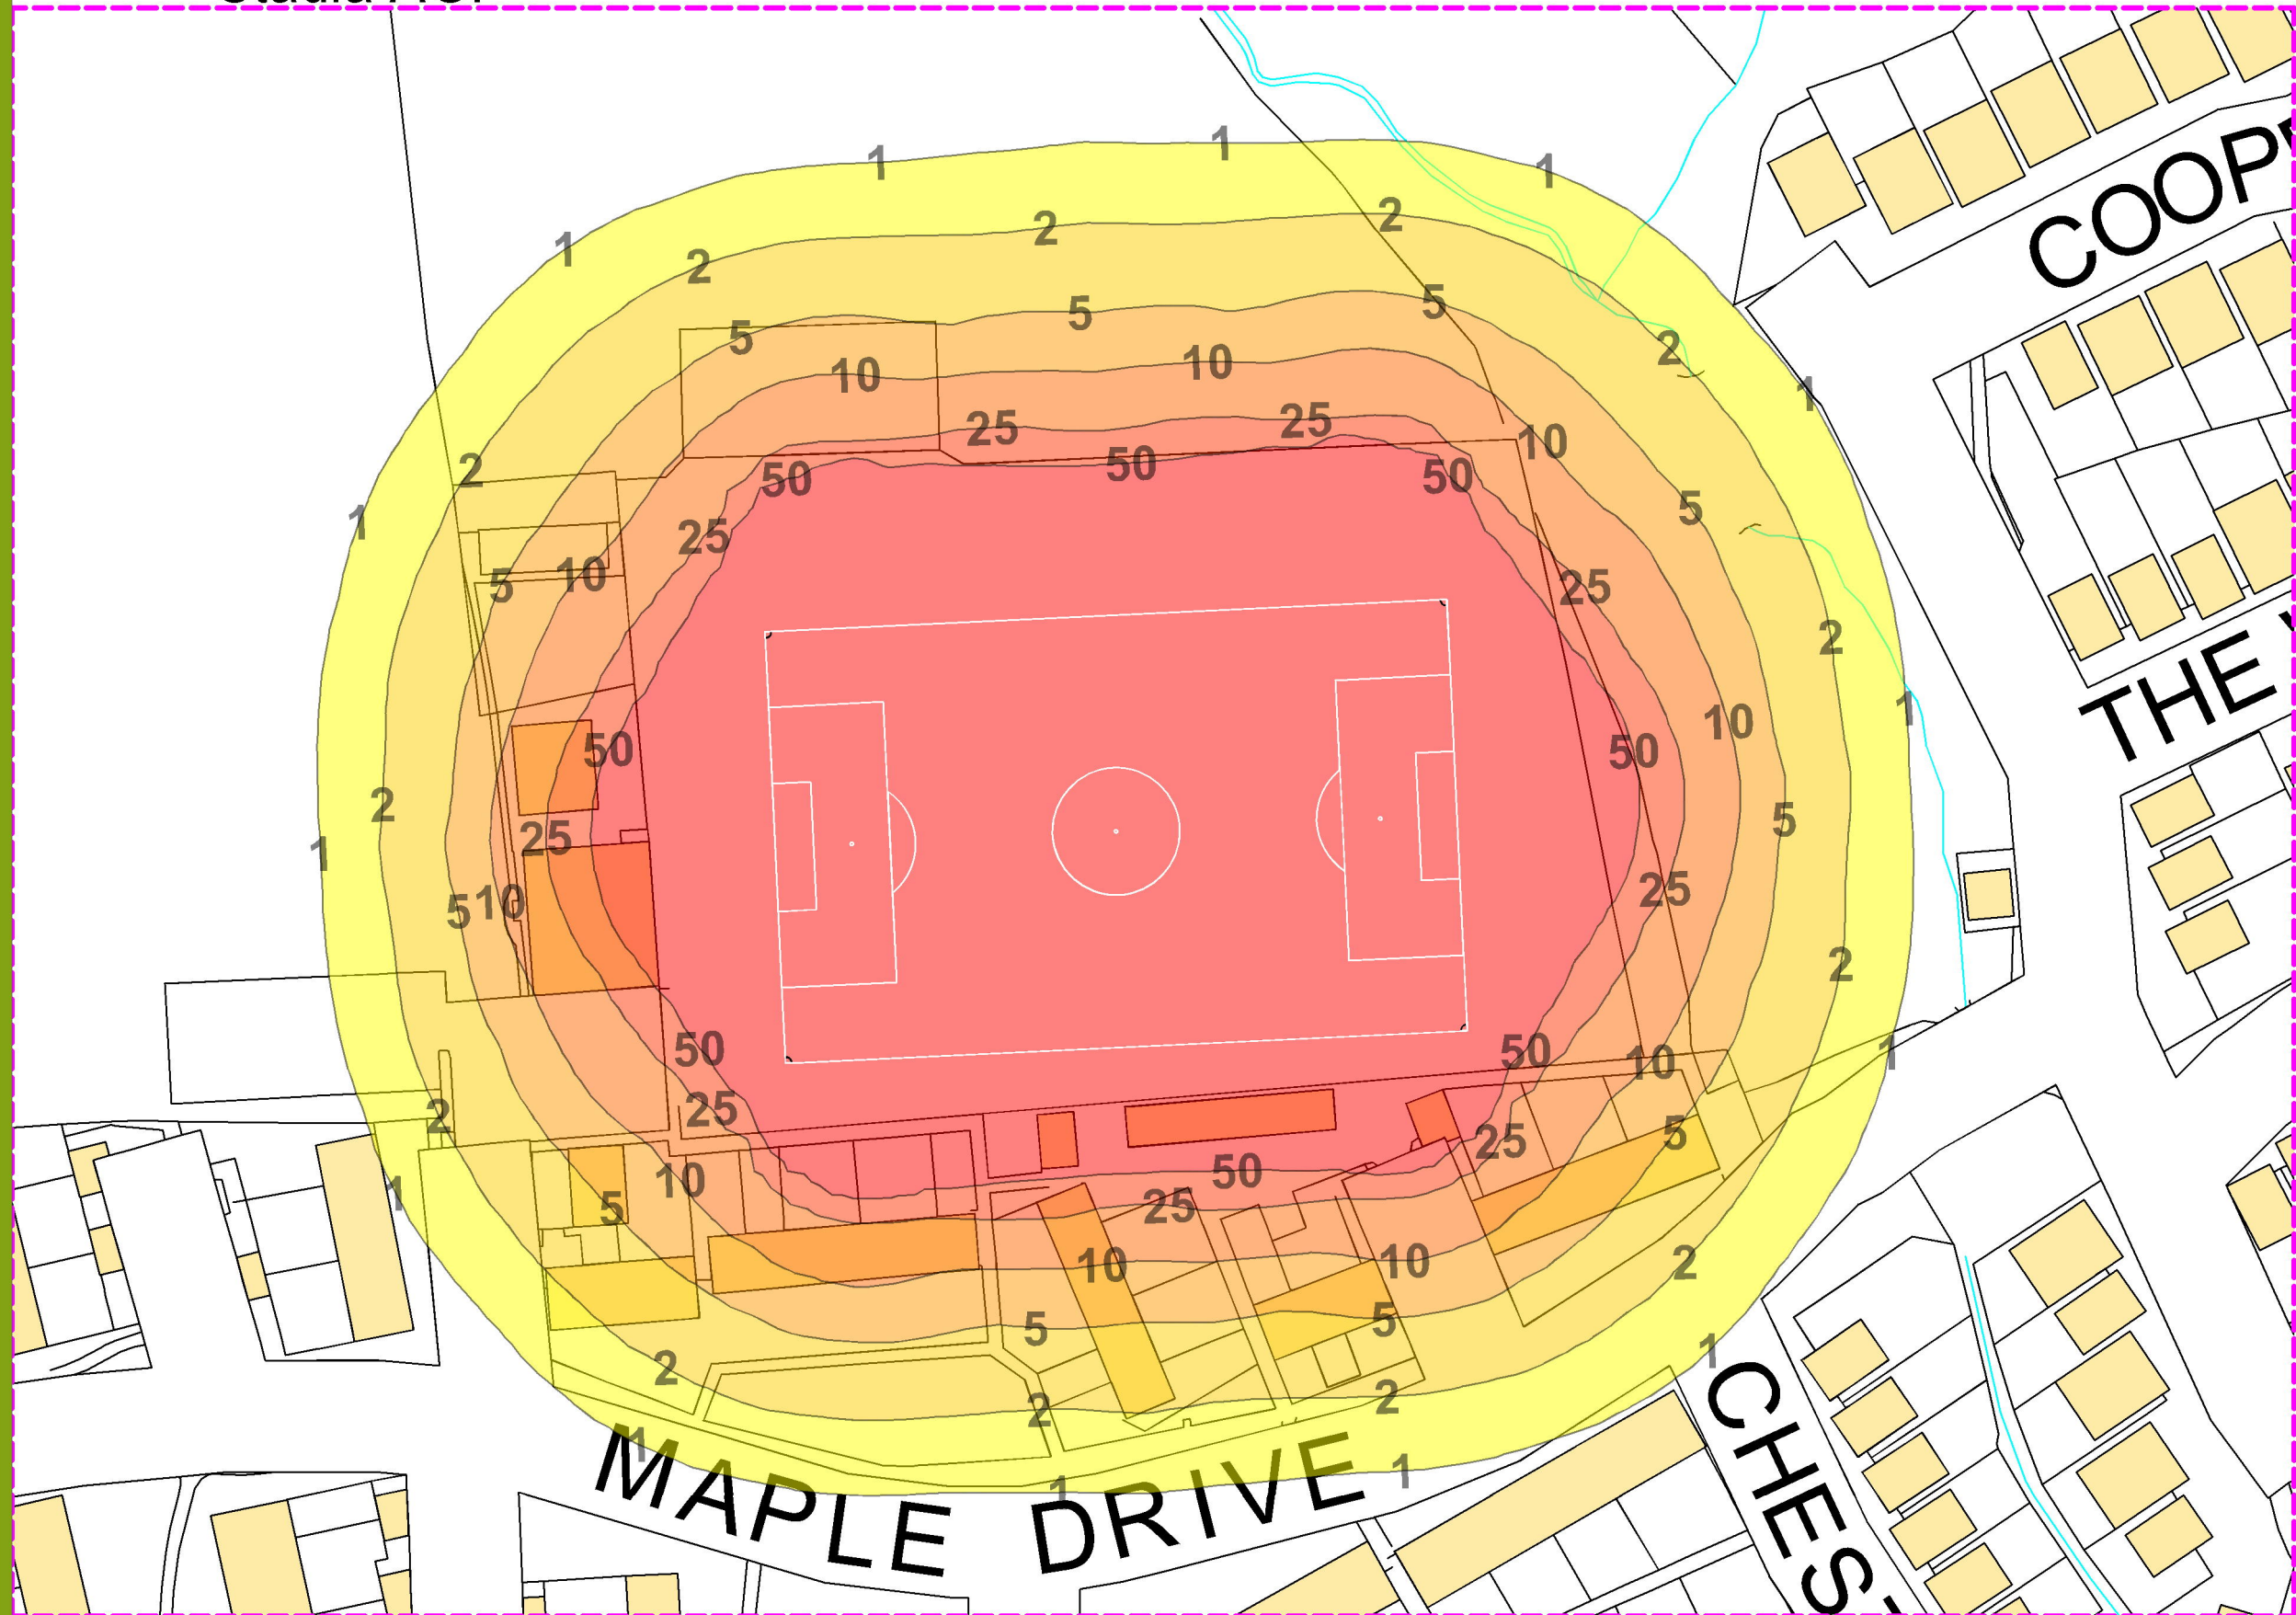
Existing Spillage

- Notes:
- The existing site spillage shows the spillage of the existing pitch metal halides
  - The proposed site spillage shows the spillage of the proposed LEDs
  - The spillage comparison shows both the proposed LED spillage and the existing metal halide spillage.

Please note the spillage shown for the AGP is shown without any obstruction, and are therefore a worst case scenario.
