notes + revisions				client + project		title		scale	number
				Telbridge Properties		Existing Side Elevation		1 : 50 @ A3	2236.S11
				Twineham Court Farmhouse				date	status
				Bob Lane, Twineham				14.11.2022	SURVEY

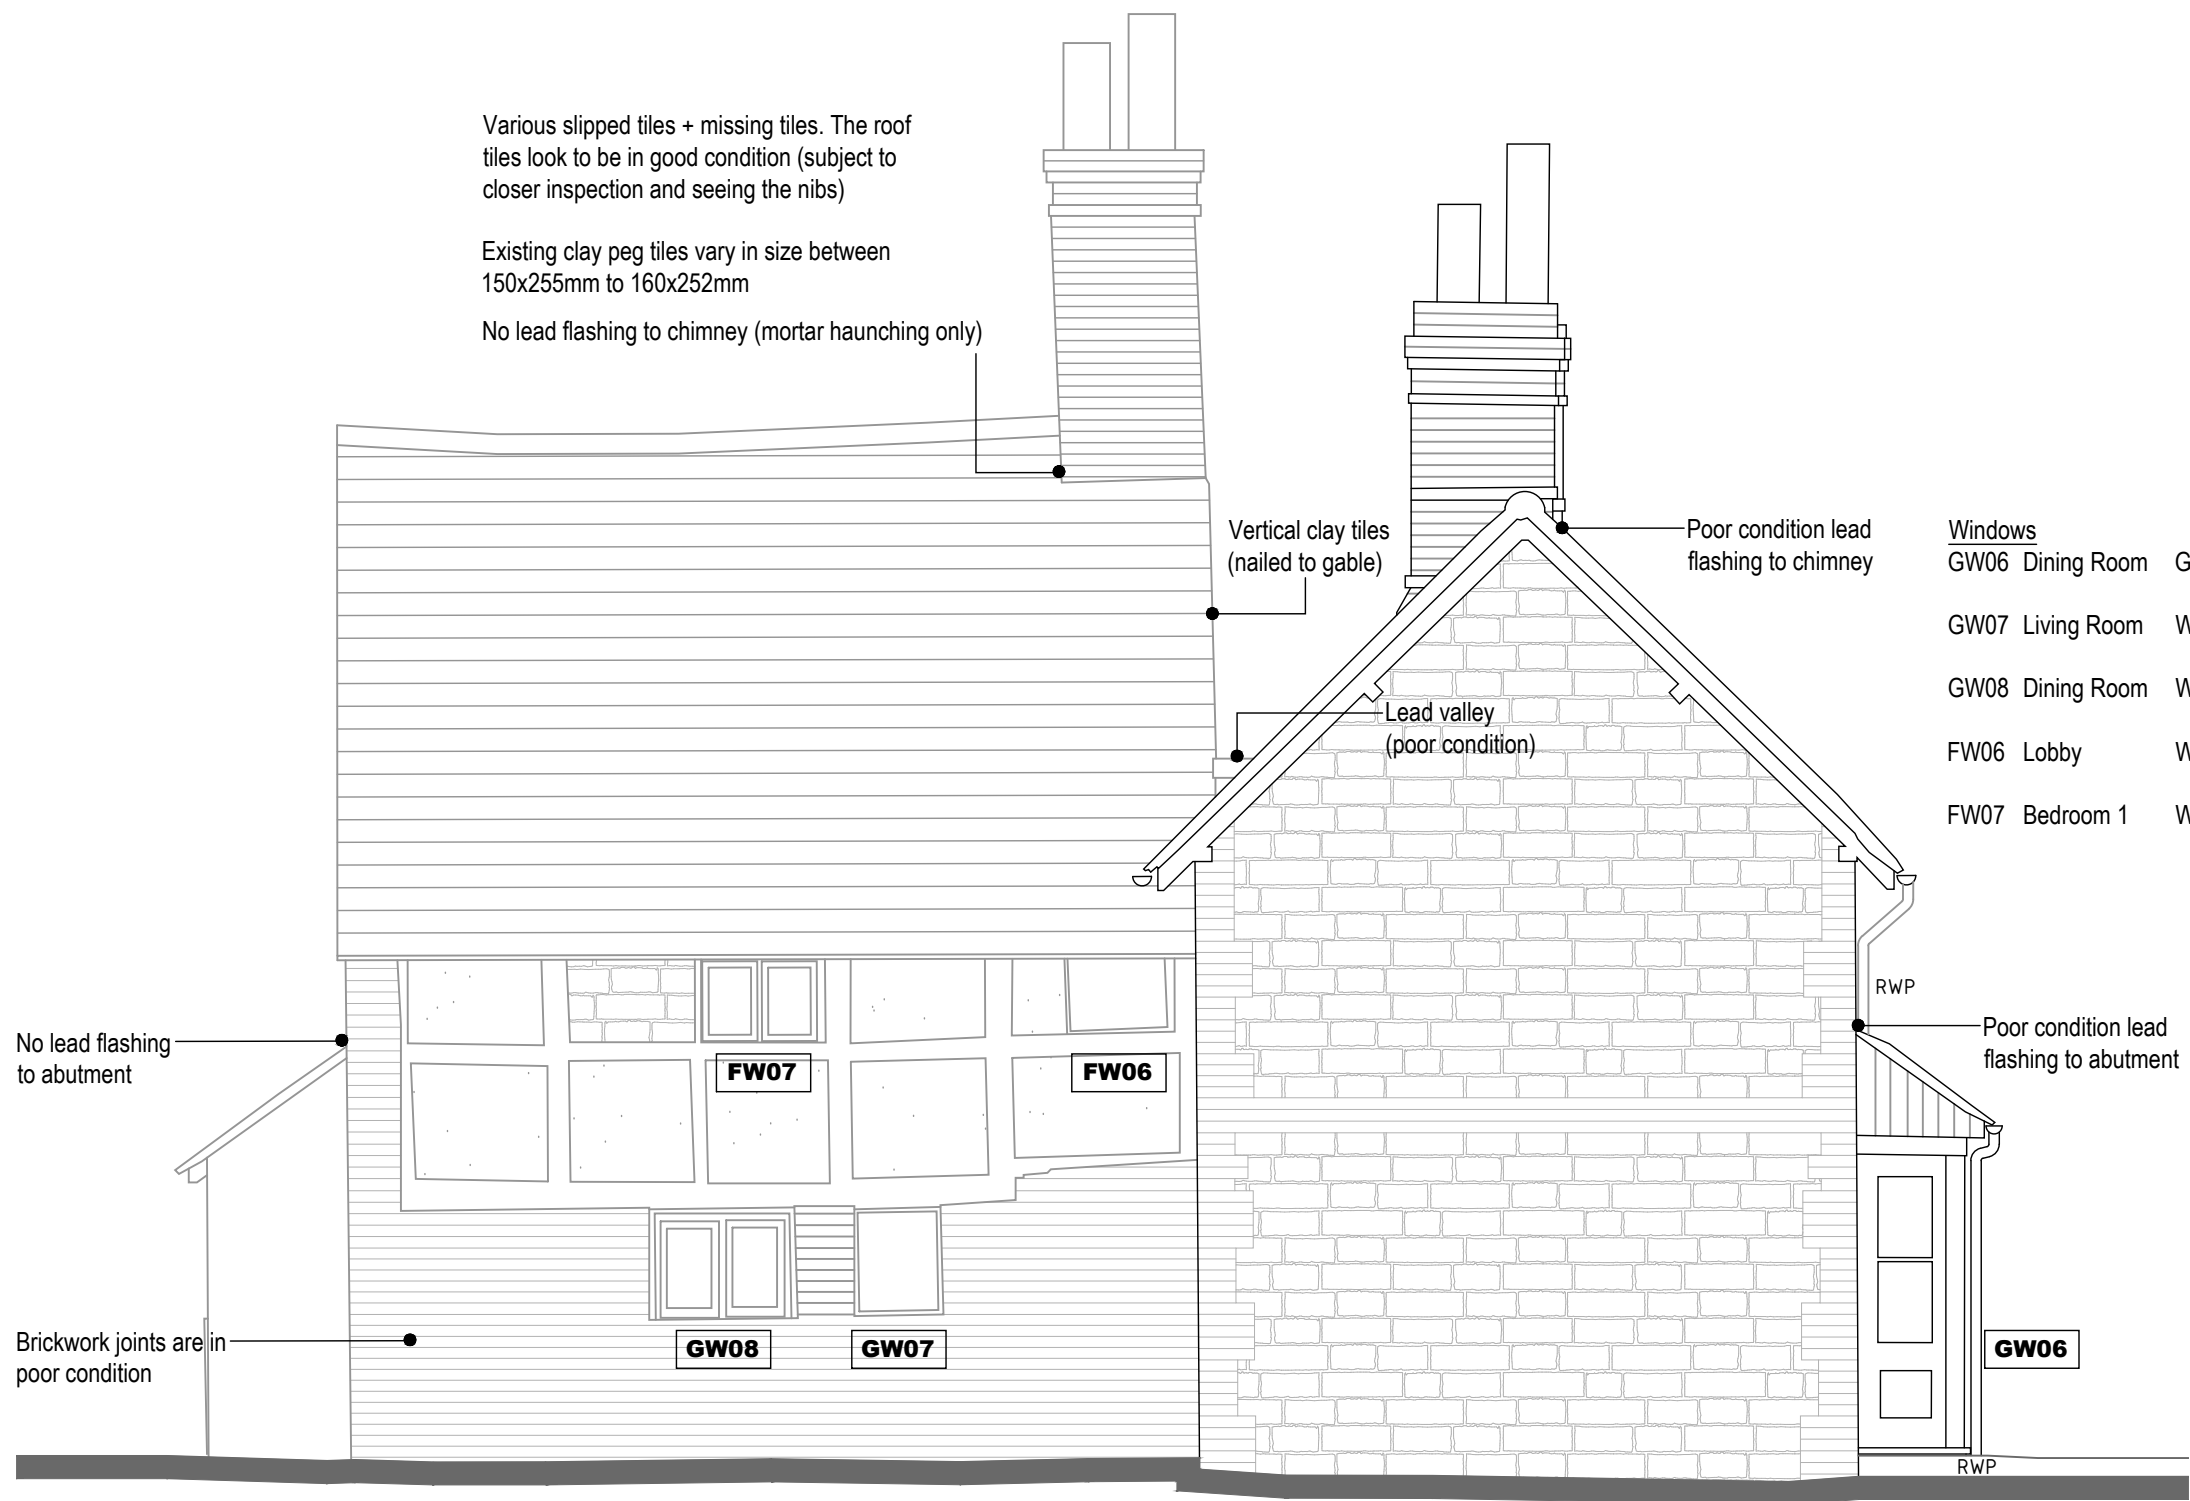
side elevation  
west

Windows		
GW06	Dining Room	Good quality replacement
GW07	Living Room	Window frame in sound condition, no glazing bead
GW08	Dining Room	Window frame in sound condition, no glazing bead
FW06	Lobby	Window frame in sound condition, no glazing bead
FW07	Bedroom 1	Window frame in sound condition, no glazing bead
