ground floor plan

notes + revisions						client + project	title	scale	number
						Telbridge Properties		1 : 50 @ A3	2337.S04
						Twineham Court Garage		date	status
						Bob Lane, Twineham		09.06.2023	SURVEY

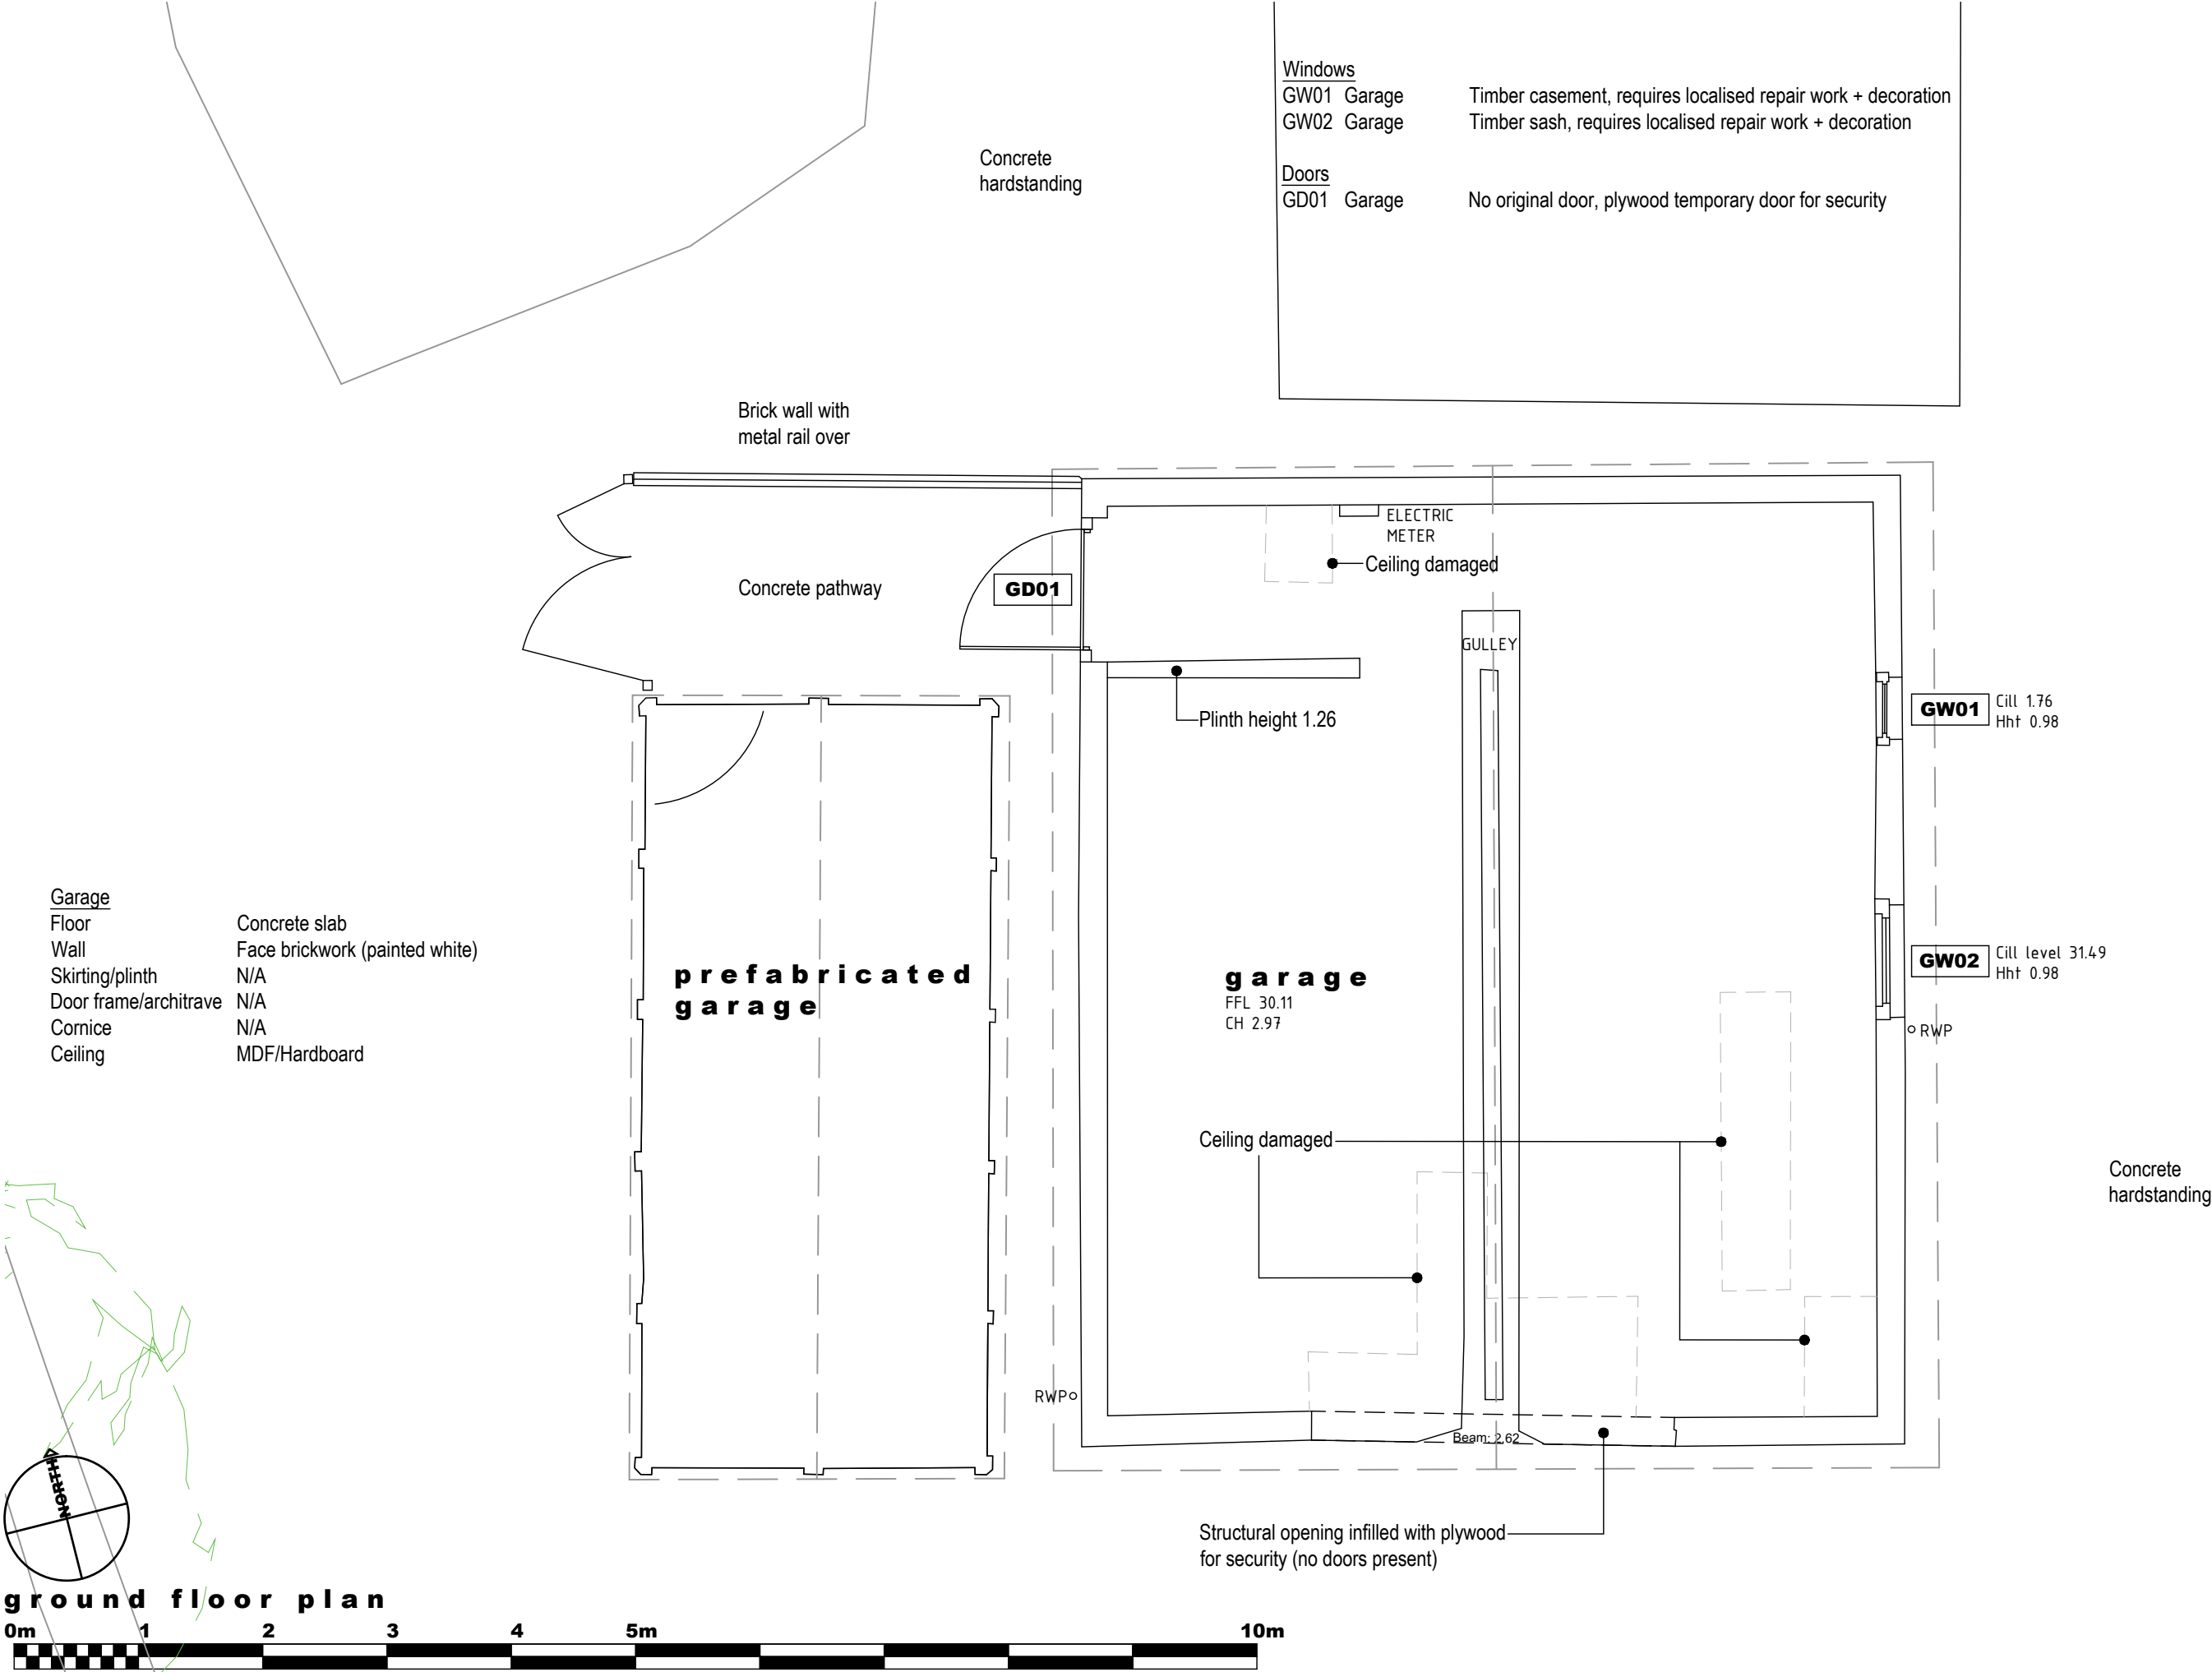
Windows		
GW01	Garage	Timber casement, requires localised repair work + decoration
GW02	Garage	Timber sash, requires localised repair work + decoration
Doors		
GD01	Garage	No original door, plywood temporary door for security

Garage	
Floor	Concrete slab
Wall	Face brickwork (painted white)
Skirting/plinth	N/A
Door frame/architrave	N/A
Cornice	N/A
Ceiling	MDF/Hardboard
