# LYWOOD BARN

ADDITIONAL WINDOW INFORMATION

## Kitchen Window - Context

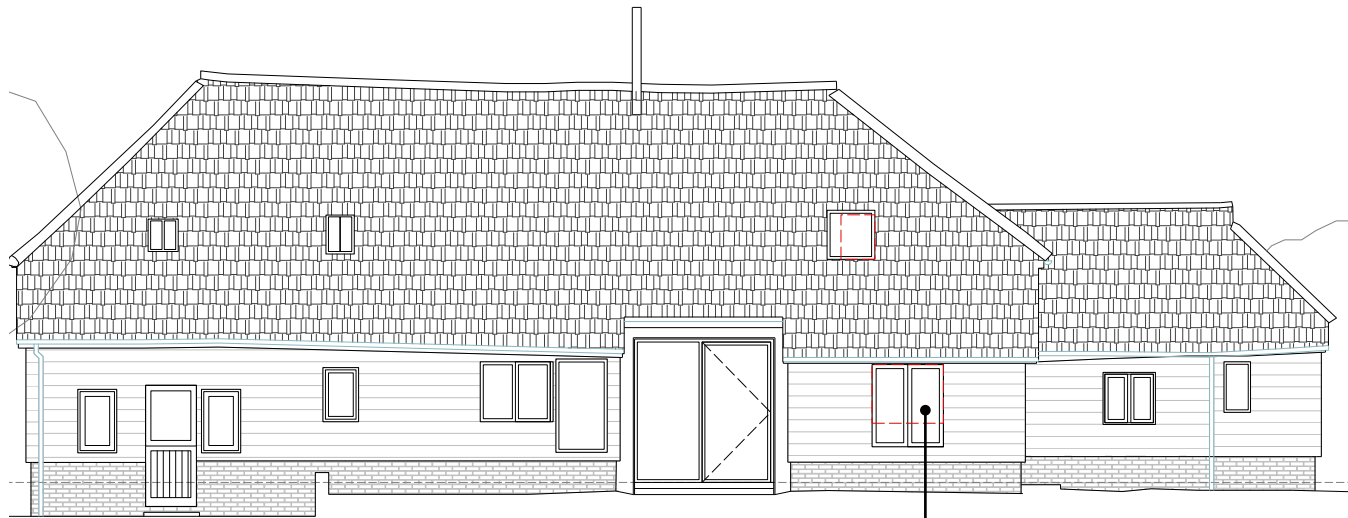
**Proposed Elevation:**  
Location of Window

Window to  
be lowered

It is proposed to lower the window in the current kitchen so that it can be an appropriate height for a window seat. These pages are to demonstrate that no original timbers would need to be removed/affected by lowering this window. The existing window cill will be removed, but this is not thought to be an original timber.

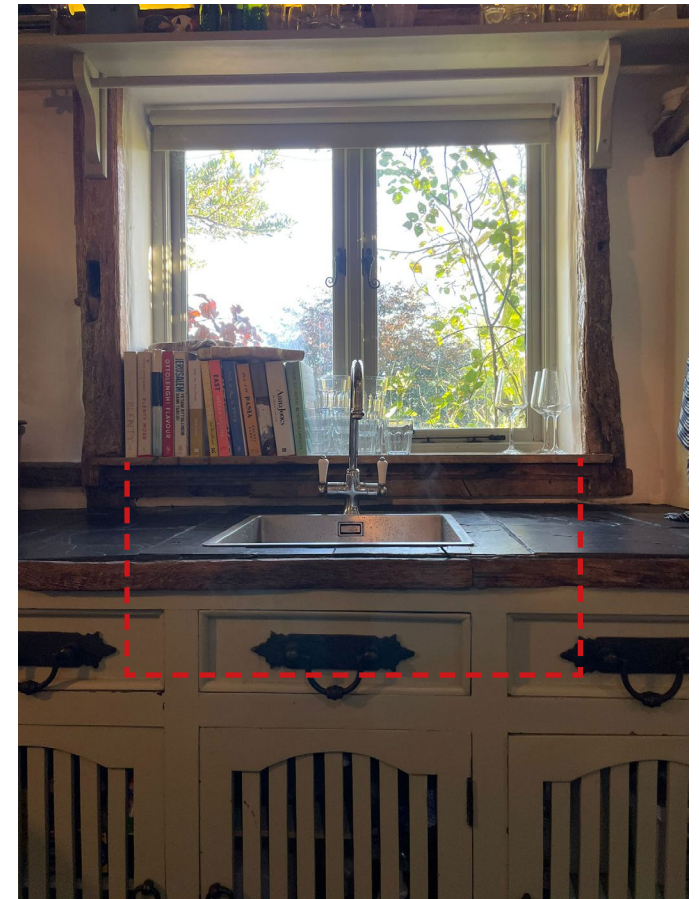
**Window location:**  
Internal view of window with  
proposed lowering (dotted)

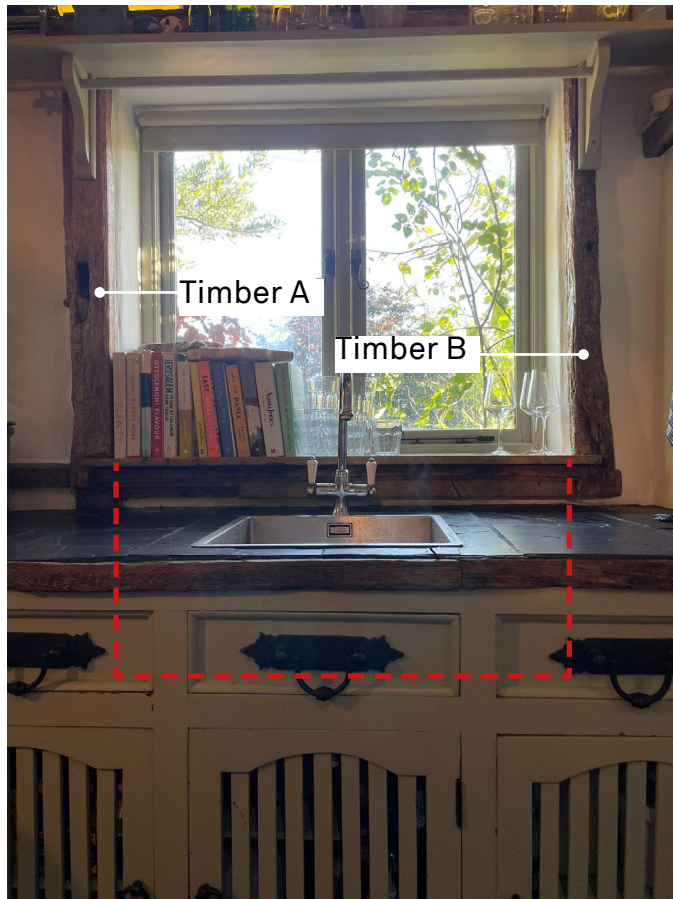
### Window location:

Internal view of window with proposed lowering (dotted)

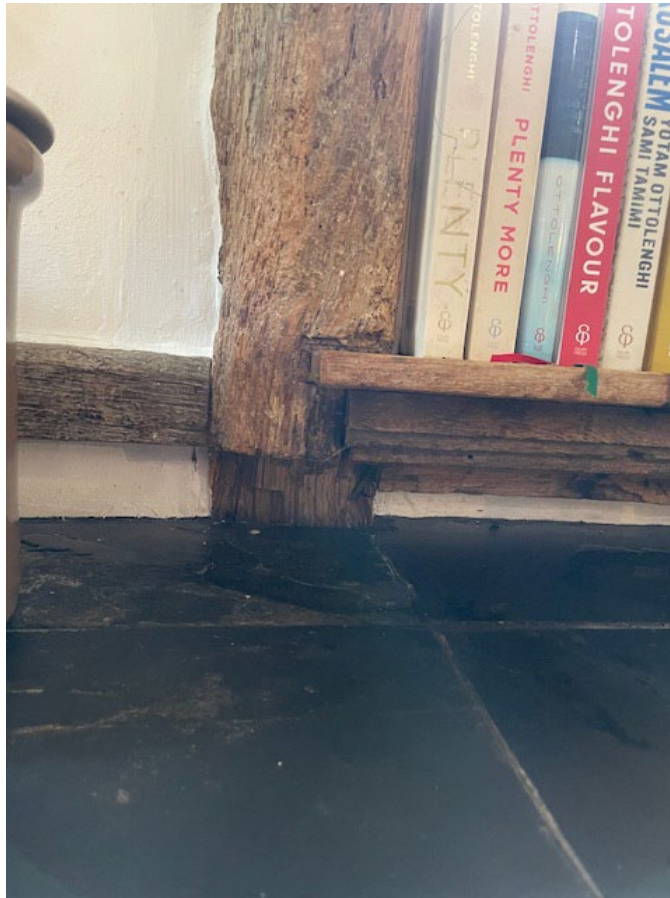
### Timber A:

Vertical timber is notched back slightly and carries down through worktop

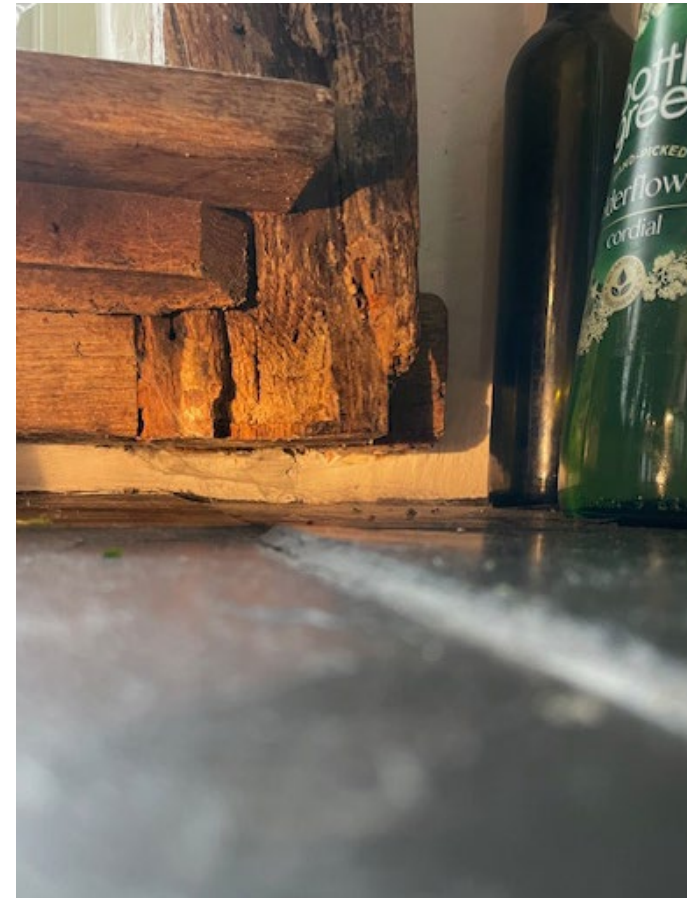
### Timber B:

Vertical timber seems to be cut at window level, but does carry on vertically down below worktop

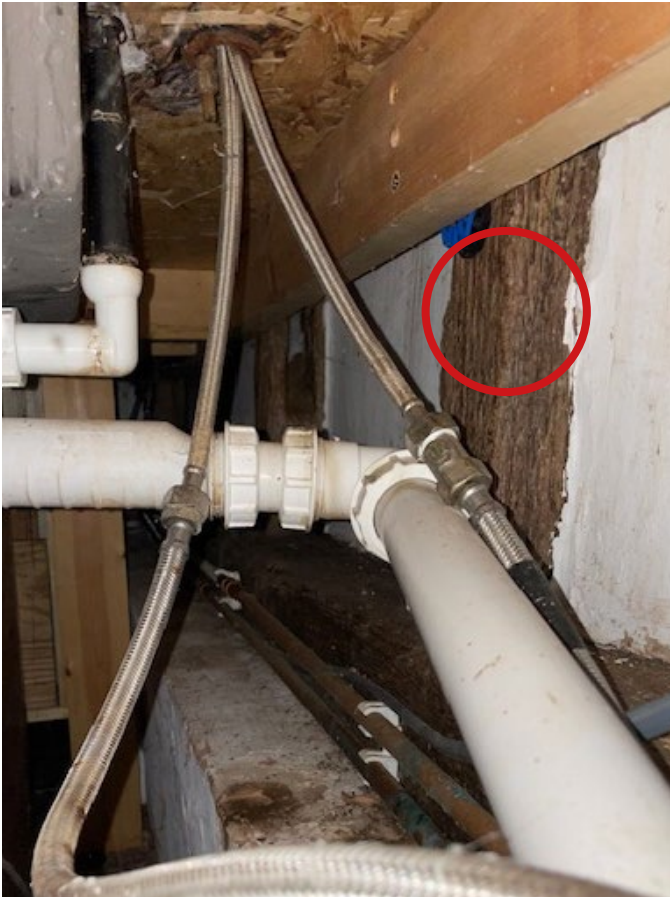
### Timber A:

Vertical timber comes down through worktop and terminates at plinth level.

It appears no horizontal timber would need to be cut to lower window

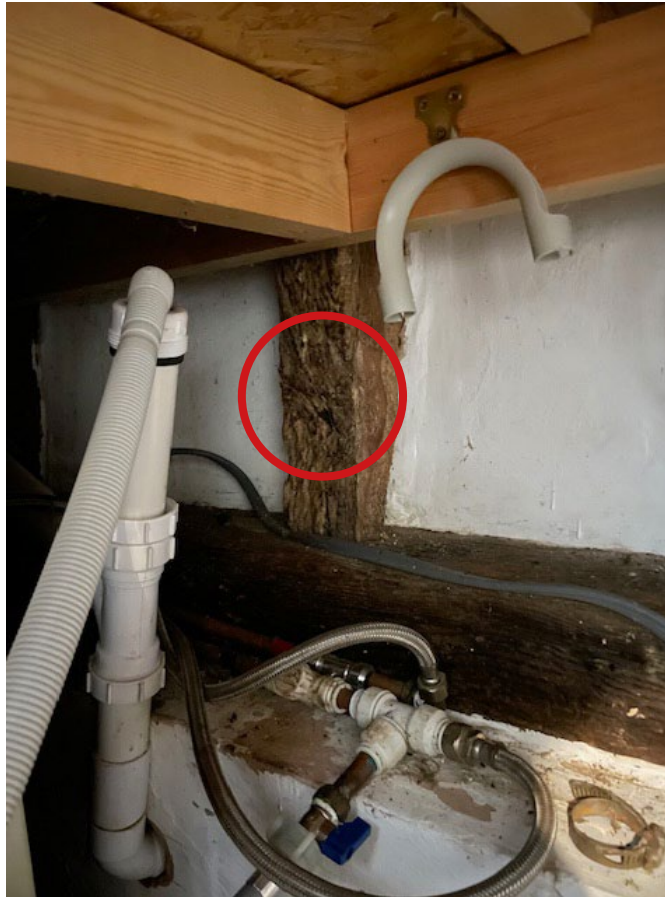
### Timber B:

Vertical timber continues below worktop and terminates at plinth level.

It appears no horizontal timber would need to be cut to lower window

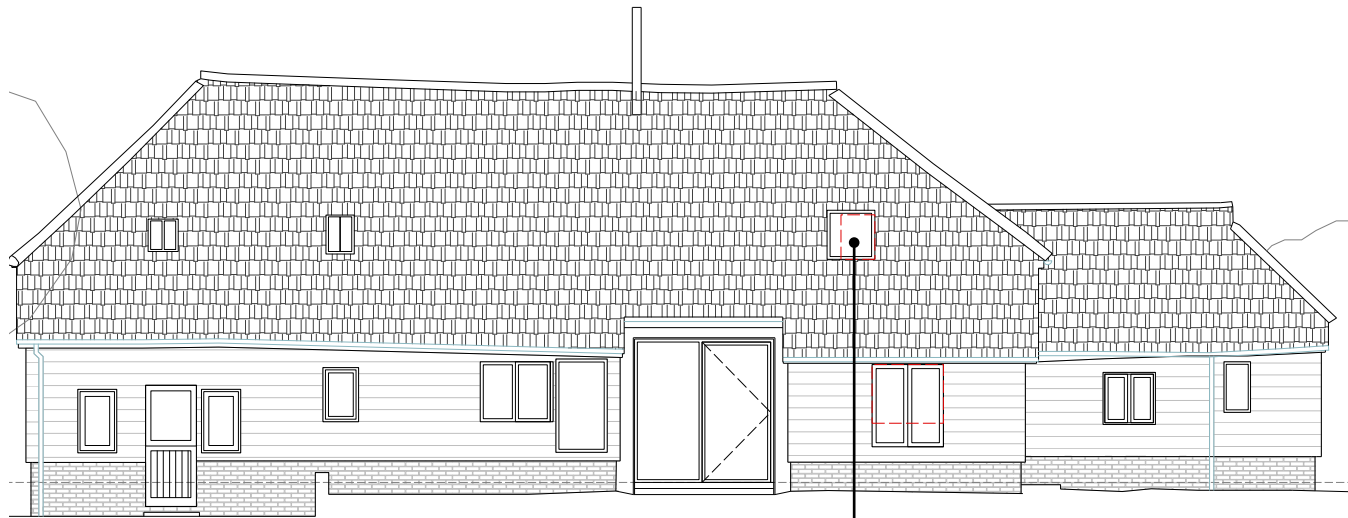
**Proposed Elevation:**  
Location of Window

Window to  
be enlarged

It is proposed to expand an existing rooflight in the first floor mezzanine to allow more light into the space. These pages are to demonstrate that no original timbers would need to be removed/affected by enlarging this window. The timbers currently framing the rooflight are not thought to be original.

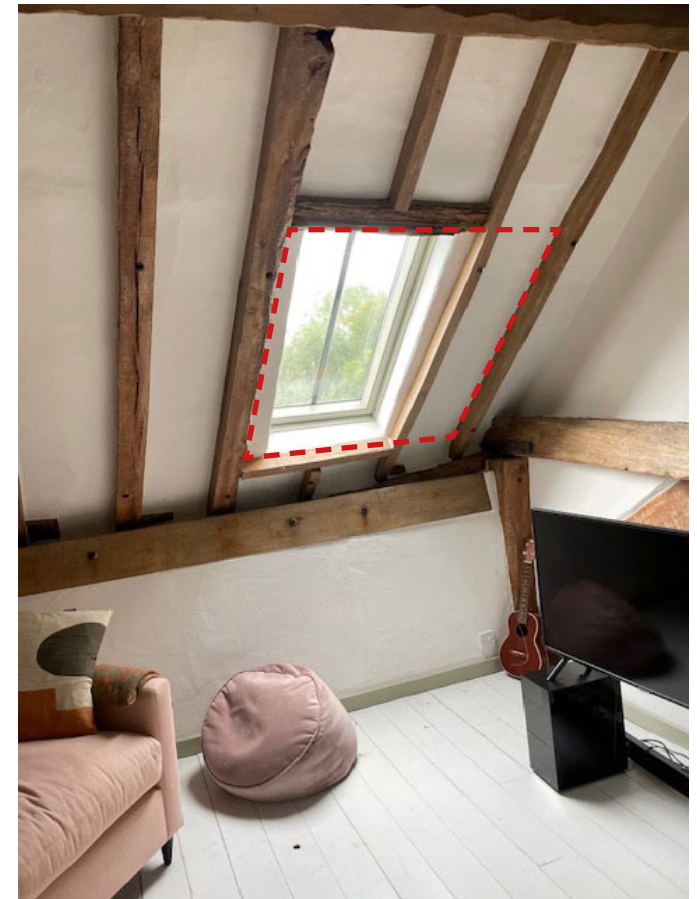
**Window location:**  
Internal view of window with  
proposed expansion (dotted)

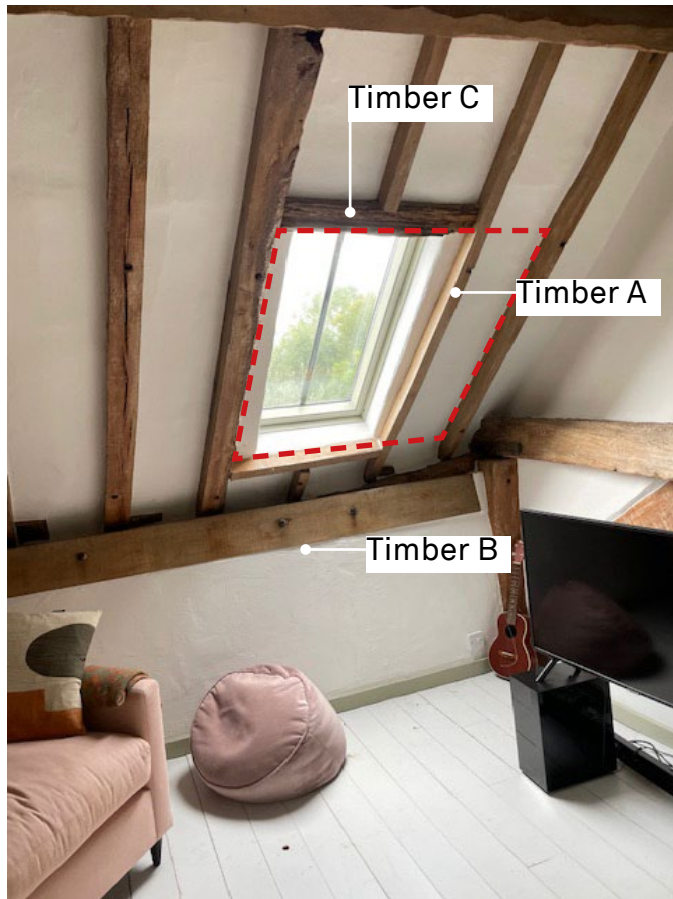
### Window location:

Internal view of window with proposed expansion (dotted)

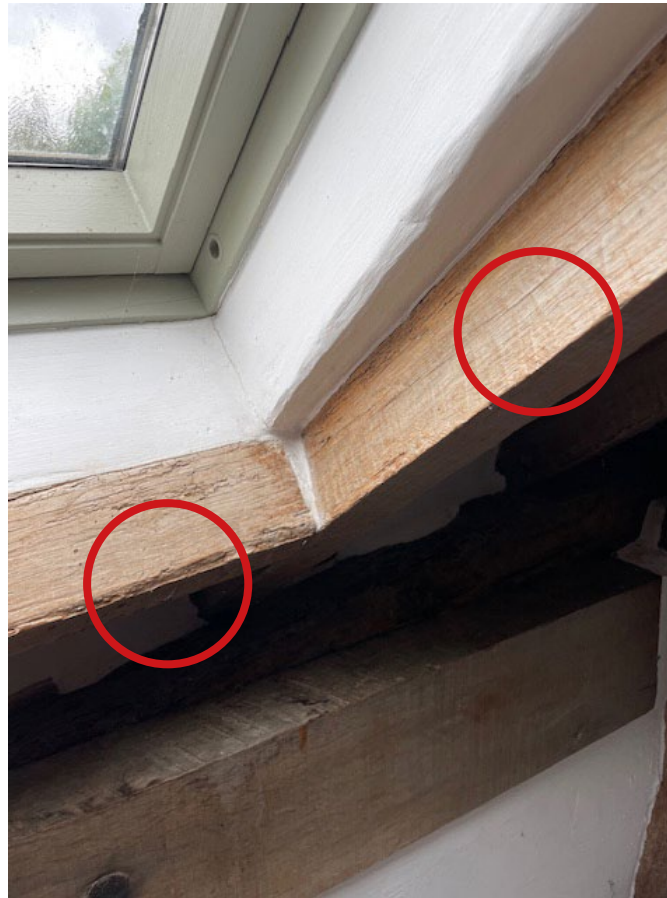
### Timbers A & B:

Both timbers are recent additions. The proposed expansion would cut timber A and replace timber B, but neither are deemed to be of any heritage value.

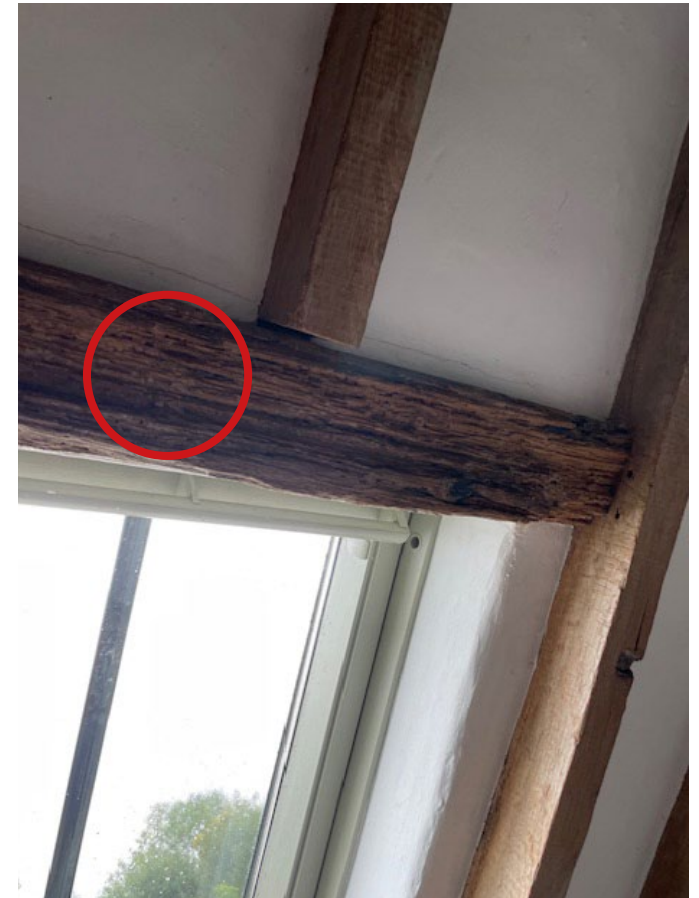
### Timber C:

This timber is older, but also a recent addition for the purpose of framing this rooflight. This timber would be replaced with an aged piece of wood that spans the updated width of the window.
