Plan notes

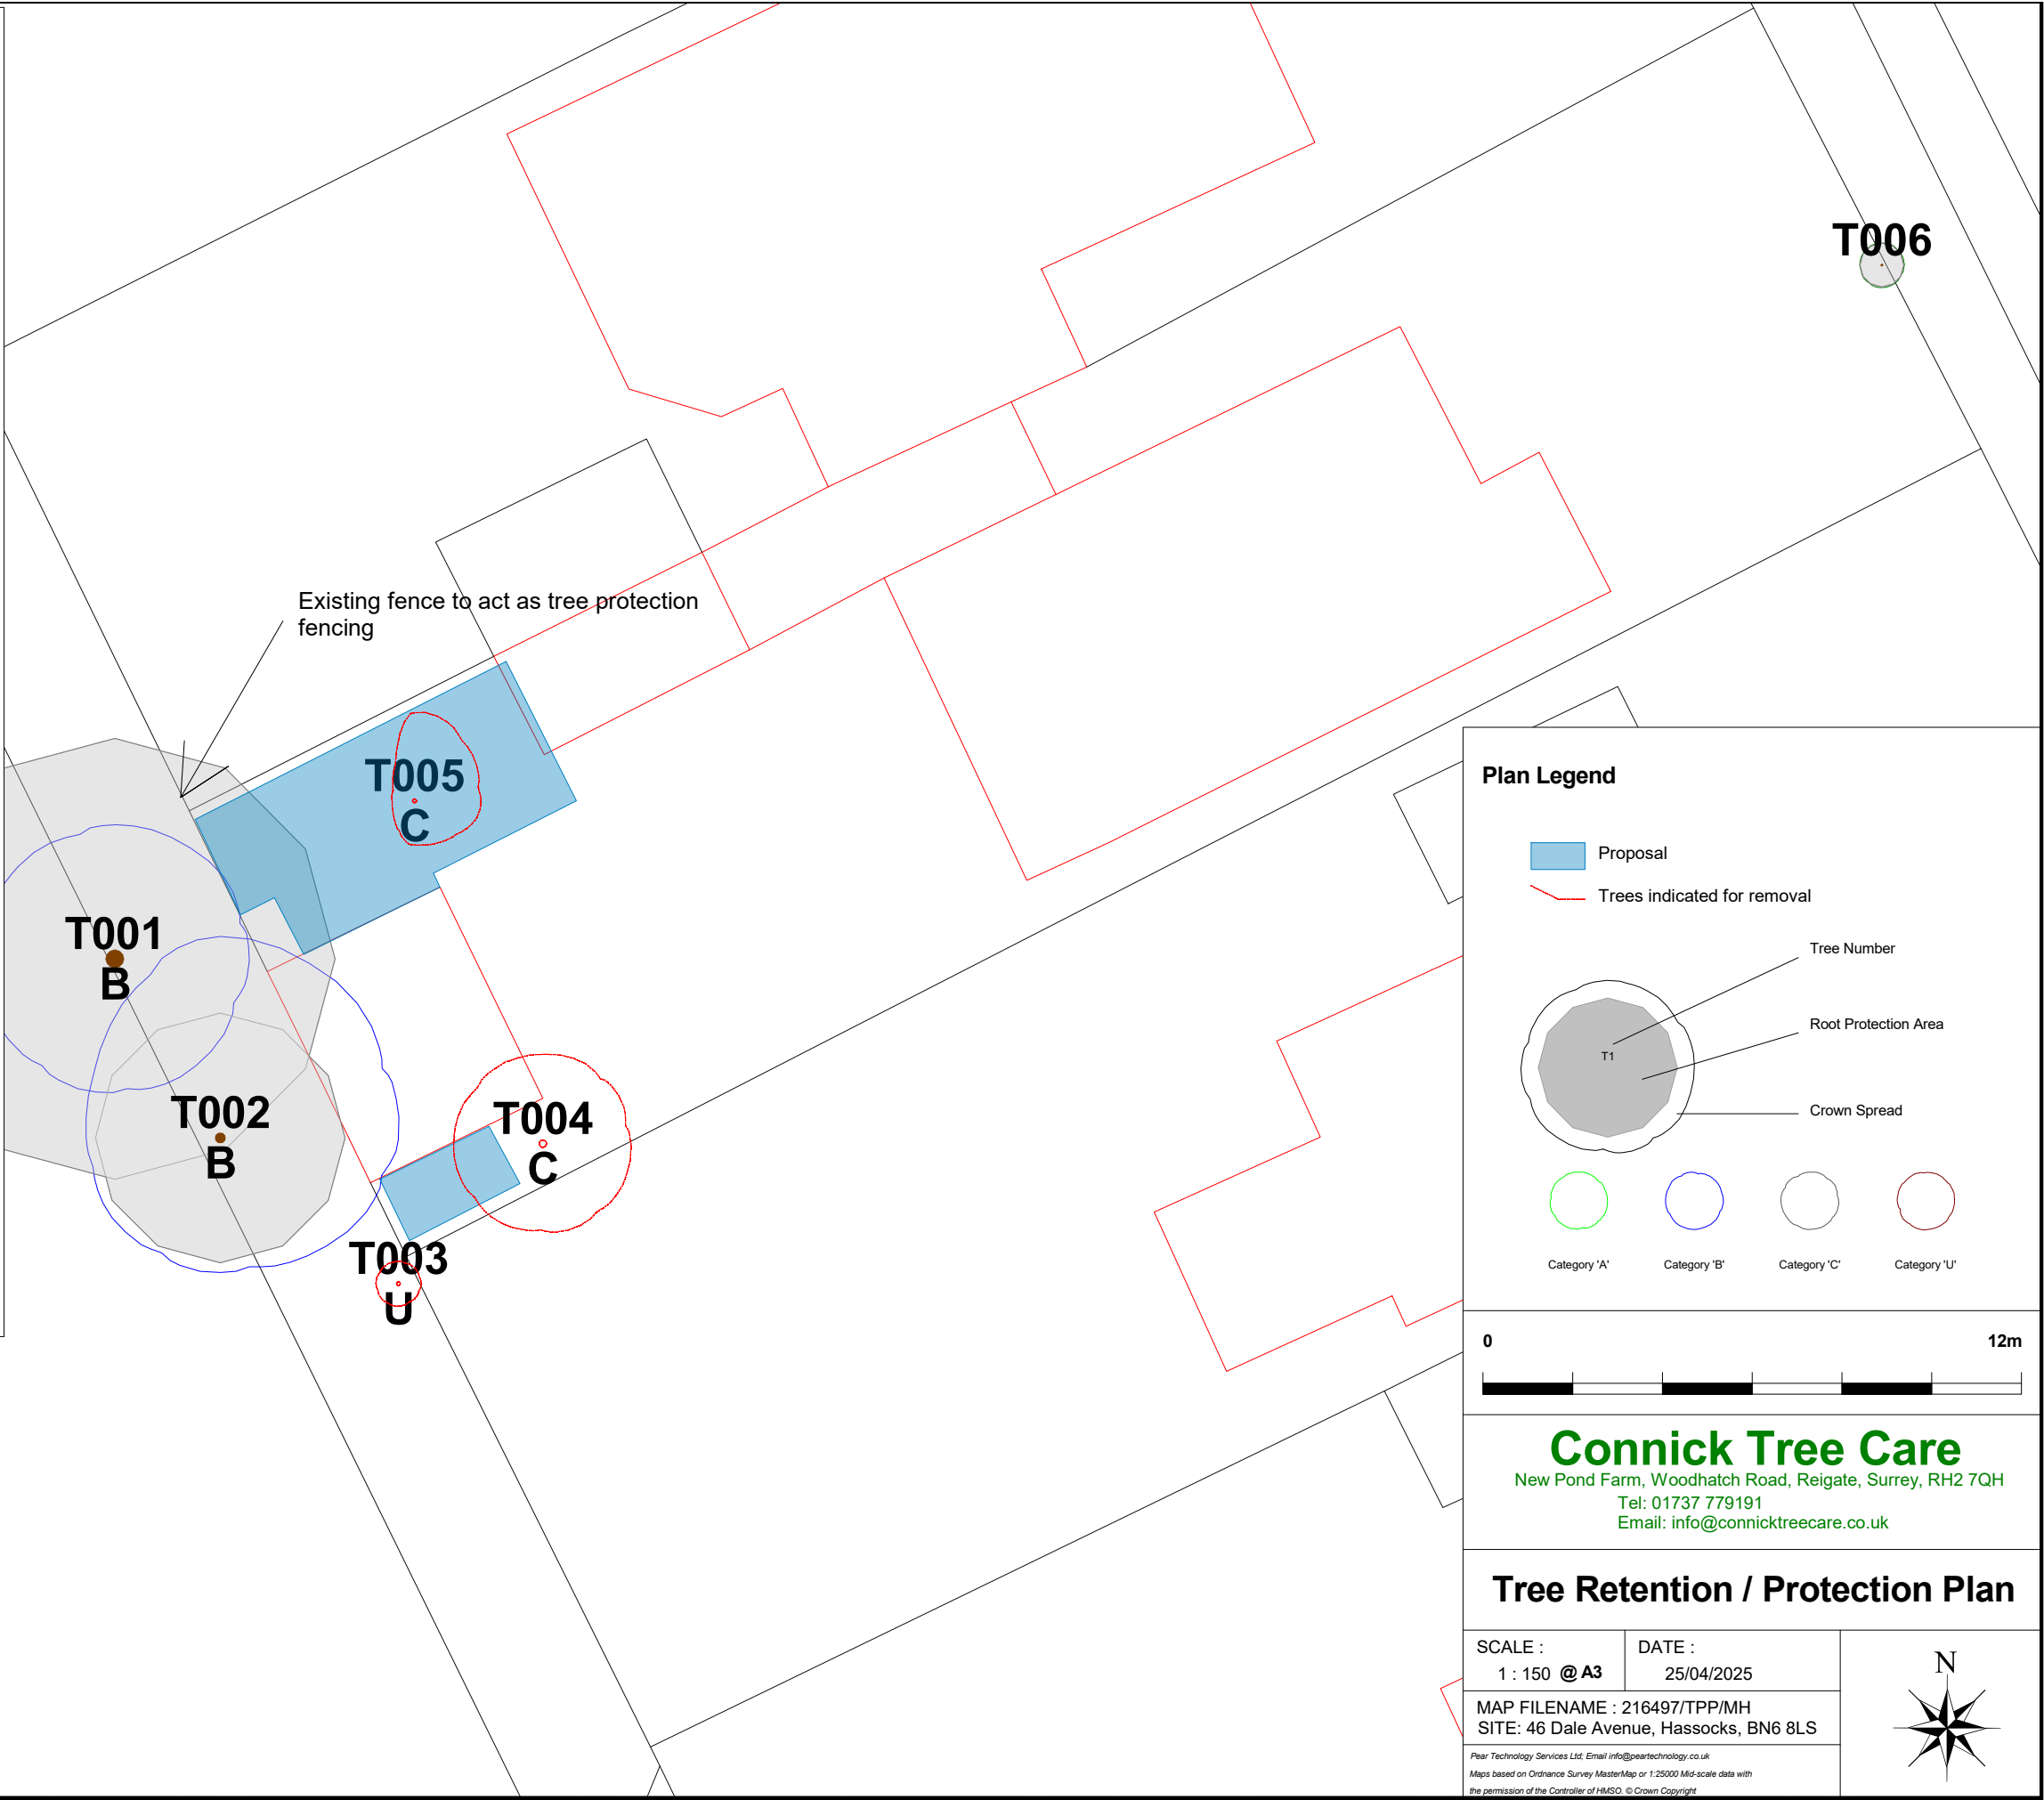
Tree loss is limited to 2 low grade category 'C' trees, T5 a Flowering Cherry and T4 a Plumb will require removal to facilitate the proposal.

The intrusion into the RPA of T1 of the garden room extension is calculated to be 7.6%. The 2022 Google Earth imagery shows a previous structure in the intrusion area, anecdotely reported as being a hot tub on a solid concrete base. The rooting morphology in this area is therefore likely to have been restricted lowering the impact level to one deemed to be tolerable.

No tree protection is required as the existing western boundary fence will serve this purpose.

The construction exclusion zone (CEZ) is located entirely on 3rd party property behind the tree protection fence.

To prevent leaching of chemicals into soils within or adjacent to RPA's all footings where wet pour concrete is required will be lined with an impermeable membrane.

Mitigation planting of 2 new Flowering Cherry standards will be carried out in the front garden in the next dormant season after completion of all works.

No temporary ground protection is required

Works to demolish the existing garage and carry out the re-modelling of the property take place well away from all retained tree RPA's and require no arboricultural instruction.
