# BT SH 3.0 Screen Testing for CCTV Overexposure & Glare - (March 2025)

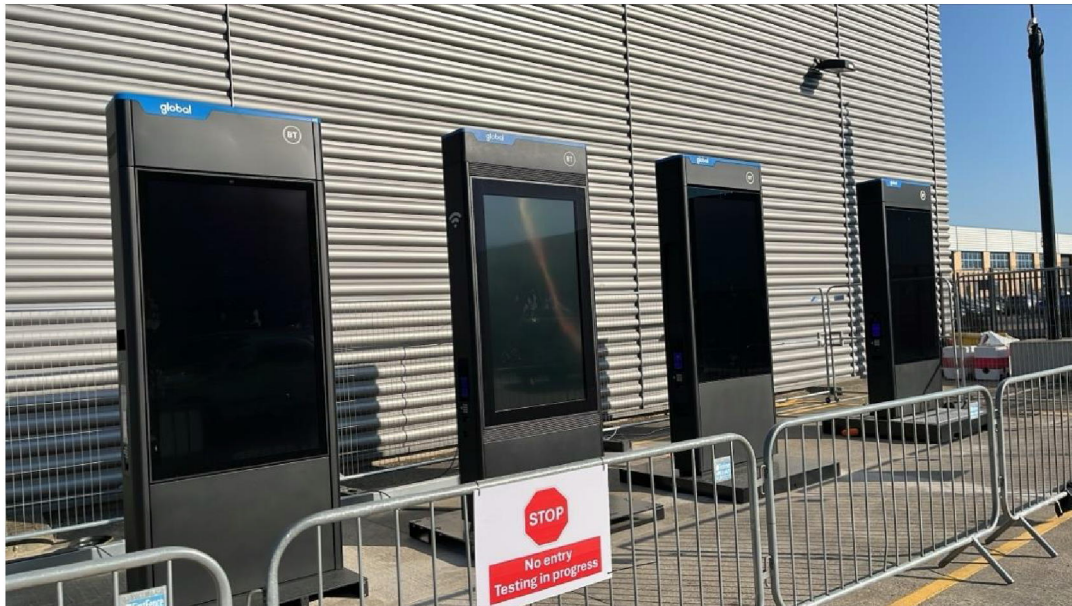
Testing on prototypes in bright sunlight demonstrated that reflection on the glass is minimal. See Figure 3 below.

Figure 3 - close up image of screens in direct sunlight

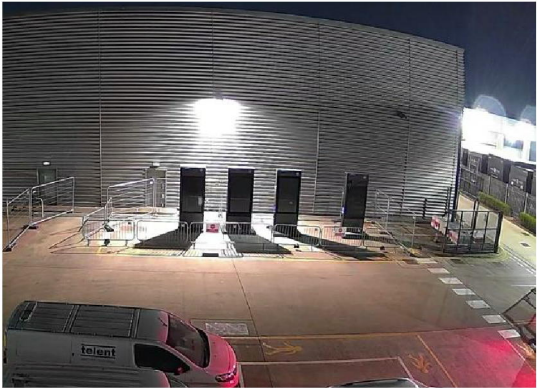
A CCTV camera (TP-Link C501GW 1.0) was used to monitor the behaviour of four units at various times of the day. The following still images were captured to demonstrate the effect on the performance of the CCTV camera.

| <p>22:00 – Content with additional rear lighting</p> | <p>00:00 – Display off with additional rear lighting</p> |
| <p>06:00 – Content at dawn</p> | <p>Units off in direct sunlight</p> |

The images show that there is no loss of detail in the CCTV image caused by the BT SH 3.0. There is however evidence of overexposure caused by other light sources in the images, particularly very bright light sources at elevated positions; as annotated in Figure 4.
