**Sussex Police Sites Security Review 18.08.25**  
Example Perimeter Fencing at Typical Tower Site  
GDH/PB 3613-P1-FAIR-SK01 Rev.2

**Sussex Police Sites Security Review 03.09.25**  
Example Perimeter Fencing Photographs  
GDH/PB 3613-P1-FAIR-SK02 Rev.2

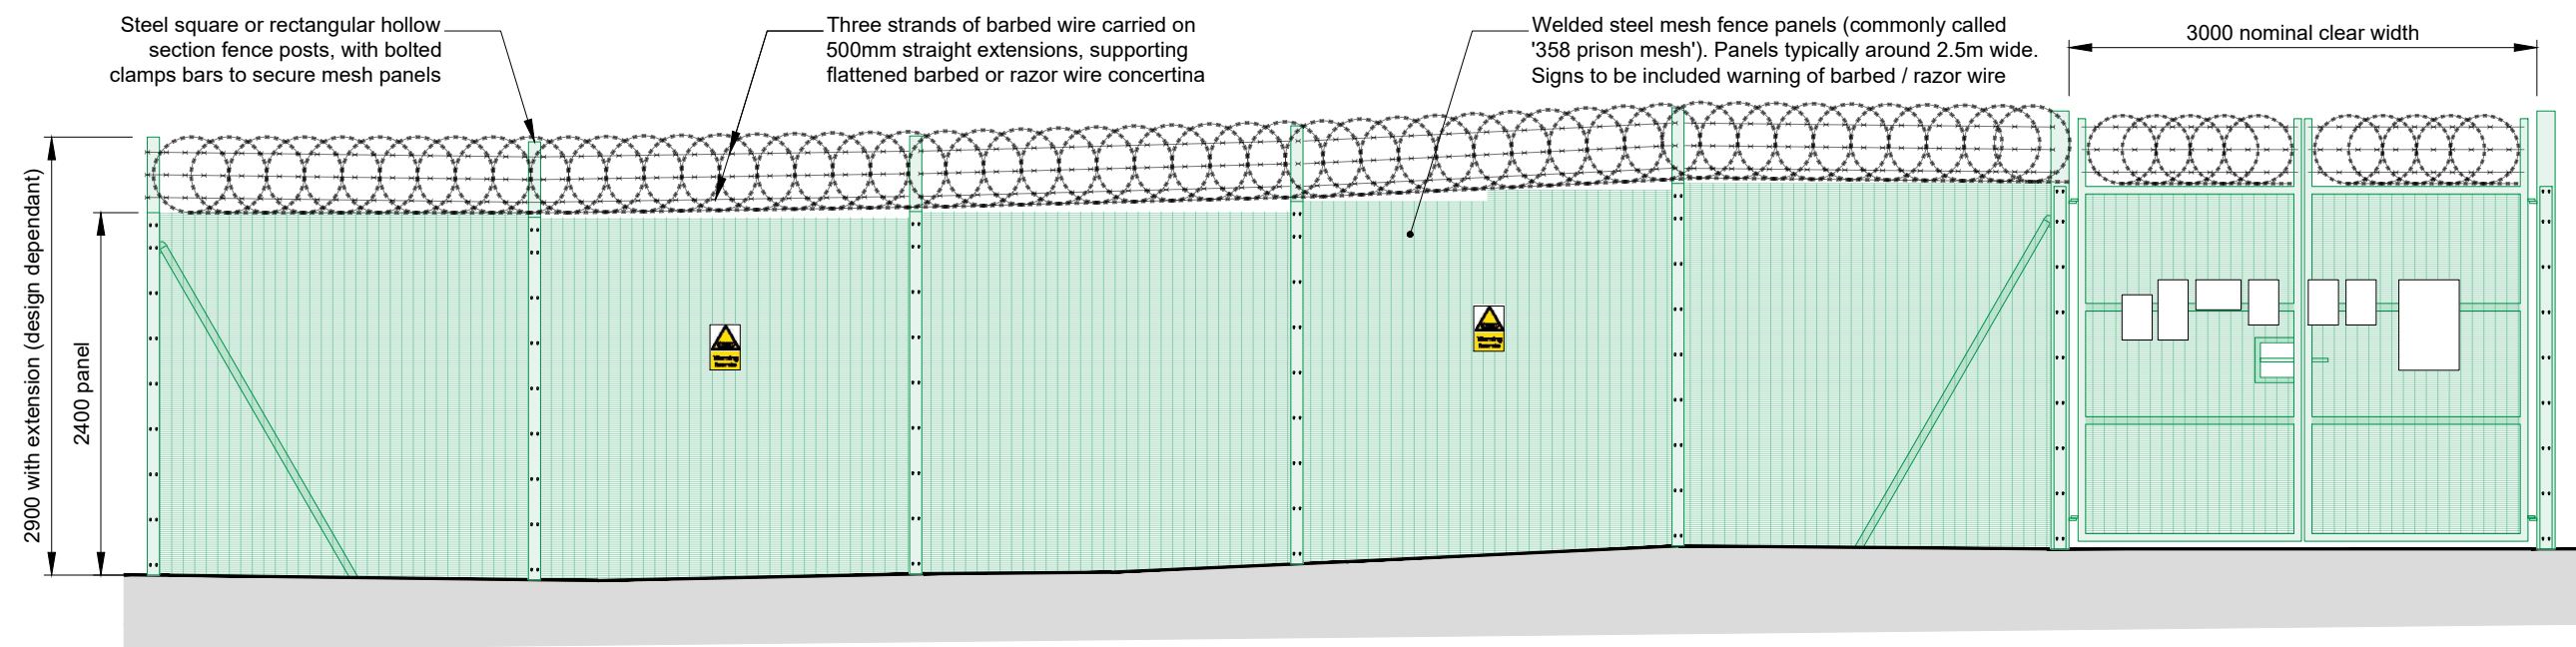
Illustrative Upgraded Elevation

1. The proposed fencing system to be one that has been tested to LPS 1175, achieving a security rating of B3 (SR2). All items (except barbed / razor wire) to be colour powder coated, likely either RAL6005 Moss Green or RAL9005 Black.
2. As part of the works programme to improve site security, Sussex Police wish to exclude any openings in the perimeter fenceline that might present a vulnerability. To this end - and subject to existing legal agreements - before any fencing upgrade Sussex Police will seek from operators an undertaking to relocate any energised meter cabinets (and their foundations) incorporated in the fenceline to a mutually agreeable location within the compound. Sussex Police will also pursue removal of any such operator meter cabinets and their foundations which are defunct

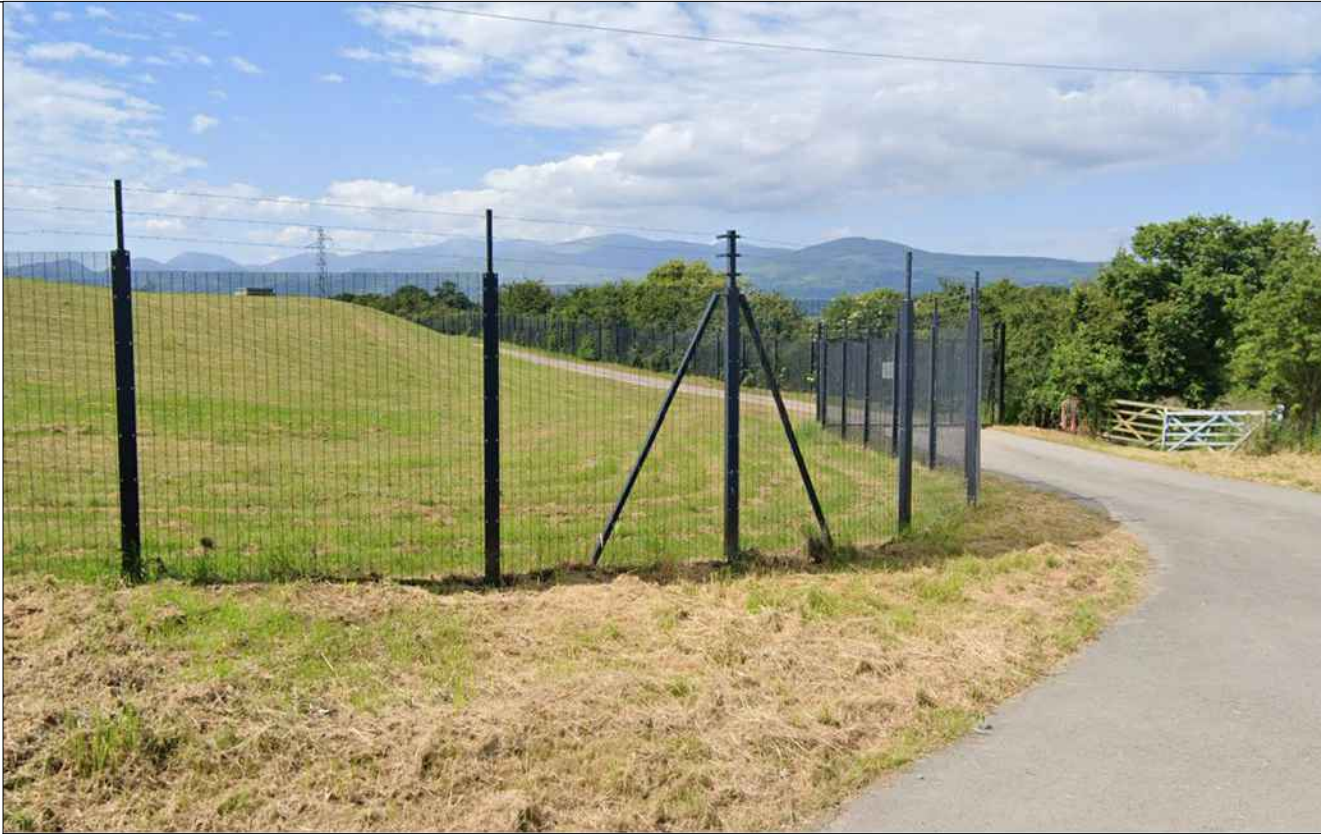
Covered reservoir from Streetview capture © 2025 Google  
Image illustrates typical installation of a steel welded mesh fence (unknown product and rating). Note the raking braces for the corner straining post and the thin extension pieces carrying three strands of barbed wire over. Panels stepped to accommodate ground profile

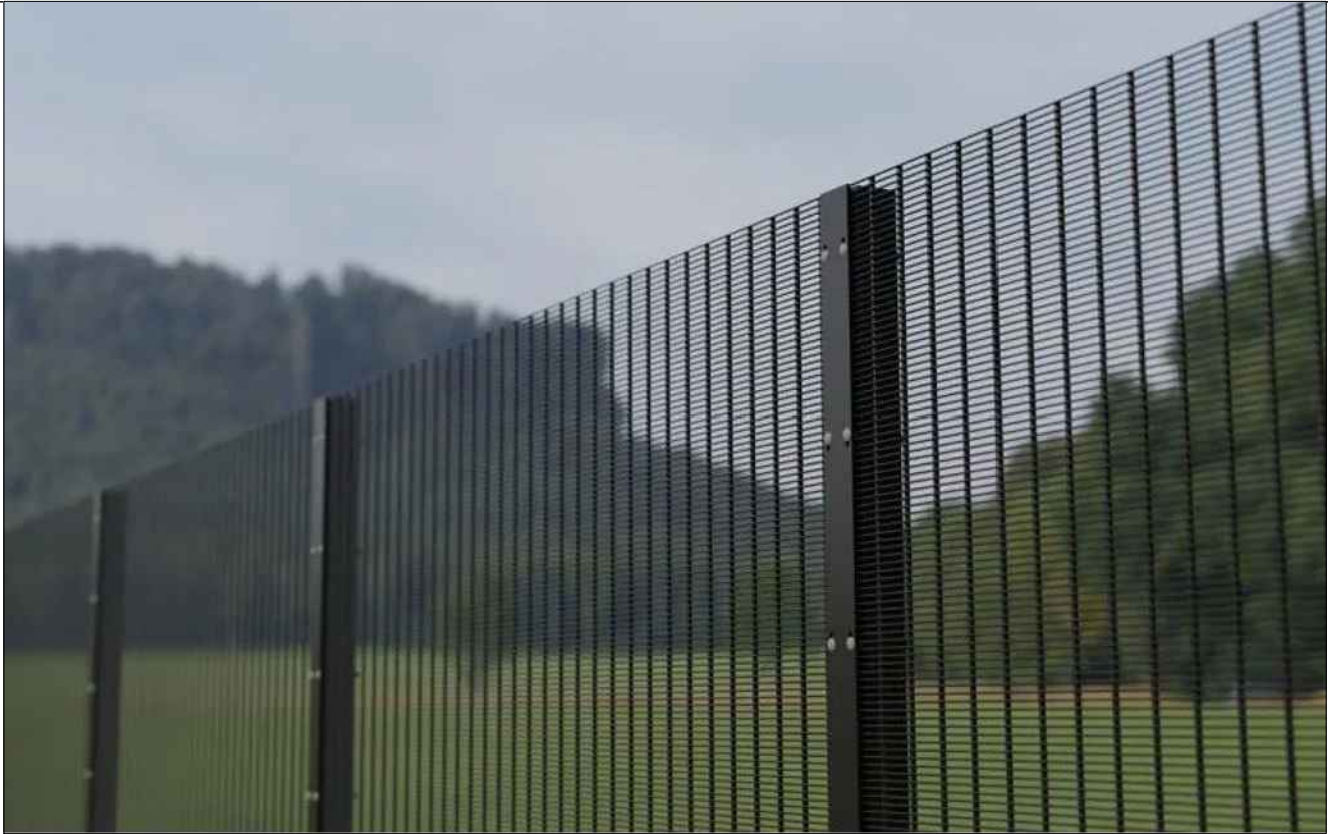
Image from CLD Systems website  
Image illustrates product with an LPS 1175 security rating of B3 (SR2). Note single layer of mesh (permitted by use of heavier 10mm vertical bars) and the bolted strap plates on each post. This system may be deployed using off-site assembled modules

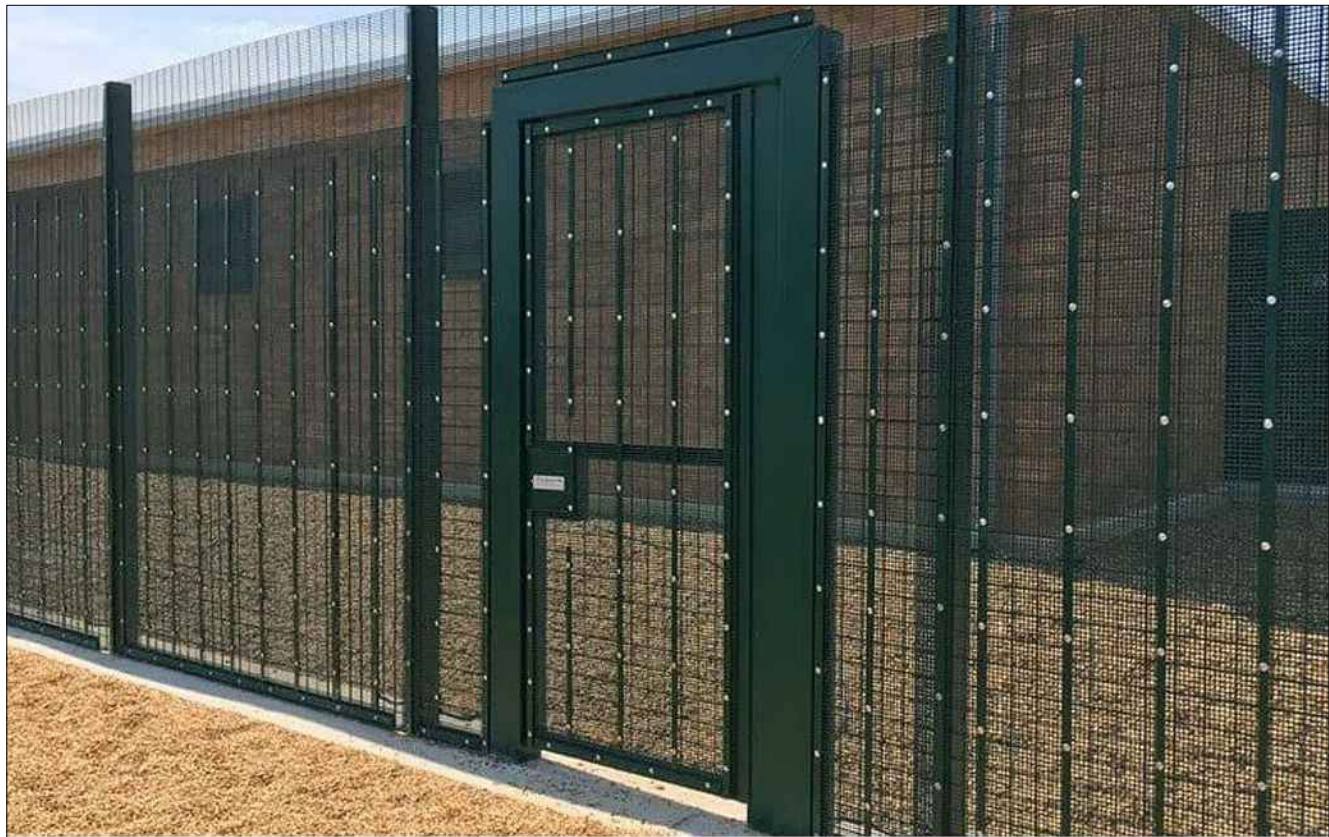
Image from Jacksons Fencing website  
Image illustrates product with an LPS 1175 security rating of B3 (SR2). Note with this systems the double layer of mesh requiring extra vertical strap bars

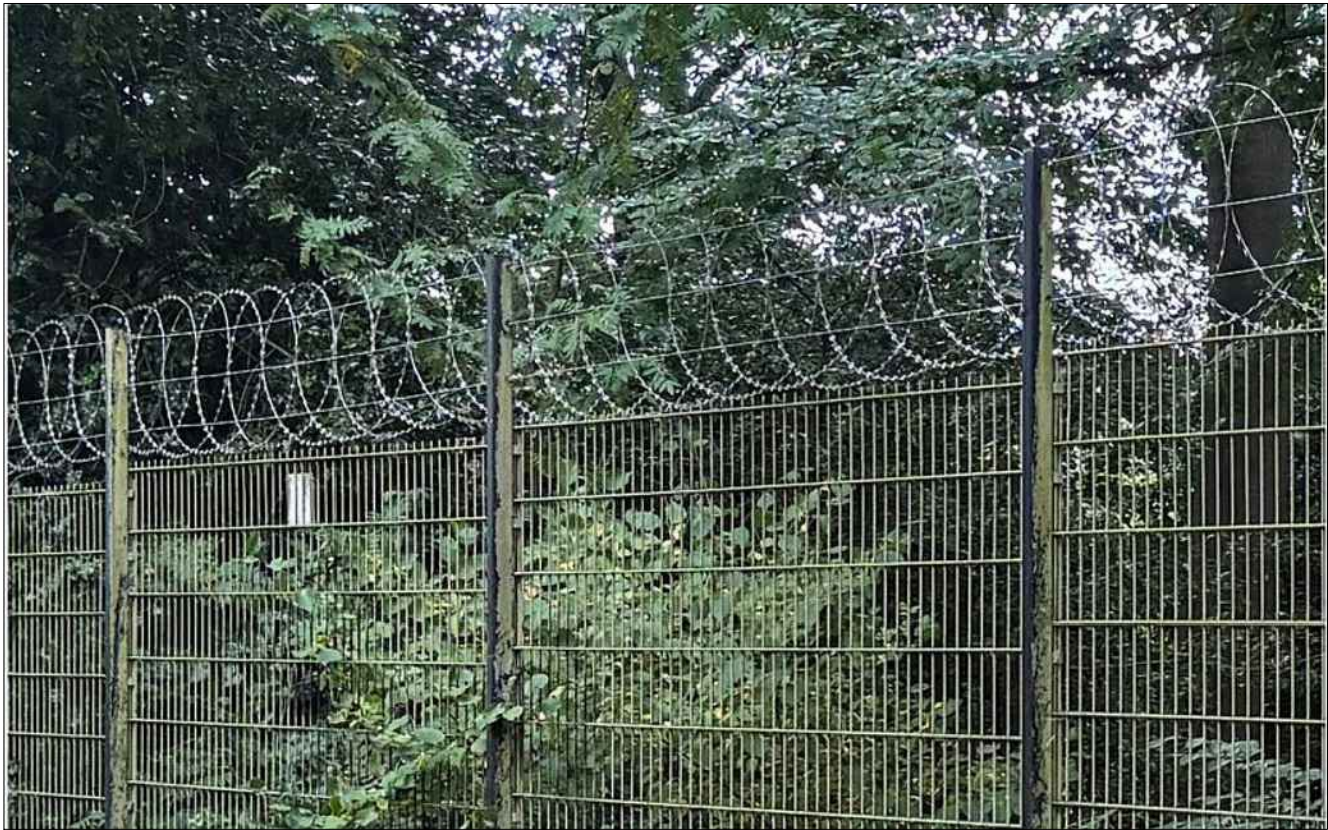
Image from MFD Communication Infrastructure Ltd  
Image illustrates fence topping of flattened barbed wire concertina carried on three strands of barbed wire. Although this fencing product probably does not carry an LPS 1175 security rating of B3 (SR2), it does show the an installation of the preferred topping at a governmental secure site
