**674021 Mitchells and Butlers Miller and Carter Haywards Heath**

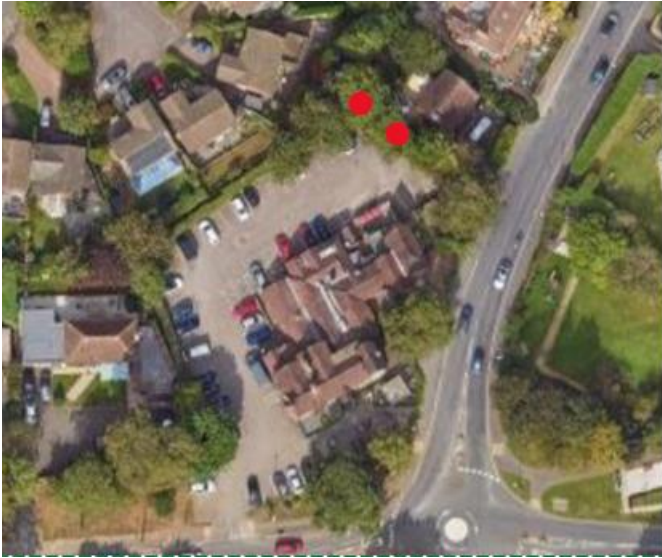
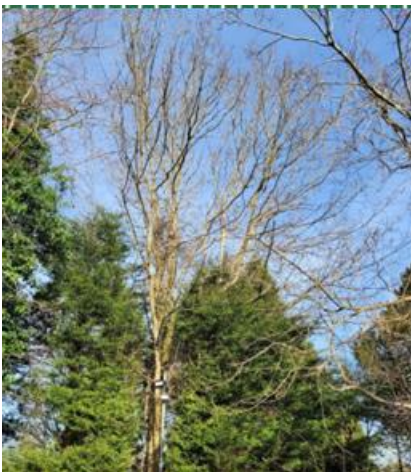
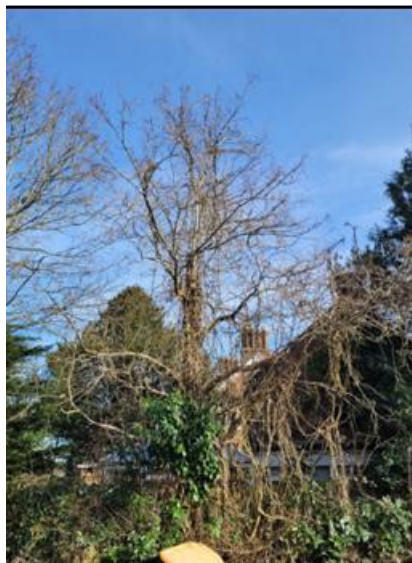
2x Ash trees located in carpark

Trees are showing signs of dieback and need to be felled to ground level, the ecoplugged to prevent regrowth
