## Drainage:

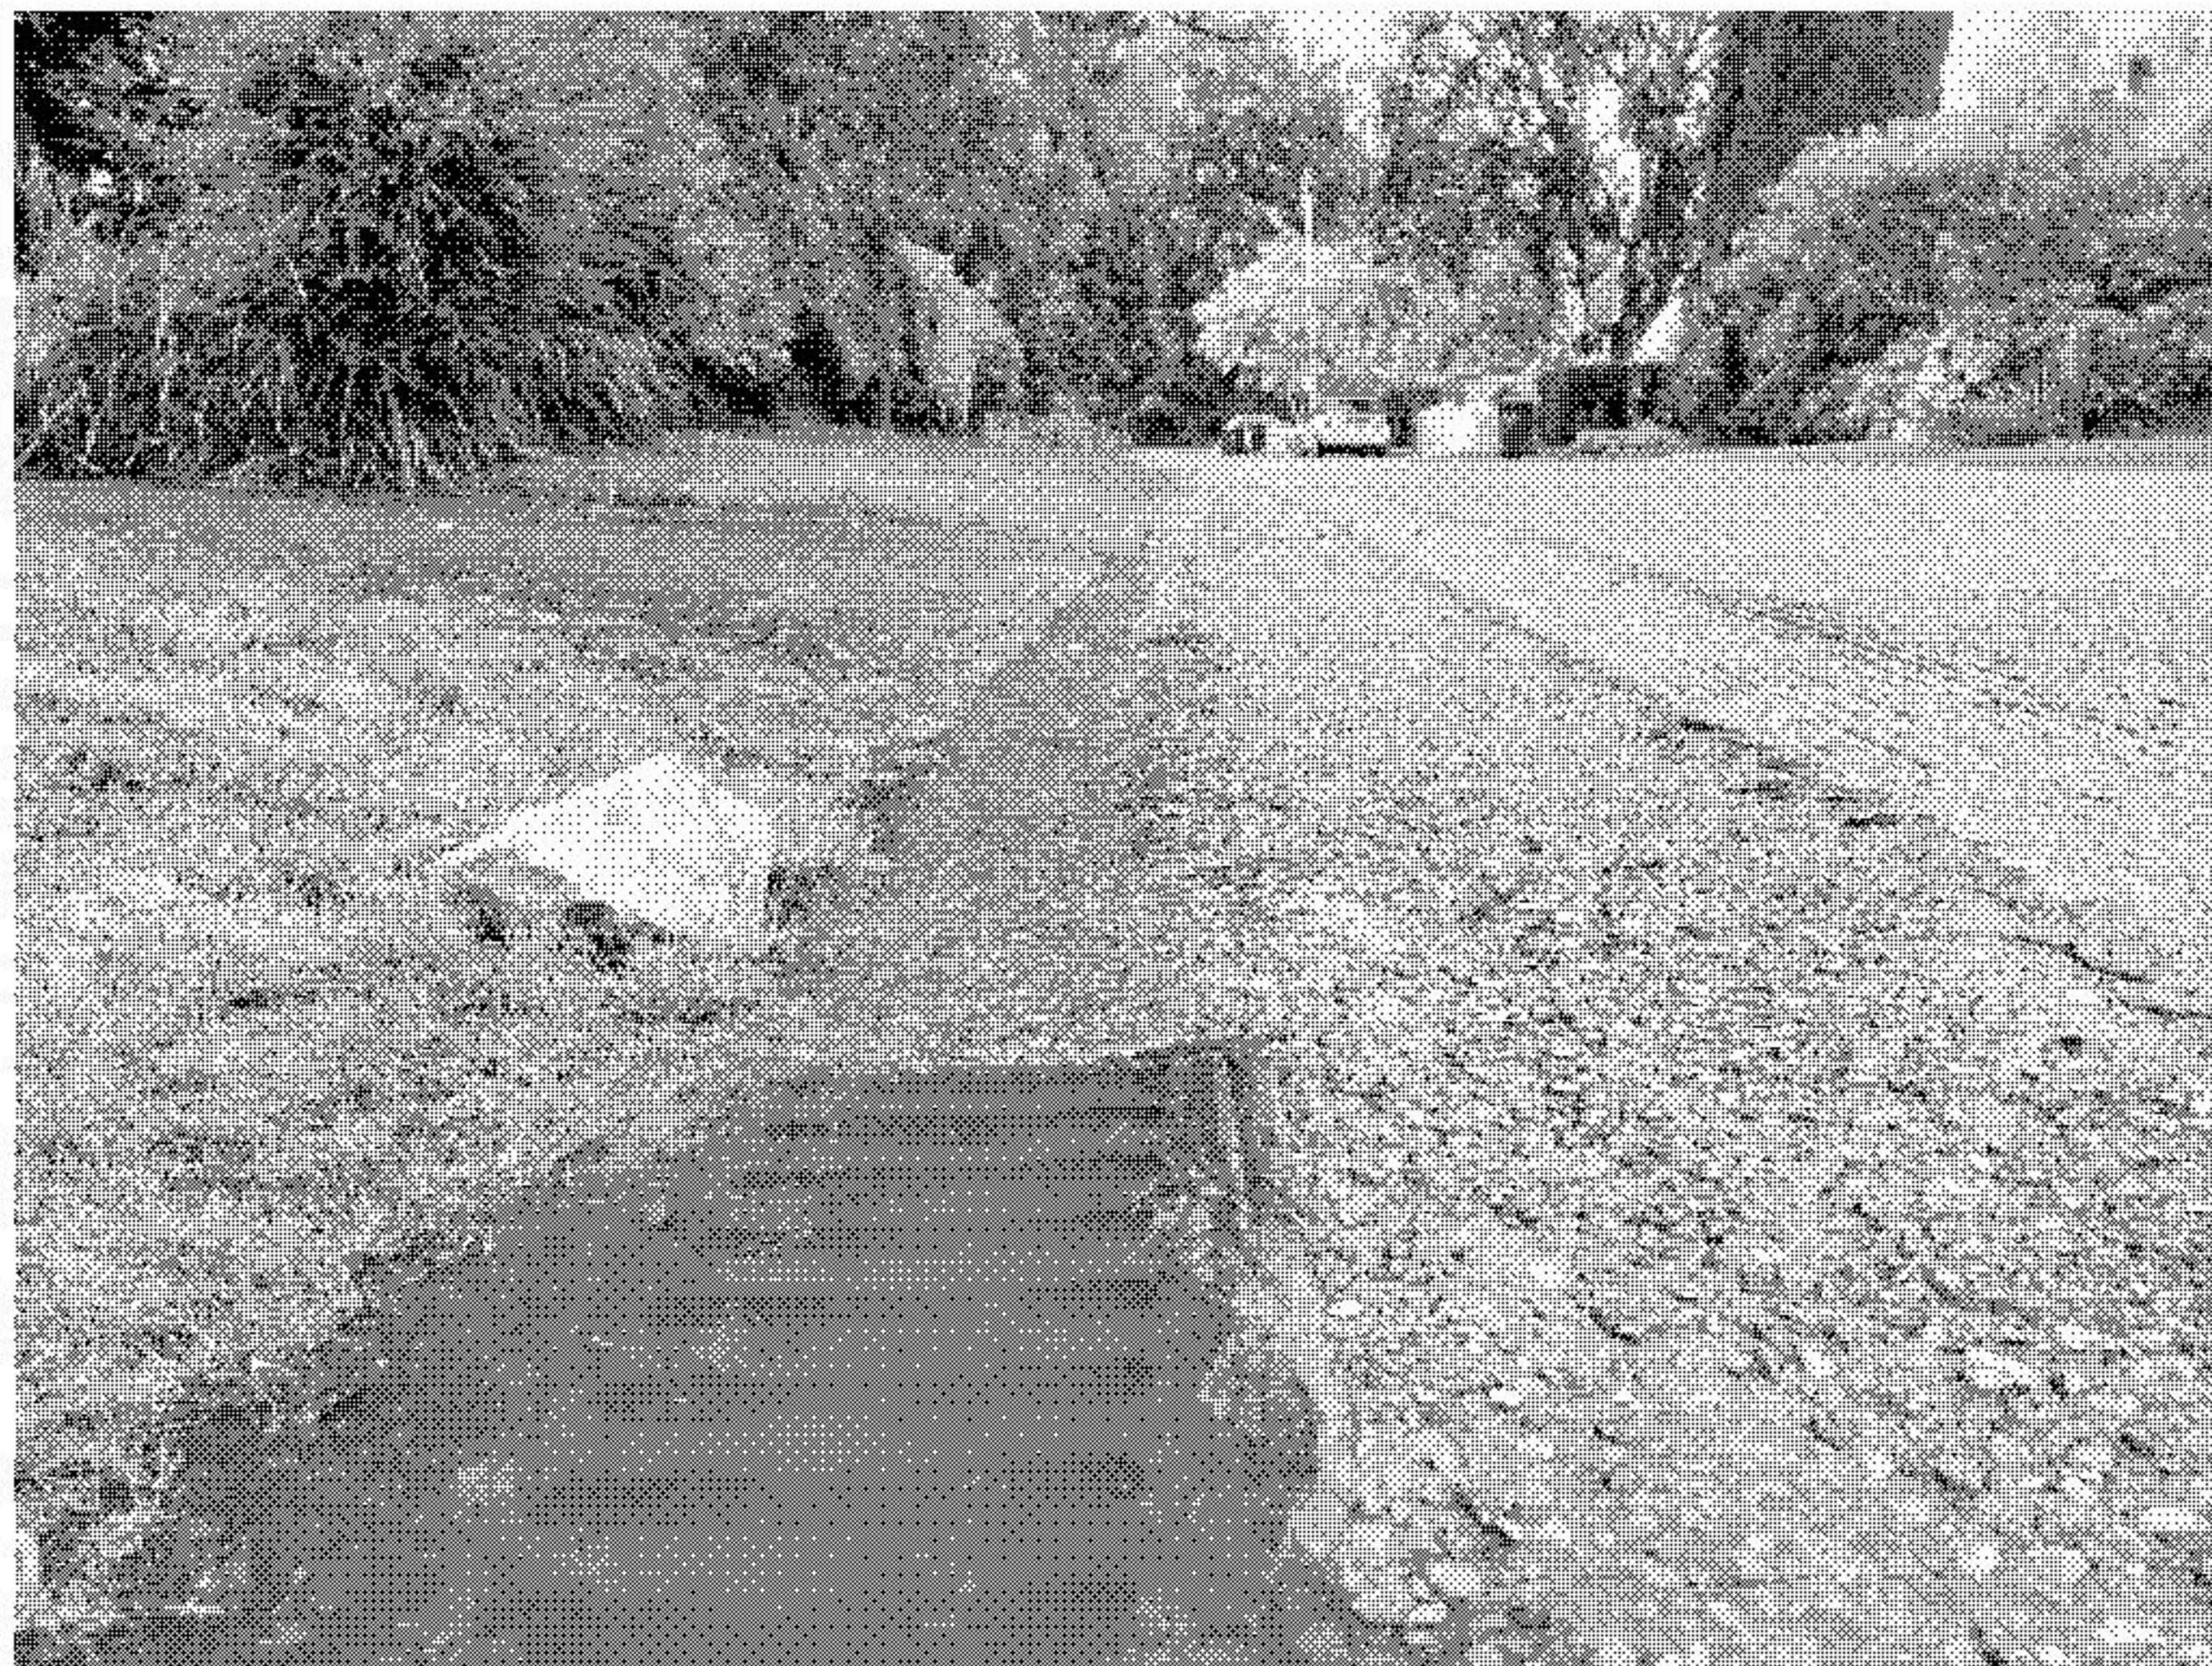
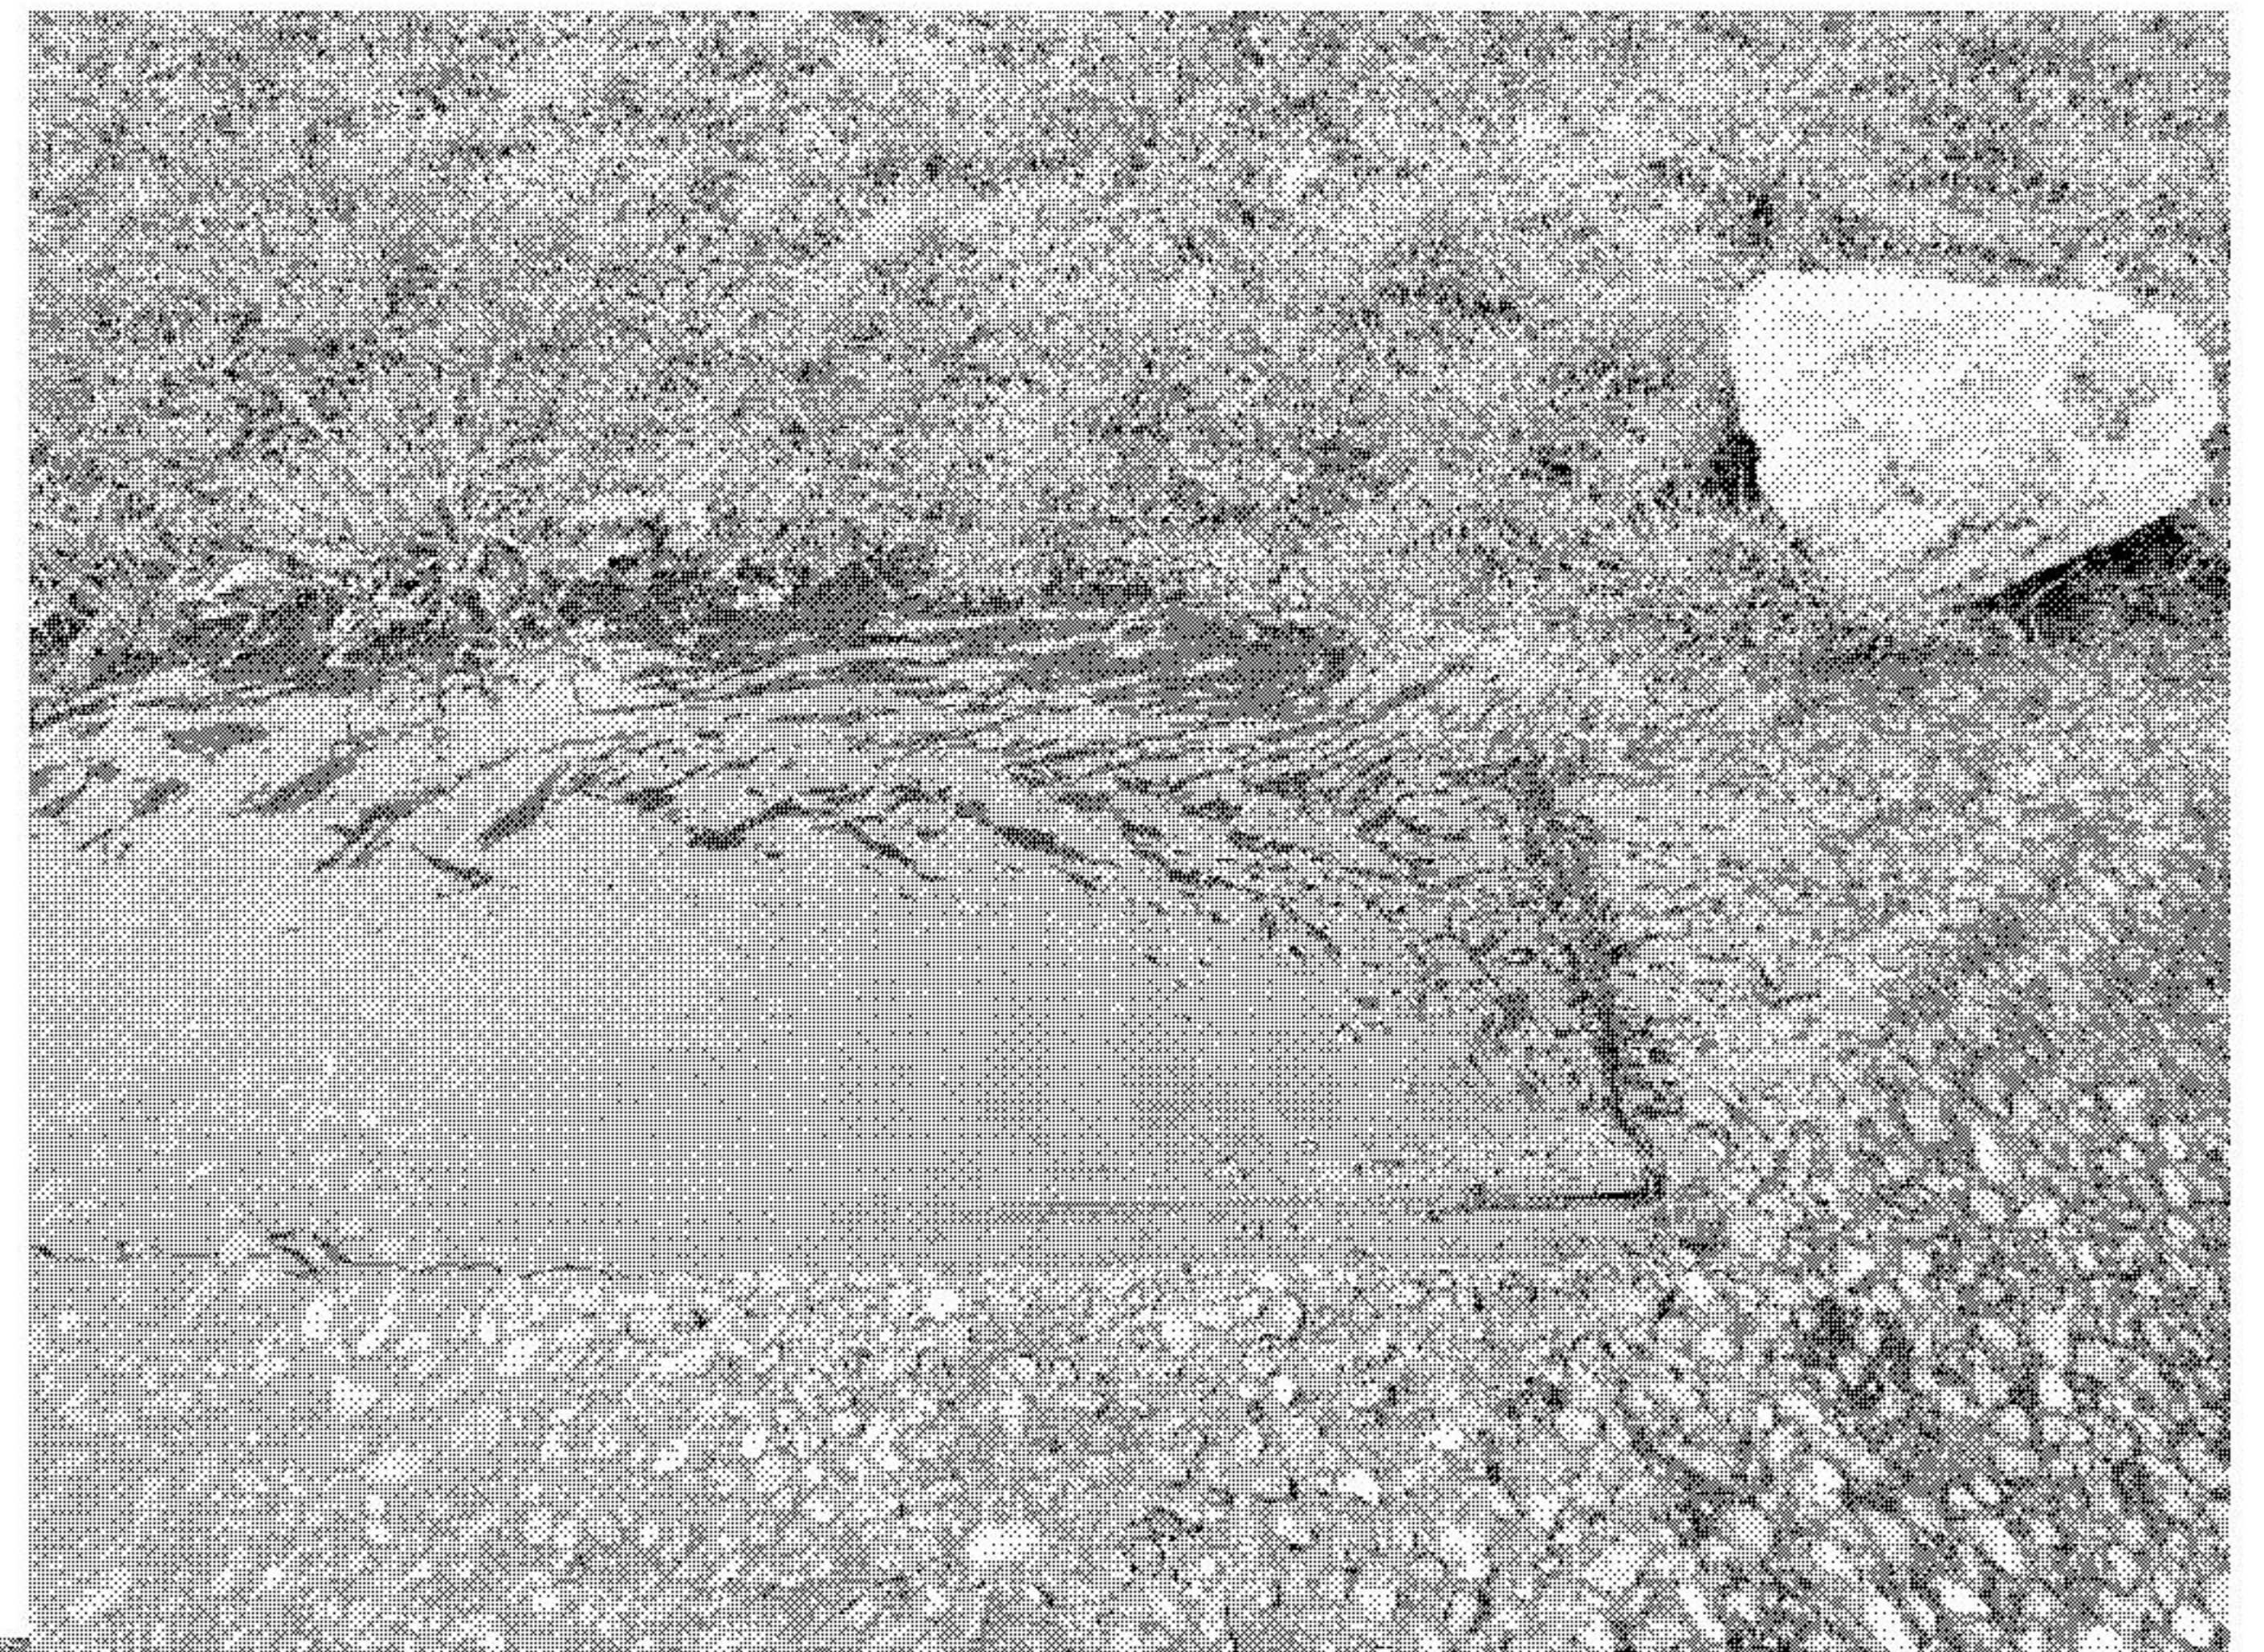
2. From no 48 the existing system runs downhill, to College Road for approximately 300 metres. Heavy (and not so heavy) rainfall regularly overwhelms the system, this is evidenced by water coming out of the drain covers and discharging along the length of Wickham Way (from about No 44) and the resulting stream that run down the surface road. The existing drainage does not have capacity for the current level rain surface water, the result is flooding at the junction with College Road. Note, this is despite regular professional clearing of the drainage system paid for by residents. The three photos below are evidence of the existing system being overwhelmed by a shower on 02/06/26. This is outside of No 48 and No 46, so just downhill from the proposed inlet to the existing system – this is a pretty mild example of the flooding that occurs.

3. There is no footpath along Wickham Way, so it is the pseudo-footpath that floods, forcing pedestrians into the centre of the road that is used by traffic.

4. It is pretty obvious that the existing drainage is already overwhelmed and it has no capacity to cope with this additional targeted discharge.
5. Drainage is a problem for the site (48's garden), presumably caused by the extensive development that the same developer has already undertaken on the same land.
