Project: Ruckford House, Malthouse Lane, Hurstpierpoint, Hassocks, BN6 9JX

Client: Hurstpierpoint College

Drawing: Arboricultural Impact Assessment

Drawing No: Arbtch AIA 01 **Rev:** FG

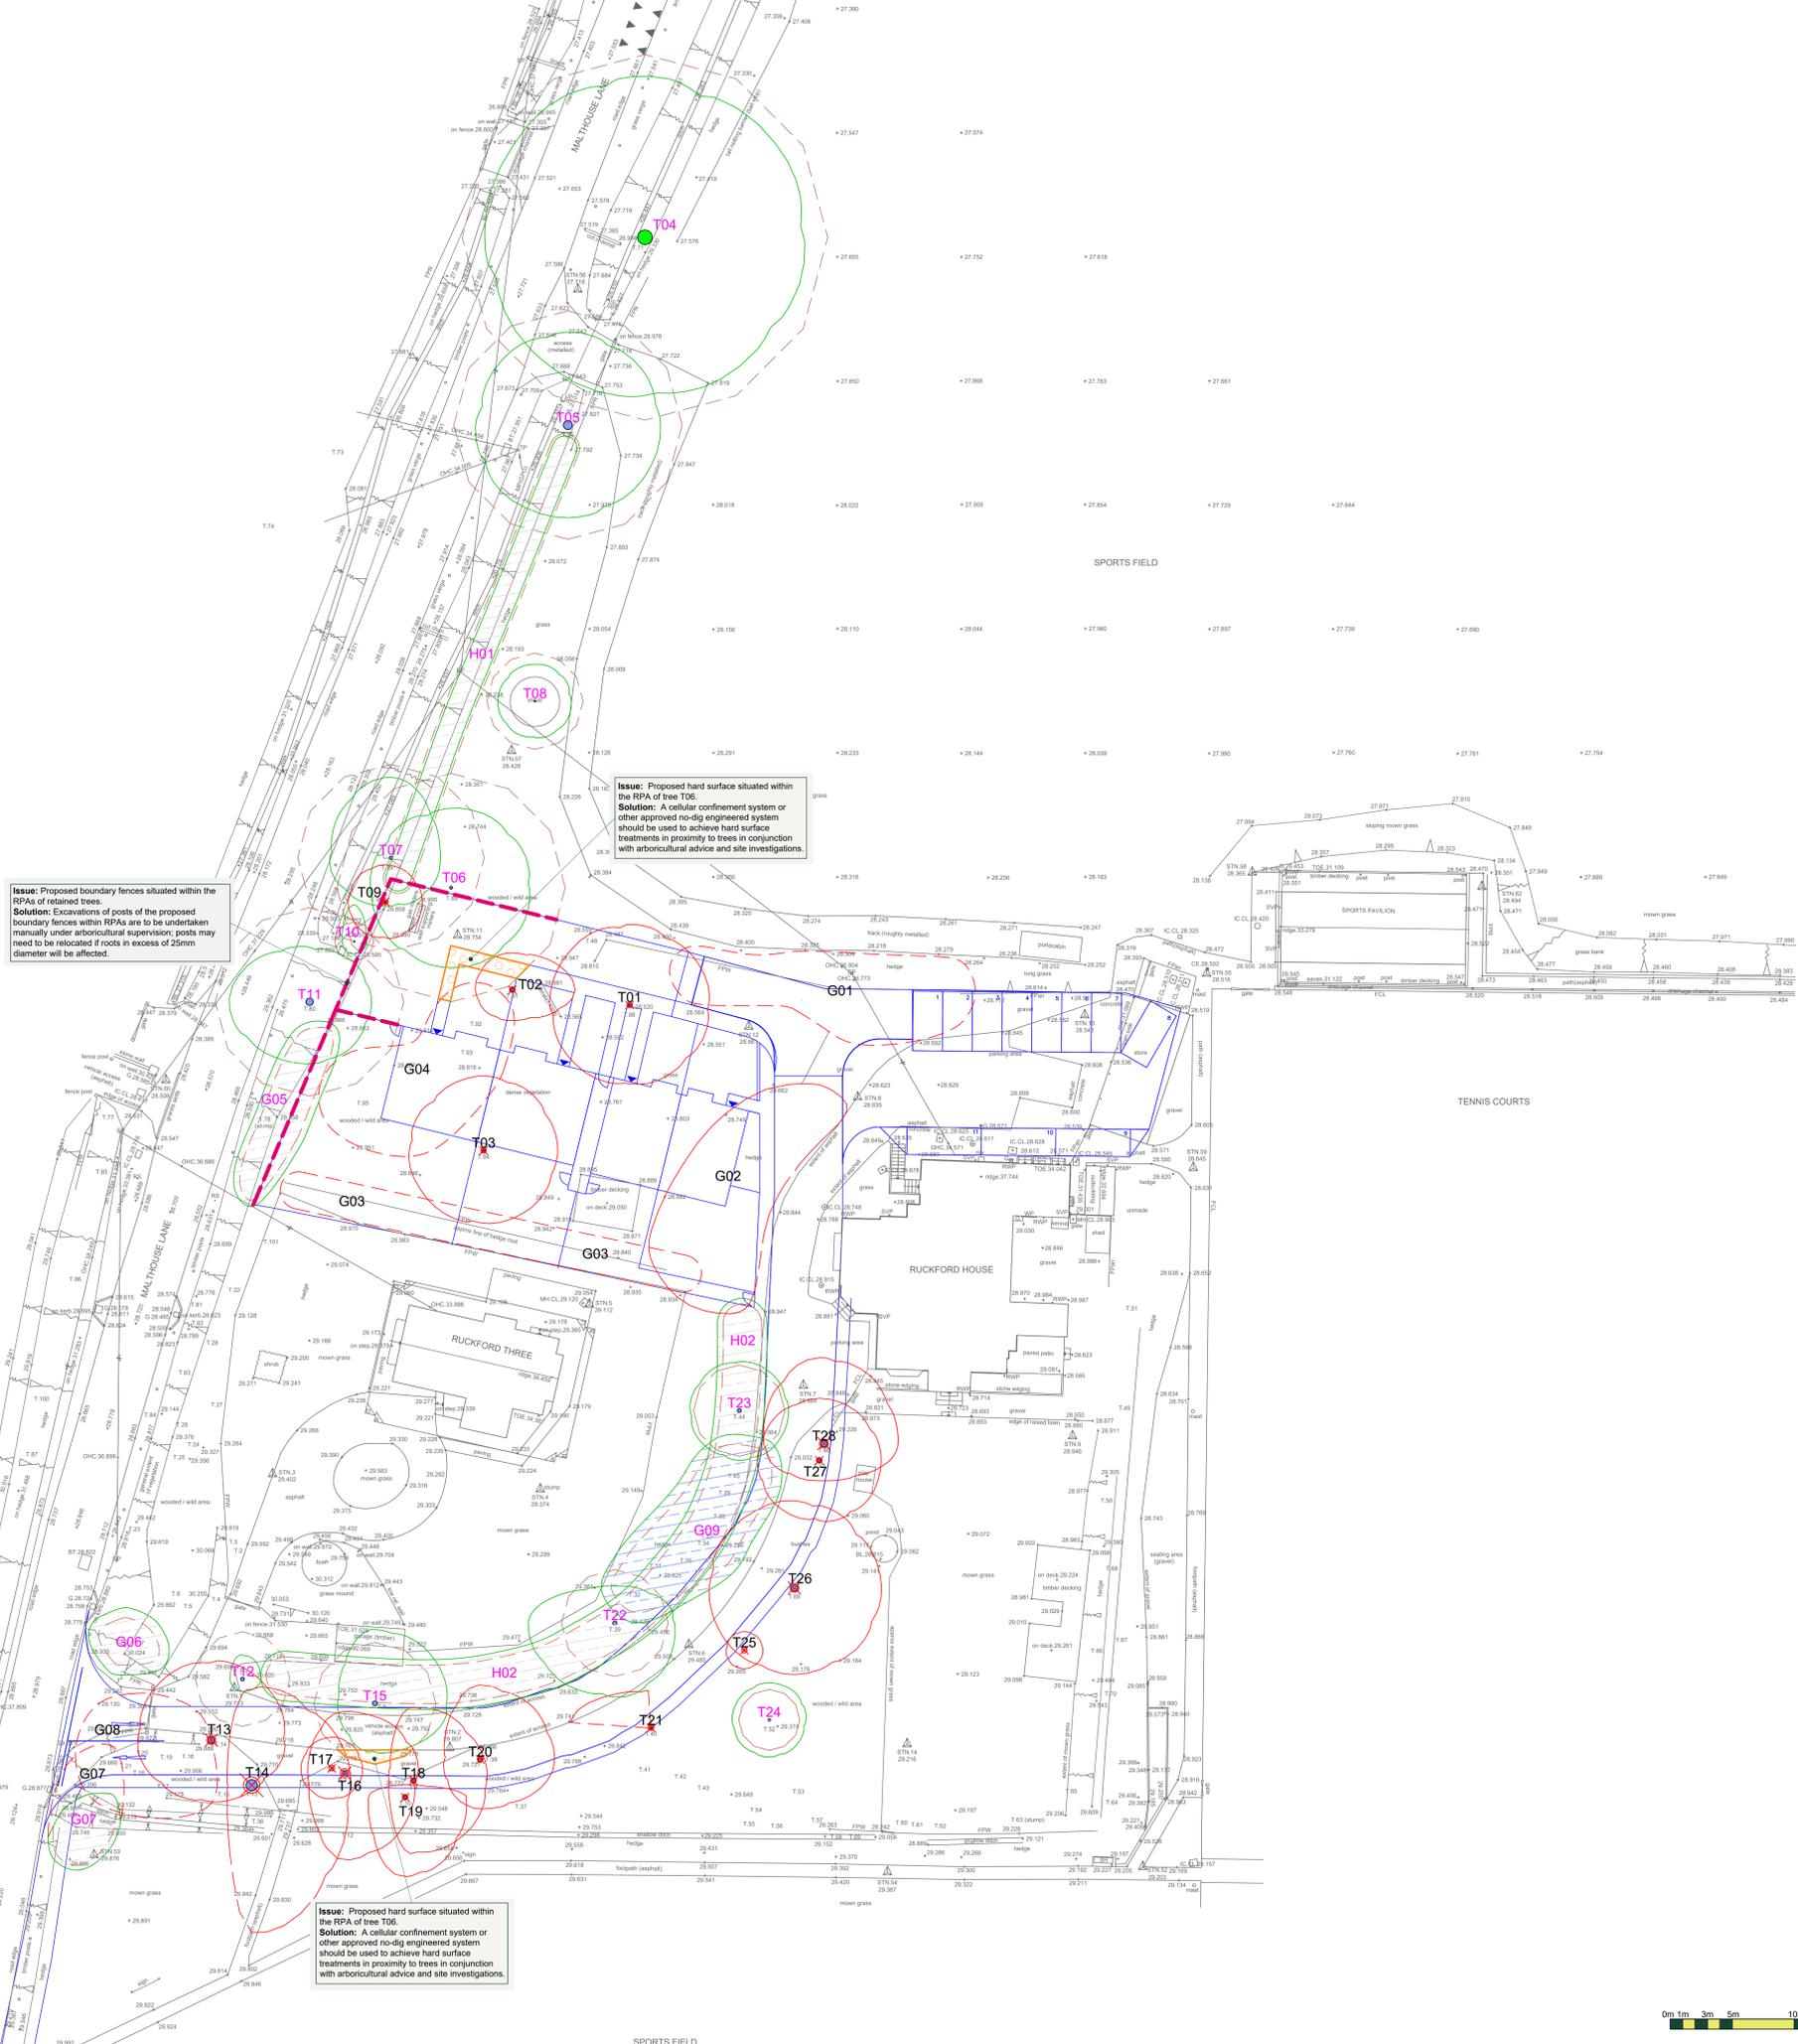
T04	Tree	Trunk
Category 'A' trees	Category 'A' trees	Category 'A' trees
Category 'B' trees	Category 'B' trees	Category 'B' trees
Category 'C' trees	Category 'C' trees	Category 'C' trees
Trees to be removed	Tree to be removed	Tree to be removed
Proposed Site Plan	Incorporation - Hard Surfacing	Incorporation - Fences
