Project: Barn at Brook Farm, Brook Street, Cuckfield

Sketch title: Foundation Details - Stable

Sketch No: 0142 / 23

Andrew Turner  
Engineering

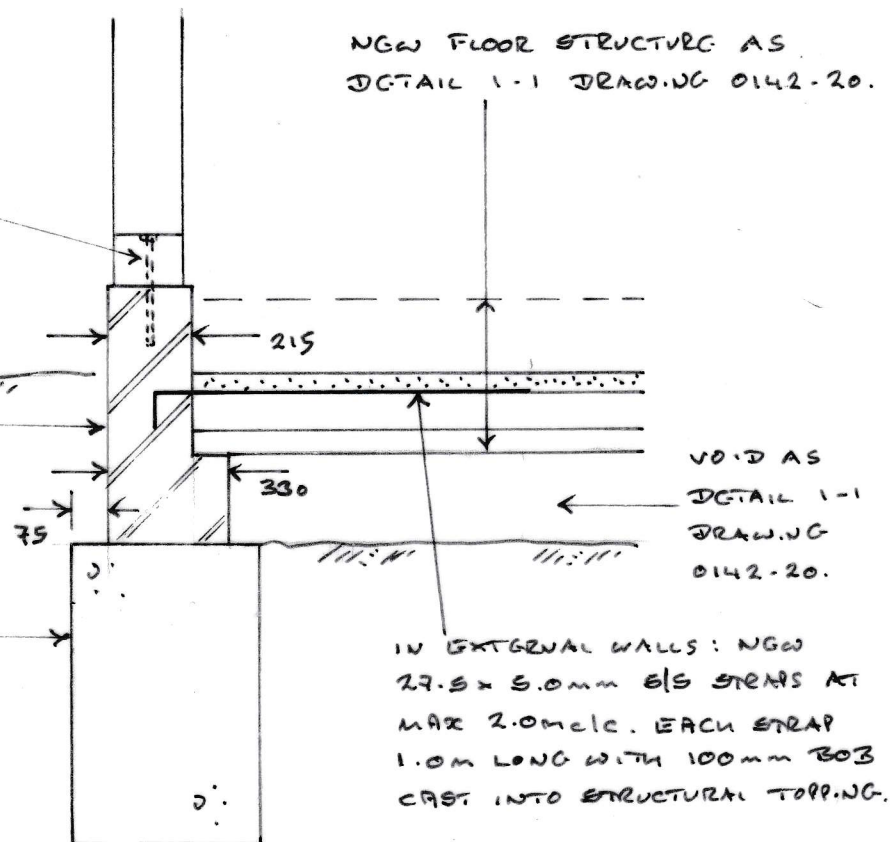
DETAIL 20-20

TIMBER FRAME AS  
DRAWING 0142-17

NEW RESIN ANCHOR AS  
DETAIL 2-2, DRAWING  
0142-20.

ALTERED & CRACKED WALL  
DISMANTLED & REBUILT.  
INTRODUCE  
NEW BRICKWORK  
TO CREATE MIN WALL  
THICKNESS SHOWN.  
FLEMISH BOND.

NEW MASS CONCRETE  
TRENCH FOOTING

NEW FLOOR STRUCTURE AS  
DETAIL 1-1 DRAWING 0142-20.

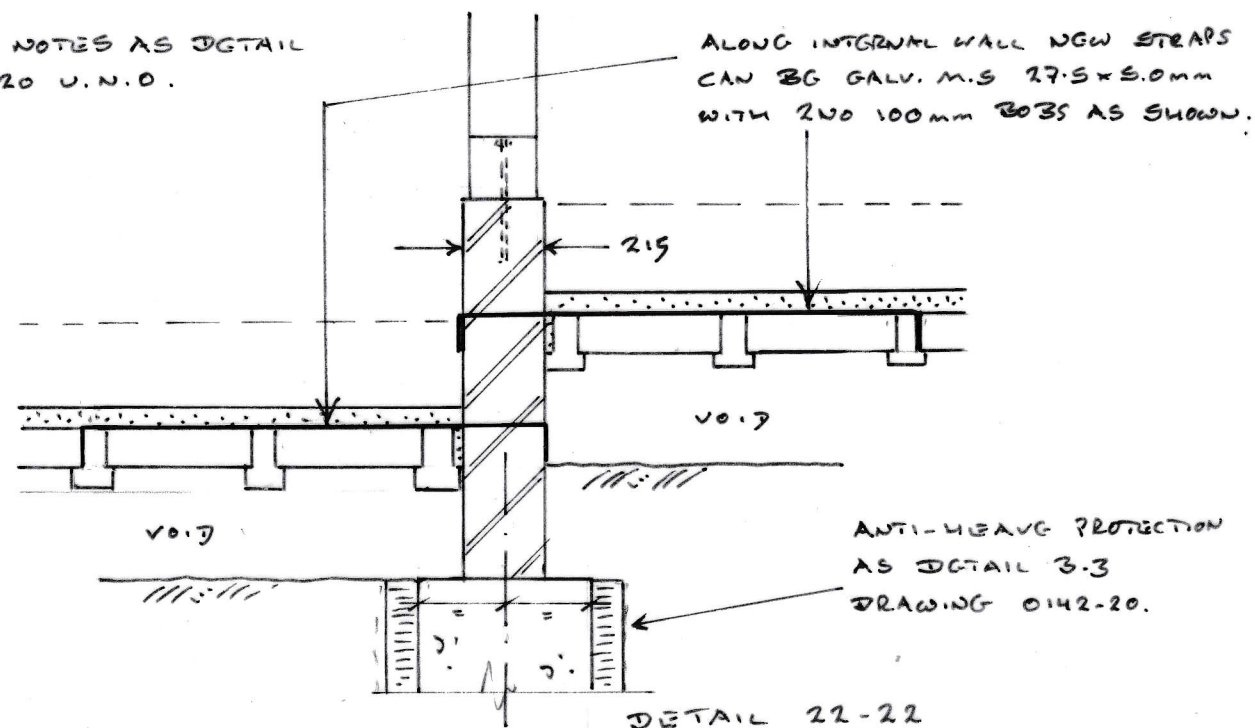
DETAIL 22-22

ALL NOTES AS DETAIL  
20-20 U.N.O.

STABLE

LEAN TO

NEW FLOOR STRUCTURE AS  
DETAIL 1-1 DRAWING 0142-20

TIMBER FRAME AS  
DRAWING 0142-17.

RESIN ANCHOR AS  
DETAIL 2-2  
DRAWING 0142-20.

STRAP AS 20-20

VOID AS  
DETAIL 1-1  
DRAWING  
0142-20

INTRODUCE ANTI-HEAVE  
PROTECTION AS DETAIL 3-3  
DRAWING 0142-20 WHERE  
FOOTING DEPTH > 1.5m.

EXISTING FLOOR JOISTS TO  
BE RE-SUPPORTED OFF NEW  
CILL PLATE, REUSING EXISTING  
TENONS.

EXISTING PARTIALLY  
COLLAPSED MASONRY WALL  
DISMANTLED & REBUILT.  
INTRODUCE NEW BRICKWORK  
TO CREATE MIN WALL  
THICKNESS SHOWN.  
FLEMISH BOND.

MAX 200mm STEP IN  
GROUND LEVEL.

NEW MASS CONCRETE  
TRENCH FOOTING.

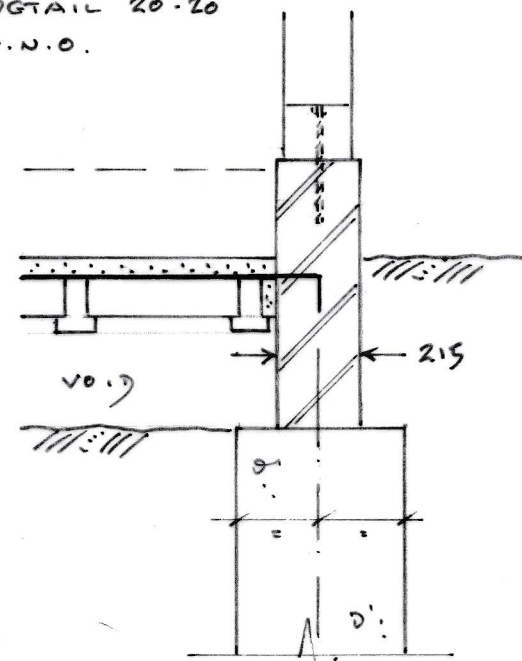
DETAIL 23-23

ALL NOTES AS  
DETAIL 20-20  
U.N.O.
