## **Planning Statement - Design & Access Statement**

REV4 - 10 07 2025

### **Park Centre, 60 Park Rd, Burgess Hill RH15 8ET**

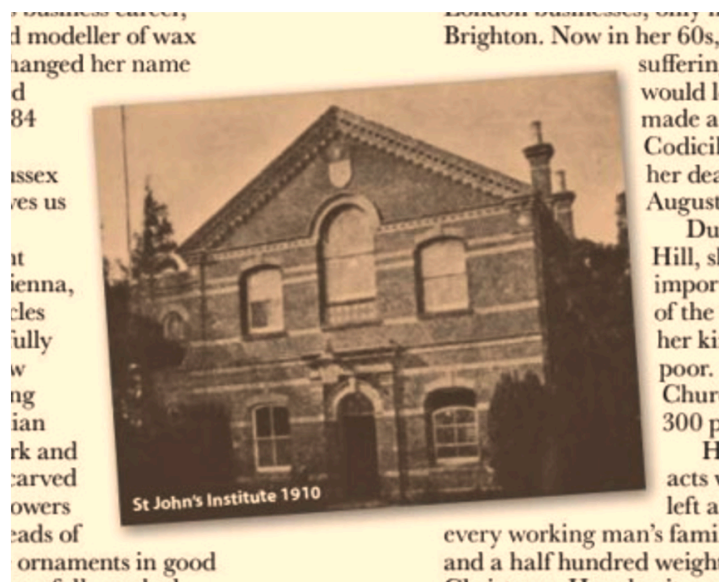
Image of Park Centre from 1910 from article *Emily Temple: Burgess Hill Benefactress*.

The existing front elevations is at the moment a mix with rendered area for the pediment and painted brickwork underneath. We were hoping to be able to bring back the existing brick aspect of the front elevation as shown in a picture from 1910 attached above, however this is not possible, as per explanation below:

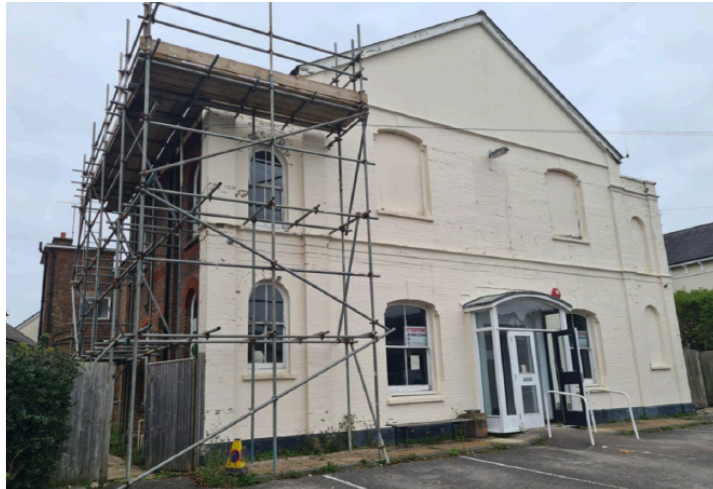
Image showing the current appearance of Park Centre

The front elevation has undergone several modifications throughout the 20th century. The original portico was demolished and replaced with a painted timber and glass porch featuring a felt roof. Two first-floor windows on the front elevation have been boarded up with plywood as well as many of the windows on the side elevations. The entire front elevation has been painted white, and wall-mounted lighting has been installed above the front door. The front pediment has been filled with what appears to be render. The right side of the front elevation was extended to mirror the left side of the elevation and a lift was installed behind which is now out-of-use. An original large central window on the front elevation above the main entrance has been lost.

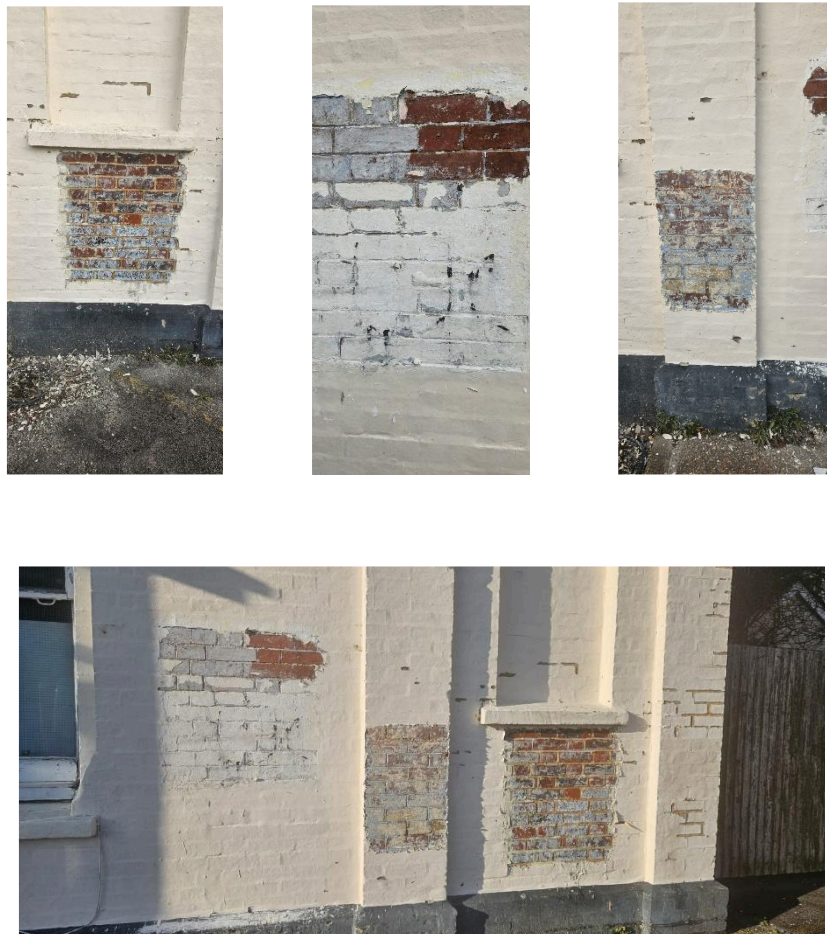
Concerning the overall condition of the original elevation, we are particularly concerned about the state of the gable end. As shown in the attached picture, this area was rendered some years ago, and attempting to reveal the brick here will likely cause significant damage to the underlying structure. It is possible that the gable end may need to be rebuilt entirely.

Additionally, upon revealing the existing brickwork, we observed that a different type of brick was used for the front extension (on the right side when facing the building). The mortar used here is also a different thickness and in cement compared to the original building, which is thinner and in lime. This contrast in materials may create an awkward visual disparity if this section is left as part of the same elevation.

We also noted that the original blue band brick on the existing elevation has lost much of its colour and contrast, which now stands out in relation to the surrounding brickwork.”

We complemented this investigation with the pictures below to illustrate the above.

Therefore, we are opting for a natural lime render finish to the front elevation, with ashlar lines to match next door. This will give a uniform and qualitative finish to the building, using natural materials.
