# BS 5837:2012 Tree Survey, Arboricultural Impact Assessment, Arboricultural Method Statement and Tree Protection Plan

The Birches  
Hophurst Lane  
Crawley Down  
RH10 4LJ

Date: 11/09/2026

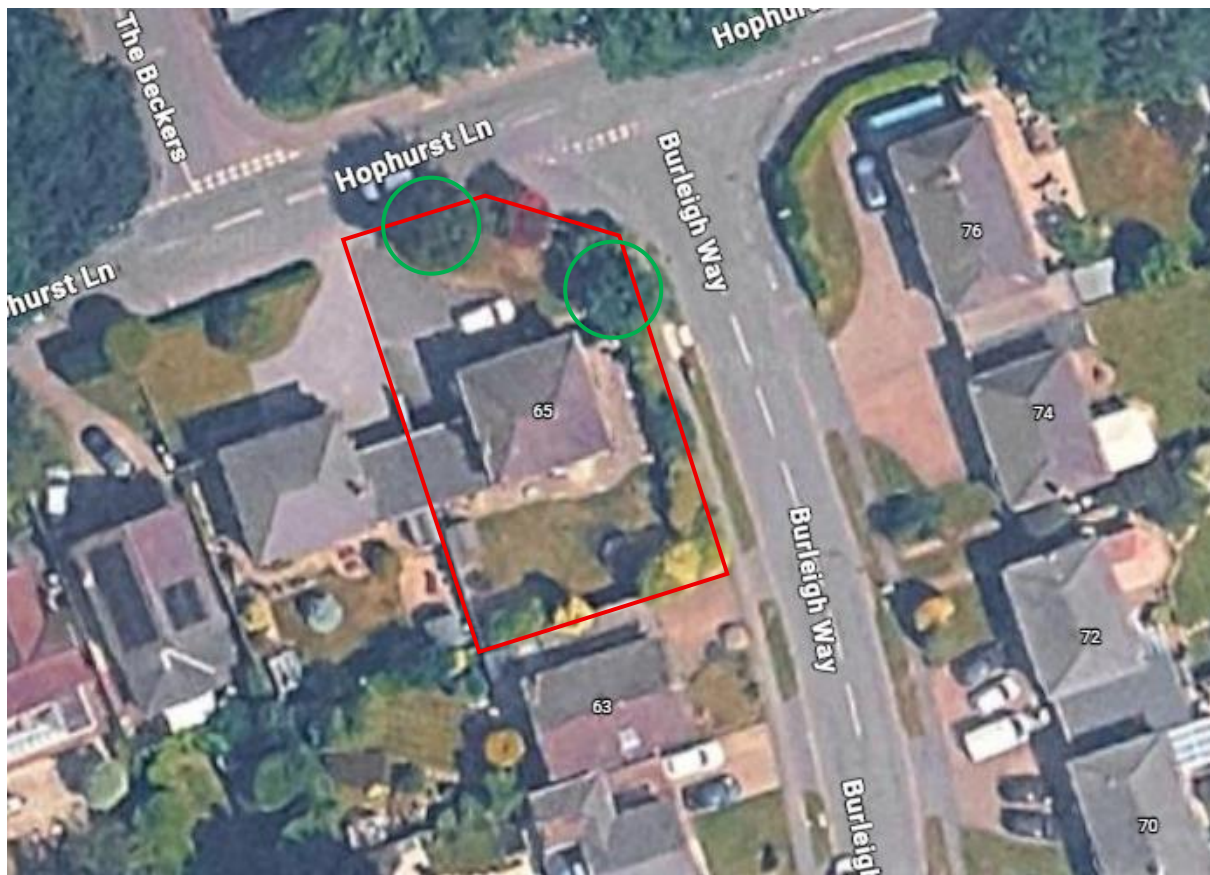
Image above, courtesy of Google Maps with the application site outlined in red and subject trees in green.

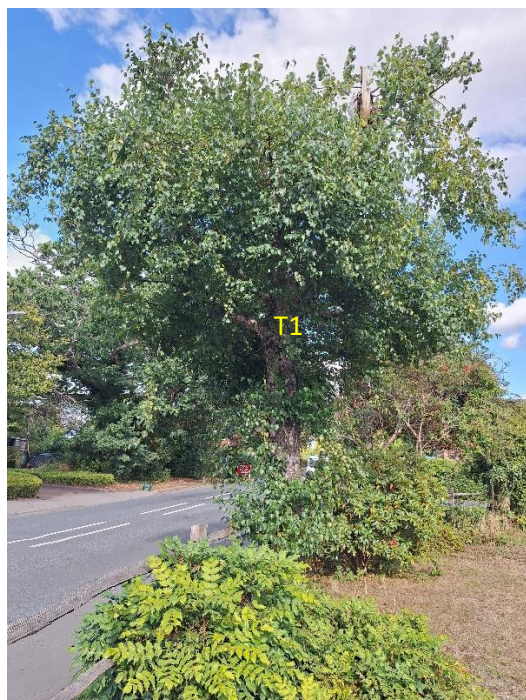
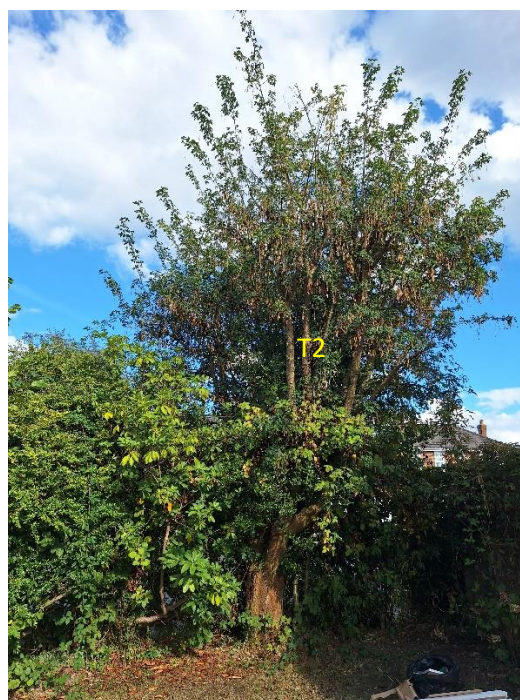
Photos above of T1 category C birch and T2 category C laburnum. Both trees will be adequately protected throughout all stages of development.

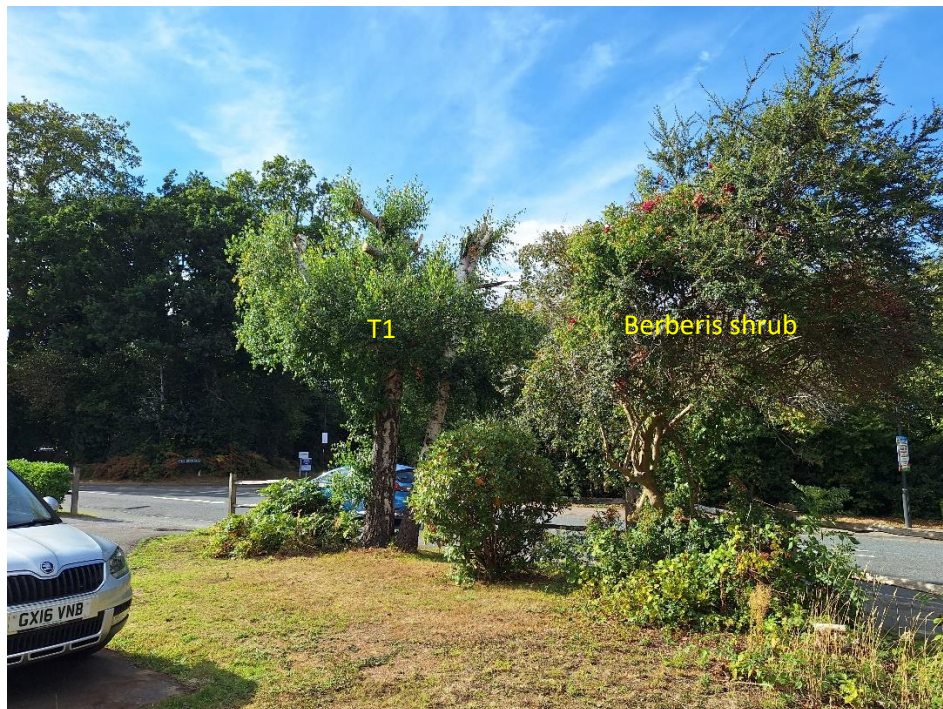
**T1** Silver birch is located within an a lawned area on the site frontage. The root protection area (RPA) has been modified to take the adjacent highway into account.

Photo above of T1 Silver birch. The closer shrub is a berberis and not considered a tree for the purpose of this report.

**T1** will be adequately protected with tree protective fencing and ground protection boards throughout all stages of development.

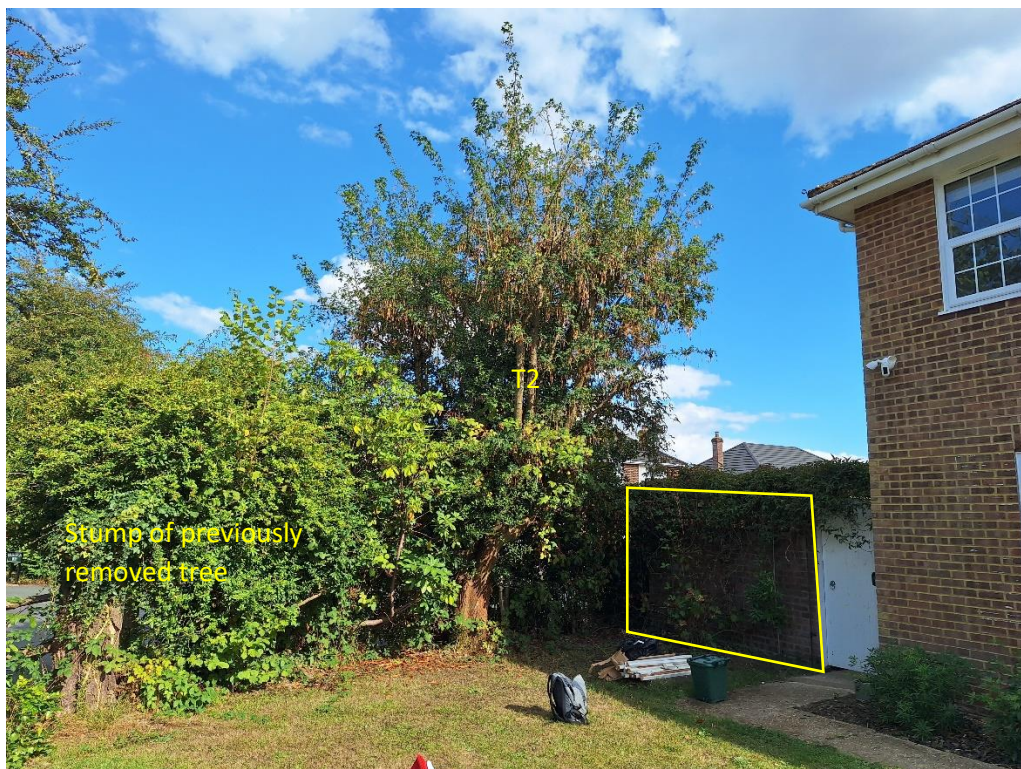
**T2** Common laburnum grows on the site's east boundary in proximity to an existing garden wall.

The RPA of **T2** has been modified taking the adjacent highway, garden wall and house into consideration.

The extension will extend to the property frontage encroaching on a small percentage of the modified RPA of **T2**.

The RPA encroachment amounts to an area of 3m<sup>2</sup>, or 2.5% of the tree's total RPA.

Photo above of T2 Common laburnum. The garden wall to be demolished is outlined in yellow.

Encroachment will involve the excavation of ground for the installation of new foundations.

Initial excavation will be carried out by hand and under arboricultural supervision. Any exposed roots will be carefully cut back to the excavation edge.

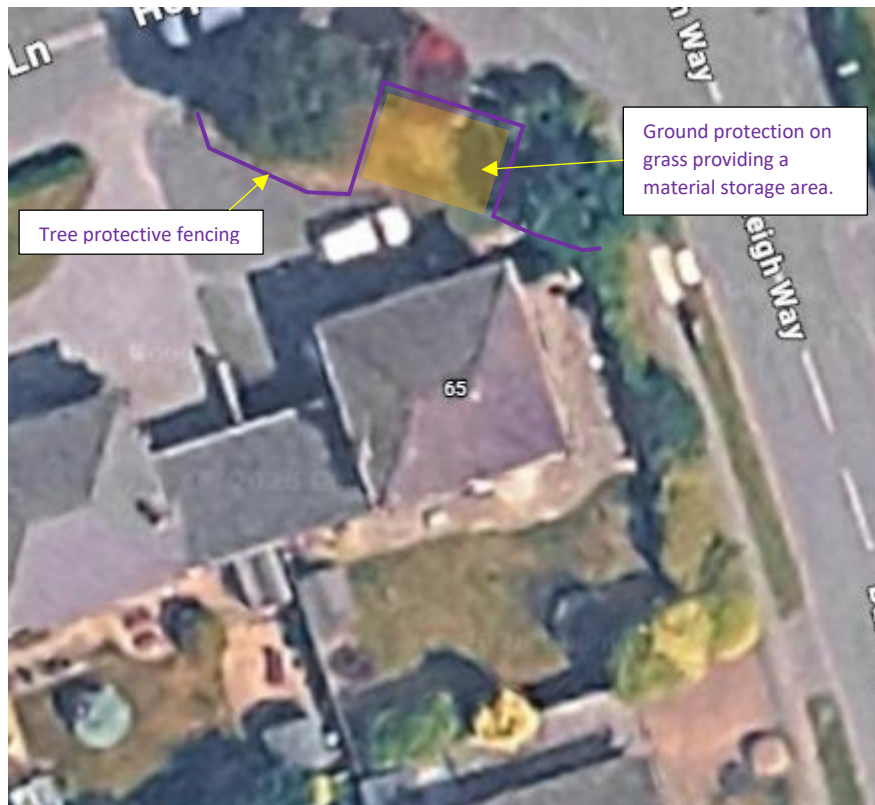
The Google image above shows the application site with the location of tree protective fencing and ground protection added. An accurate tree protection layout can be found at appendix D of this report.

Both **T1** and **T2** will be adequately protected with tree protective fencing and plywood ground protection boards throughout all stages of development.

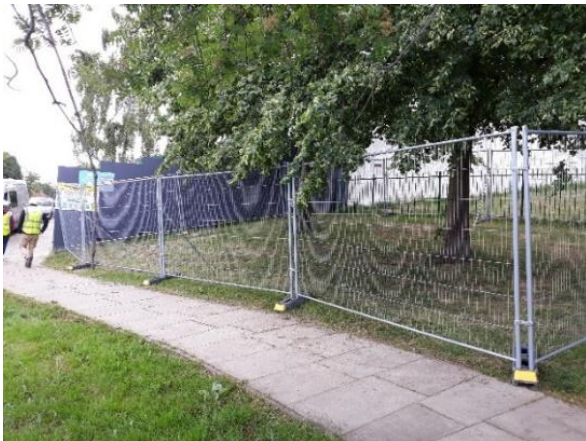
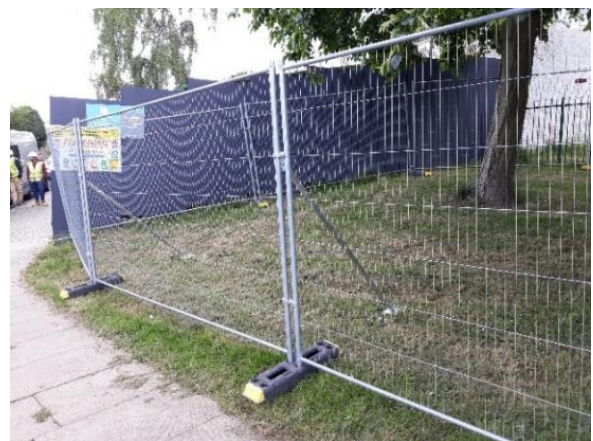
Images above show protective fencing installed as per BS5837:Fig 3A with rubber blocks and stabilizer struts driven into the ground.

- Erect protective barrier fencing in locations shown on the tree protection plan at **appendix D**. A protective fencing diagram can be found at **appendix E**. Barriers will consist of a heras type panel inserted into rubber blocks and reinforced with a stabiliser strut. Two clamps either end of each section will ensure the area within the fence (CEZ) remains out of bounds during all construction activities.
