# Grove Farm

Heritage Setting Assessment  
June 2026

Grove Farm House  
Grade II English Heritage reference  
1245461  
Written by Nicolas Pople Architect  
Graduate Diploma in Building  
Conservation AA

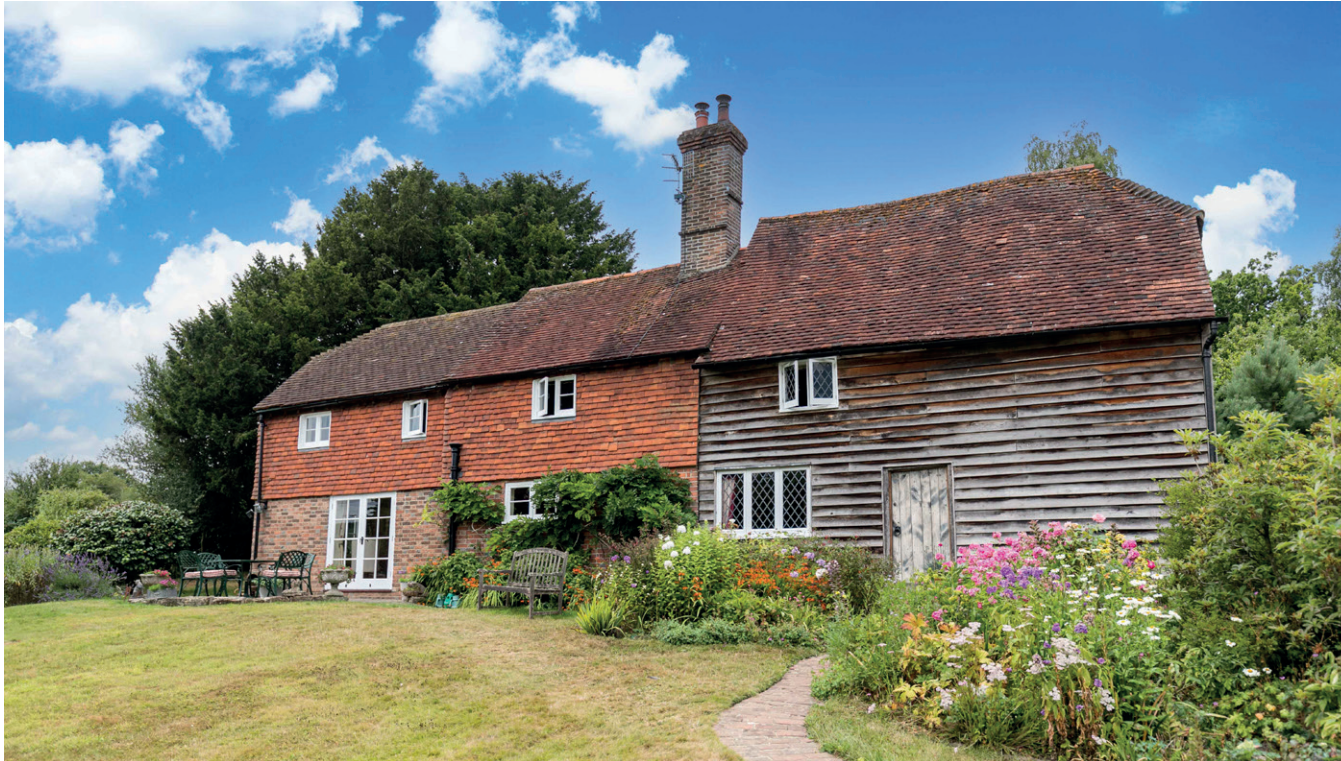
1.View of Grove Farm House

A two storey house, formerly farmhouse, C16 or earlier. Two bay building extended by one bay to the east C18. Timber framed, mainly clad in weather boarding on sandstone plinth but east bay has red brick ground floor in flemish bond with some grey headers and tiled first floor. Half hipped tiled roof with one off centre brick chimney stack.

Inspection of the building suggests inaccuracies in the Historic England listing : the additional later bay is actually to the south and appears to have been substantially rebuilt with in the recent past using cement mortar.

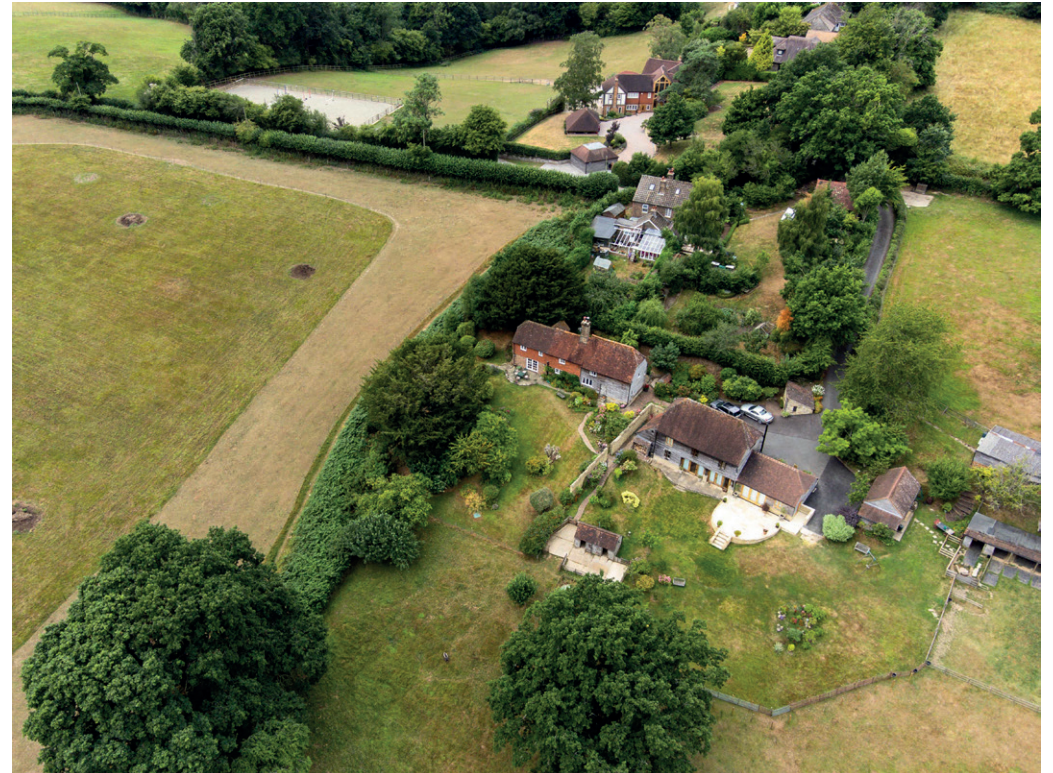
2. Drone view of Grove farm looking west (prior to repair work and enactment of DM/221393)

The site is a relatively steep East facing slope. The cluster of buildings, including the listed Farmhouse and its curtilage listed barn, are partially visible from the footpath off Cansiron Lane. There are distant views of the buildings from the eastern extreme of Cansiron Lane to the south before it also becomes a track along the ridge. From this vantage point, the buildings can be seen to be in a valley at the bottom of which is a fairly dense wood. There is ribbon development along Cansiron Lane all the way from Ashurst Wood to the S bends by the access to Grove Farm and Grove Farm House. At this location neither is visible nor any of the outbuildings and there is a transition between the village and the more open rural landscape.

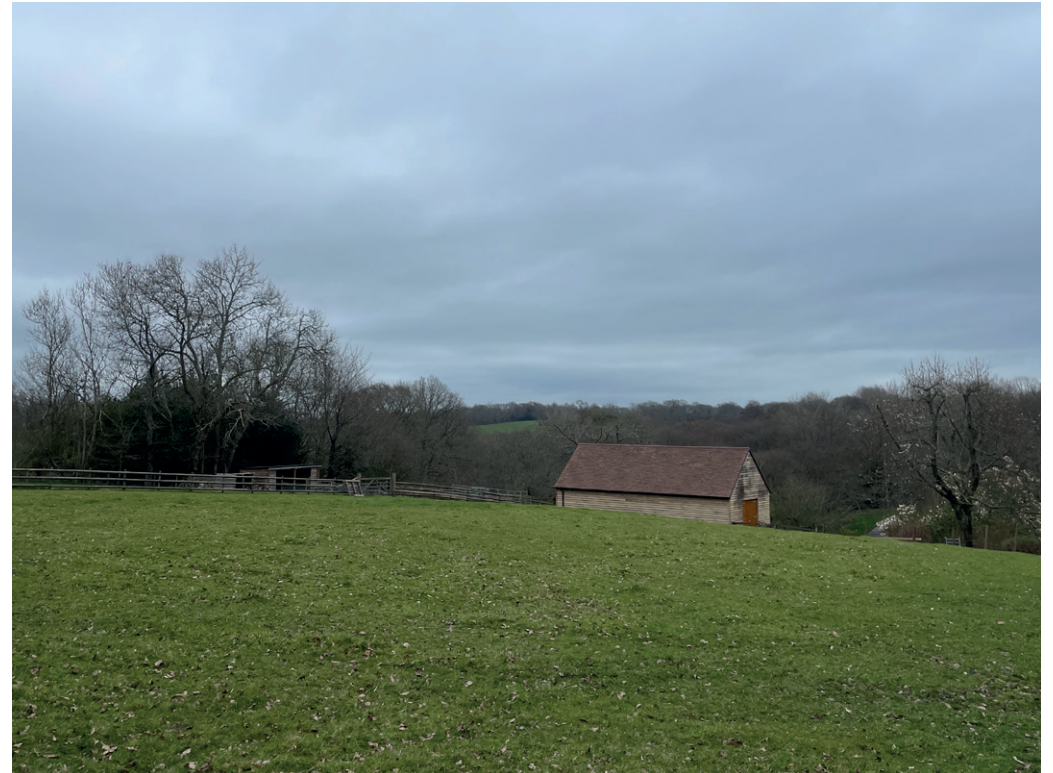
3. View of existing outbuilding

The building that is the subject of this application first appears on available historic maps in the 1960's but inspection suggests it may be older. It is of timber construction on a brick plinth, the oak feather edge weatherboarded walls and pitched clay tile roof relate to the historic buildings on site, in particular Grove Farm House. Seen either close up or at a distance there is a consistent palette of materials in the cluster furthermore its siting is relatively sensitive being oriented along the contours of the hill.

The proposal for works to the application building does not change the figure ground – the footprint of the existing and the proposal are identical with the basic structure retained on the brick plinth. The only significant change is the replacement clay tile roof, as conditioned by MSDC conservation officer Emile Wade in 2022. The new roof pitch of 35 degrees will result in a modest increase in ridge height. The west facing elevation will only be altered with the introduction of an indented entrance door screened by a new mixed hedge against the existing fence line. As an annex it is no longer necessary to enact the existing consent to build a separate drive or turning space. The existing provision, with two spaces at the top of the drive, is adequate and reduces the environmental impact of the work considerably.

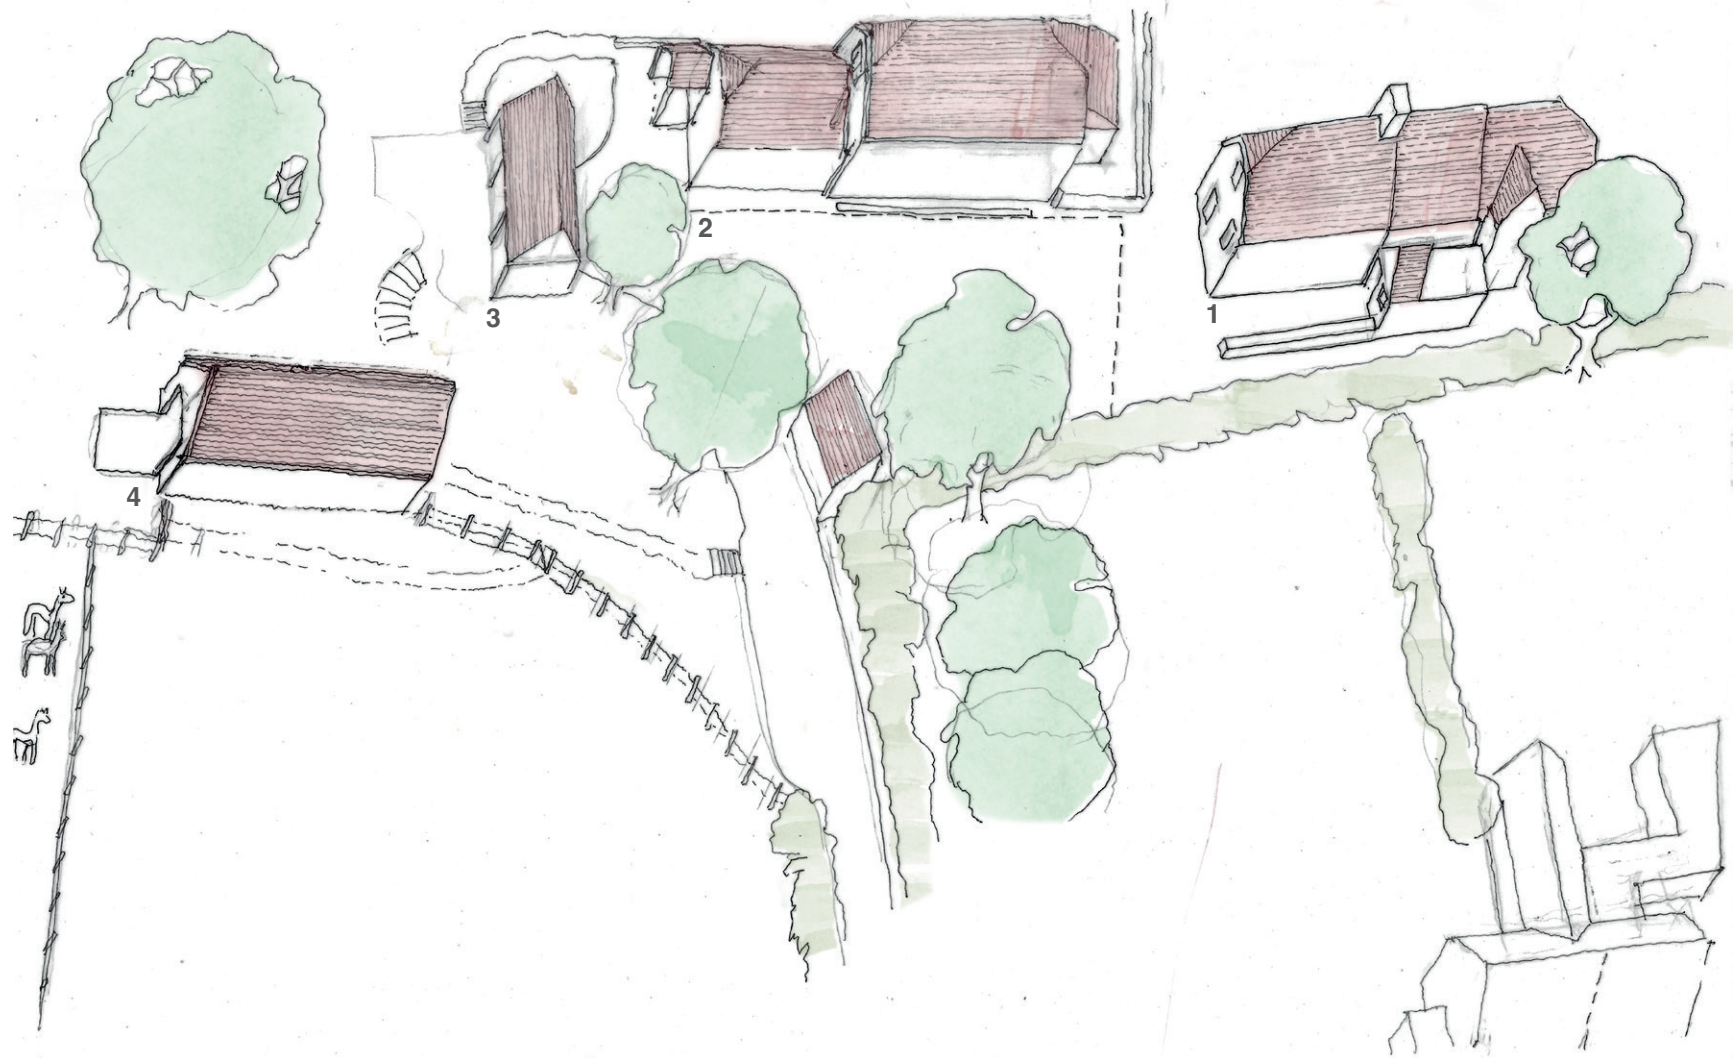
**Existing 3D view**

- 1 Grove Farm House
- 2 Grove Farm
- 3 Stable / Feed Room
- 4 Outbuilding

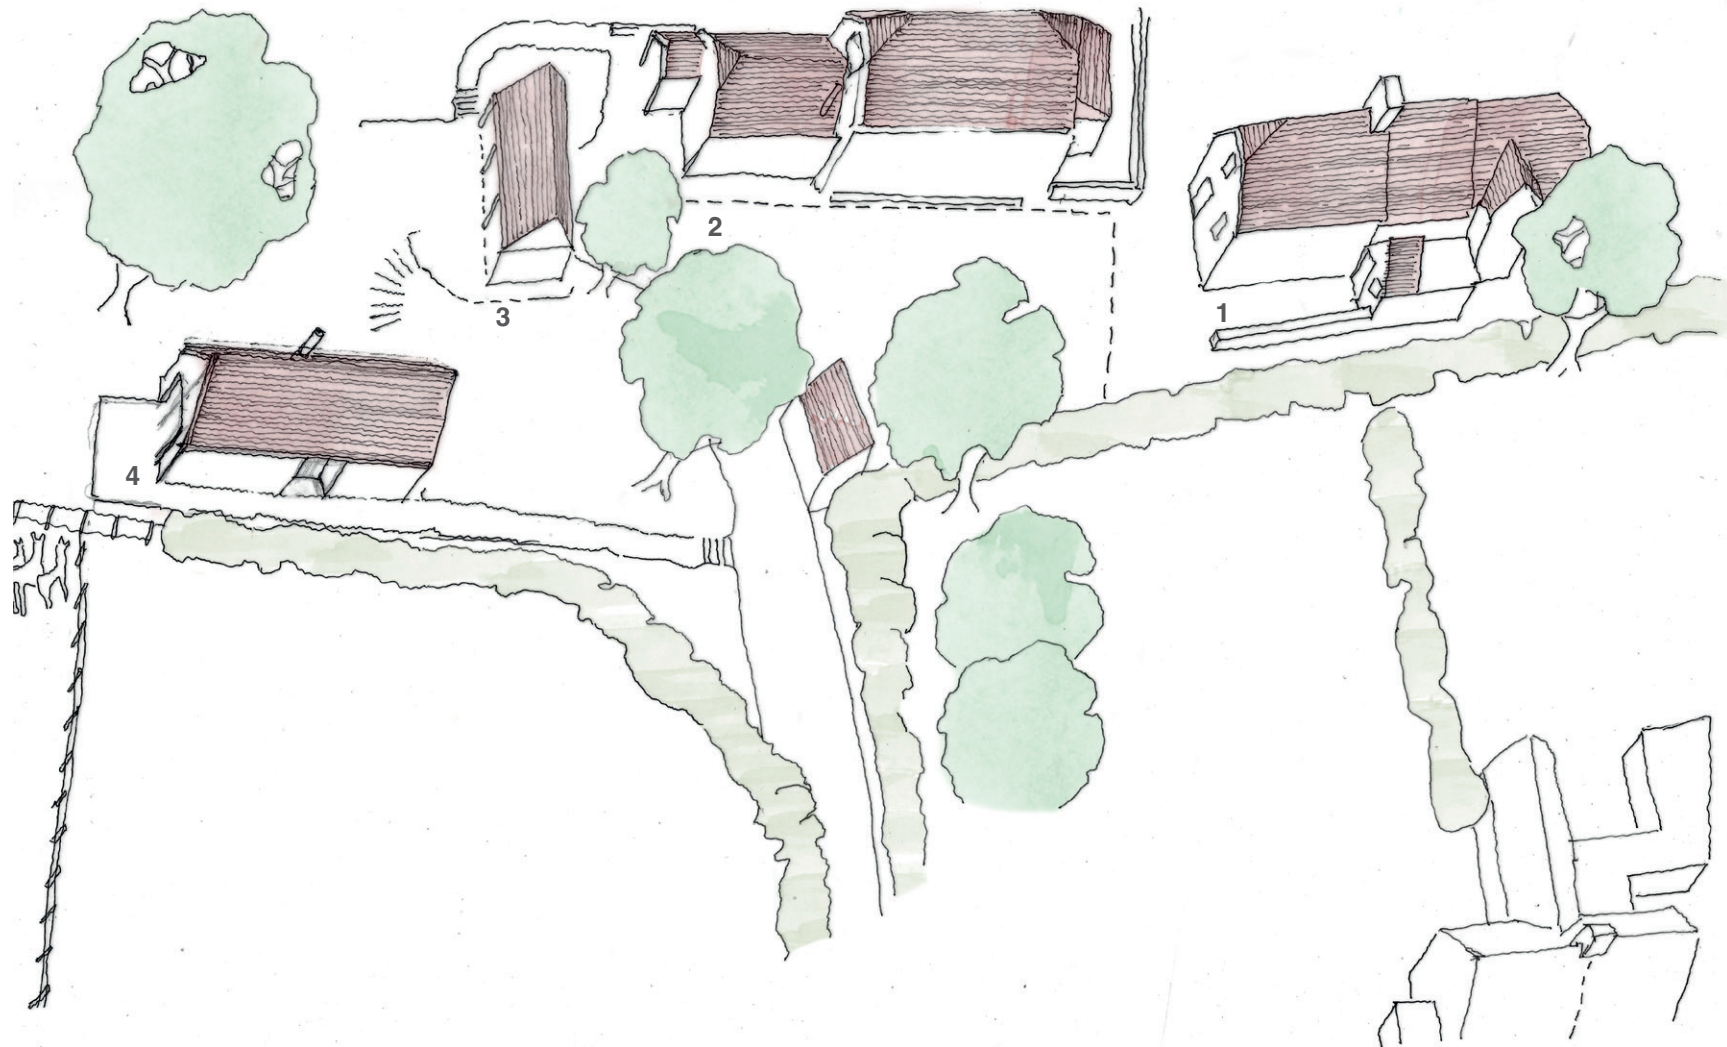
**Proposed 3D view**

1 Grove Farm House

2 Grove Farm

3 Stable / Feed Room

4 Proposed Annex

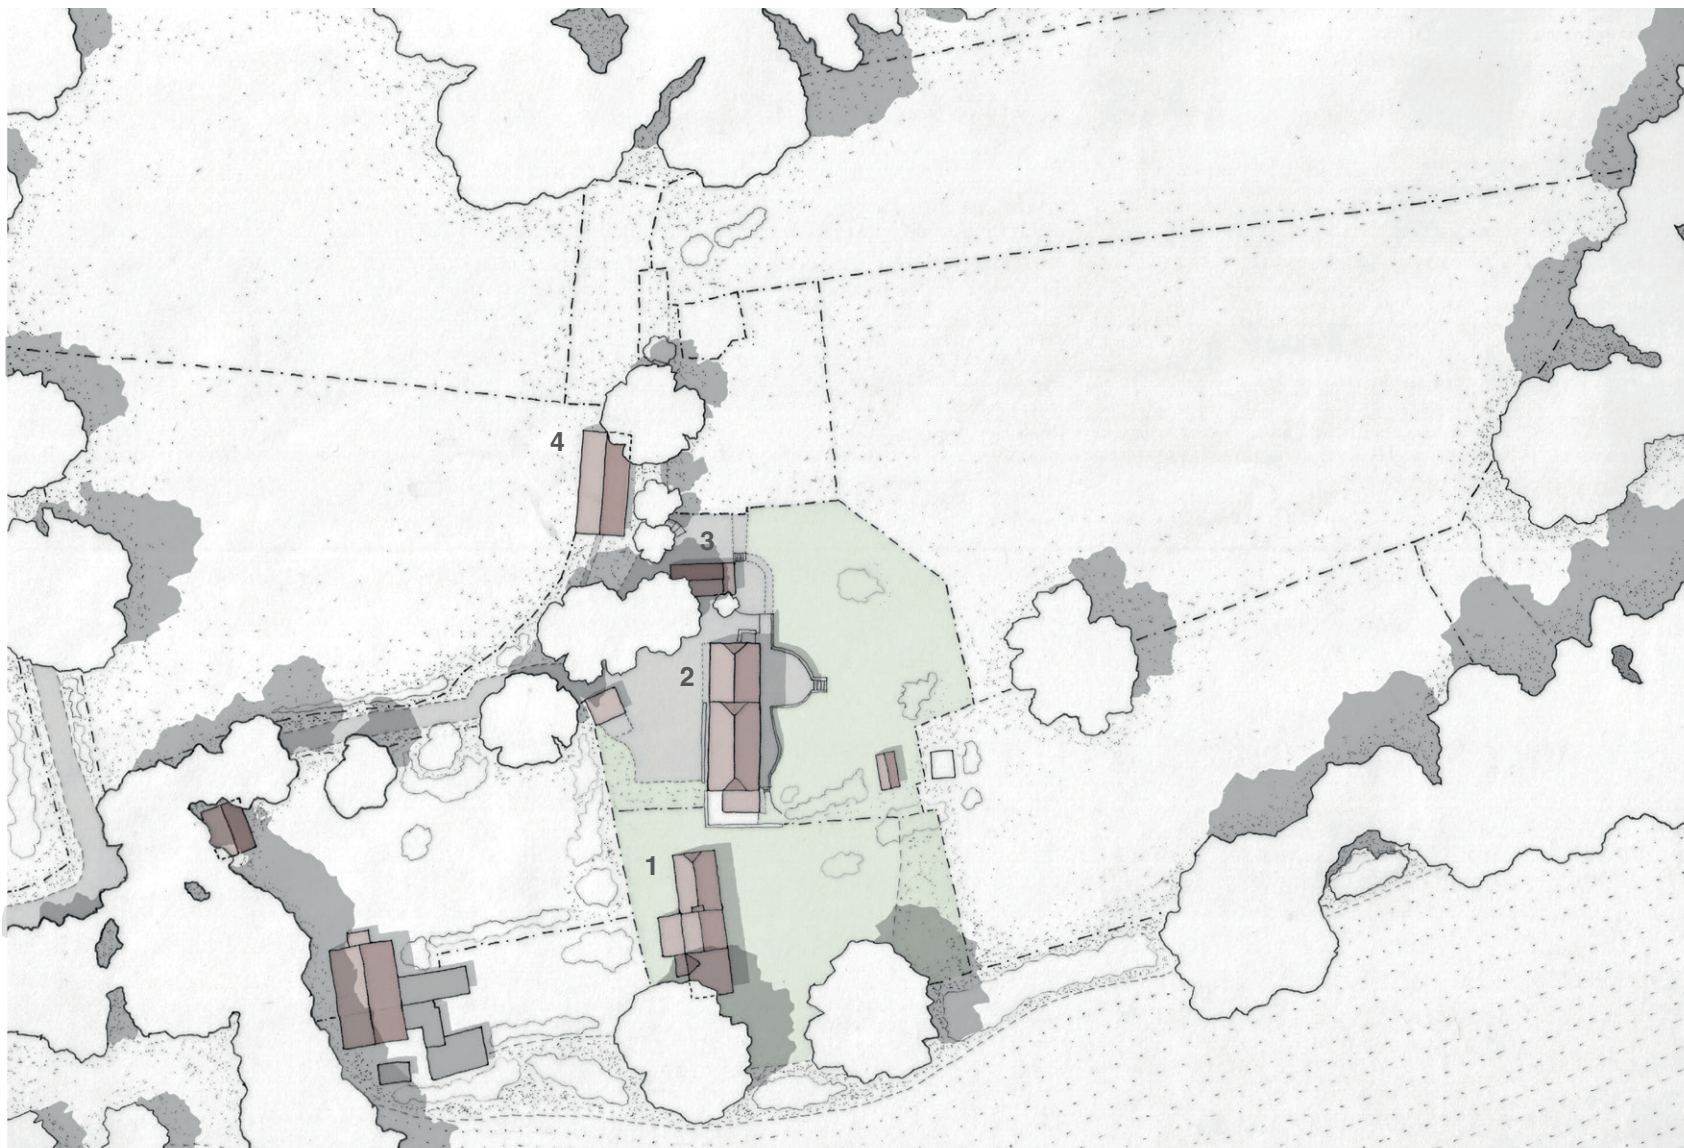
### Existing Site Plan

- 1 Grove Farm House
- 2 Grove Farm
- 3 Stable / Feed Room
- 4 Outbuilding

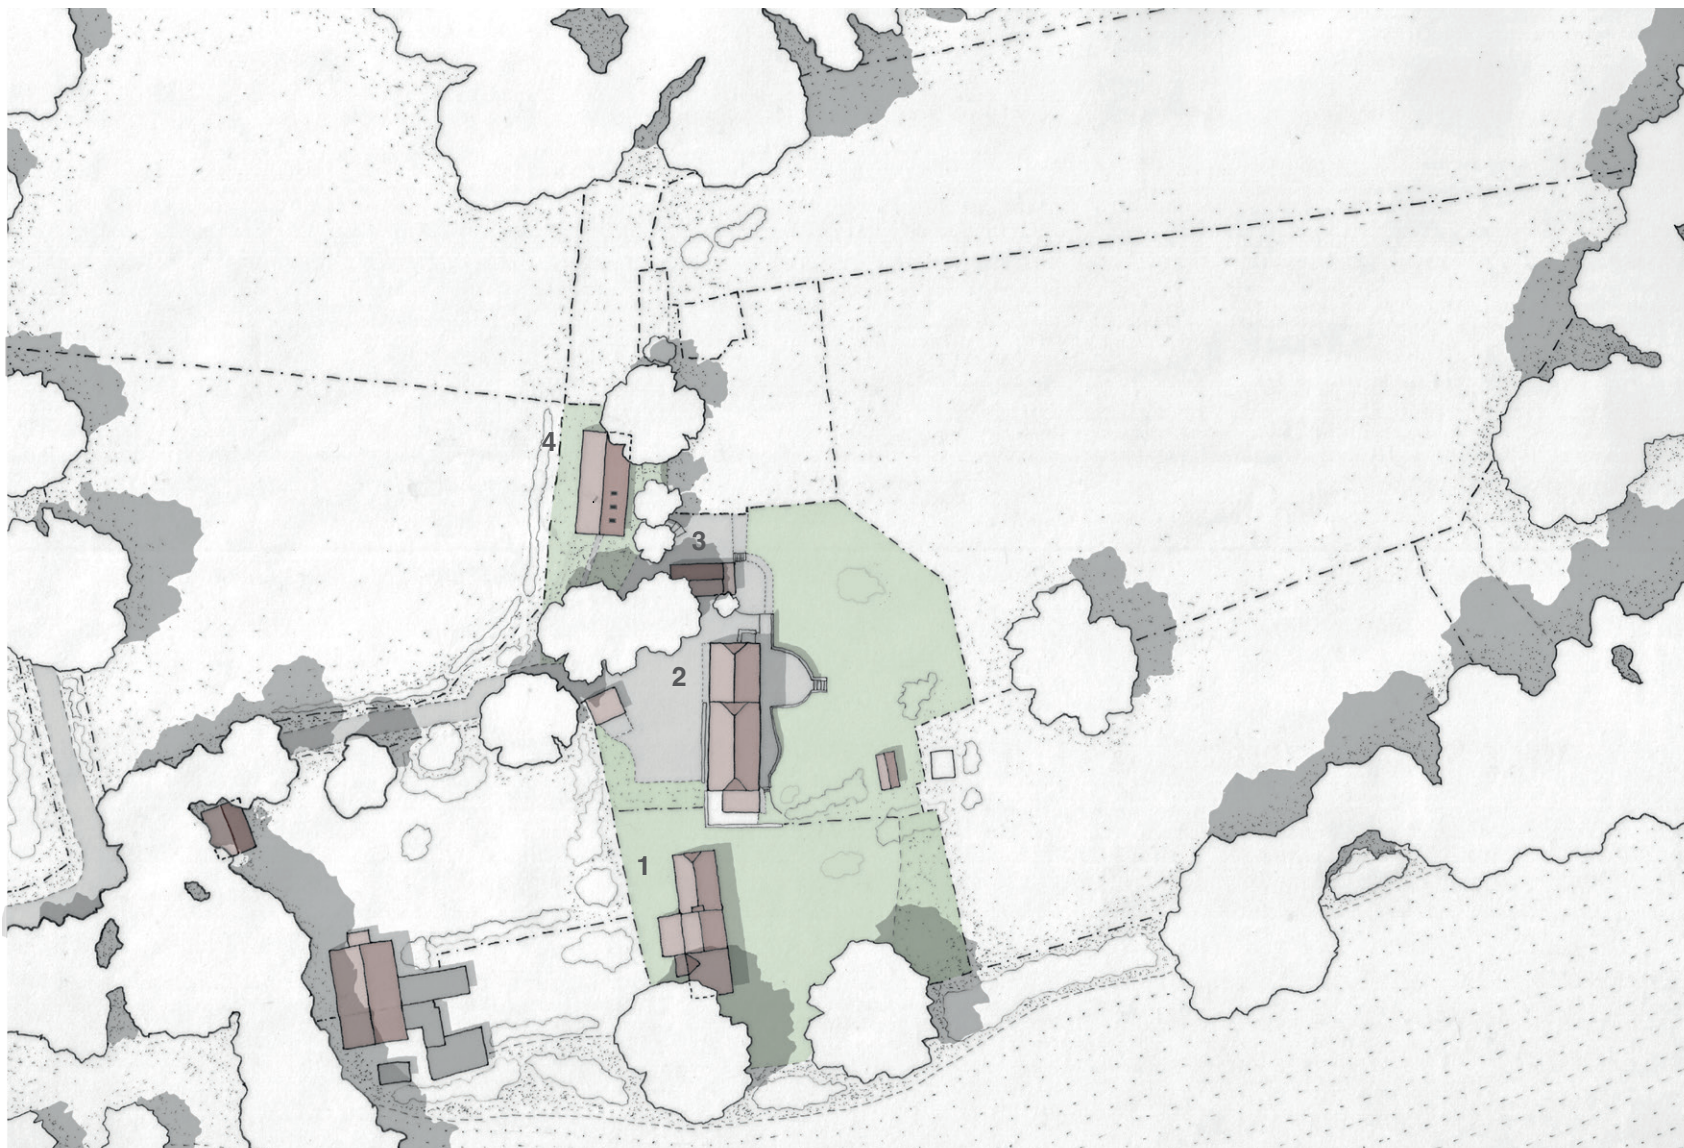
### Proposed Site Plan

- 1 Grove Farm House
- 2 Grove Farm
- 3 Stable / Feed Room
- 4 Proposed Annex
