## Drainage:

Looking at the updated drainage information required by MSDC in May 2026 reflected in the 3<sup>rd</sup> (I think) application.

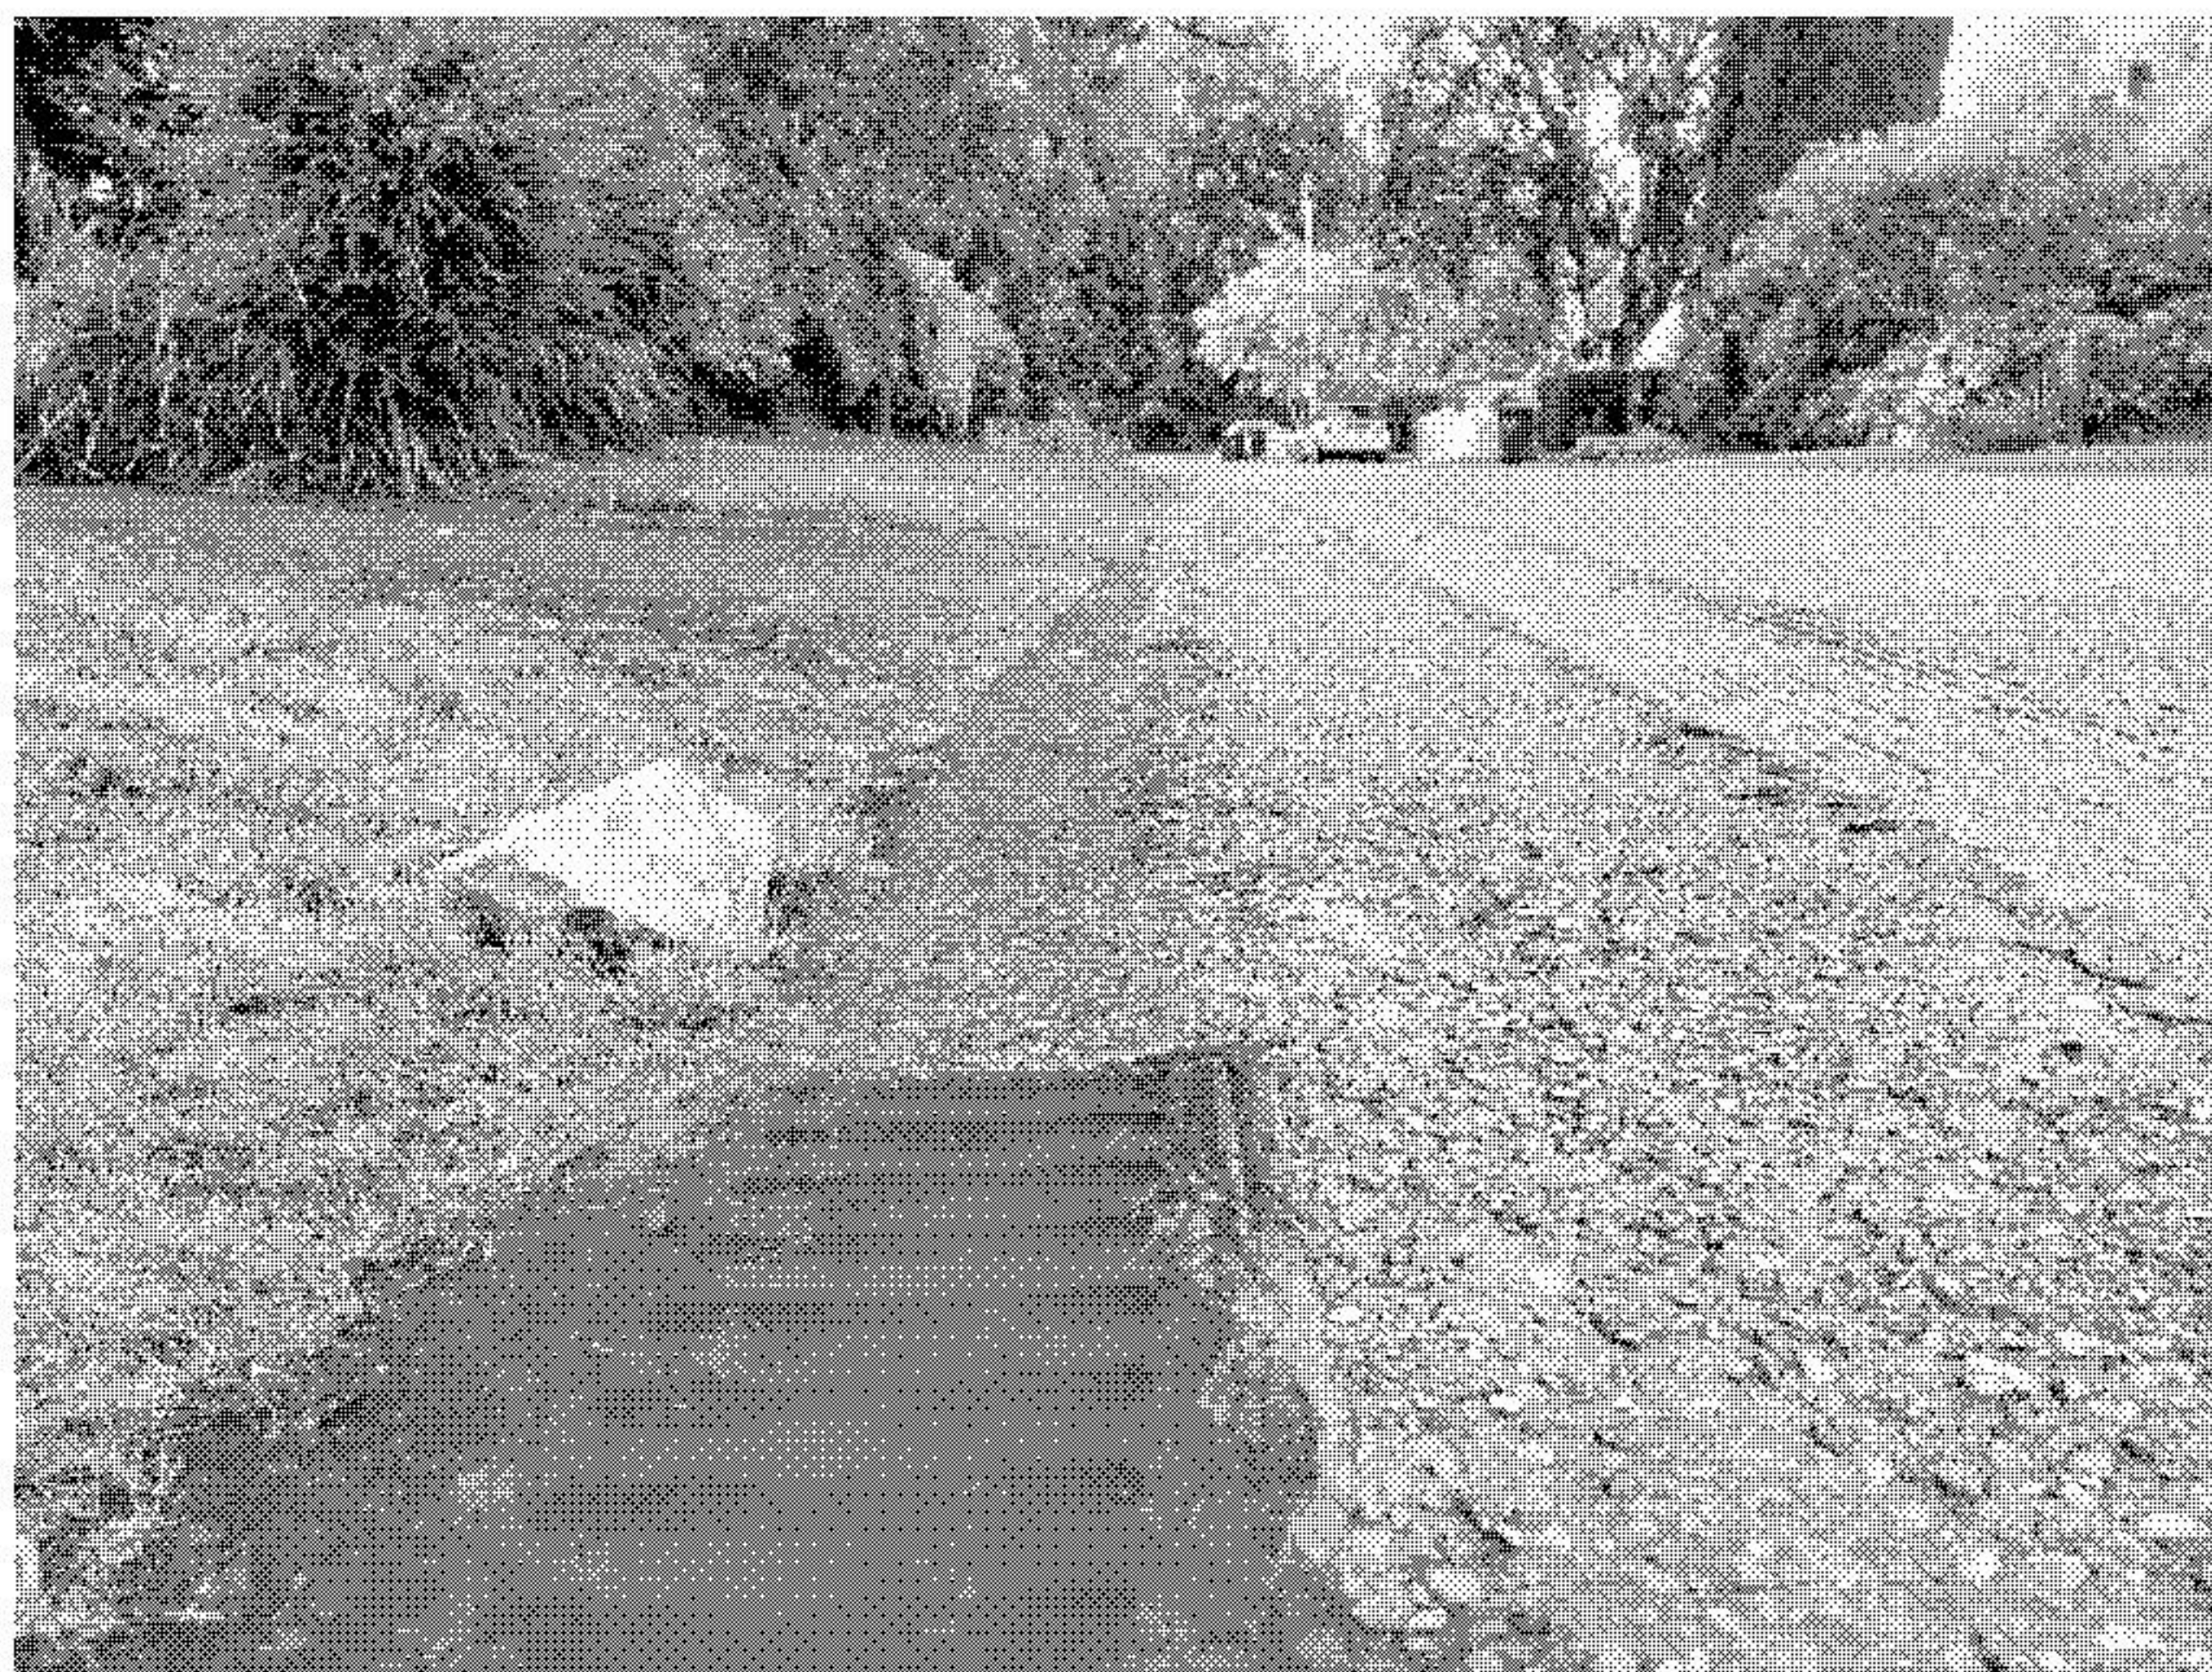
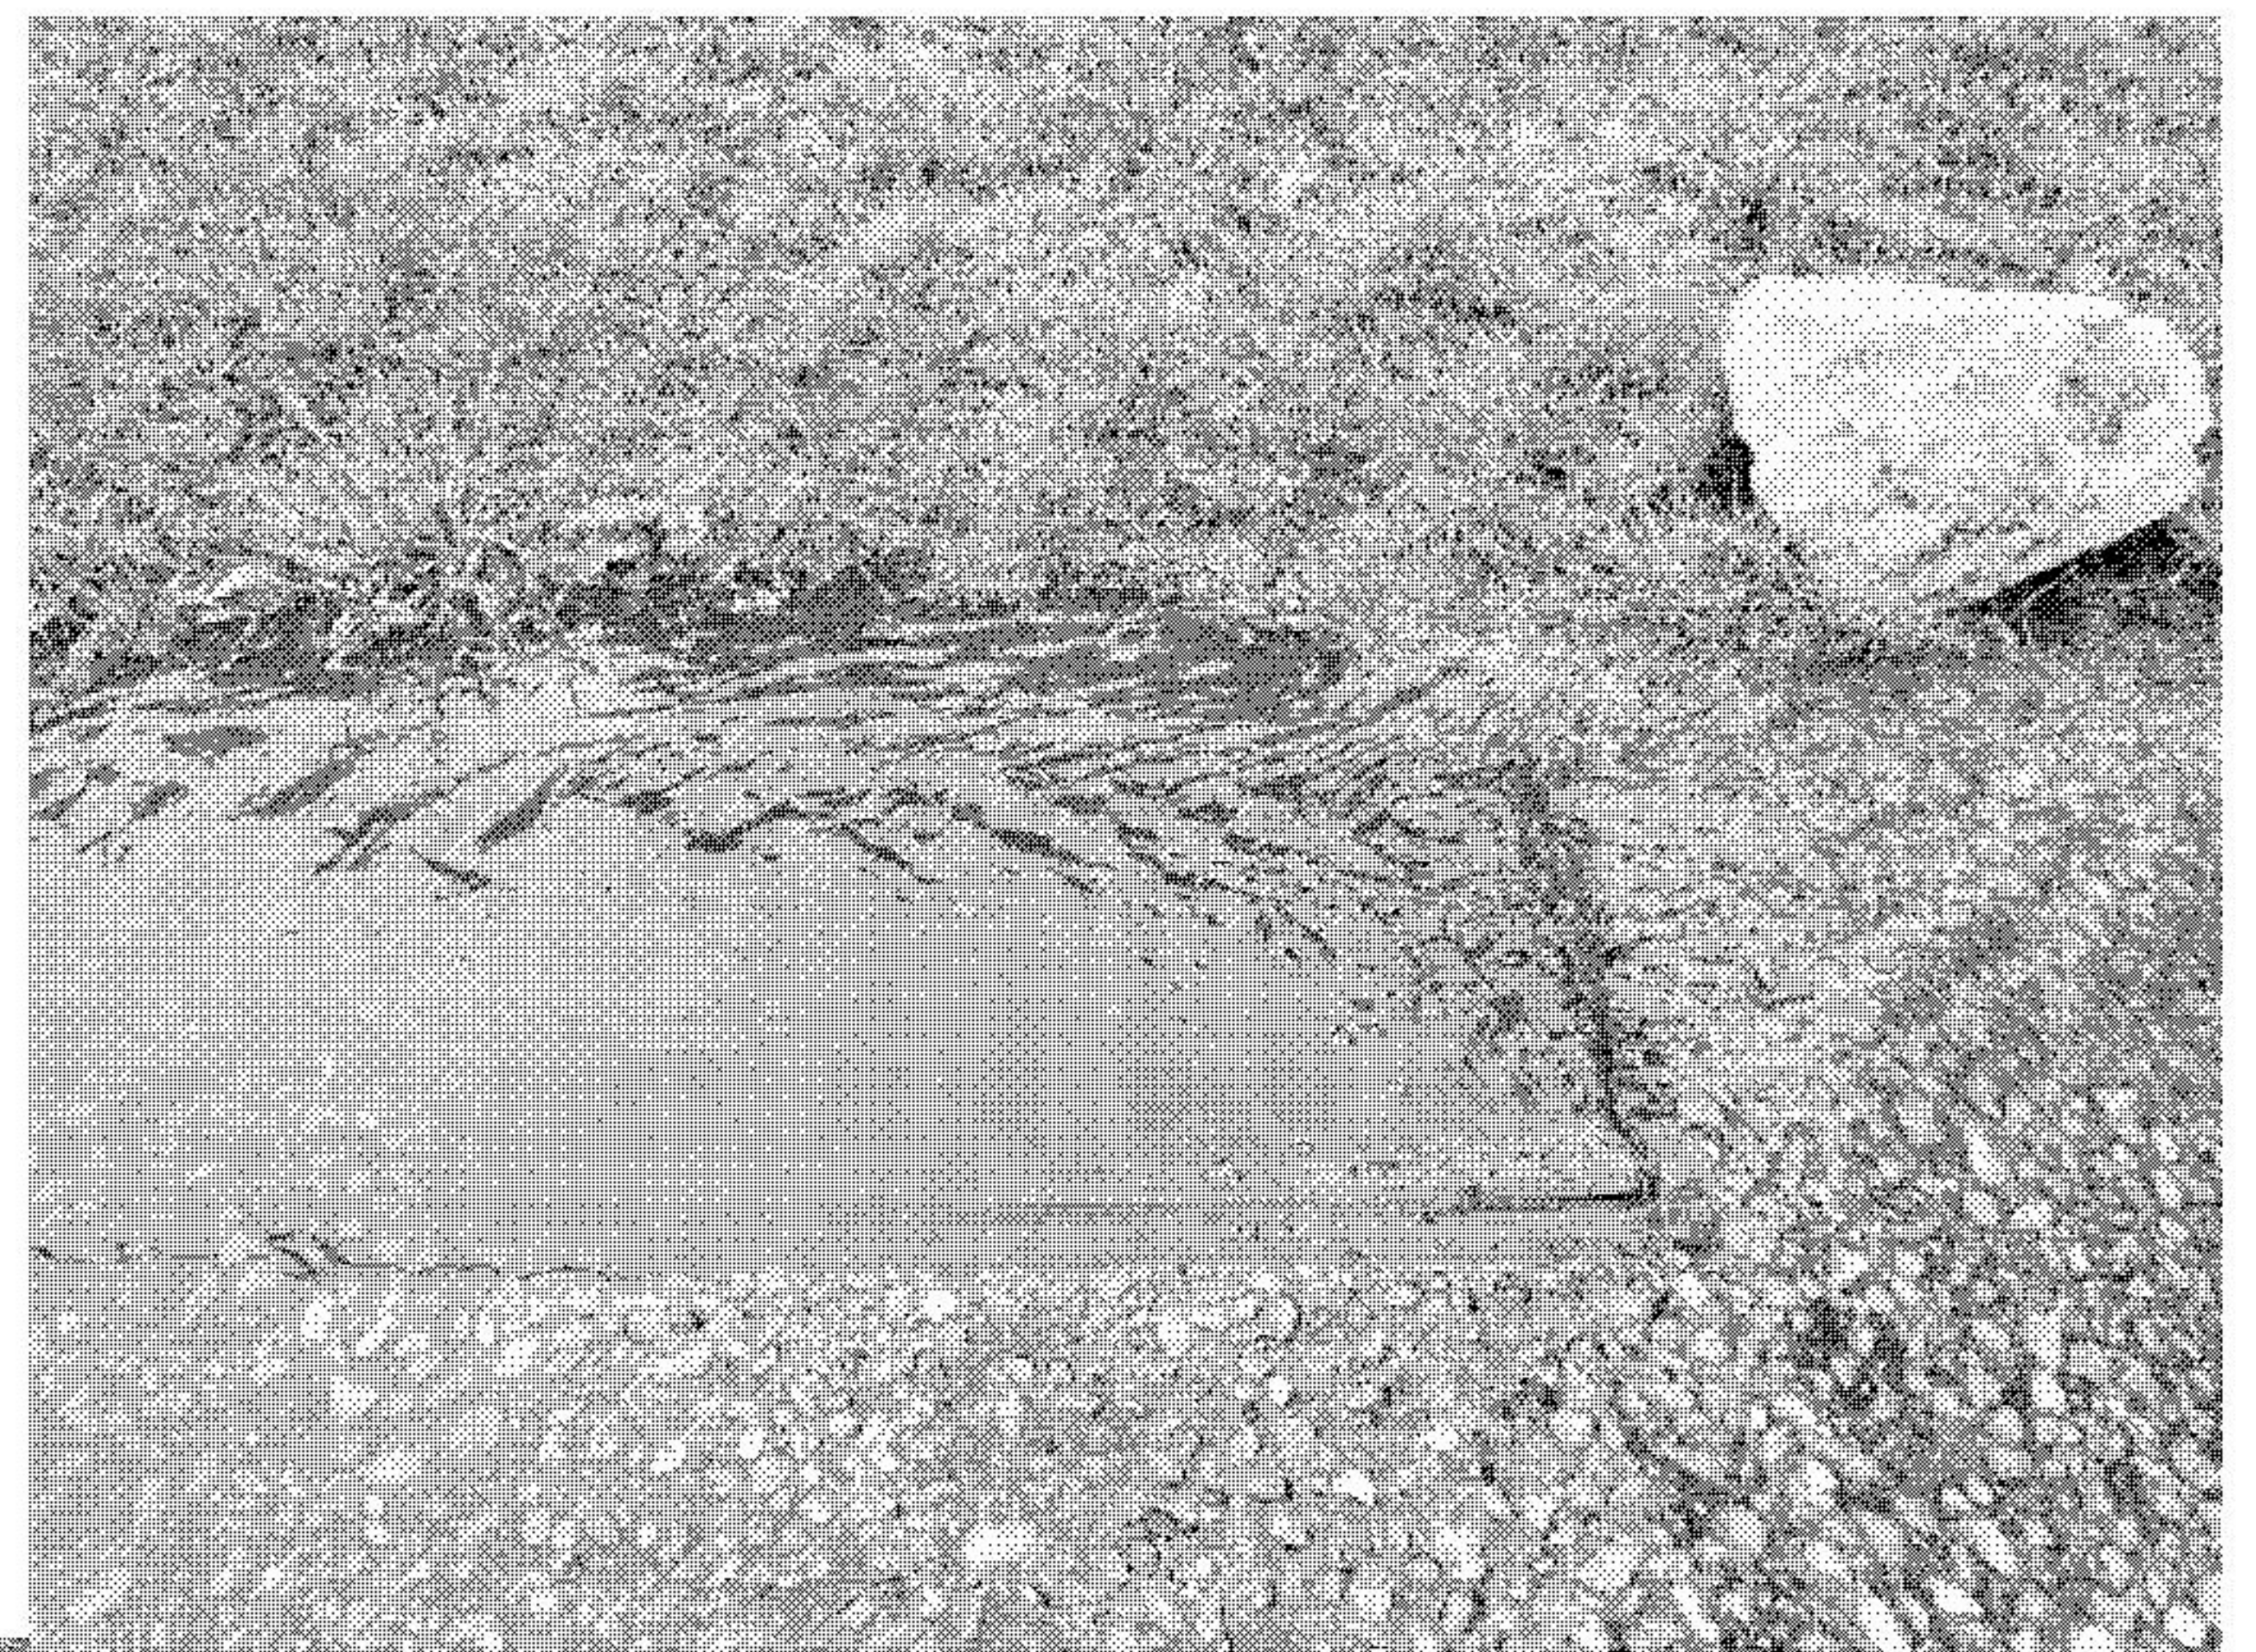
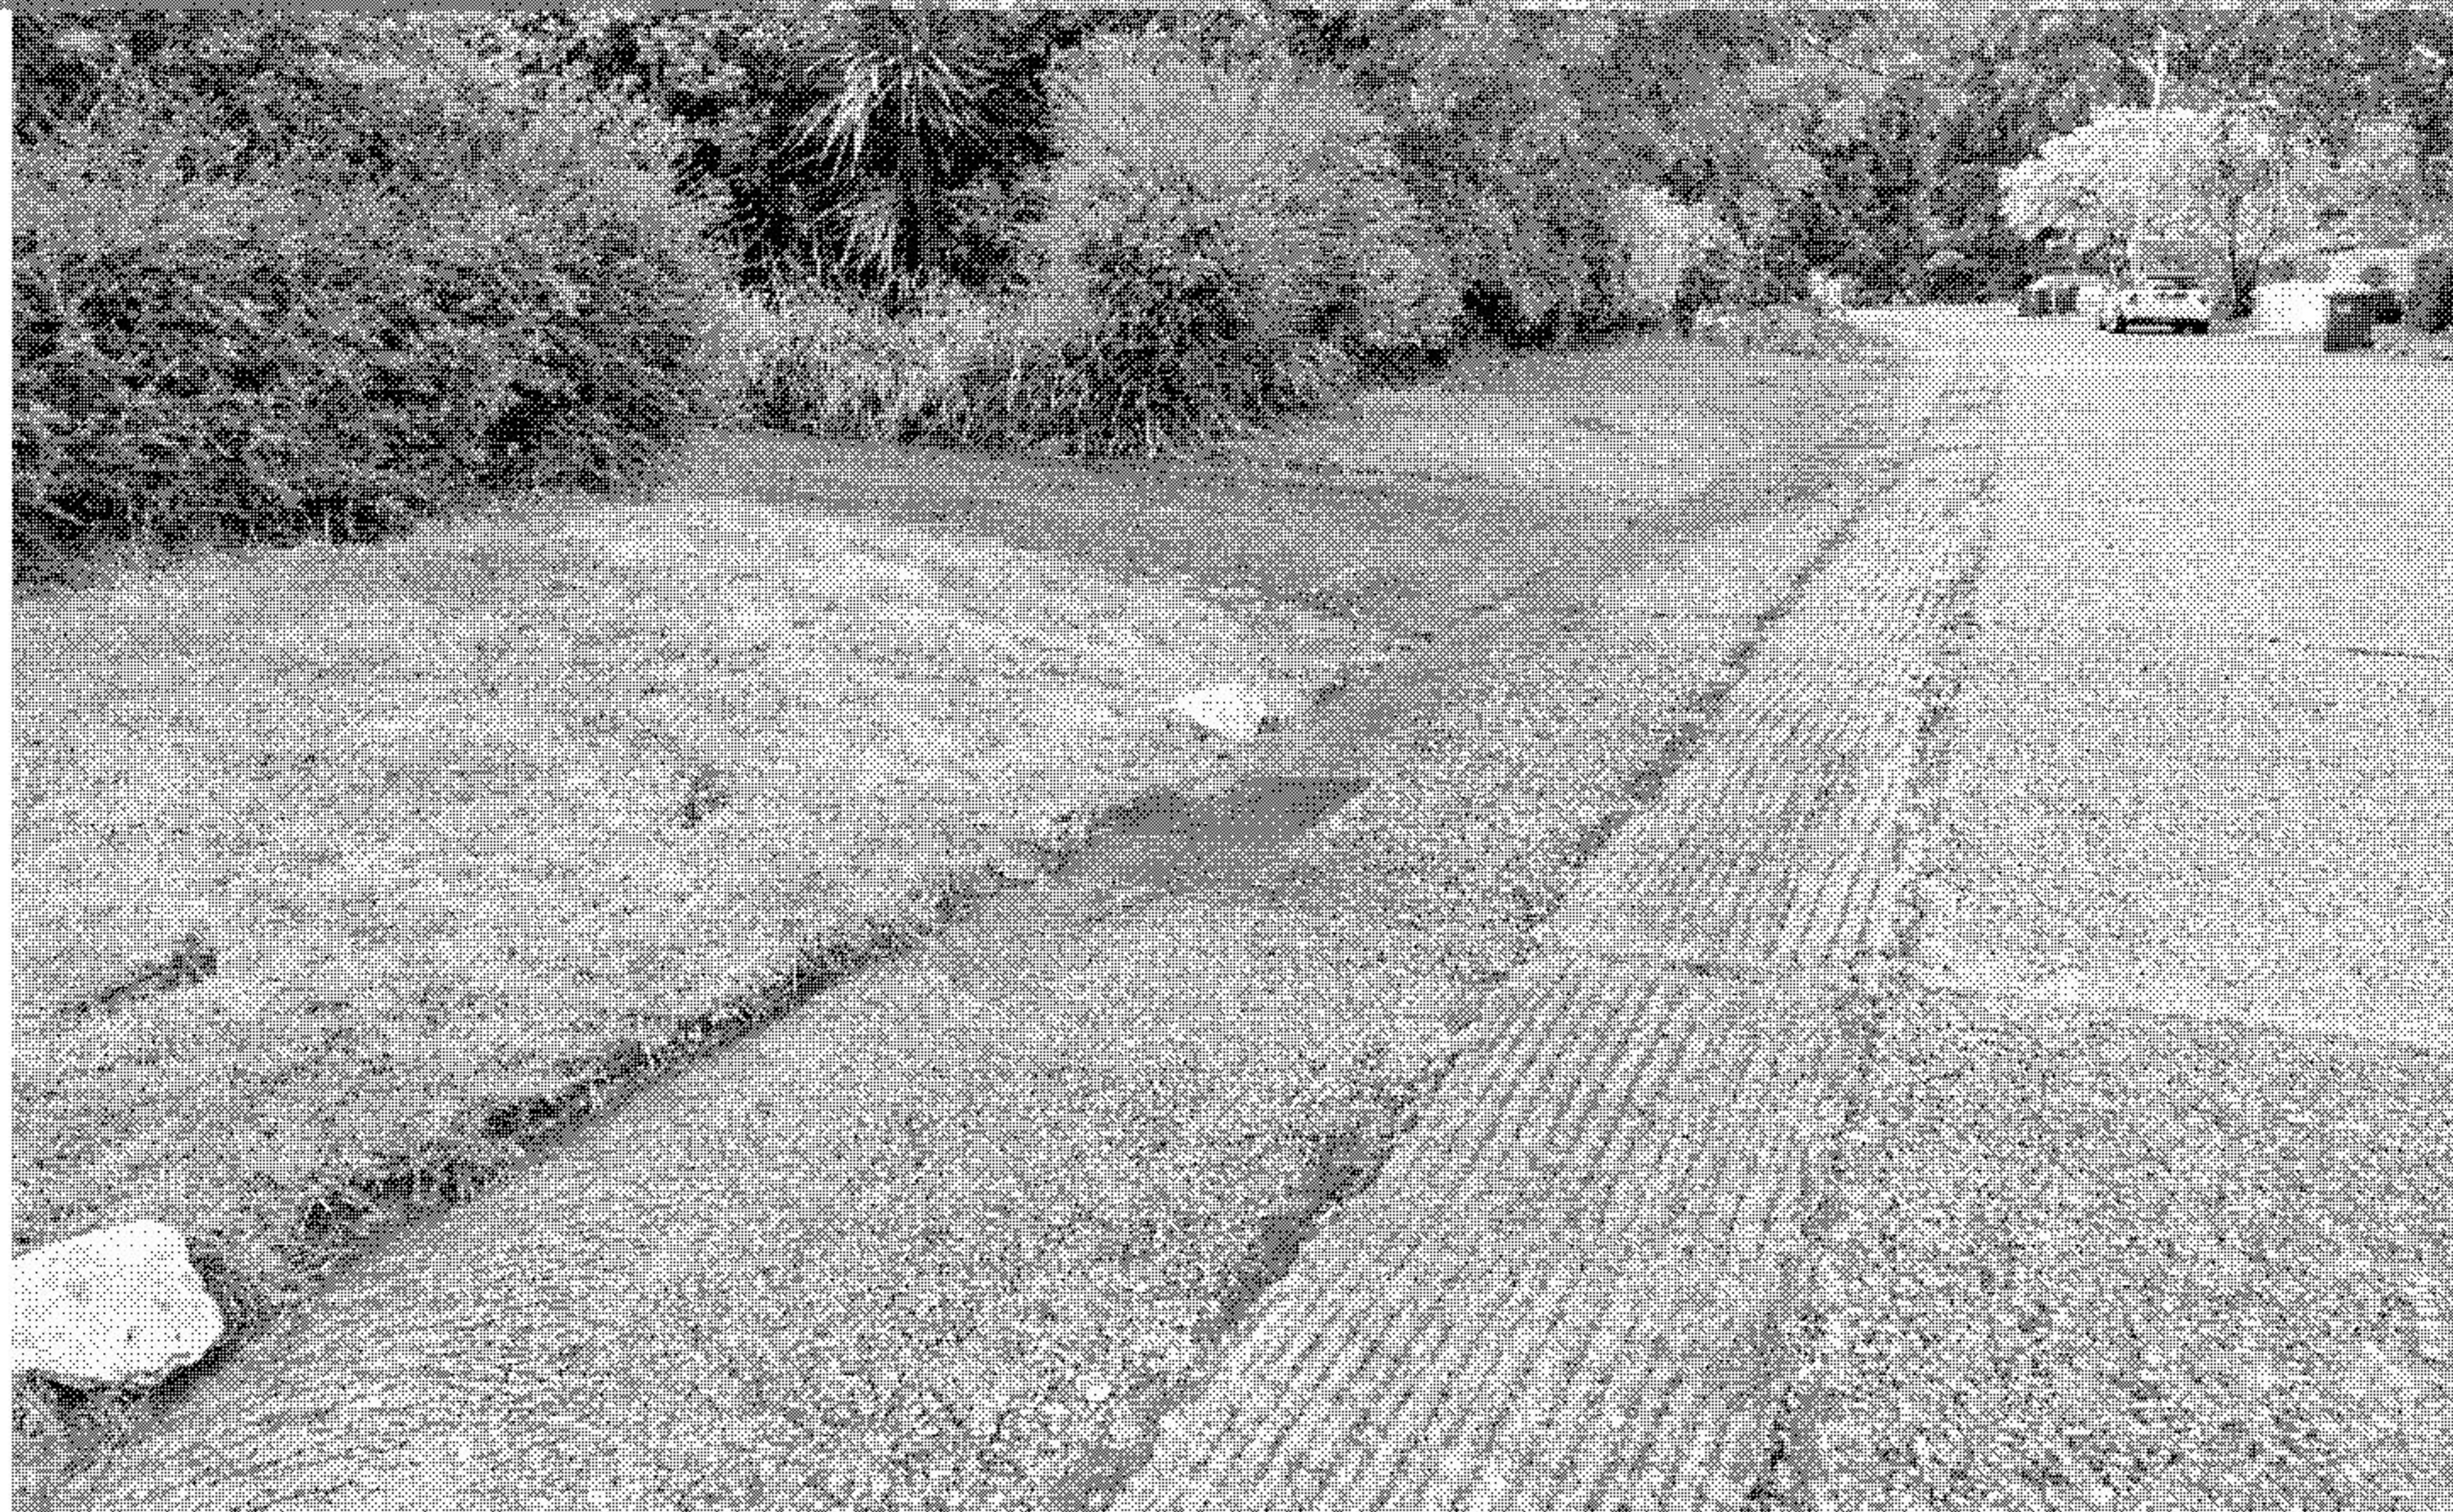
2. From no 48 the existing system runs downhill, to College Road for approximately 300 metres. Heavy (and not so heavy) rainfall regularly overwhelms the system, this is evidenced by water coming out of the drain covers and discharging along the length of Wickham Way (from about No 44) and the resulting stream that run down the surface road. The existing drainage does not have capacity for the current level rain surface water, the result is flooding at the junction with College Road. Note, this is despite regular professional clearing of the drainage system paid for by residents. The three photos below are evidence of the existing system being overwhelmed by a shower on 02/06/26. This is outside of No 48 and No 46, so just downhill from the proposed inlet to the existing system – this is a pretty mild example of the flooding that occurs.

3. There is no footpath along Wickham Way, so it is the pseudo-footpath that floods, forcing pedestrians into the centre of the road that is used by traffic.

4. It is pretty obvious that the existing drainage is already overwhelmed and it has no capacity to cope with this additional targeted discharge.
5. Drainage is a problem for the site (48's garden), presumably caused by the extensive development that the same developer has already undertaken on the same land.
