# EXISTING GUTTER & PROPOSED SOLUTION

**CLARE HOUSE  
LEWES ROAD  
EAST GRINSTEAD  
RH19 3SY**

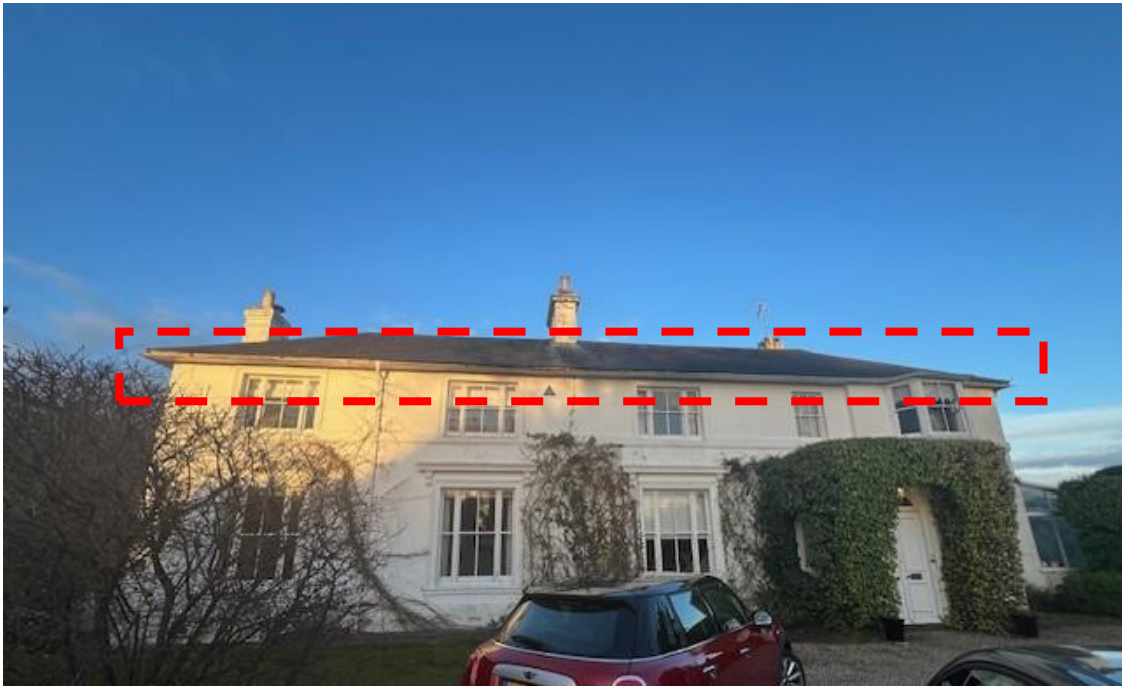
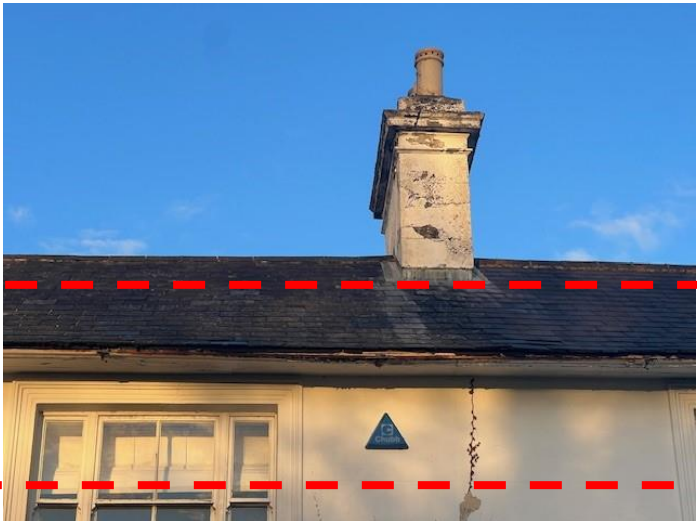
1. Propose to install new horizontal white finished cast iron gutter to replace the existing cast iron guttering which runs across the front elevation of our house and the adjoining Manor House. This is due to the existing gutter being very corroded and currently acting as a water fall to the centre of the house between both properties.

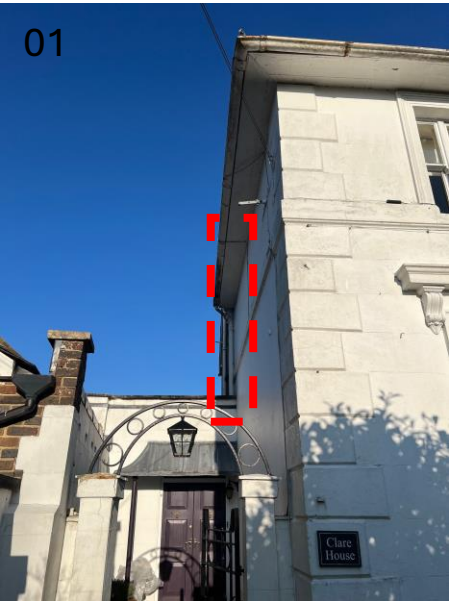
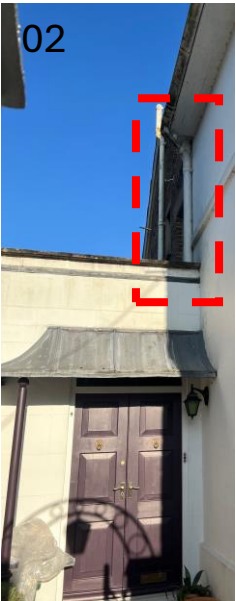
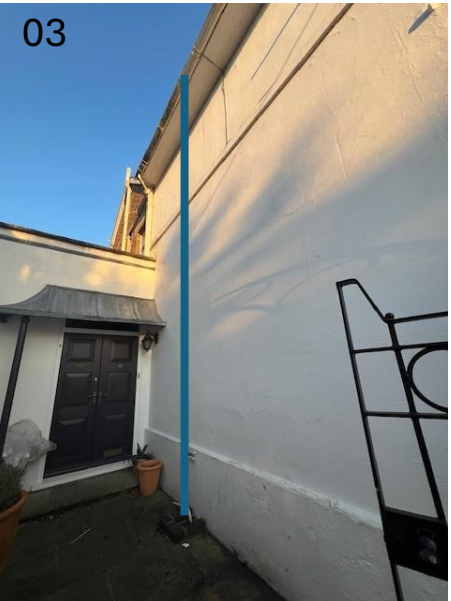
2. Propose to install a new cast iron down pipe in place of the existing cast iron down pipe (shown in image 01 & 02) to meet existing drain (shown in image 03) to the returning left side elevation of Clare House

Purpose is to remove the existing cast iron gutter which runs internally through the house as it is currently causing water damage to the interior lobby ceiling due to its existing location and replace with new cast iron down pipe and shown in image 03 above and to the rear of the building.

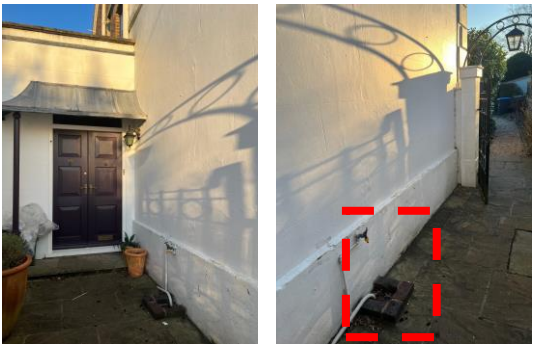
Proposed new down pipe location to existing drain
