## Heritage Statement & Impact Assessment Wykehurst House, nr Bolney RH17 5QQ

**Prepared by Stickland Wright Ltd for:** Michael and Sarah Blencowe

**Job No:** 25041

**Listed Designation:** Grade II\*

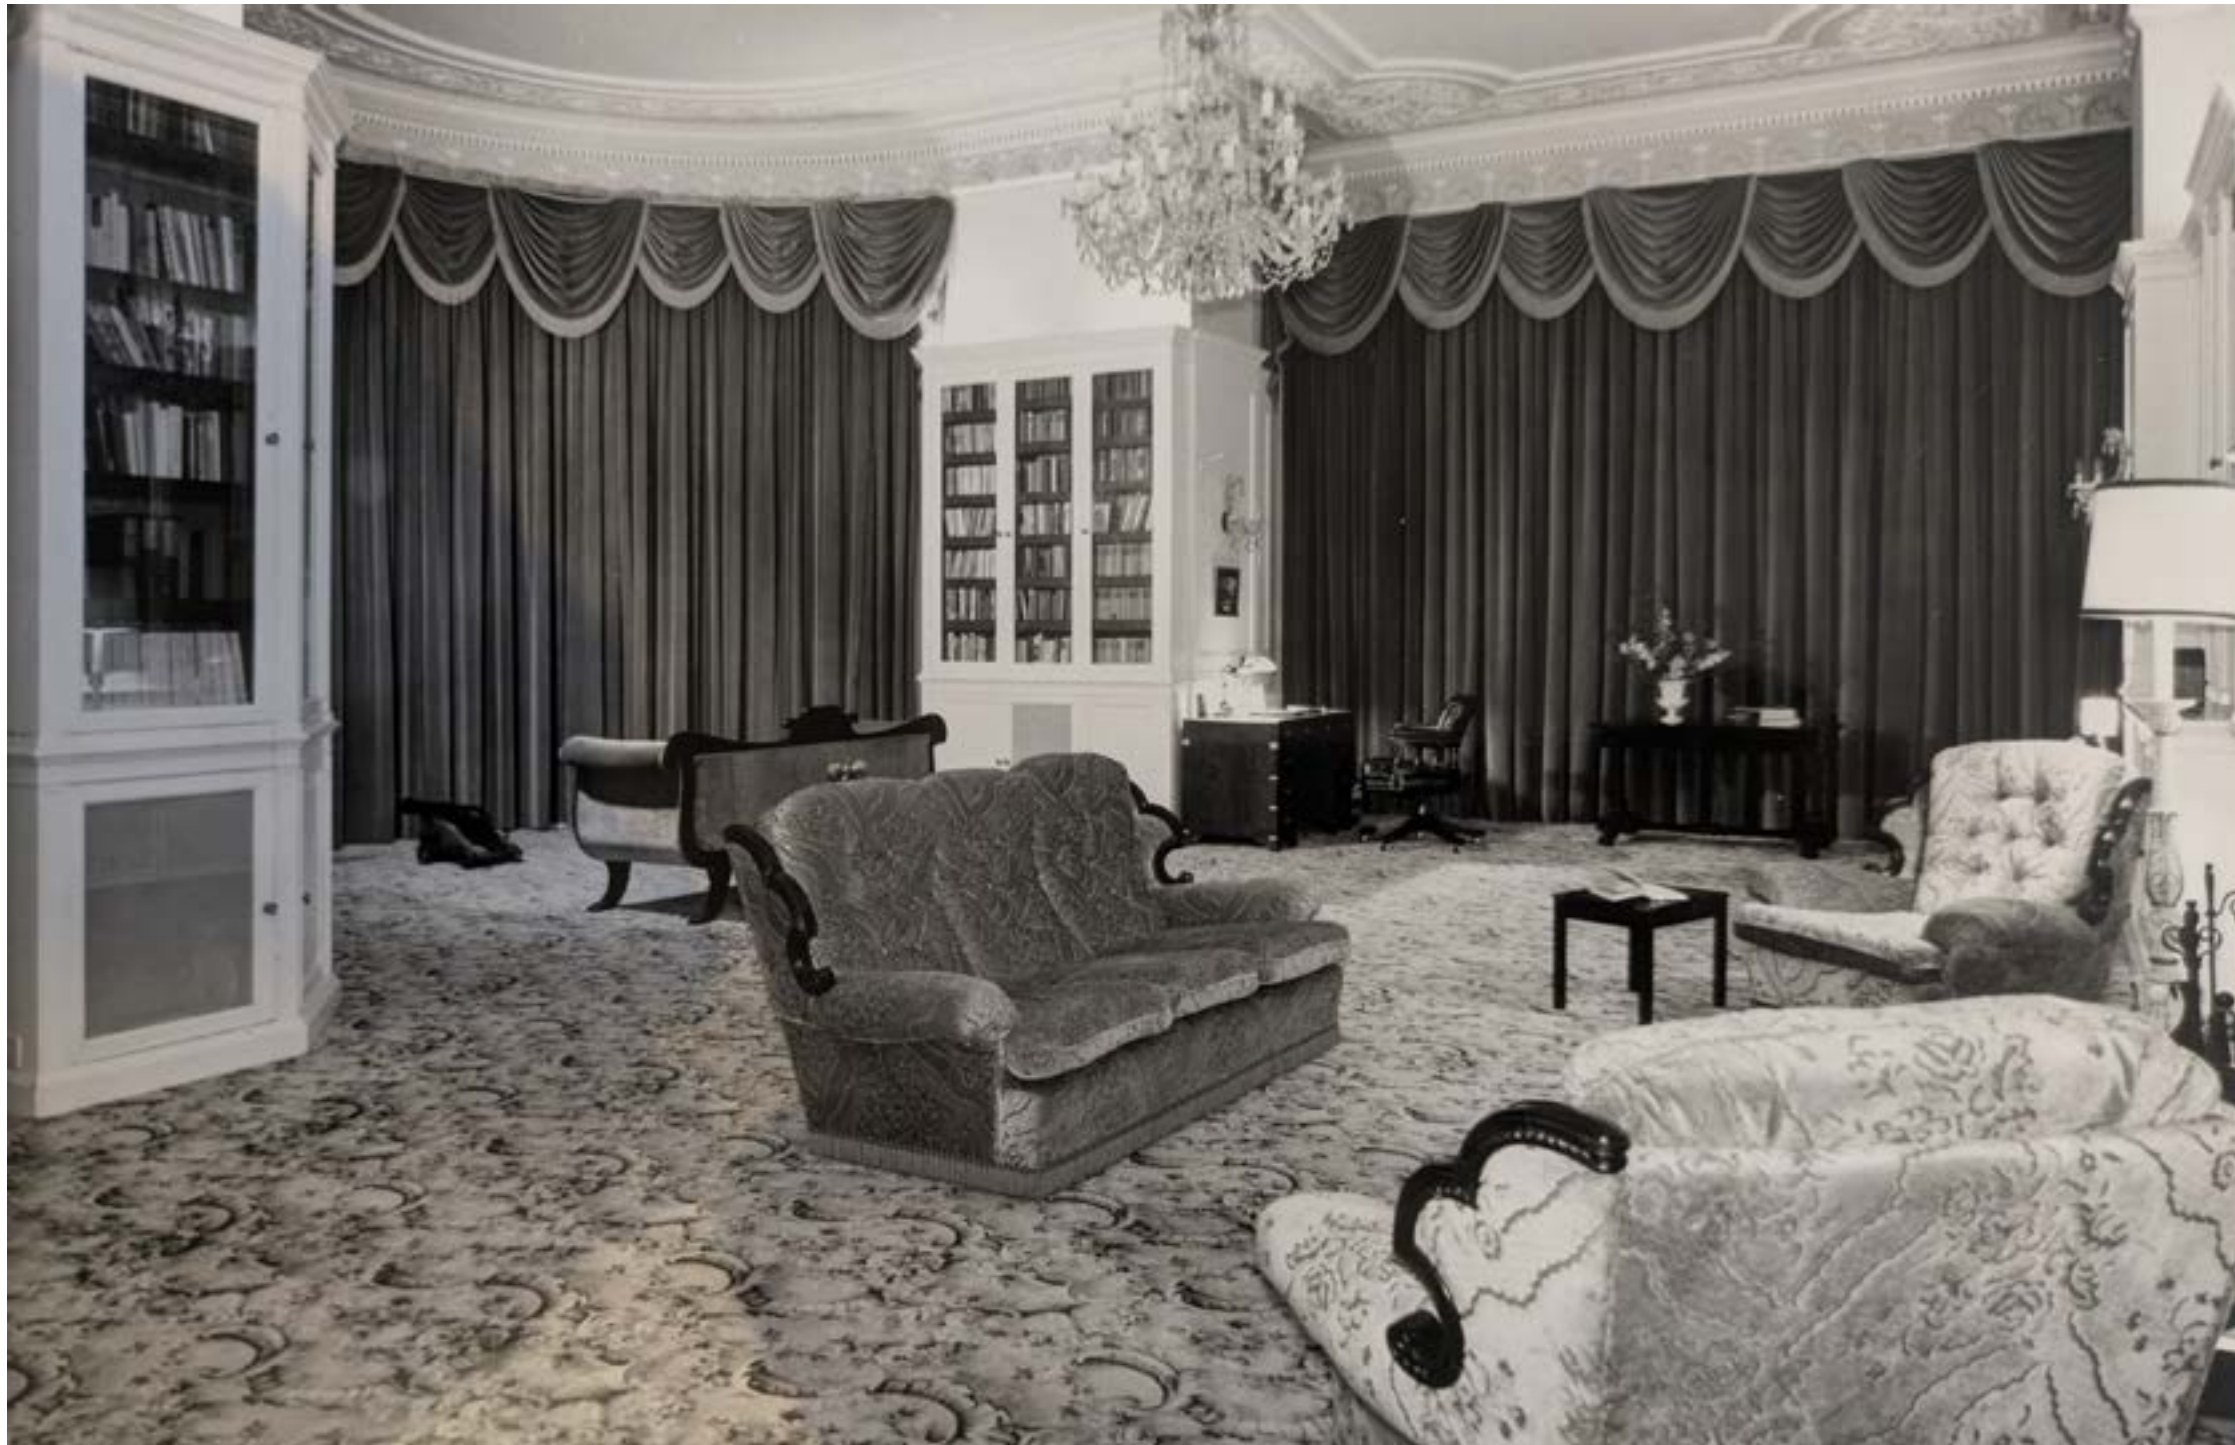
**Figure IV.01**

*Copy of photograph - author unknown.  
Photograph of library (G26) assumed during Doyle possession due to furniture and fittings*

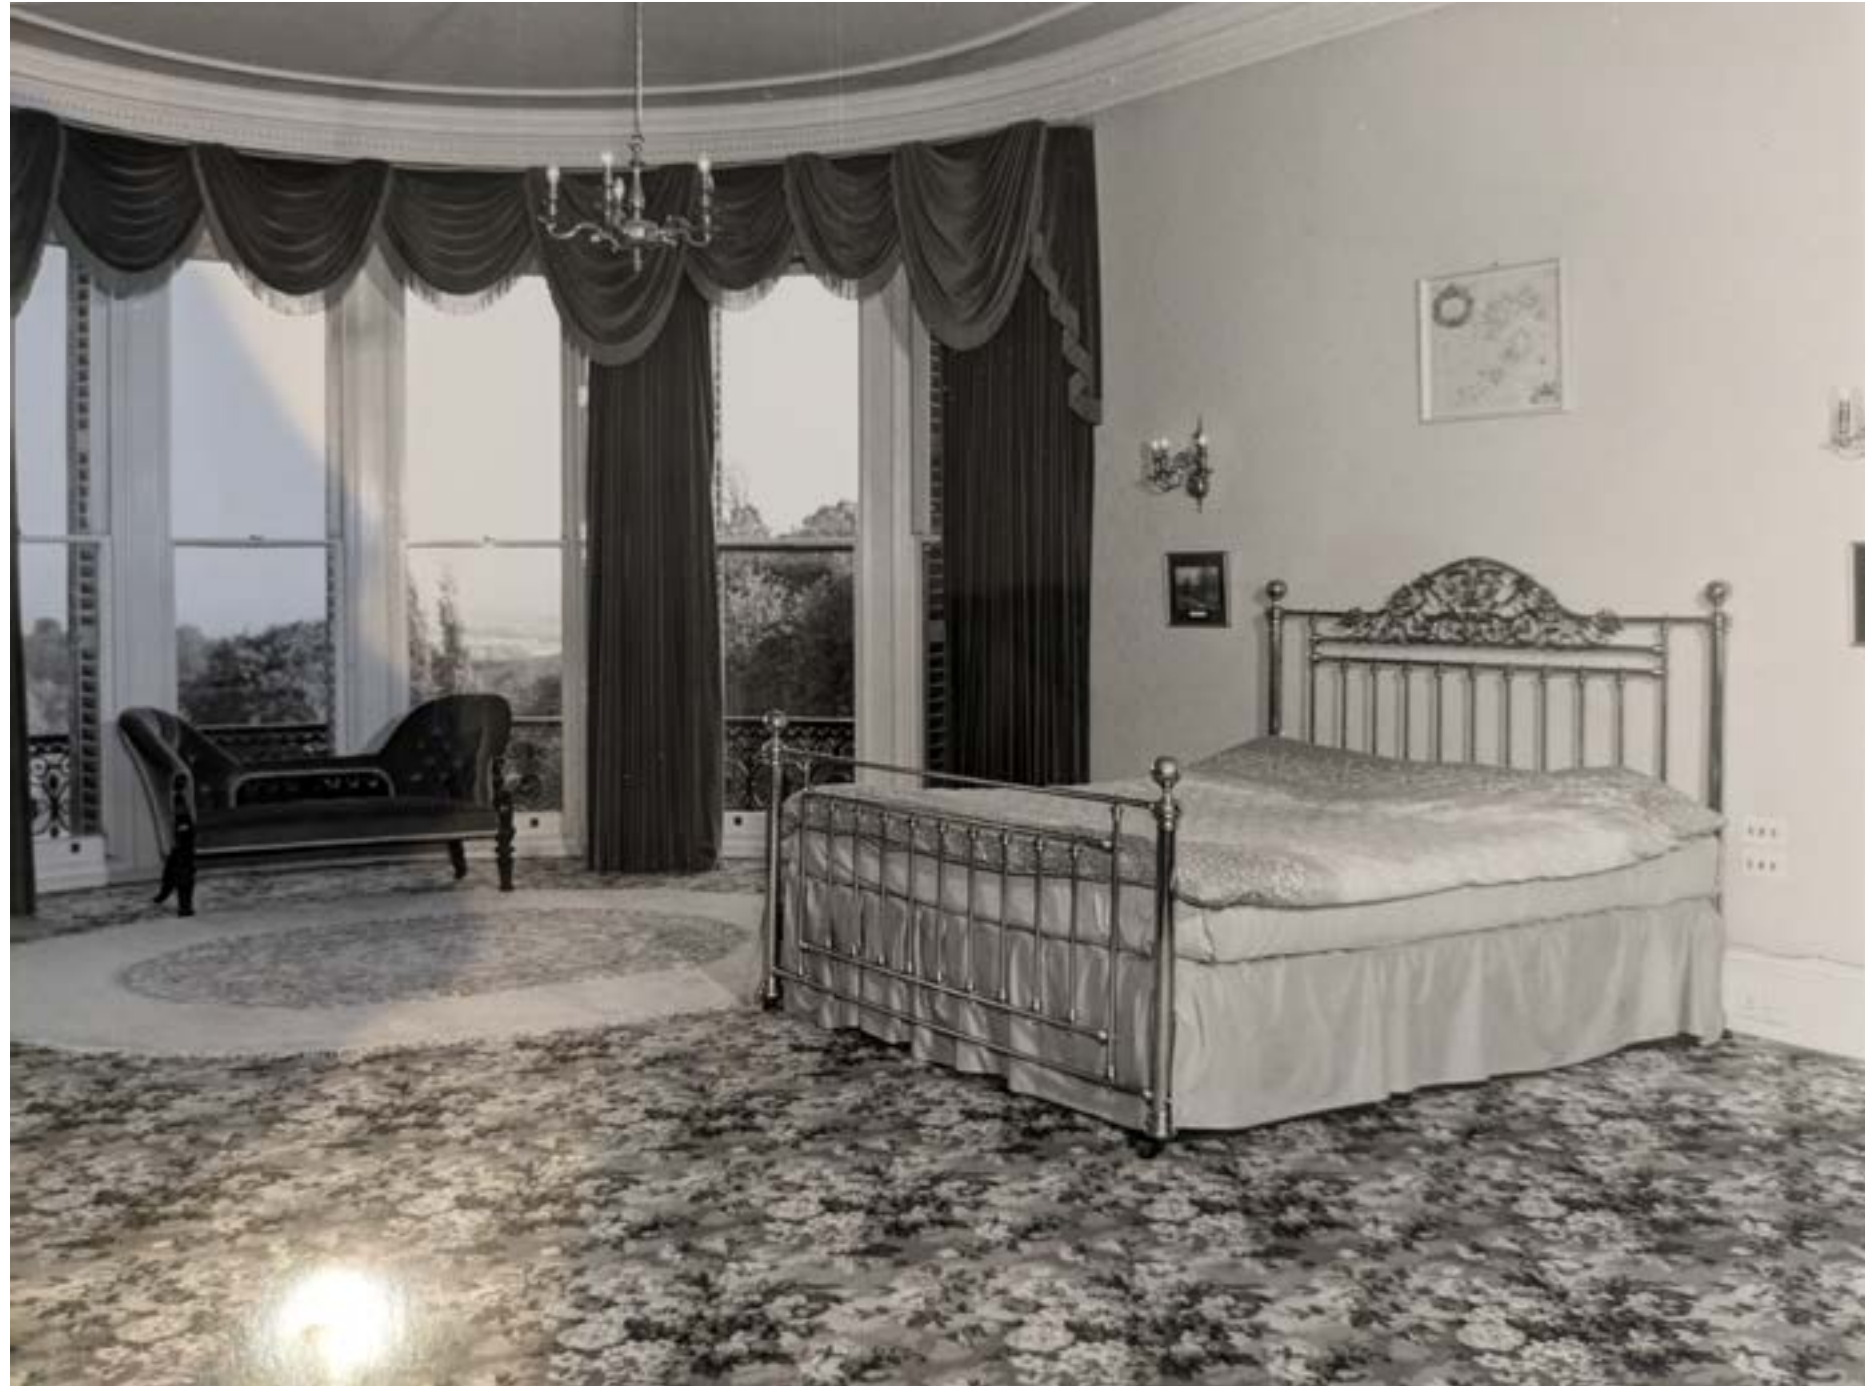
**Figure V.01**

*Copy of photograph - author unknown.  
Photograph of Bedroom 1 (F08) assumed during Doyle possession due to furniture and fittings*
