# Heritage Statement

Marlow House  
107 High Street  
Lindfield  
RH16 2HR

April 2025 | Project Ref 10899A

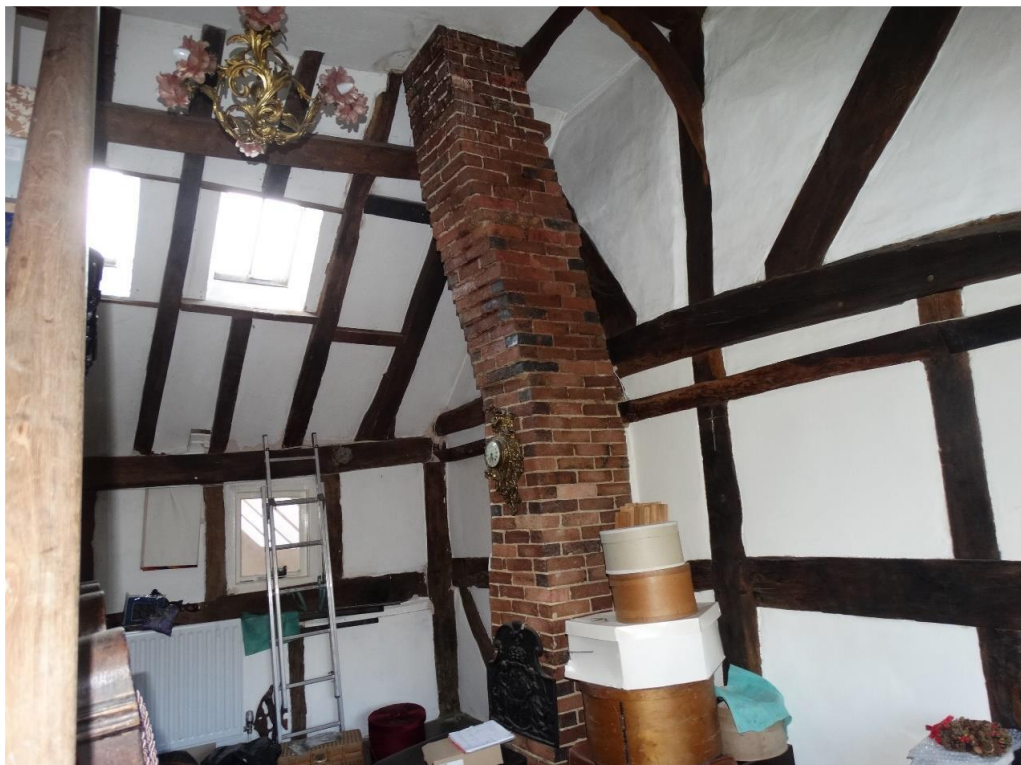
*Figure 9: 19<sup>th</sup> century brick stack adjacent to the north wall of the 15<sup>th</sup> century house prior to its removal. Source: Desbruslais Chartered Surveyors Statement of Heritage Significance of 13<sup>th</sup> October 2022*

**3.22** It is not known when this was carried out. However, this is presumably well after the early 19<sup>th</sup> century brick stack was inserted through the space (**Figure 9**).

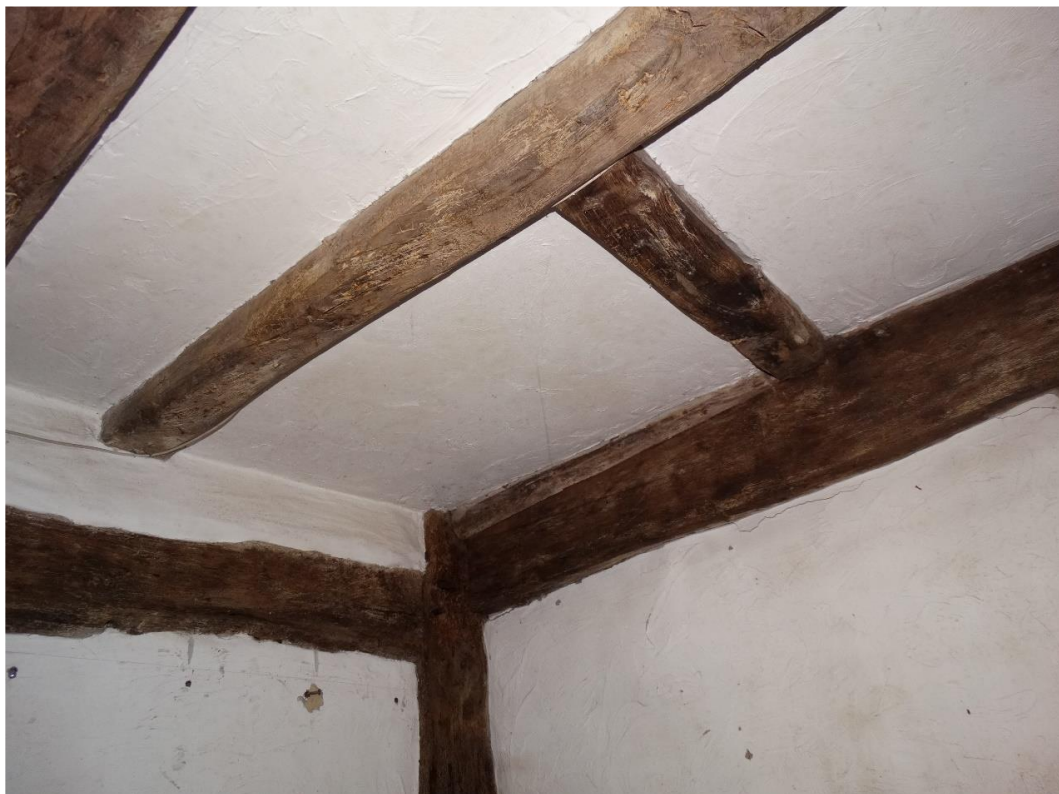
*Figure 10: Corner trimming for a ladder stair hole in the northwest corner and this is considered to be original. Source: Desbruslais Chartered Surveyors Statement of Heritage Significance of 13<sup>th</sup> October 2022*

- 3.26** Within the north bay, however, there is corner trimming for a ladder stair hole in the northwest corner and this is considered to be original (**Figure 10**).

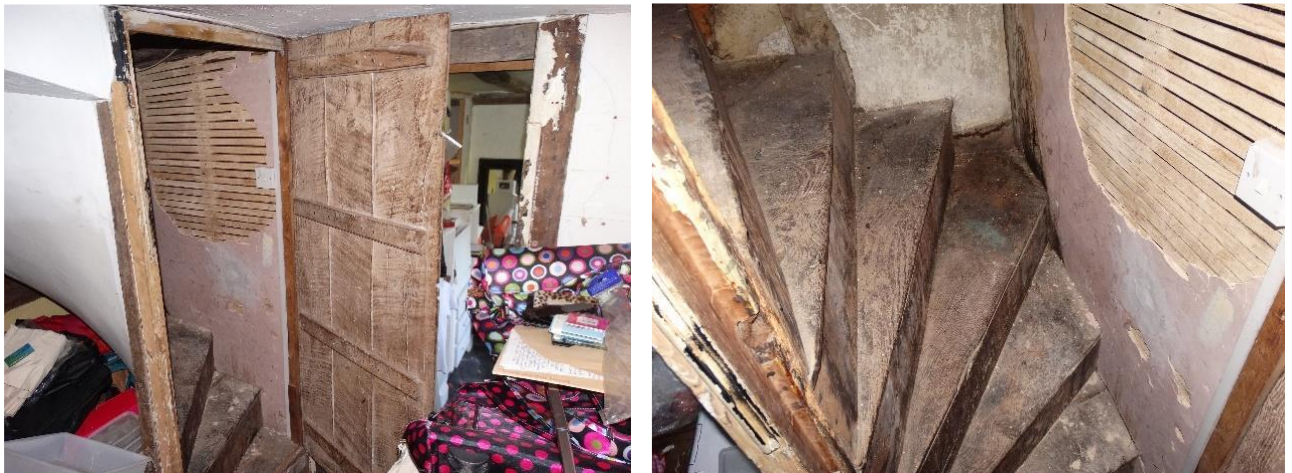
*Figure 11: Views of the 17<sup>th</sup> century upper flight of the corkscrew staircase. Source: Desbruslais Chartered Surveyors Statement of Heritage Significance of 13<sup>th</sup> October 2022*

**3.27** Later phases of stair have been added. The 17th century winding stair to the loft rooms are partially complete. The upper part from the landing to the second floor as shown in the images below was complete and shows no serious loss of material apart from wall plaster to the enclosure (**Figure 11**).

**5.17** Although not original to the 15<sup>th</sup> century house, the 17<sup>th</sup> century winder stair was an important remnant of the building as it evolved from a house into a shop with accommodation over, positioned over the basement stair and accessing all levels of the building. The better-preserved element was at first floor level, and this is to be fully reinstated using the original fabric (which is retained) as part of the Proposed Scheme. At ground level, where the state of preservation had less integrity and comprised largely modern replacement timber dating from c. 1999 (see **Appendix 3**), a ghosted outline of the stair is proposed in the form of the edging of treads adjacent to the abutting north and west walls of the space with a handrail and trimmer beams placed to make the form of the stair legible again.

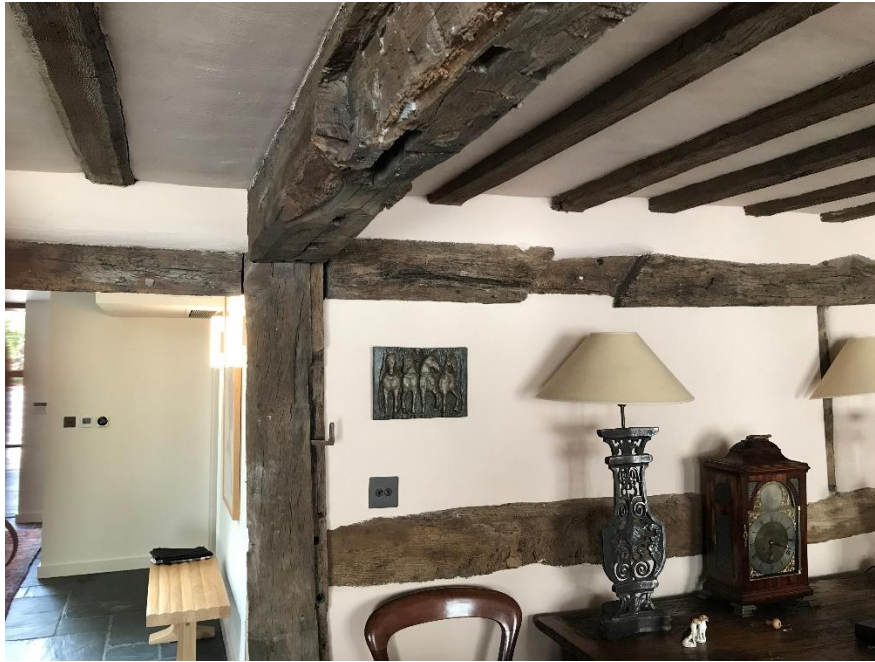
*Figure 12: main E-W ceiling beam to the living room showing the location of an original partition and doorway adjacent to the northwest wall.*

living room north of the chimney breast (**Figures 12 and 13**). Whilst there is some central support in masonry, the joint where the axial first floor support beam crossed the tie is weak and has had to be propped with modern steelwork (**Figure 14**). The existing seasoned oak gunstock post which replaced the improvised support is shown at **Figure 15**.

**3.32** However, the underside of the tie does reveal the design of the partition in this instance, and the doorway at the end into the snug area looks to be in its original position (**Figure 12**).

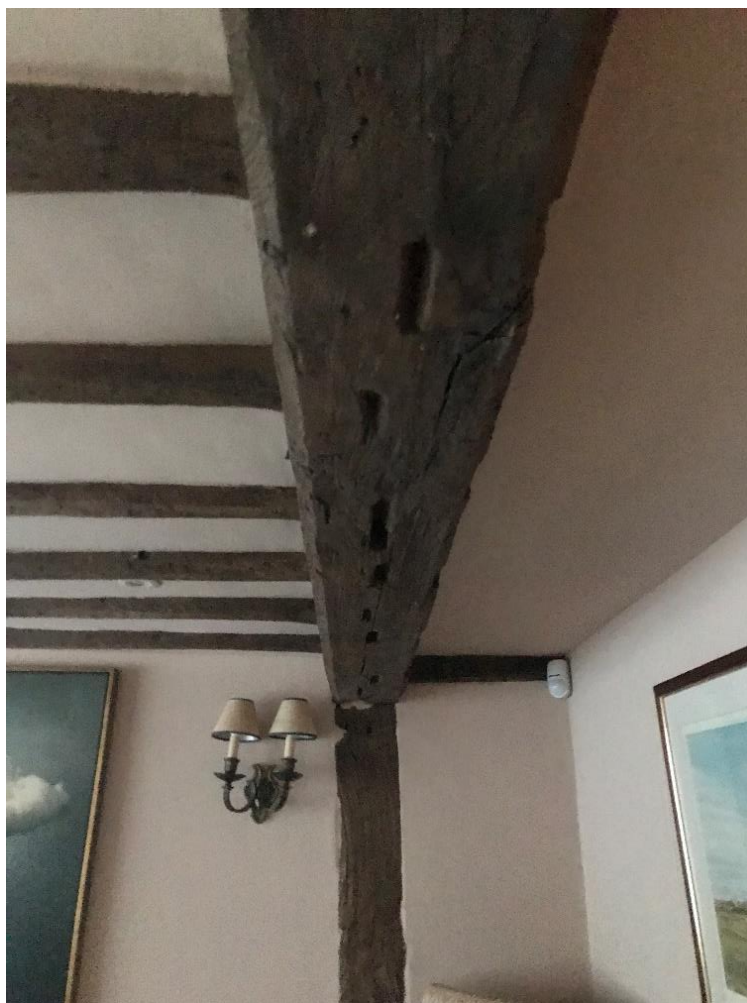
*Figure 13: N-S ceiling beam to the former dining room to the south bay with mortices indicative of historic partitioning within this space.*

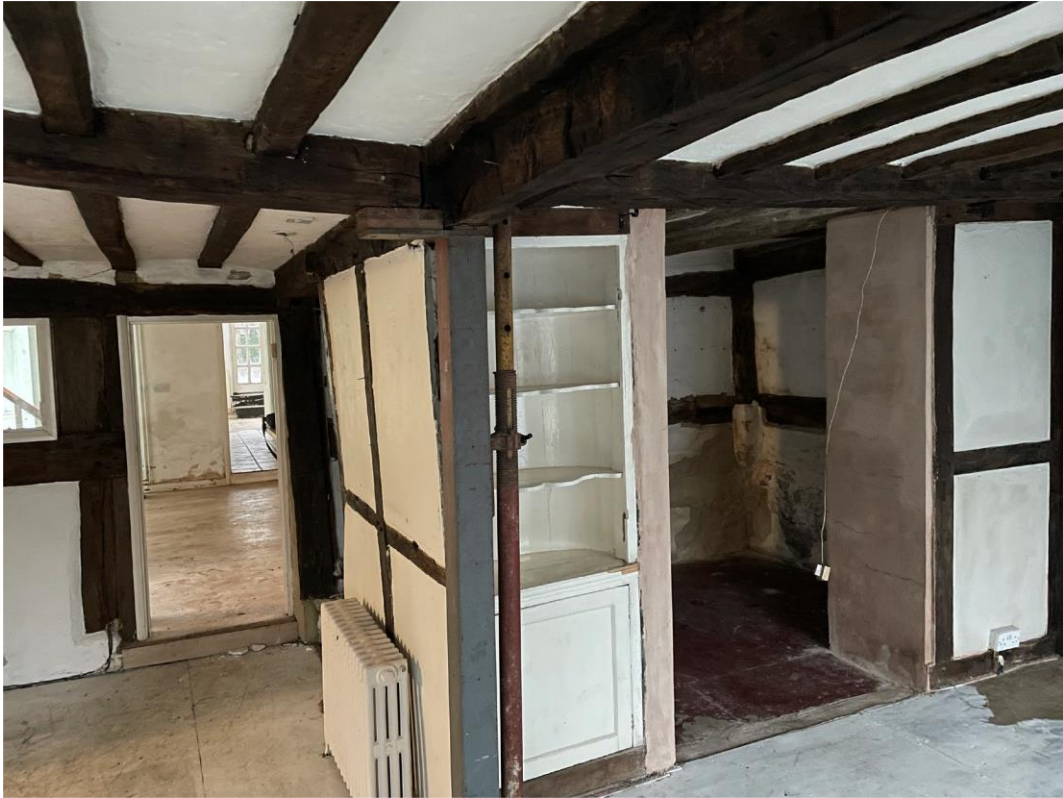
*Figure 14: Central supporting post to main living room. Source: McCarey Simmonds, Structural Inspection Report of 15<sup>th</sup> March 2023*

- 5.31** To implement the above repair it was necessary to remove a short section of stud partition which previously enclosed a small snug to the northwest corner of the main parlour (**Figure 14**). The timber studs were of uncertain provenance but the quality of the timber in conjunction with the modern in-fill panelling suggests that the stud partition did not comprise historic fabric, though possibly contemporary with the inserted 19<sup>th</sup> century chimney stack. Some crude 'cutting in' to the main beam (**Figure 12**) also suggests that this partition had been altered to accommodate some fitted joinery or other furniture at the time the partition was added since it lines up squarely with the recessed face of the clearly later cut back section of the main beam.

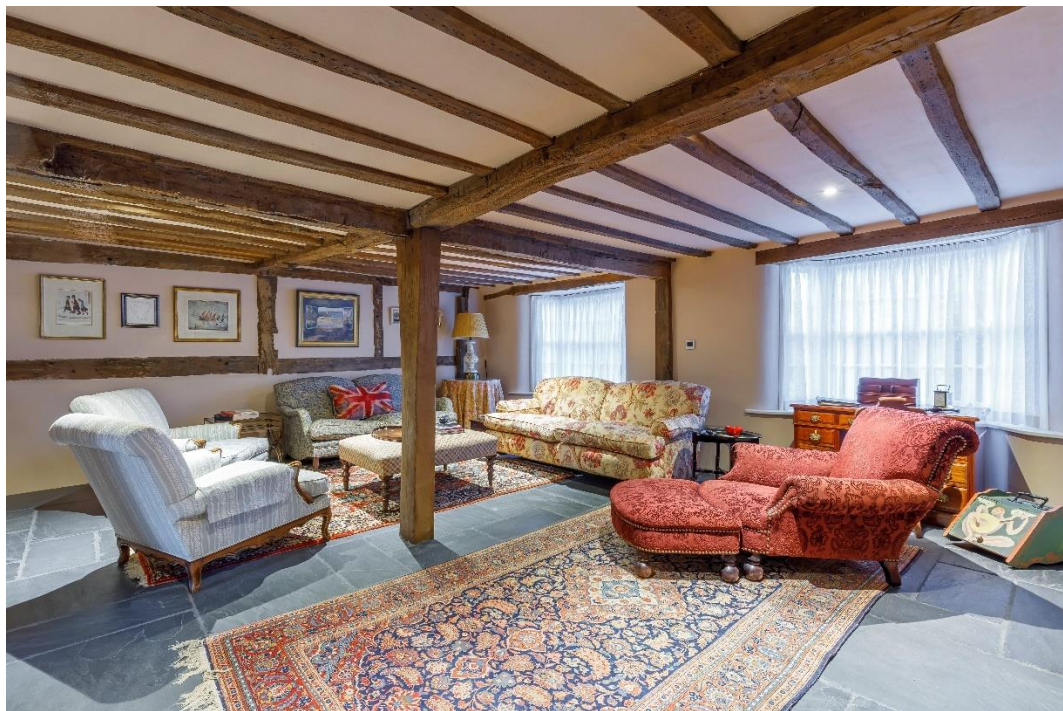
*Figure 15: Supporting timber post in seasoned oak as implemented*

- 5.30** This intervention represents a significant improvement on the improvised steel post and Acro-prop arrangement which it replaced. The Oak post is of a traditional design, with tapering 'gunstock' jowls. It is a credible and archaeologically accurate form of repair which nonetheless reads as honest and new. This repair is of clear heritage benefit and should be afforded moderate weight.

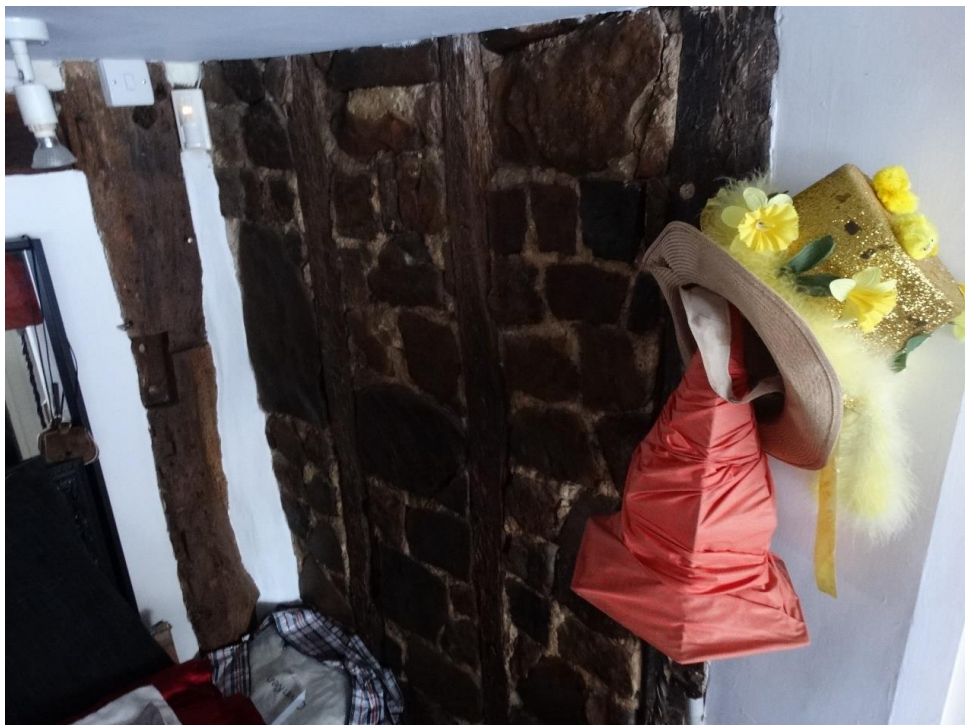
*Figure 16: feature wall to the partition between the entrance hall and southern bay dining room.  
Source: Desbruslais Chartered Surveyors Statement of Heritage Significance of 13<sup>th</sup> October 2022*

**3.34** The studs are out of alignment with the main bay post of the lower end of the house and the wall looks to be a later infill at the end of the cross passage. The door positions to the lower end services are not visible and it may have been constructed to re-face the end of the passage and close off one of the service door positions. Being Sussex, it would be more common to see service end doors towards the outer bay positions rather than centrally placed, like is found the further east you go towards Kent.

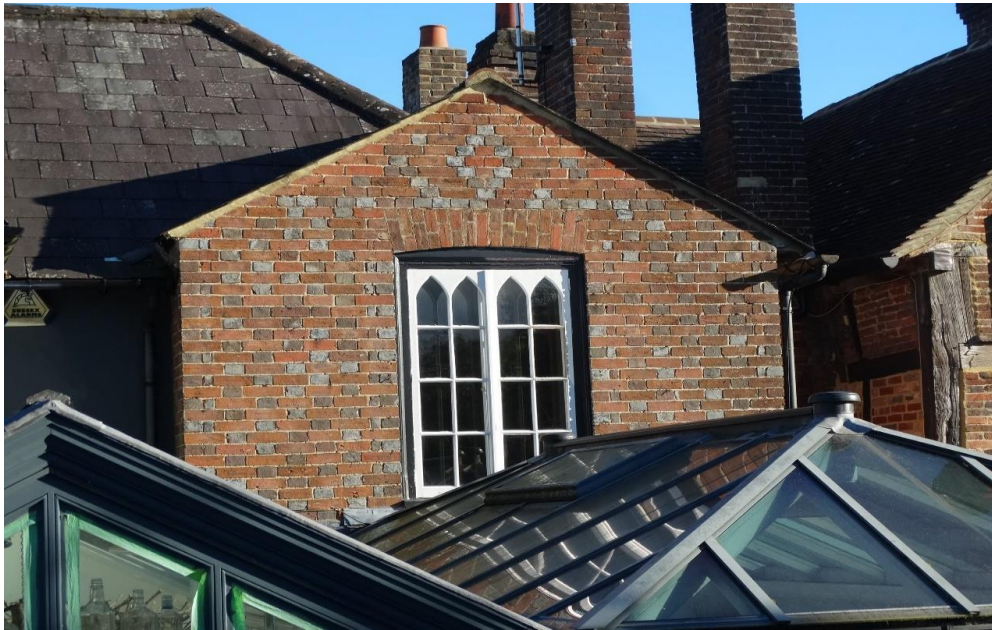
Figure 17: 1830s gabled outrigger with vitrified blue brick header detailing. Source: Desbruslais Chartered Surveyors Statement of Heritage Significance of 13<sup>th</sup> October 2022

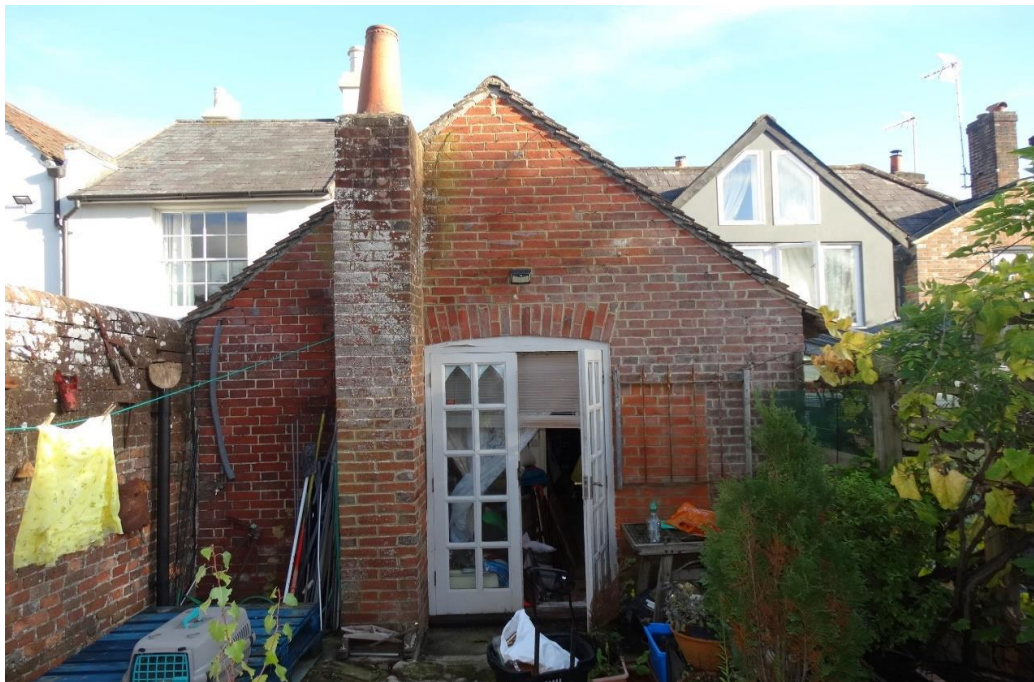
Figure 18: View of the former Bake House from the west prior to dismantling. Source: Desbruslais Chartered Surveyors Statement of Heritage Significance of 13<sup>th</sup> October 2022

- 3.41** A Bake House was also added to the rear, of which only the outer walls remained in situ (**Figure 18**). No internal features survived, and the interior linings and fixtures were wholly modern.

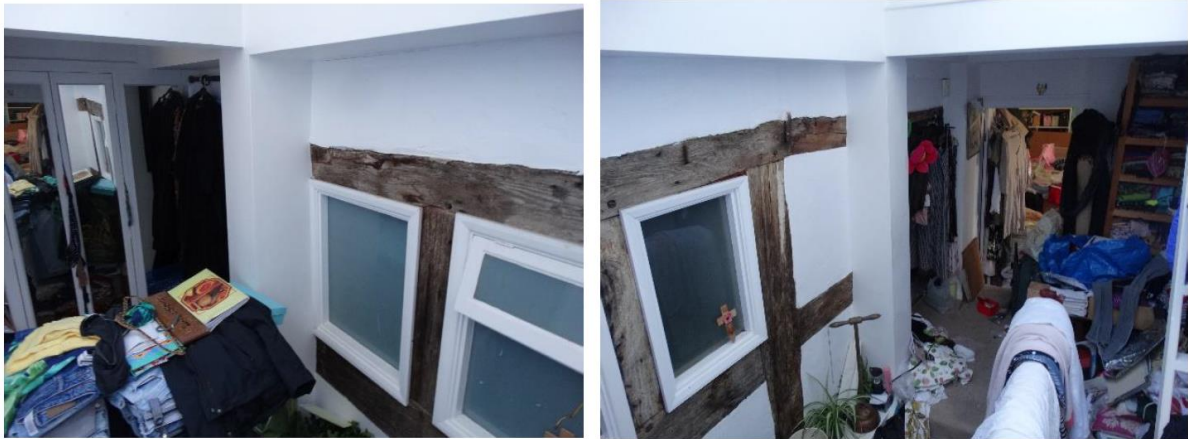
*Figure 29: Box framing to rear (west) wall of the 15<sup>th</sup> century house with internalised modern timber casement windows. Source: Desbruslais Chartered Surveyors Statement of Heritage Significance of 13th October 2022*

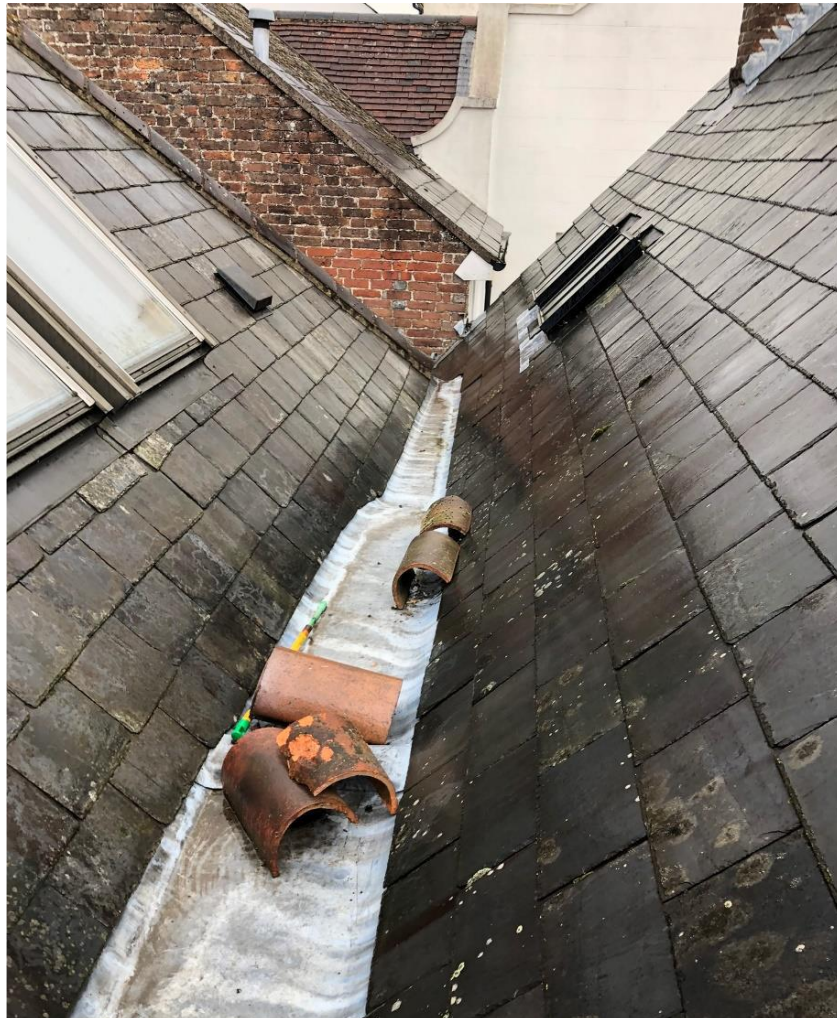
*Figure 30: the rear roof slope to the original 15<sup>th</sup> century building contained no less than 5 rooflights prior to their removal and slating over as part of the implemented scheme. Source: Gould Baxter Survey (October 2022)*

- the removal of stud partitions which subdivided the southern ground floor room (making it an uncharacteristic linear open plan) as well as the main parlour to the north of the main chimney breast towards the centre of the original house (**Figures 12 and 13**);
- insertion of modern casement windows to the box framing on the west elevation (**Figure 29**); and,
- insertion of rooflights to various roof slopes, including the main west slope of the 15<sup>th</sup> century building (**Figure 30**).

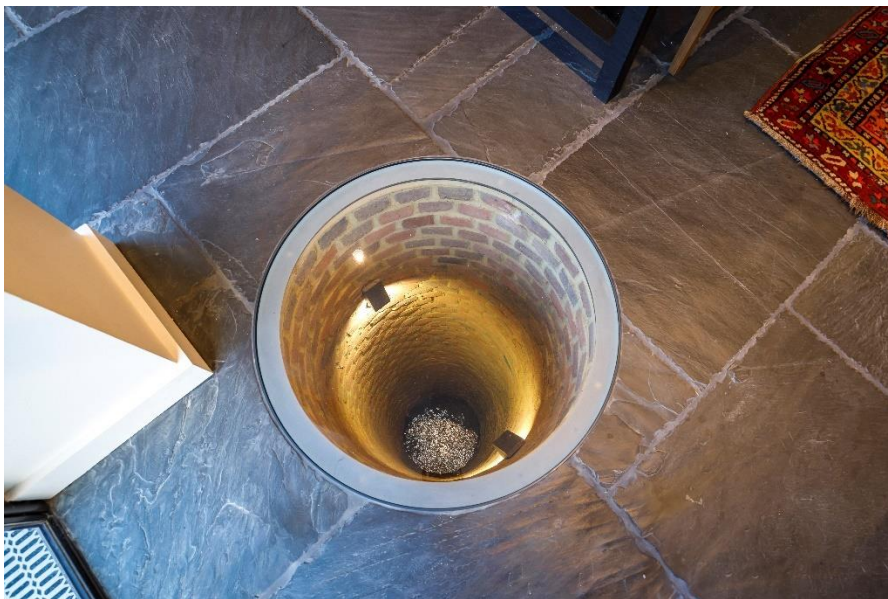
*Figure 31: Rediscovered well shaft (re-lined in handmade brick) and groundwater storage chamber within the kitchen area.*

- 5.35** The restoration of this previously hidden feature represents a notably beneficial impact of the Proposed Scheme. The repair and presentation of the well reveals and reinforces the archaeological, evidential and historical values of the listed building and its group value with the other listed buildings on High Street, many of which had wells to the rear yards (cf. **Figure 18**). This aspect of the scheme results in a heritage benefit of moderate weight

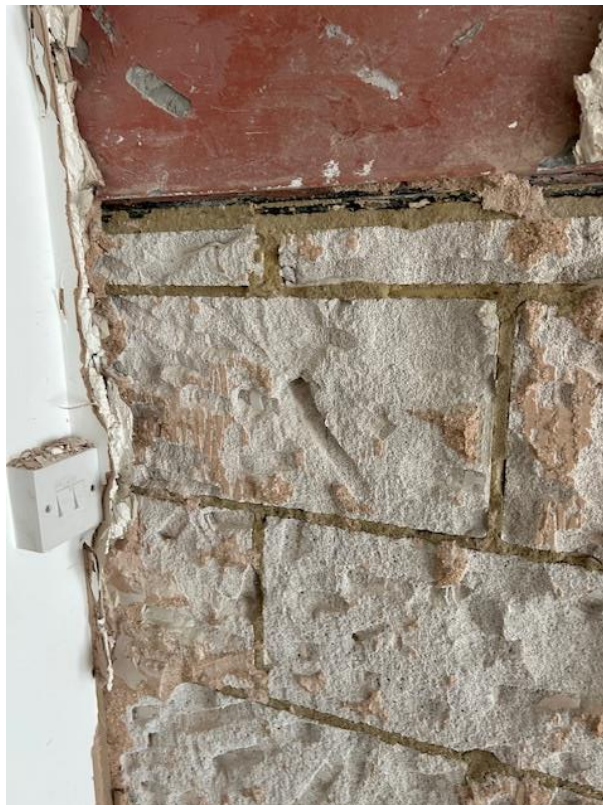
*Figure 35: Blockwork construction underlying the exposed timber stud wall with stonework nogging shown at **Figure 16***

**5.24** This cosmetic stud wall was a legacy of the 20<sup>th</sup> century tea room use. It appears not to have been an original wall or historical feature, as demonstrated by the presence of concrete blockwork within the wall uncovered during its removal (**Figure 35**). The demolition of this partition to create a reveal / recessed cloakroom at the entrance to the ground floor WC improves circulation and layout without harming significance. The impact of this change on the listed building's significance would be a minor heritage benefit as the wall was misleading and interruptive of historic plan form.

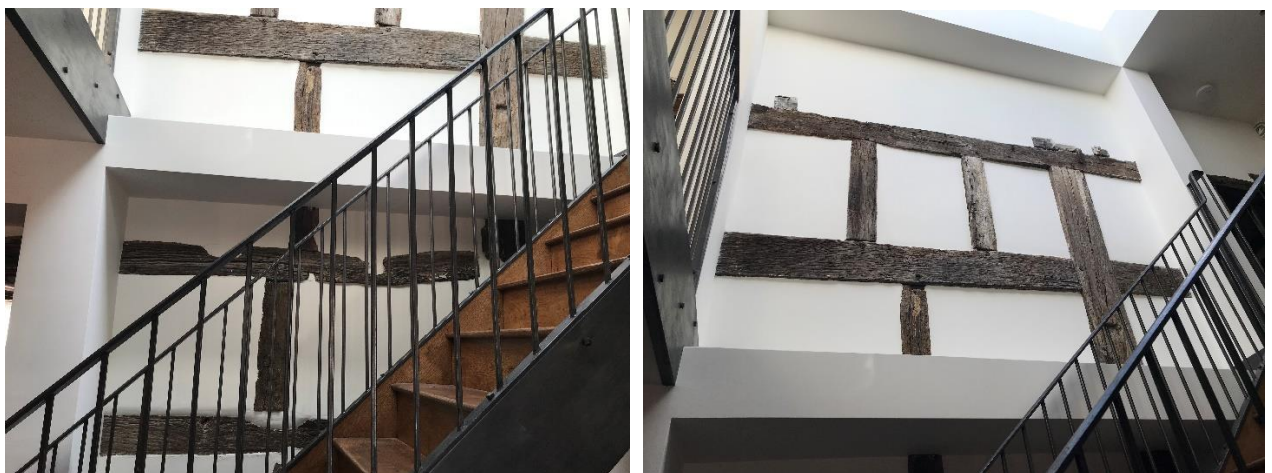
*Figure 37: Box framing to west wall of the 15<sup>th</sup> century house with internal windows infilled with wood wool panels and lime plaster.*

**5.33** The original window openings to the west wall of the house have long since disappeared. These modern windows do not represent the original window openings, the position of which is a matter of considerable conjecture. Original windows would have been in the form of fixed and metal casement lights separated by oak staves or mullions. None of these windows remained in the property prior to the implemented scheme and there is no convincing evidence for their respective positions. The removal of the modern casements and infilling using breathable wood wool boards faced in lime plaster serves to reveal and express the 15<sup>th</sup> century box framing much more clearly and is a significant heritage benefit of the Proposed Scheme (**Figure 37**). This should be weighted accordingly.

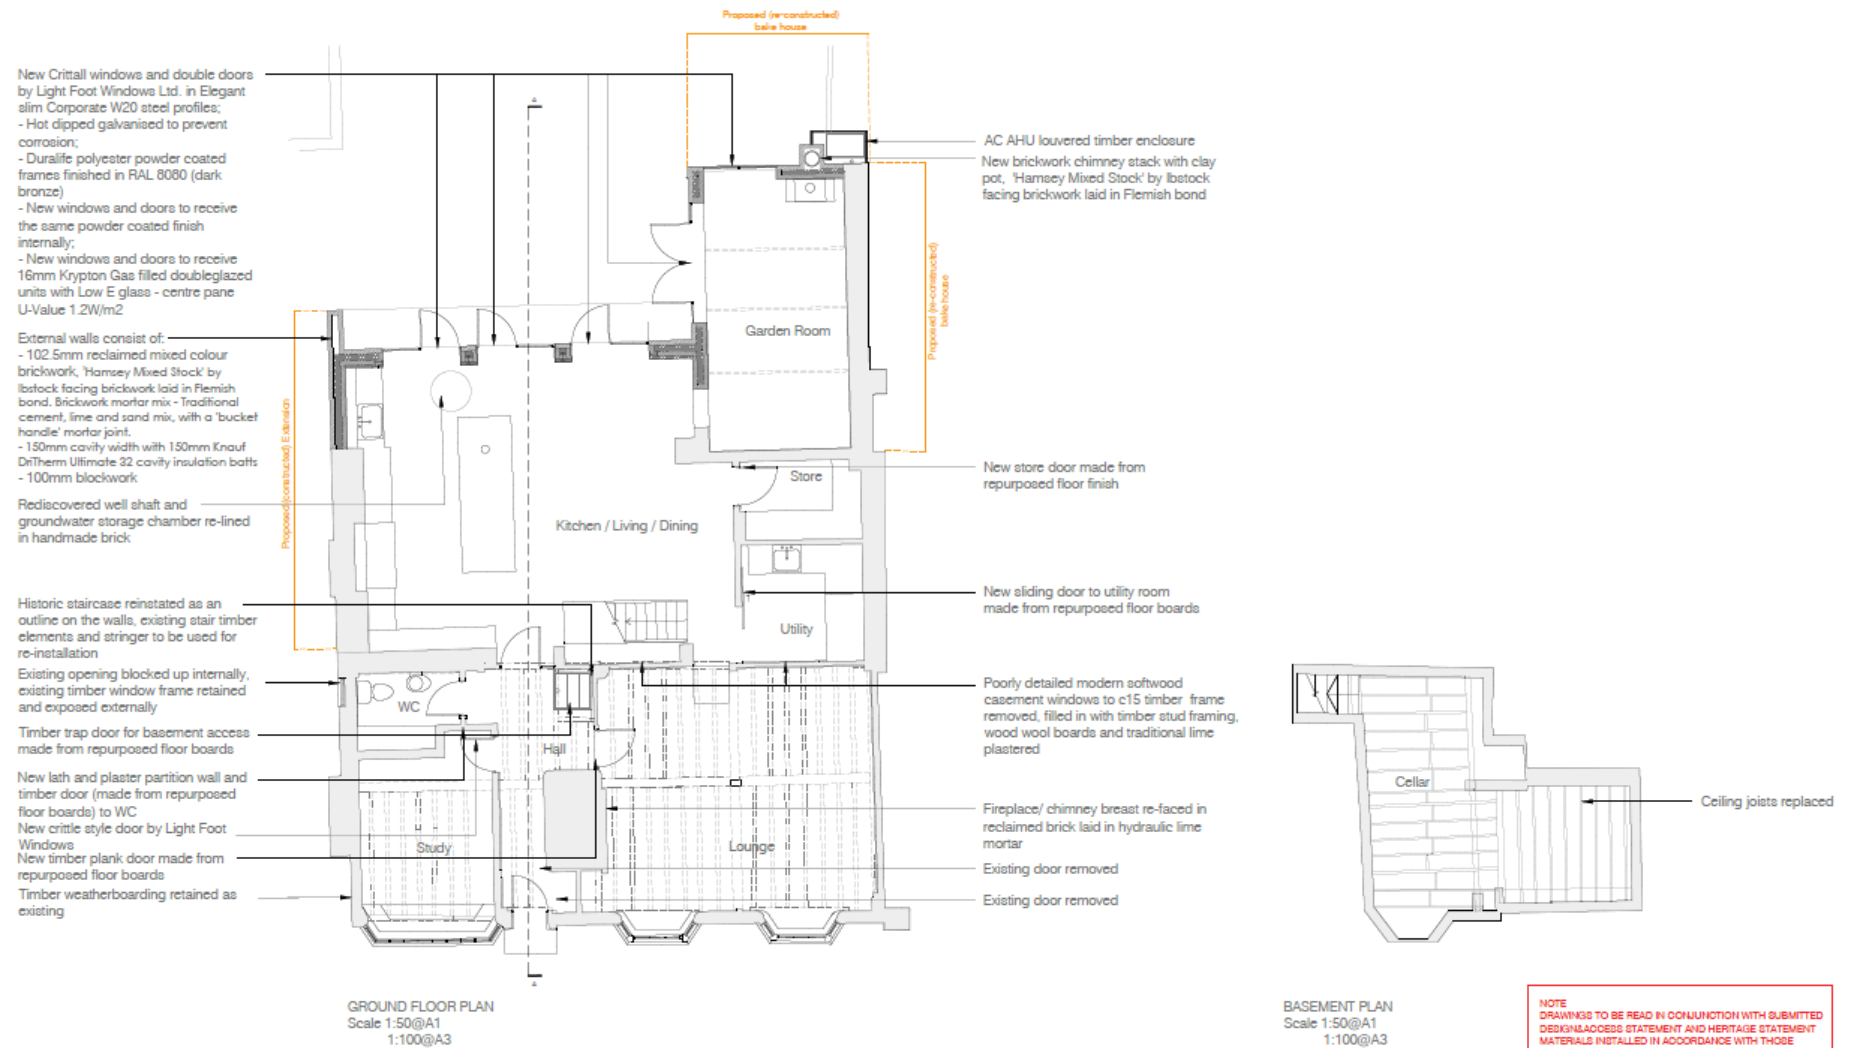
*Proposed Basement and Ground Floor Plan*

Existing window replaced with new timber sash window

Existing gypsum plaster ceiling removed, new vaulted ceiling installed within existing timber rafters

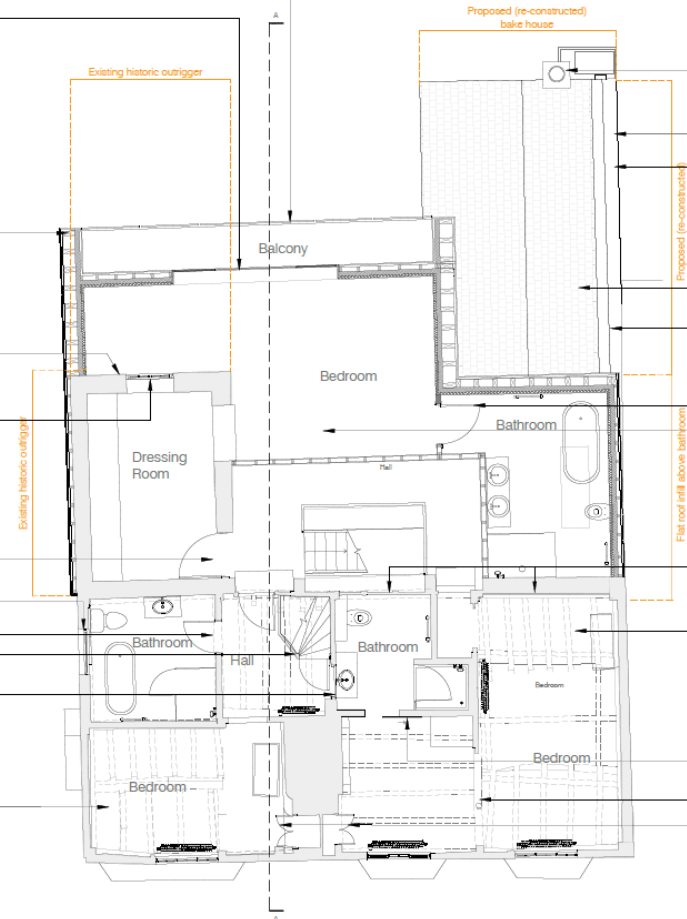
*Proposed First Floor Plan*

FIRST FLOOR PLAN  
Scale 1:50@A1  
1:100@A3

New brickwork chimney stack with clay pot, 'Hamsey Mixed Stock' by Ibstock facing brickwork laid in Flemish bond

Poorly detailed modern softwood casement windows to c15 timber frame removed, replaced with traditional lime plastered infill panels

Overlaid seasoned oak flooring overlaying original floorboards retained in-situ. Timber floor matching existing by The West Sussex Antique Timber, random width tongue and grooved character grade solid oak flooring 150mm wide x 20mm thick in random lengths up to 3500mm, hand planed on the edges of the boards, screwed and pelleted into the existing timber boards, stained to an approved colour and protected with 3 coats of a durable floor sealer.
