# Heritage, Design and Access Statement

**Broad Street House, Cuckfield**

*Mr and Mrs D Lovell*

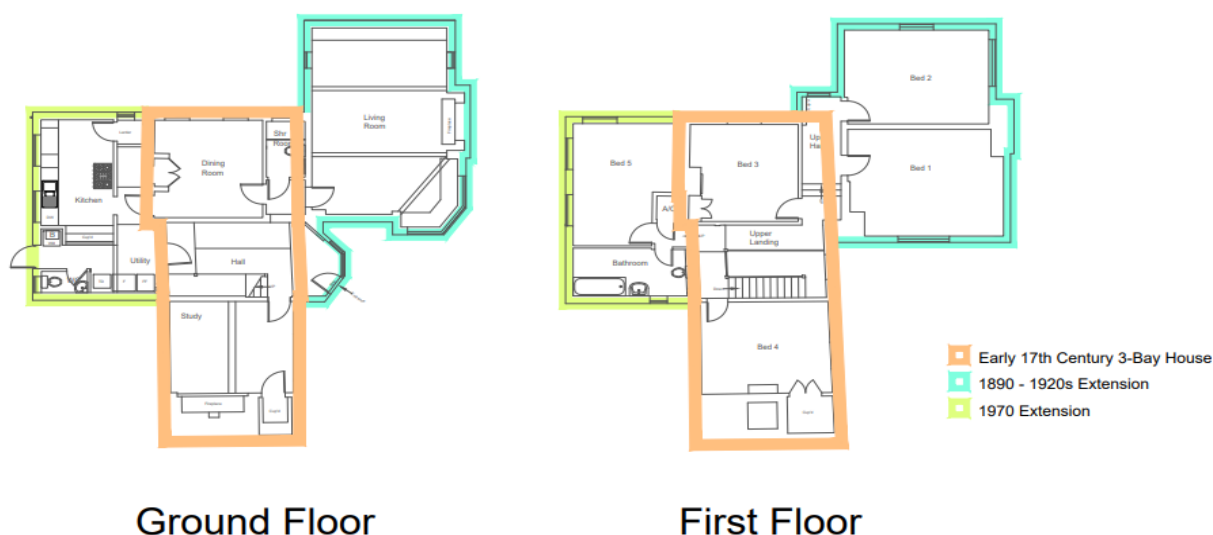
The house's architectural evolution, from its original 17th-century form to its present state, is reflected in the floor plans below. According to the listing, the 19th- and 20th-century extensions are not considered historically significant.

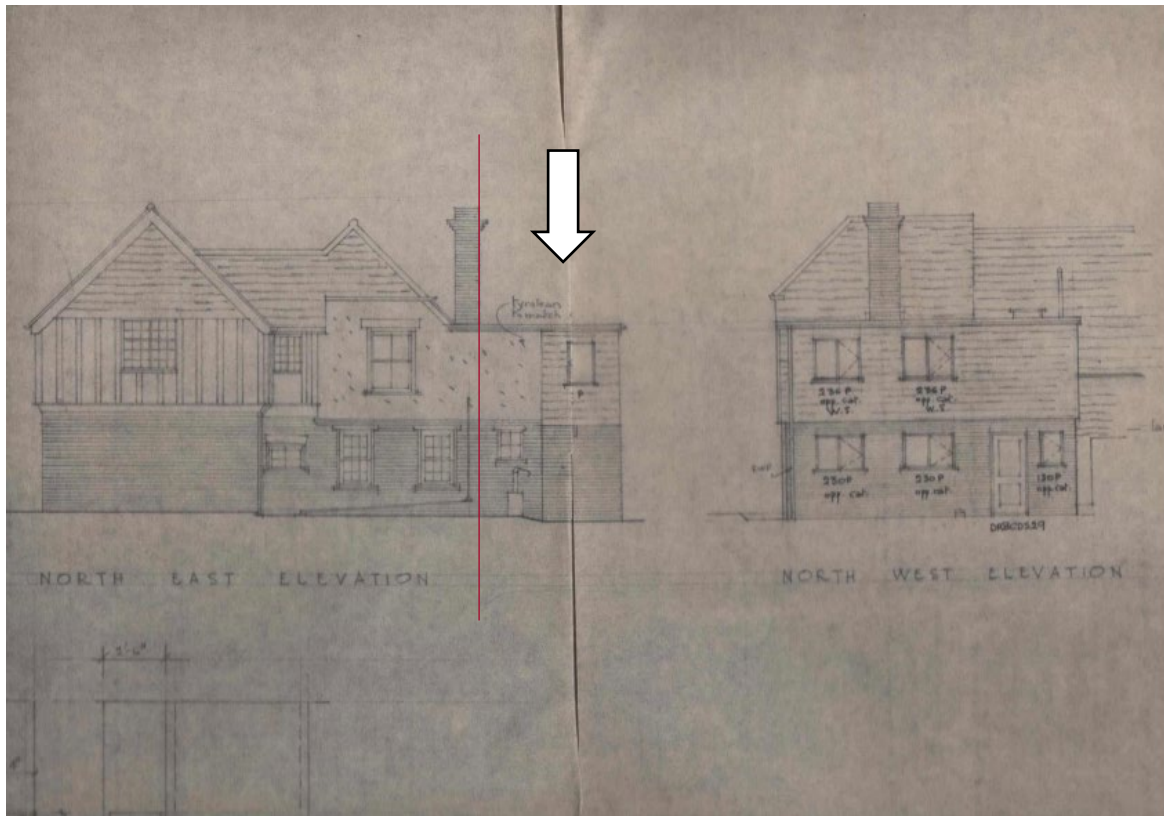
Elevation showing the 1970 two-storey extension to the west side of the house

The proposed works involve the partial demolition of non-original timber stud and blockwork partitions within the 1970 side extension to enhance the functionality of the space. New timber stud and plasterboard partitions will be installed to create a larger and more practical ground floor kitchen, as well as an ensuite for the first-floor bedroom. These alterations will improve the usability of the property while respecting its historical significance.

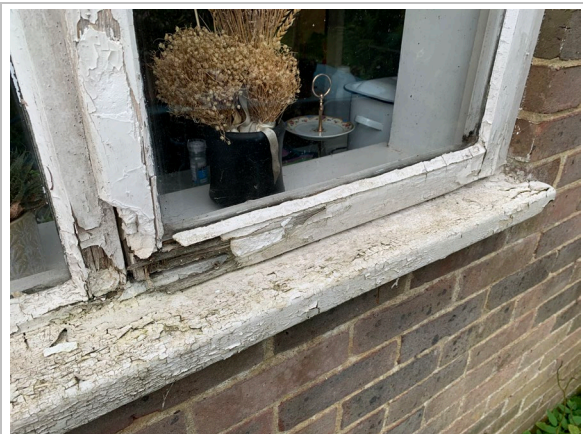
Image of rotten window to the side extension

The existing single glazed timber casement windows and doors in the 1970 extension are beyond repair, compromising both the living environment and the building's energy efficiency. Additionally, they do not complement the original architectural style of the house. Their poor thermal performance leads to heat loss, condensation issues, and increased energy consumption.

To address these concerns, it is proposed to replace the defective exterior windows and doors with new double-glazed timber casement units. These will be designed to reflect the proportions and detailing of the original building, ensuring they integrate well with the existing architecture. The use of traditional timber materials and matching profiles will enhance the property's character while improving weather resistance and energy efficiency. The replacement windows and doors will help maintain the building's overall appearance and functionality.

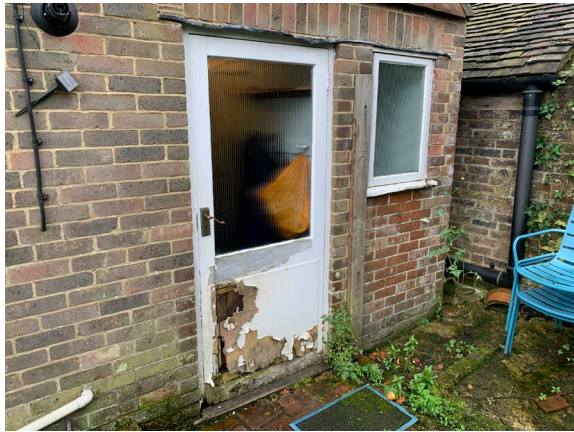
Image of rotten and damaged door to the side extension

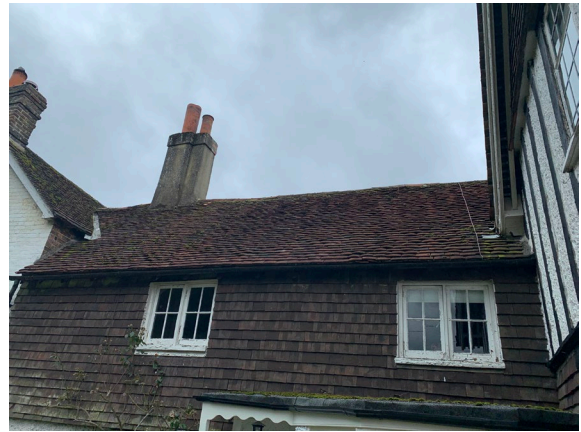
Front roof slope and chimney stack of the original roof.

The clay tiled roof is in poor condition, with frost-damaged and cracked hip and ridge tiles leading to water ingress. The lack of a felt underlay has contributed to leaks and internal damp issues. The tiles are not secured with nails, causing slippage, and there are visible gaps in the roof covering from within the roof space. The roof features a mix of machine-made and handmade clay peg and nib tiles, which reflect the building's historic character.

The old chimney stack, a prominent feature of the property, is experiencing degradation and water ingress, resulting in dampness affecting the internal fabric of the building. The large chimney pot is broken and challenging to maintain, while the lack of cowls on both pots further heightens the risk of water damage.

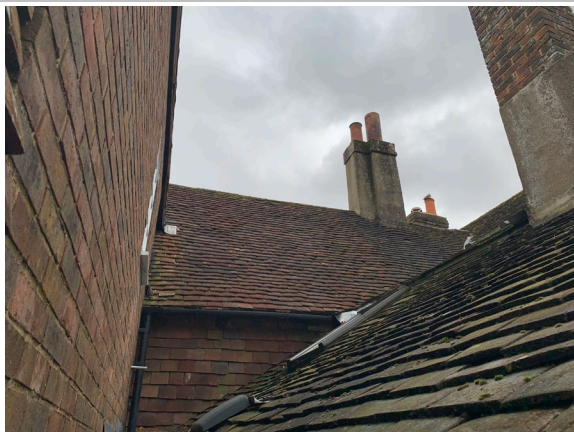
Rear roof slope and chimney stack of the original roof

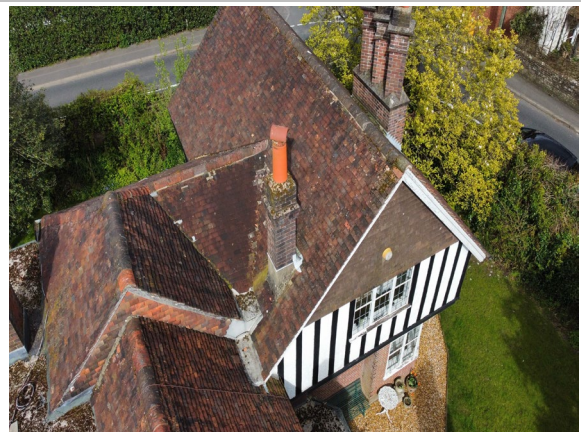
Pitched roof to original house and 19th Century extension

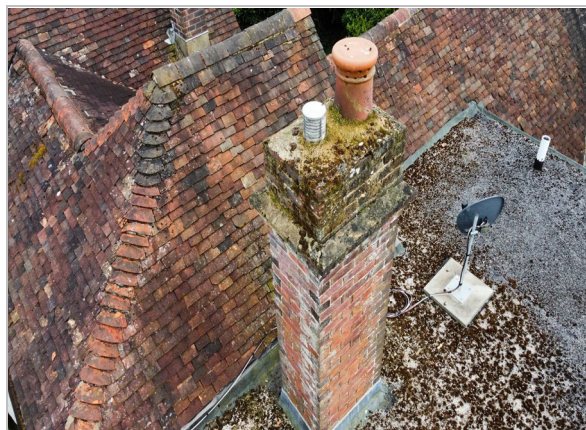
Original pitched roof to flat roof junction

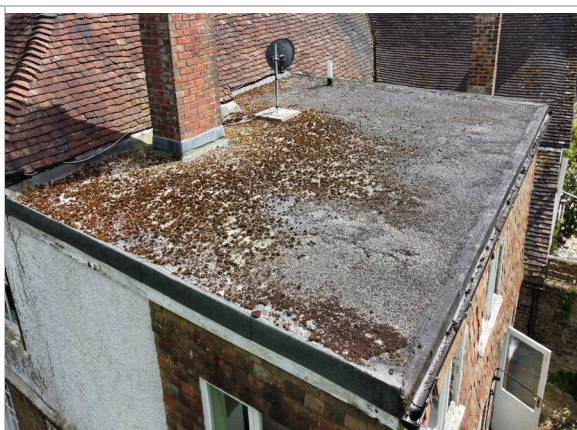
Flat roof to 1970 extension

The existing flat roof of the 1970s two-storey extension has reached the end of its lifespan, leading to water ingress, damp patches, and poor thermal performance. To address these issues, a dummy pitched roof is proposed, aligning with the ridge line of the original house. This will improve durability, insulation, and long-term maintenance while better complementing the property's appearance.

A full pitched roof was considered but deemed too dominant for the building. Instead, the existing flat roof will be retained and re-covered with high-performance felt, which will be concealed behind the dummy pitched structure. The new dummy pitched roof will be covered with matching clay tiles, using either reclaimed or carefully selected new materials to blend with the existing roofs. The vertical section of the dummy roof will feature tile hanging to match the exterior of the house.

The dummy pitched roof will be built on three sides, with a gap left at the rear for drainage. The existing roof joists will be reinforced to support the new structure. The slope of the retained flat roof section will be adjusted to improve drainage. A concealed, openable skylight will be installed in the flat roof section to allow natural light and ventilation to the upstairs landing, as well as provide access for maintenance.
