## Foul and Surface Water Drainage Report

Land Adjacent to the Meadow Little Park Farm, Hurstpierpoint

Planning Ref: DM/25/1549

Reference C3917

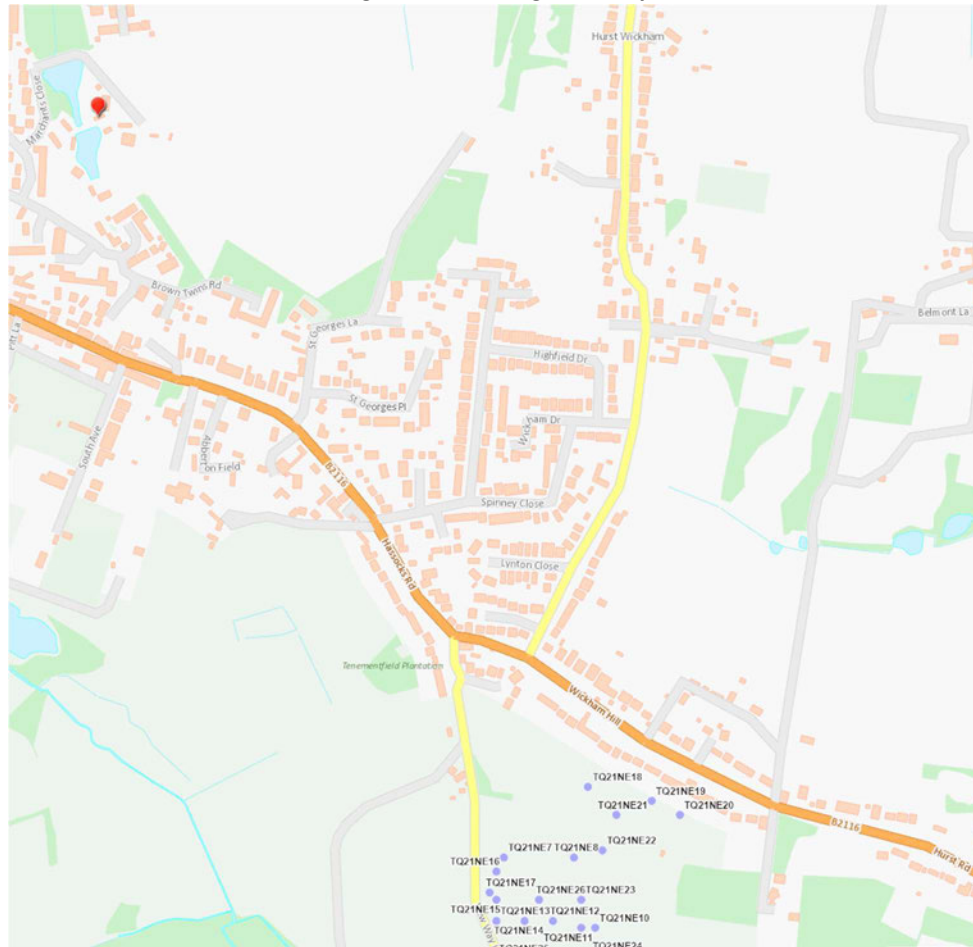
**Fig 3. British Geological Survey**

**Snippet from BGS Website showing Historical Borehole Logs location**
