**BS5837:2012 TREE SURVEY AND  
ARBORICULTURAL IMPACT ASSESSMENT:  
Fairhaven, Abberton Field, Hurstpierpoint, BN6 9QD**

Dated: 30<sup>th</sup> January 2026

Our reference: GHA/DS/160579:26

Location: Fairhaven, Abberton Field, Hurstpierpoint, BN6 9QD  
Our reference: GHA/DS/160579:26  
Client: Harp & Bright Ltd  
Dated: 30<sup>TH</sup> January 2026  
Prepared by: Glen Harding MICFor, MSc (Forestry), MArborA  
Date of Inspection: 26<sup>th</sup> January 2026

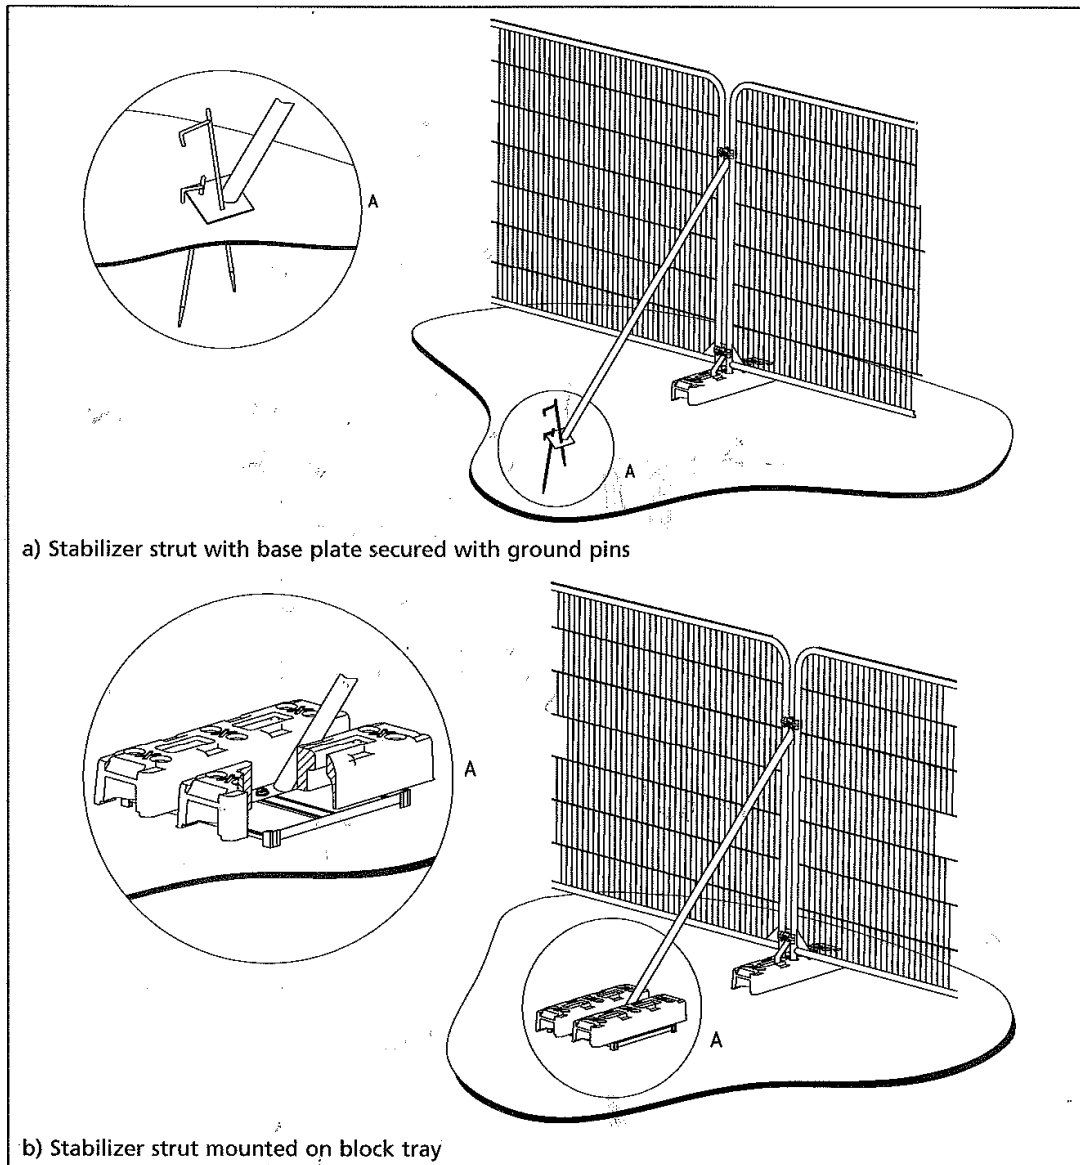
Figure 3 Examples of above-ground stabilizing systems

**Appendix C**  
**TREE FENCING DETAIL**

It is essential for the future health of the trees to be retained on site, that all development activity is undertaken outside the root protection zone of these trees. The position of the fence **MUST** be marked out with biodegradable marker paint on site and agreed with appropriate representatives from the LPA and contractor. The fencing **MUST** be erected **prior** to any works in the vicinity of the trees and removed only when all development activity is complete. The protective fencing **MUST** be as that shown in BS 5837 (see Appendix C). The herras panels **MUST** be joined together using a minimum of two anti-tamper couplers which **MUST** be installed so they can only be removed from the inside of the fence. The panels **MUST** supported by stabilizer struts, which **MUST** be installed on the inside and secured to the ground using pins or appropriate weights.
