PROJECT:  
83 High Street  
Lindfield, West Sussex  
RH16 2HN

DRAWING:  
Sectional Elevations, and Outbuilding  
2 Elevations - As Proposed

| JOB NO.<br>GH941 | DRAWING NO.<br>PL.005 | REV.<br>A |

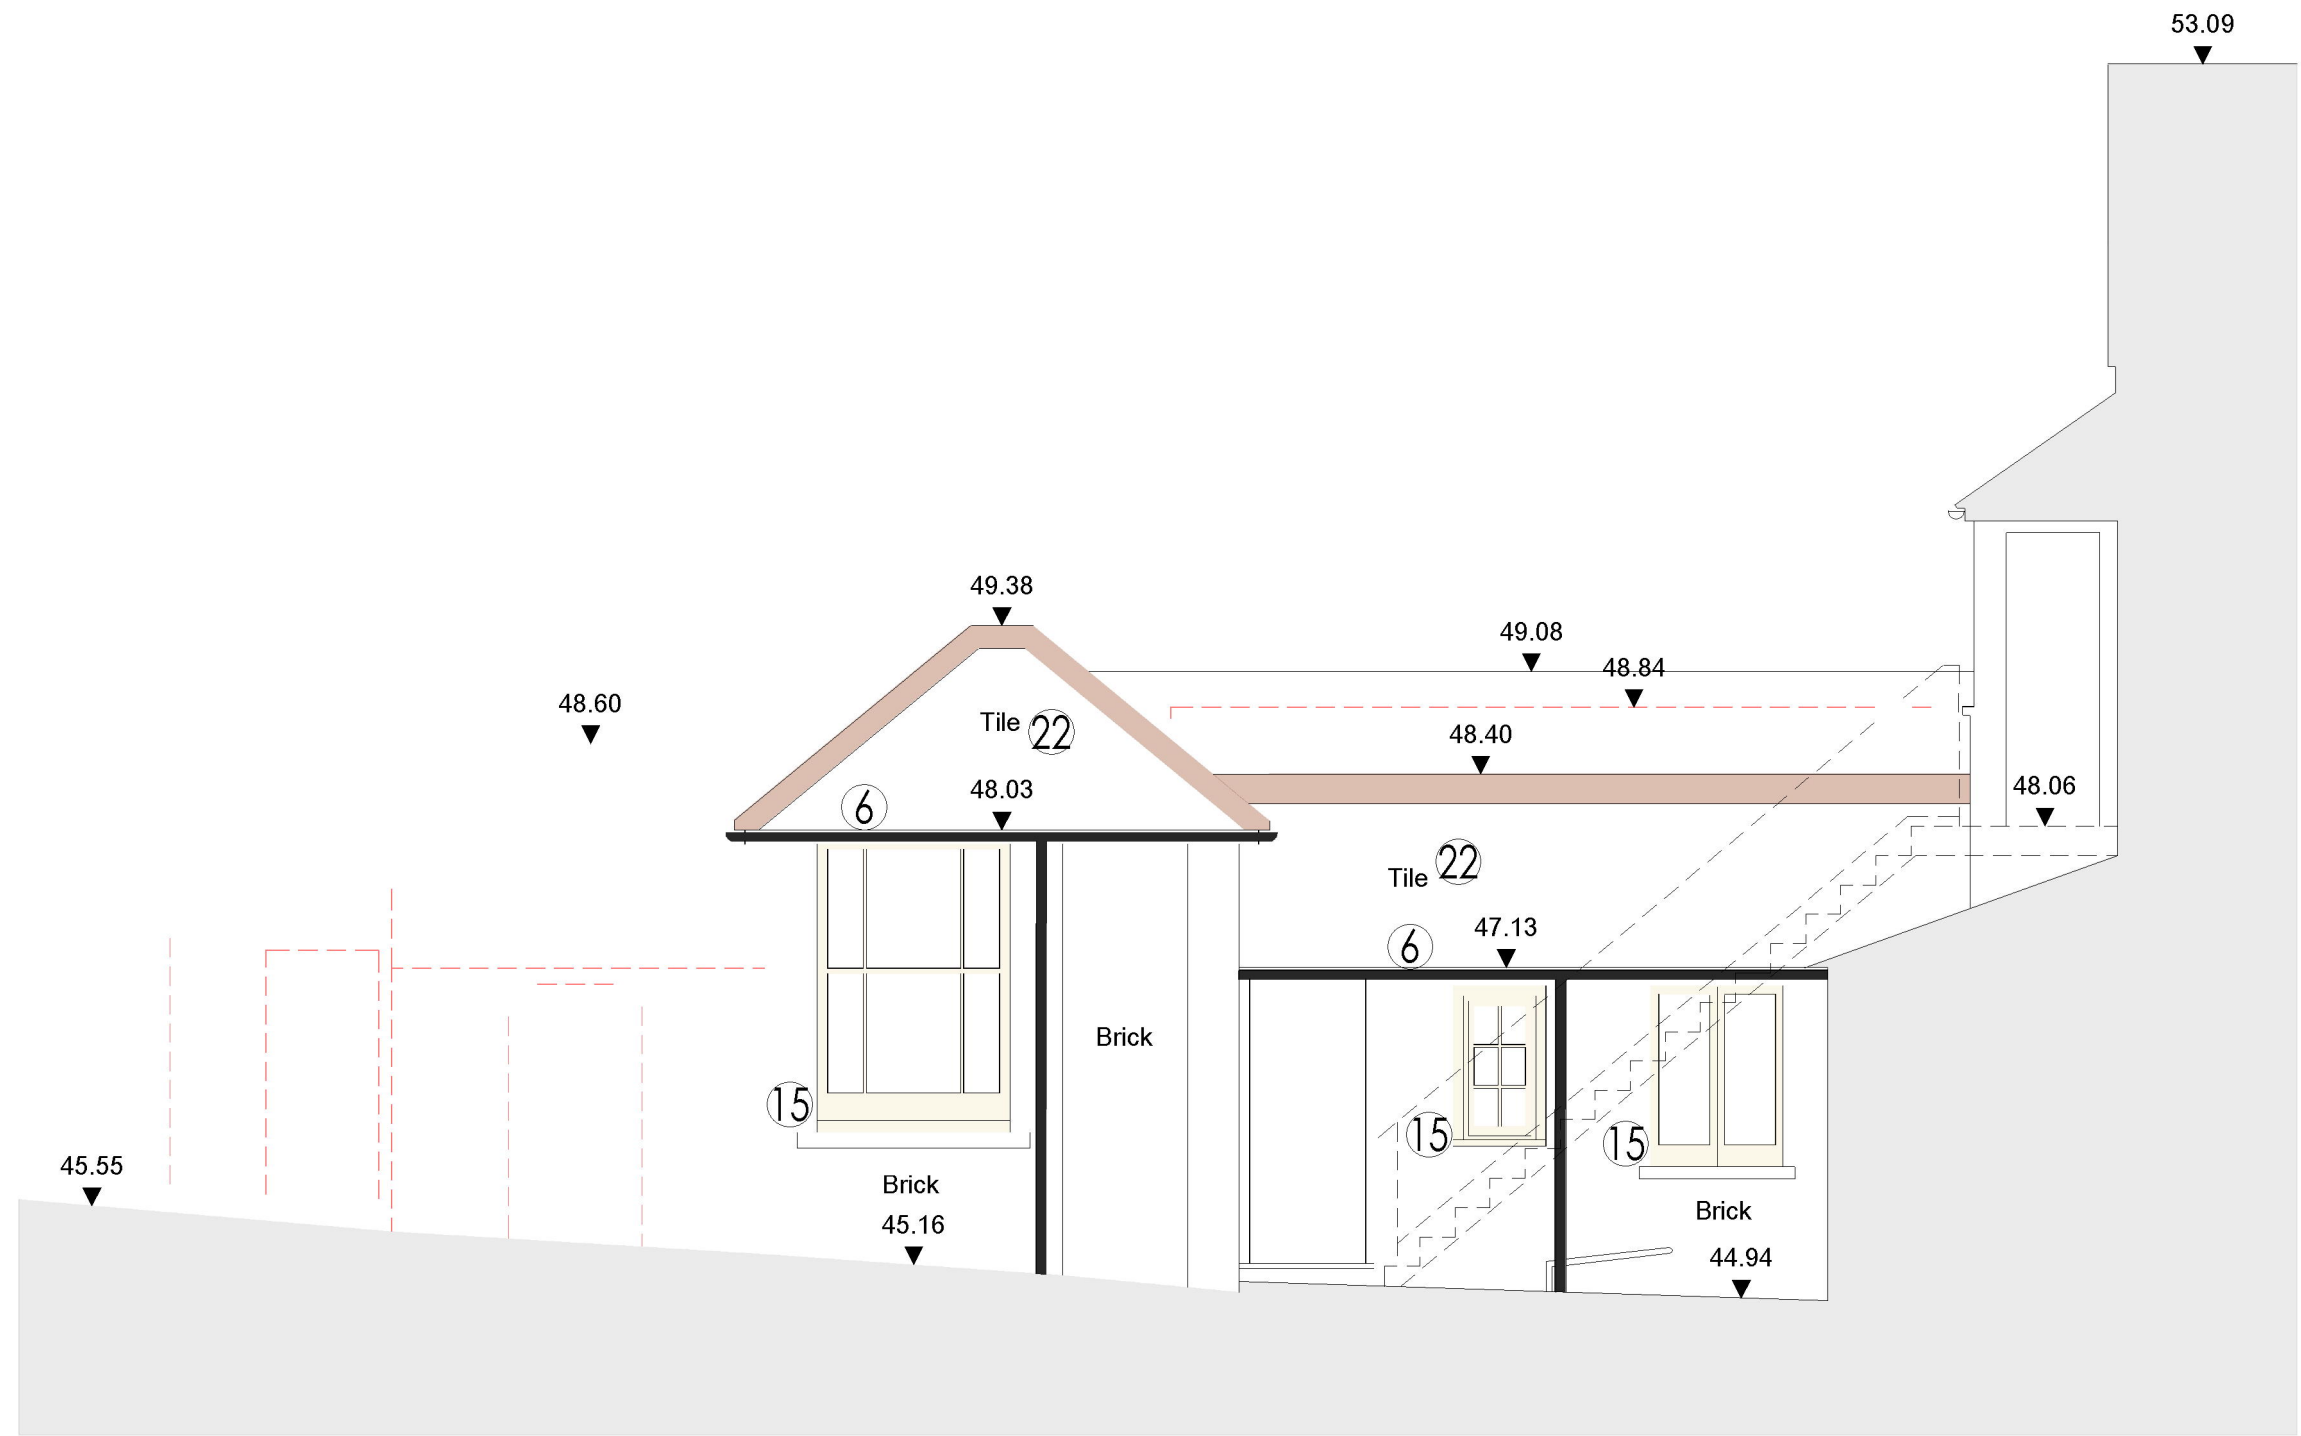
SOUTH SECTION ELEVATION - THROUGH COURTYARD - AS PROPOSED  
SCALE @ 1:50 ON AN A1 SHEET

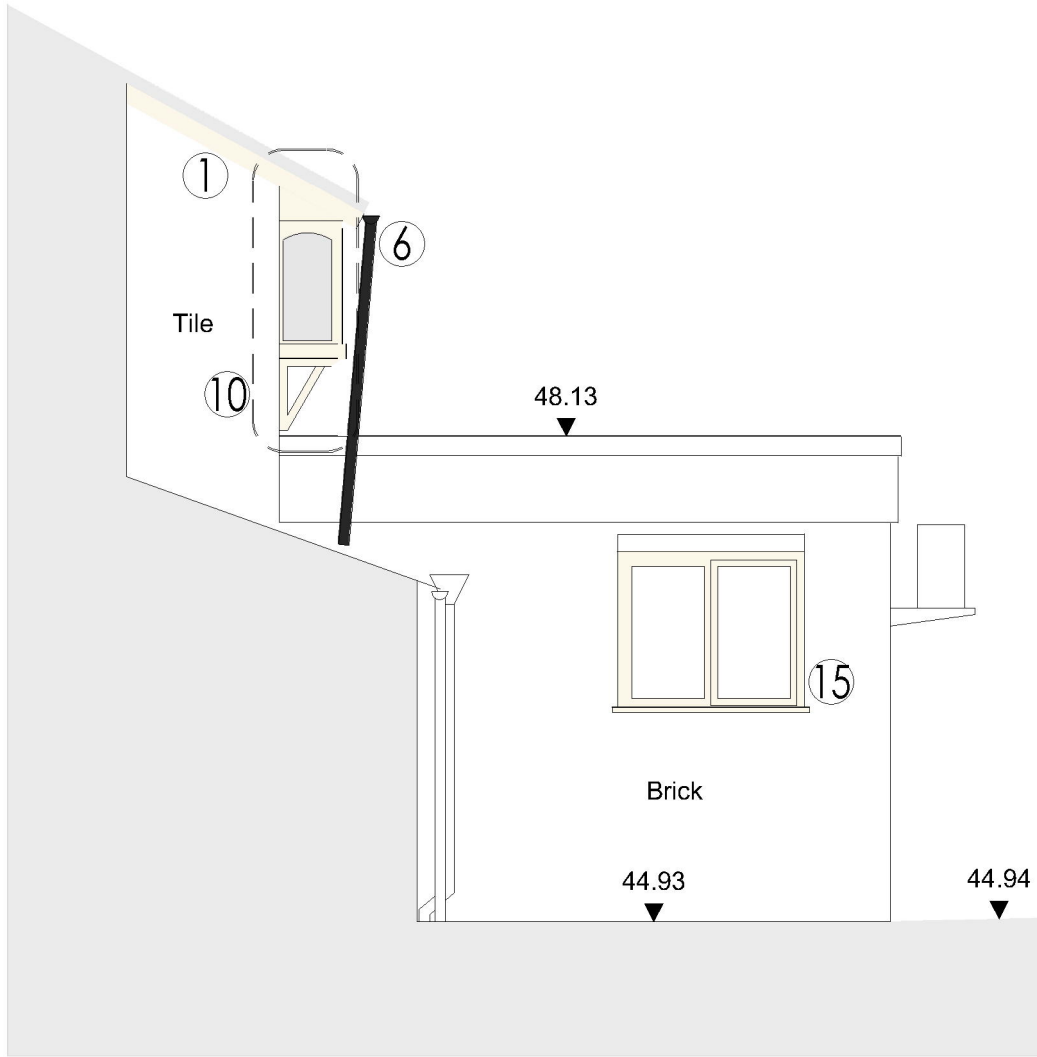
NORTH SECTION ELEVATION - THROUGH COURTYARD - AS PROPOSED  
SCALE @ 1:50 ON AN A1 SHEET

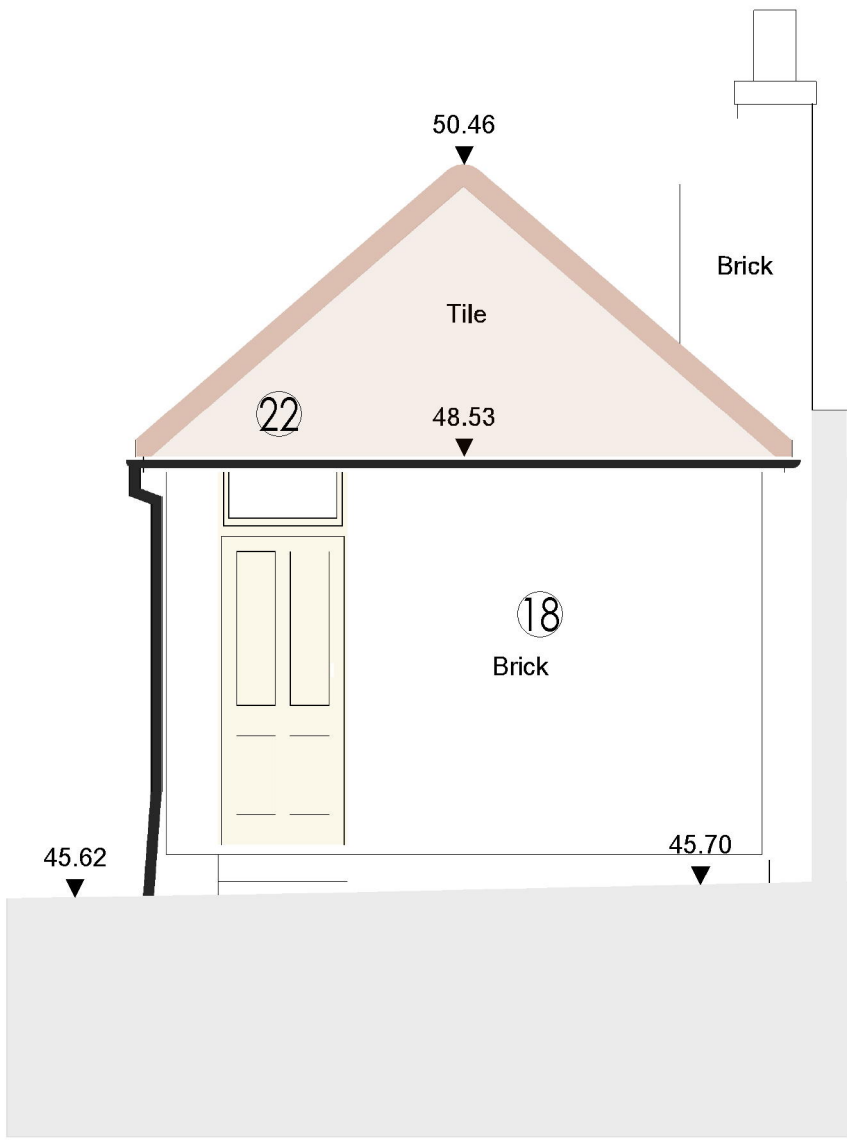
OUTBUILDING 2 EAST  
ELEVATION - AS PROPOSED  
SCALE @ 1:50 ON AN A1 SHEET

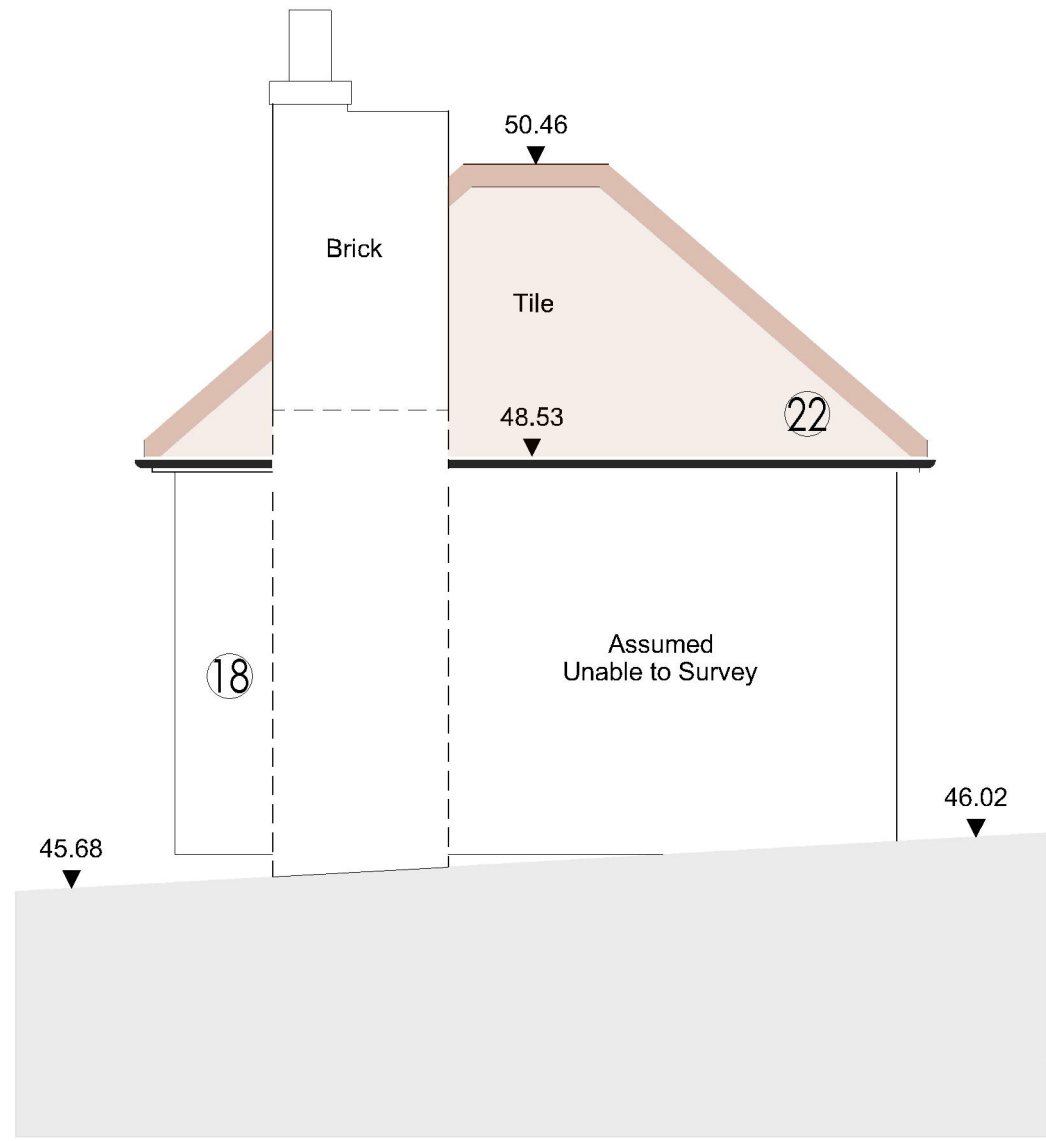
OUTBUILDING 2 NORTH  
ELEVATION - AS PROPOSED  
SCALE @ 1:50 ON AN A1 SHEET

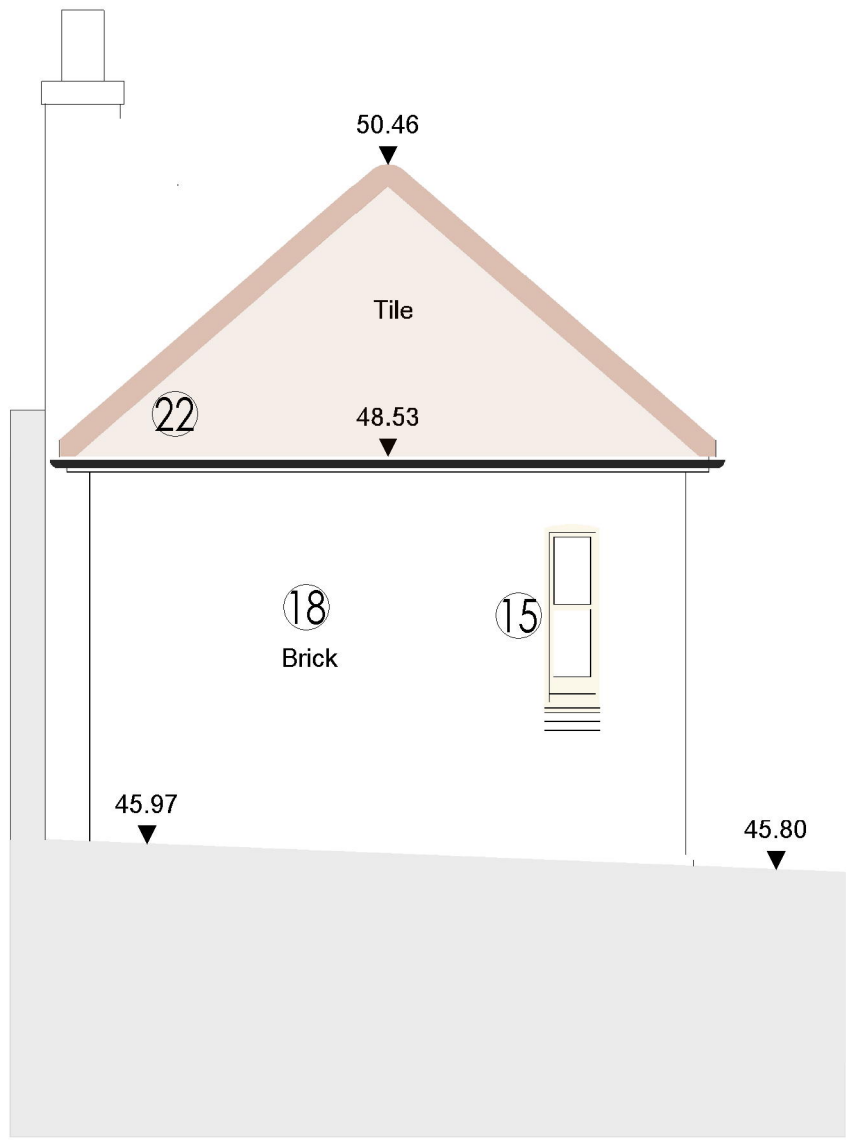
OUTBUILDING 2 WEST  
ELEVATION - AS PROPOSED  
SCALE @ 1:50 ON AN A1 SHEET

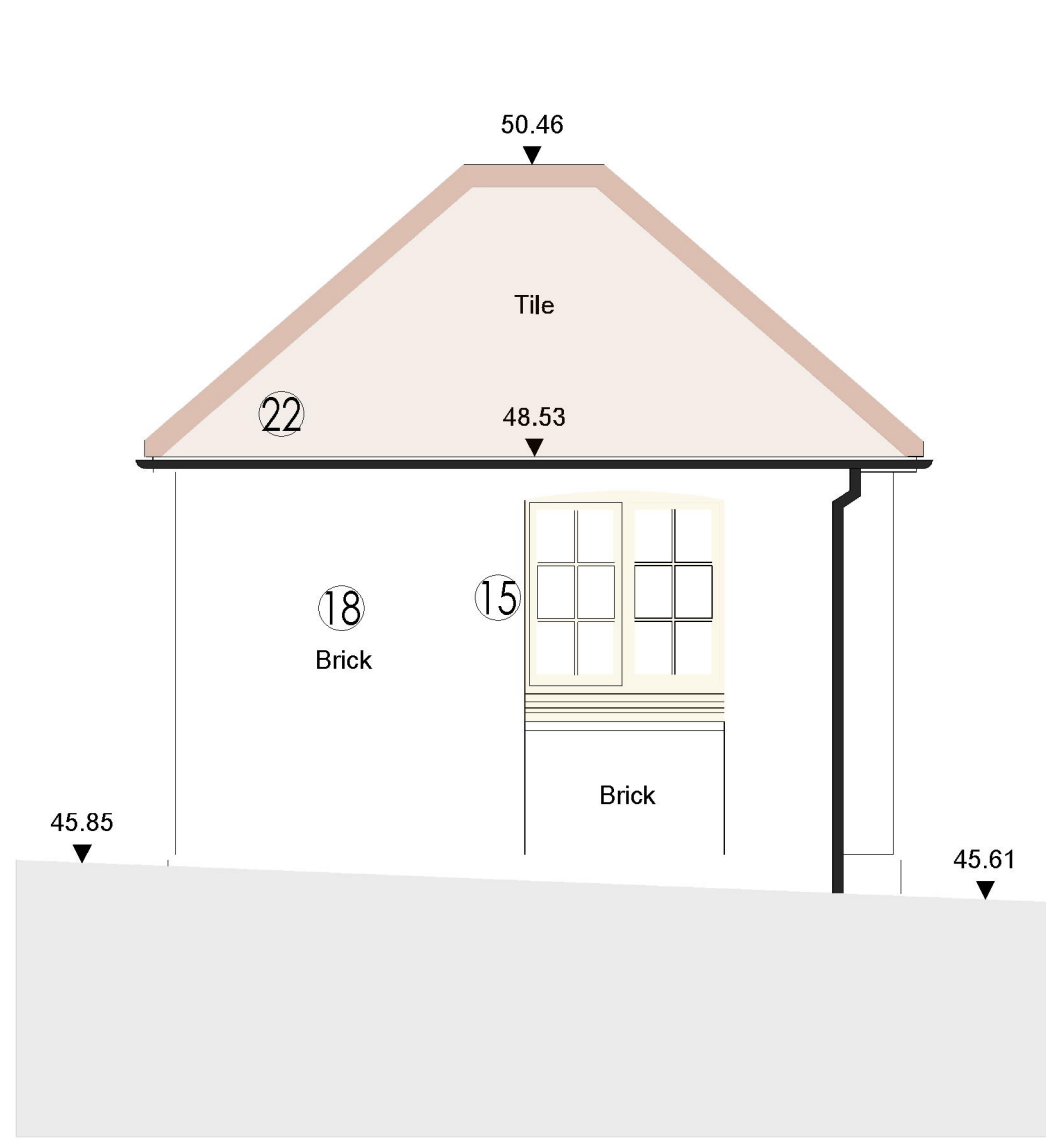
OUTBUILDING 2 SOUTH  
ELEVATION - AS PROPOSED  
SCALE @ 1:50 ON AN A1 SHEET
