# Tree survey for Balcombe Cricket Club for site for replacement cricket nets

Henry le Fleming

January 20<sup>th</sup> 2026

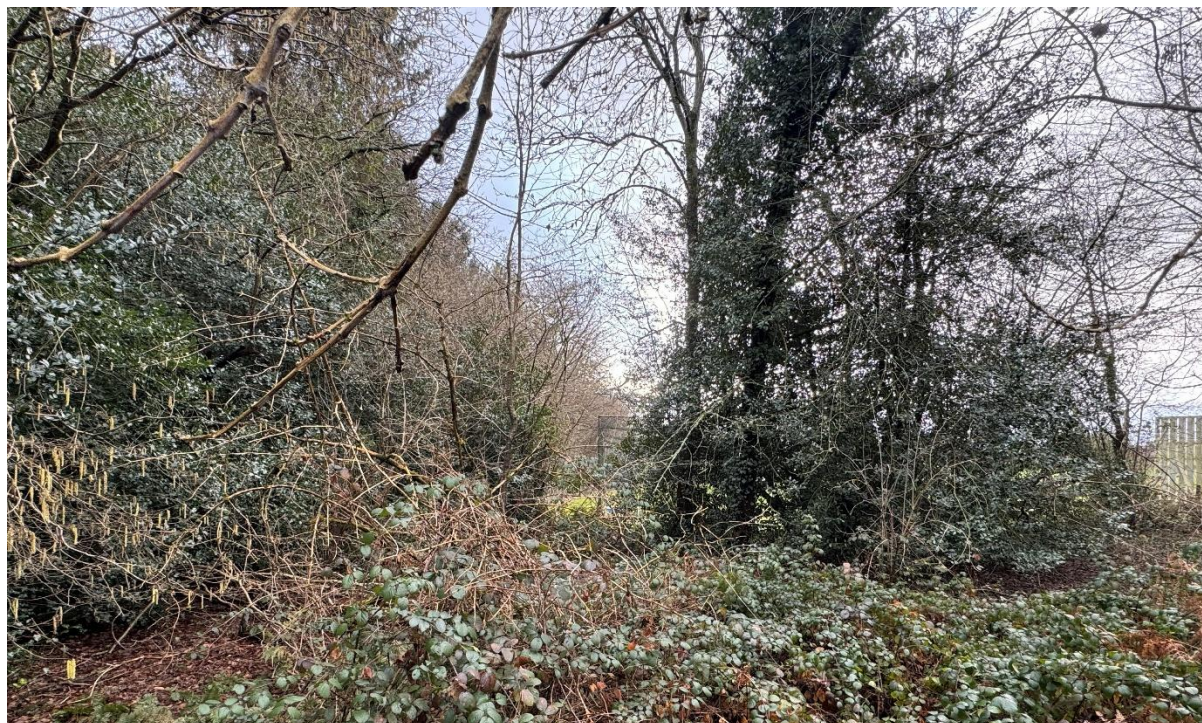
**Figure 1: View of the woodland from end of proposed nets towards existing nets**

Figure 1 shows the view from the end of the proposed site back towards the existing nets. The area is largely clear of trees. There is a group of trees on the boundary of the cricket field. The species are holly and ash. These trees would need to be removed to complete the work.

The existing habitat comprises an area of bramble and bracken, together with 6 mature holly and ash trees, the latter suffering from ash dieback (*chalara fraxinea*). A pre-development habitat survey of the area suggests that it is in a moderate condition and that the area is of level 2 significance.

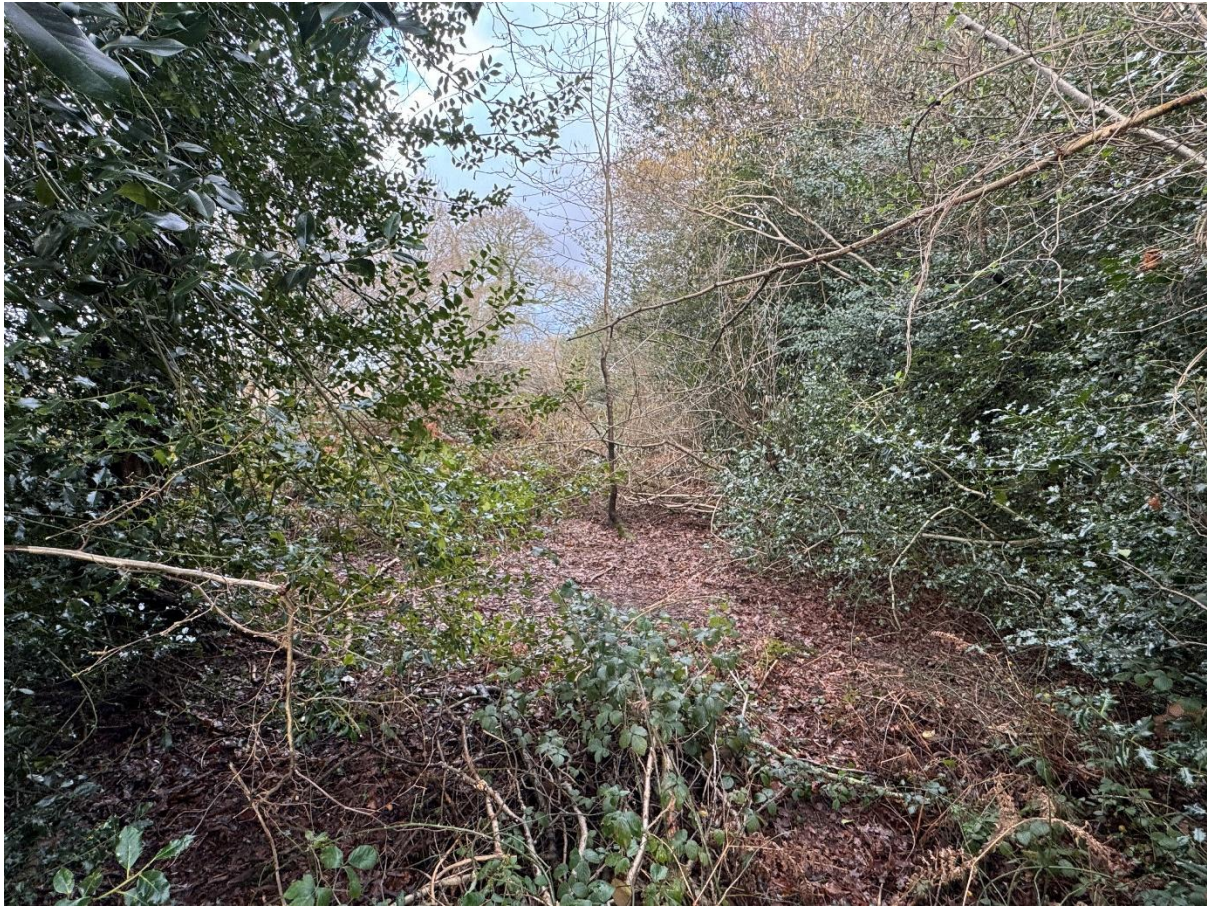
**Figure 3: View from the existing nets towards the proposed site**

Figure 2 below shows the view from the boundary towards the proposed site with the group of ash and holly and the left of the picture.

Further to the North East of the proposed area is an opening in the canopy. Some planting of mixed deciduous trees could occur in this area to replace the trees removed on the boundary.

The right hand side of the photo shows the trees in the neighbouring woodland called Braky wood. The photo shows limited canopy growth from the woodland over the site. There are some lower growth holly trees and some branches, but the canopy is not closed above the proposed site.

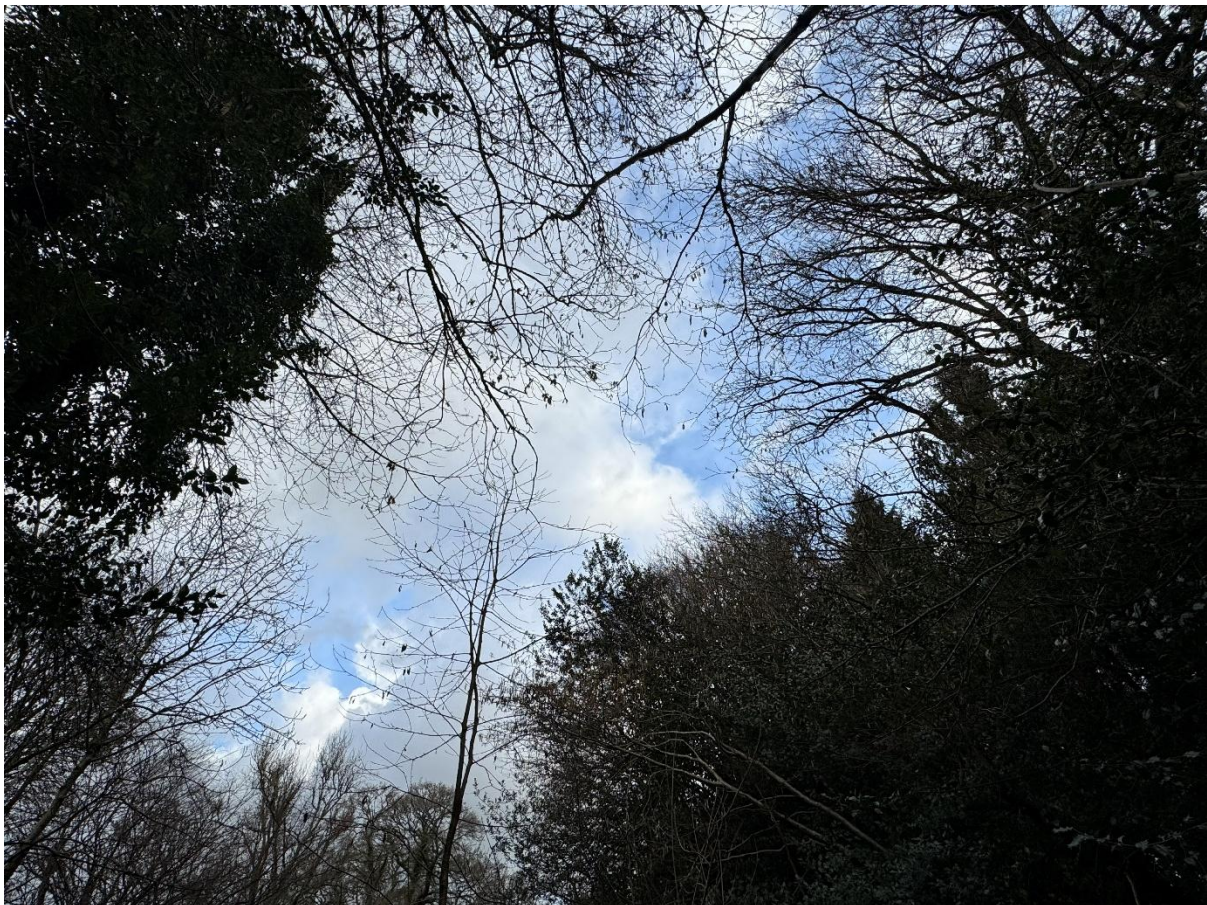
**Figure 4: canopy above the proposed site**

None of the canopies from any of the trees in Braky Wood reach over the area of the proposed work. It is therefore unlikely that the excavation and installation of light concrete pad will not significantly impact the root zone of the trees in Braky Wood. Figure 4 shows the canopy above the proposed site.
