DC/SO/1331

## DESIGN AND ACCESS STATEMENT

Lemon Meadow  
Turners Hill Road  
Crawley Down  
RH10 4EY

November 2025

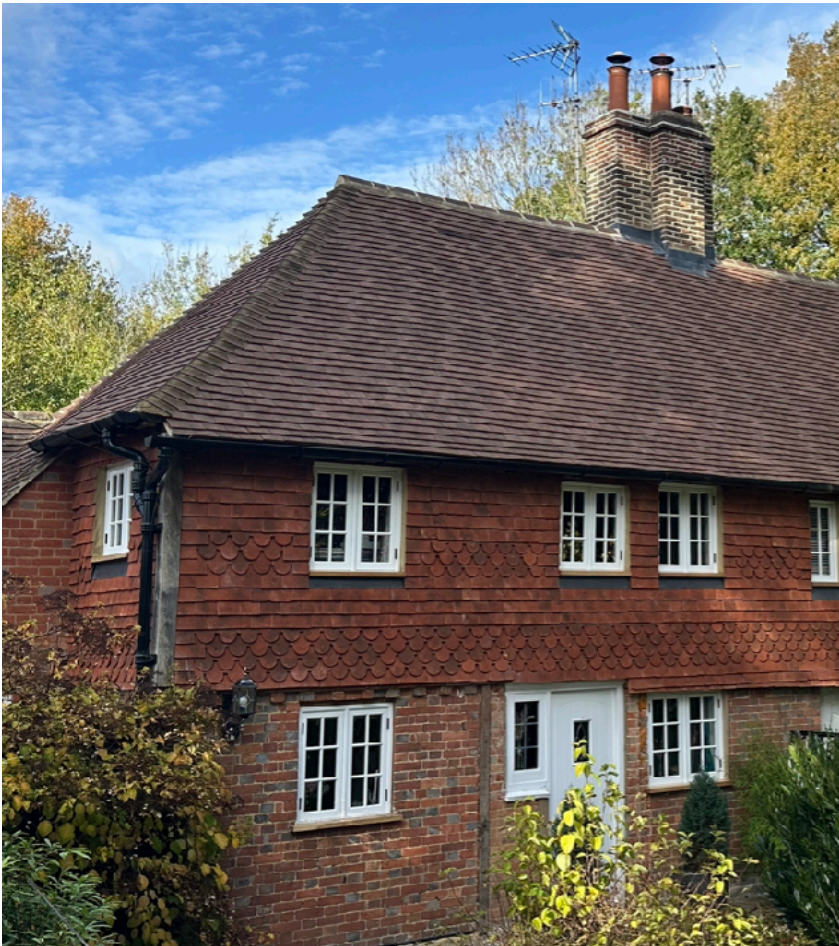
Plate 1: Lemon Meadow - front elevation
