**CUCKFIELD GOLF CENTRE**

**DRAINAGE STATEMENT**

Tumu Consulting have been appointed by Arena Global Management Ltd (AGM) to produce a drainage design to discharge Condition 5 and 6 of the Appeal Decision, REF APP/D3830/W/22/3310444. This development in comprises *“Change of use of land to storage in association with golf club and proposed erection of a storage barn for equipment and vehicles incorporating staff welfare facilities”* at Cuckfield Golf Centre, Staplefield Rd, Cuckfield, Haywards Heath, RH17 5HY.

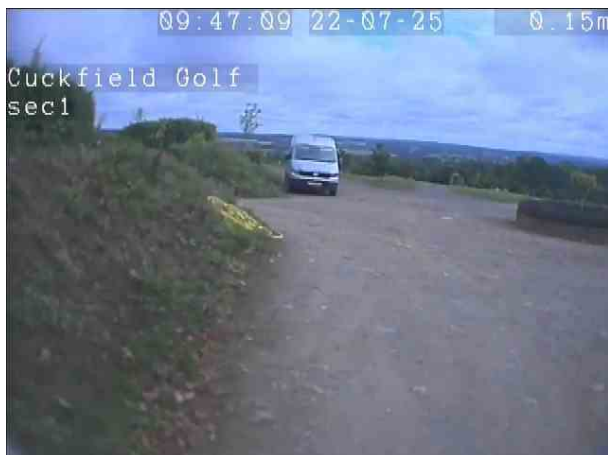
Start node, manhole, reference: RG1, over view of area

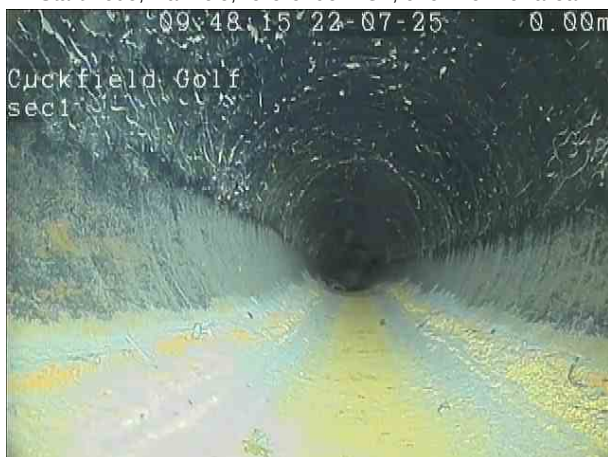
Water level, 0% of the vertical dimension

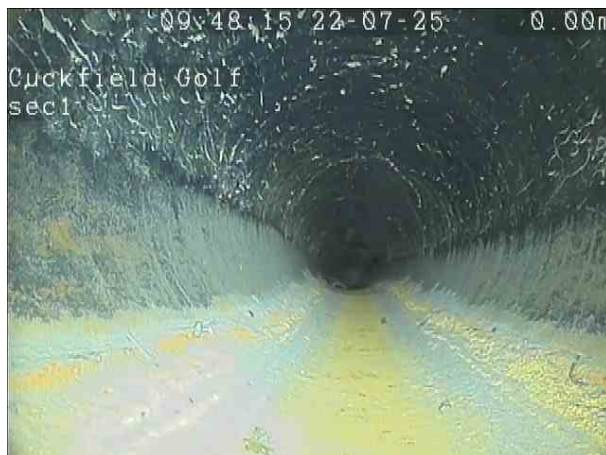
General photograph taken at this point, view inside RG1

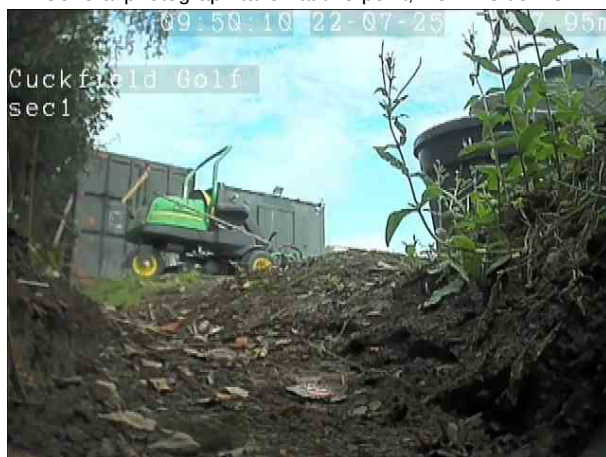
Finish node, manhole, reference: Ditch A, ditch

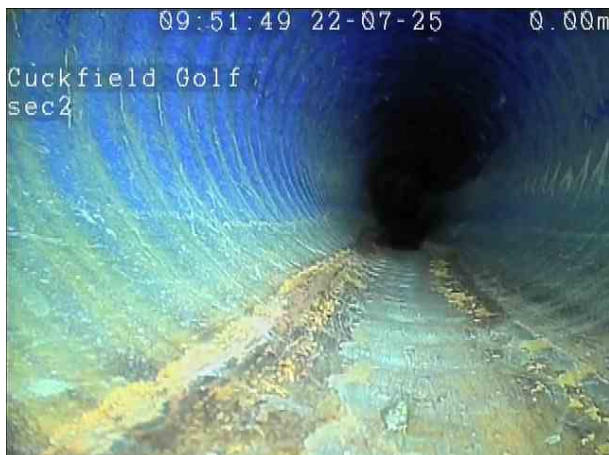
Water level, 0% of the vertical dimension

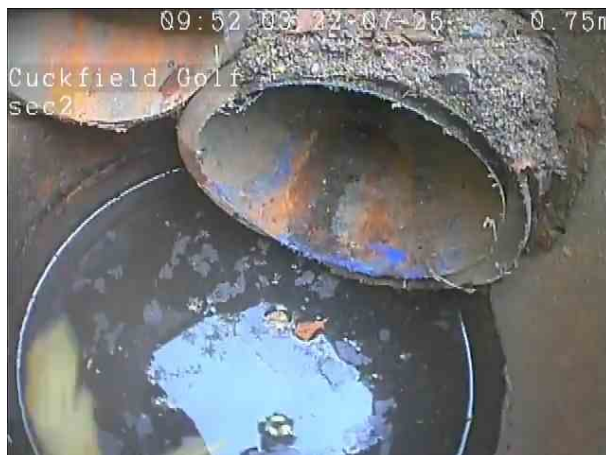
General photograph taken at this point, inlet pipe

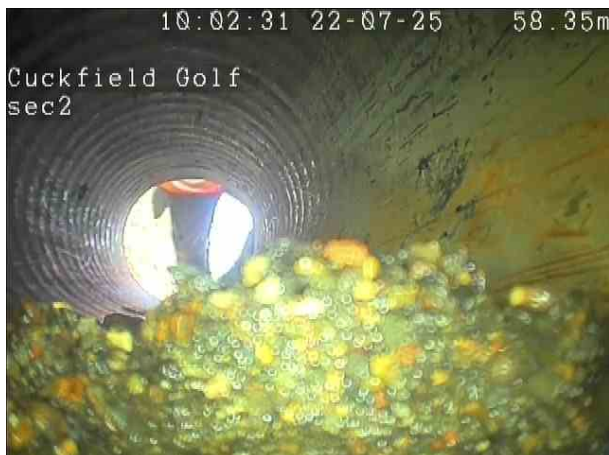
Finish node, manhole, reference: Outfall

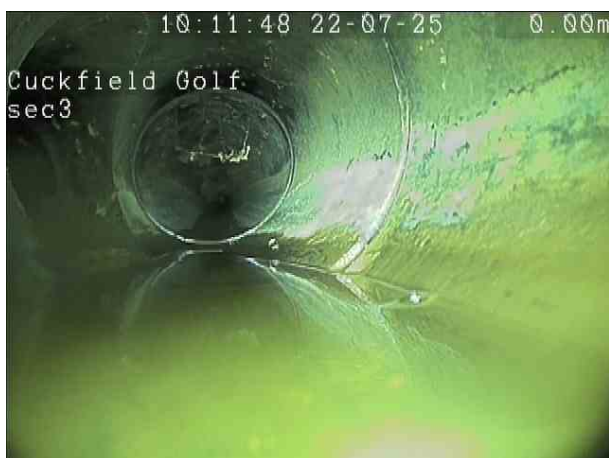
Water level, 10% of the vertical dimension

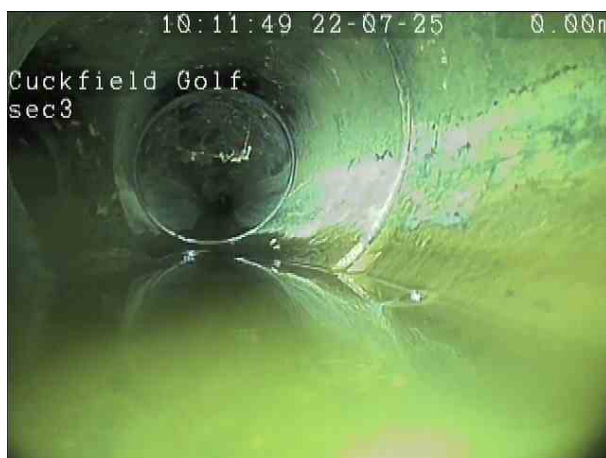
Junction at 9 o'clock, 150mm dia, serves gully

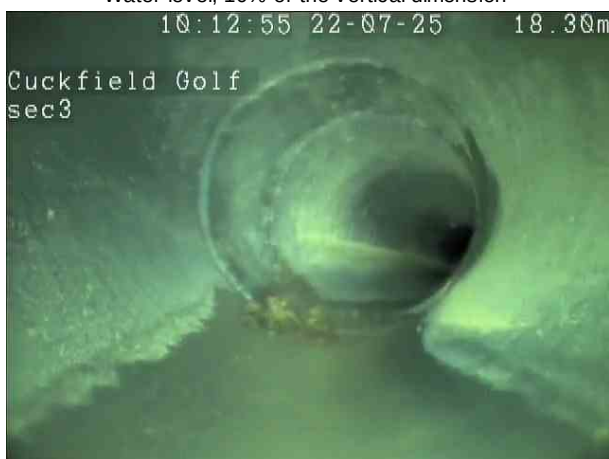
Line deviates right, slight bend

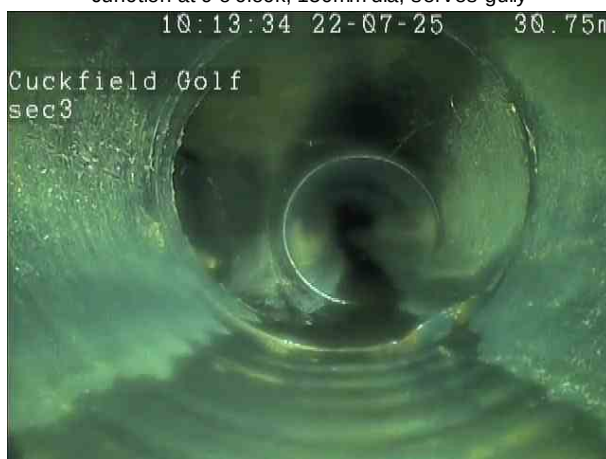
Junction at 9 o'clock, 150mm dia

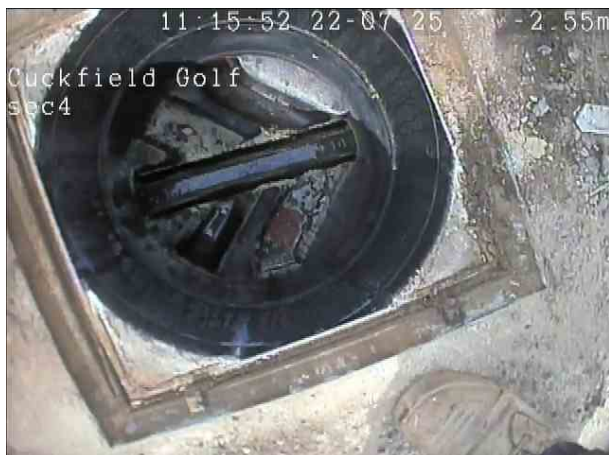
General photograph taken at this point, view inside FW4

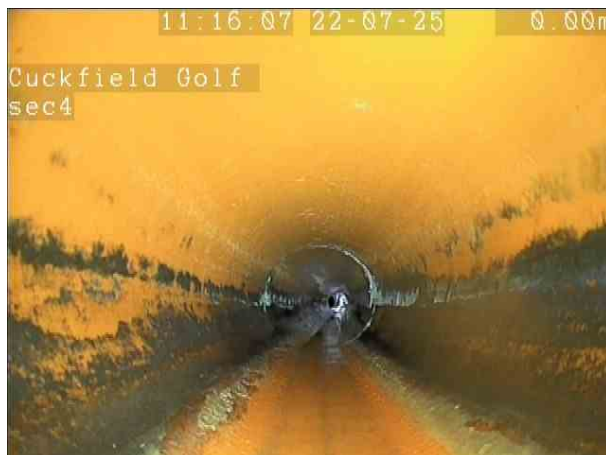
Water level, 0% of the vertical dimension

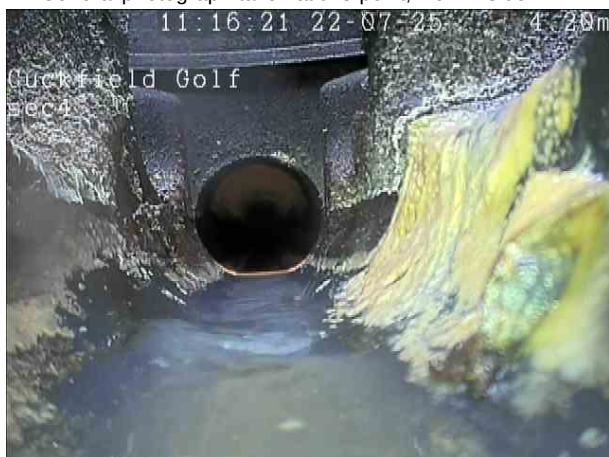
Finish node, manhole, reference: FW3

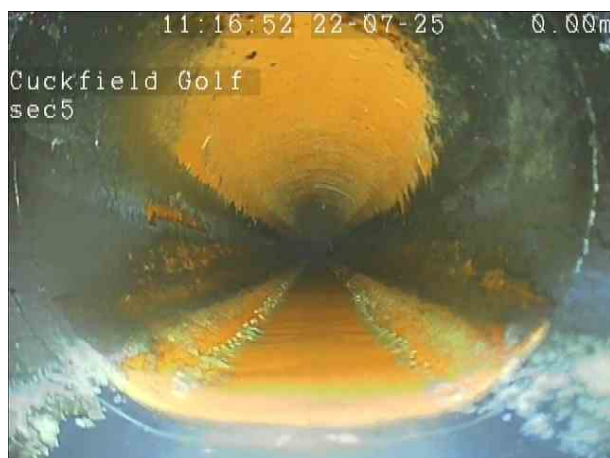
Water level, 0% of the vertical dimension

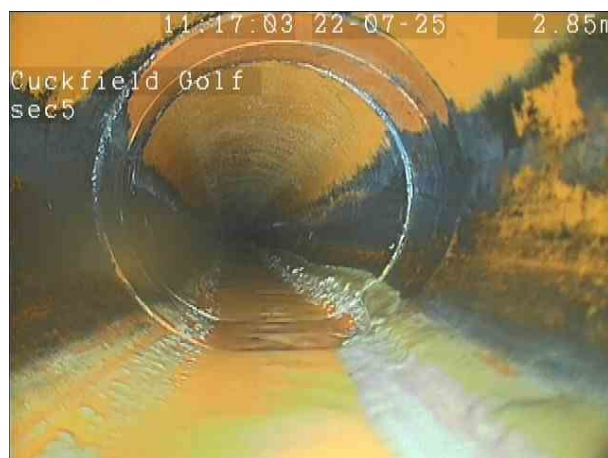
Line deviates left, slight bend

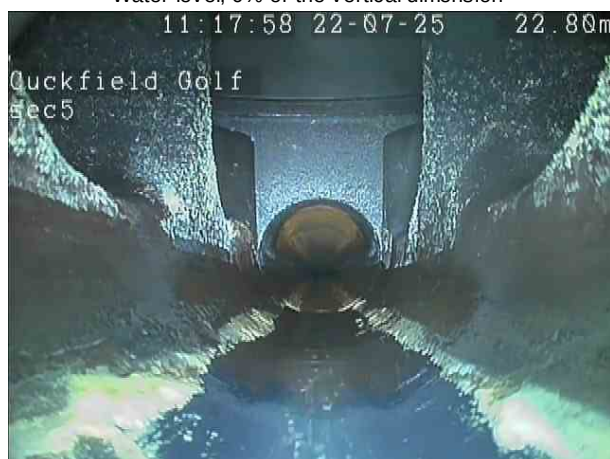
Finish node, manhole, reference: FW2, buried manhole

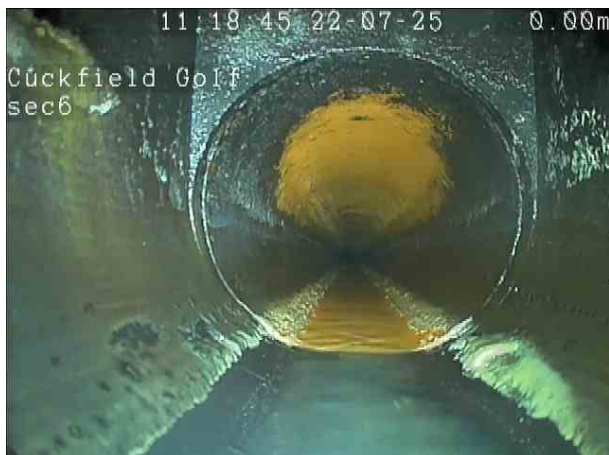
Water level, 10% of the vertical dimension, Live

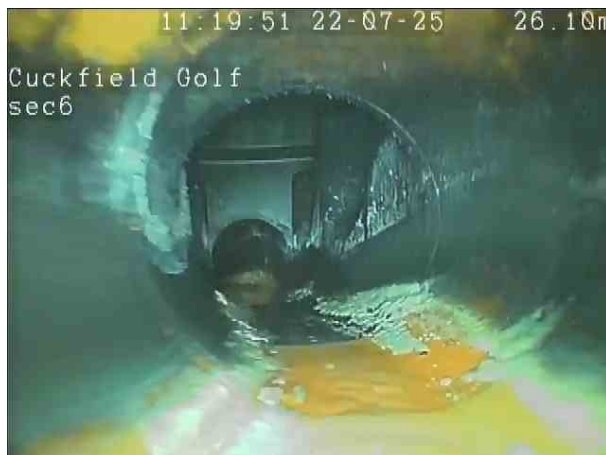
Line deviates left, slight bend

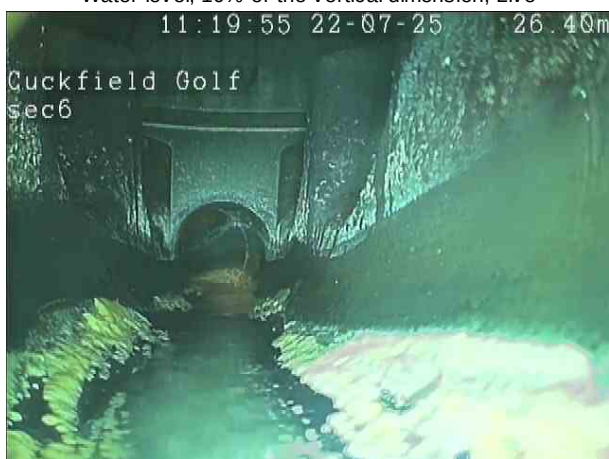
Finish node, manhole, reference: FW1

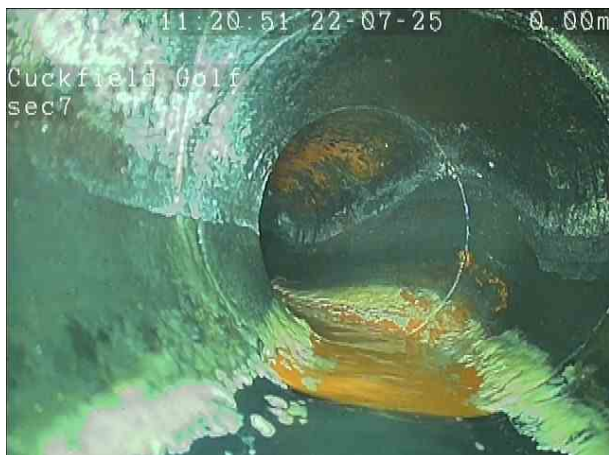
Water level, 5% of the vertical dimension, Live

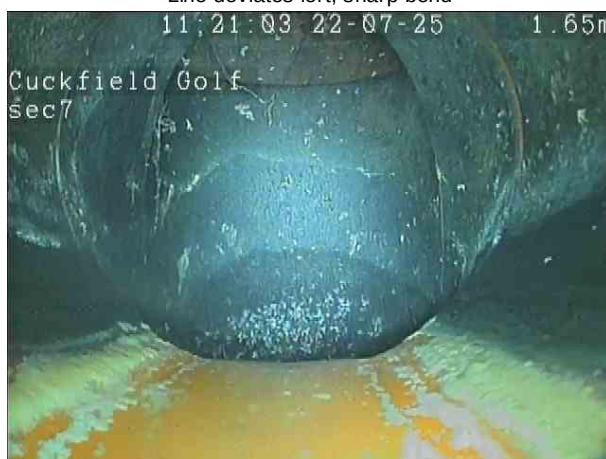
General photograph taken at this point, dipper pipe view

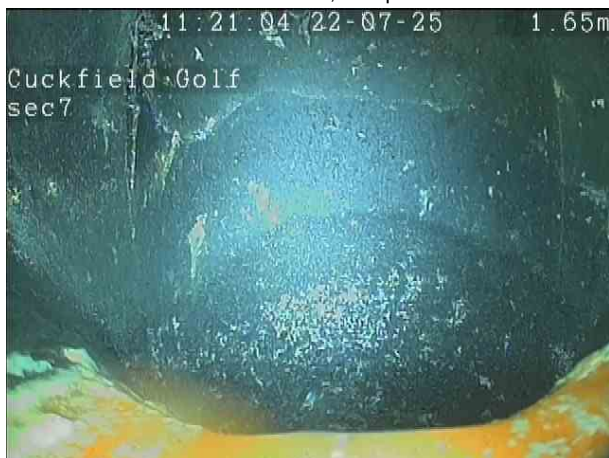
Finish node, manhole, reference: Treatment

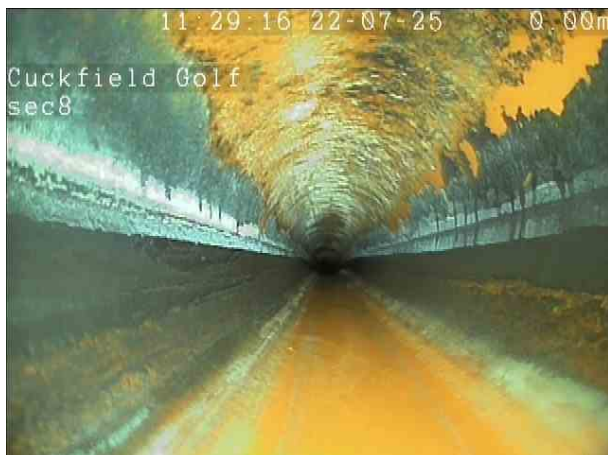
Water level, 10% of the vertical dimension, Live

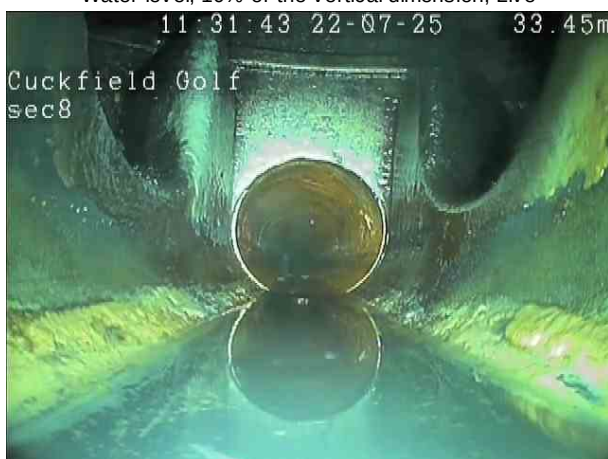
Finish node, manhole, reference: FW5

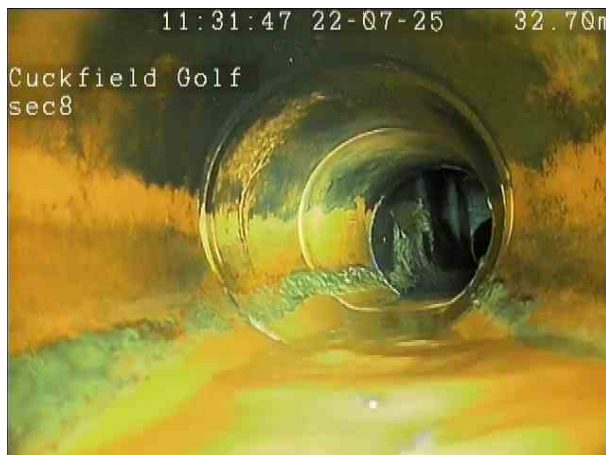
Line deviates right, slight bend

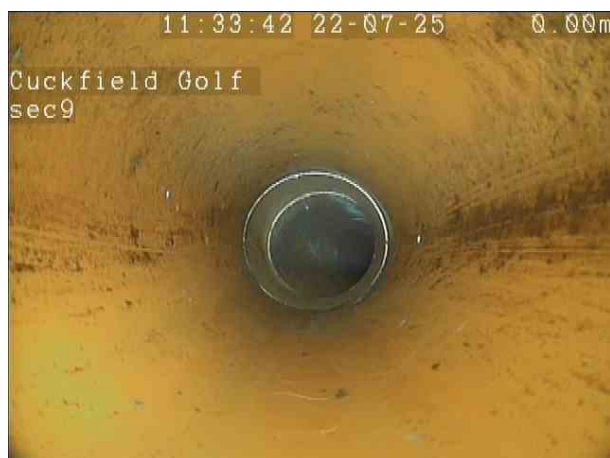
Water level, 0% of the vertical dimension

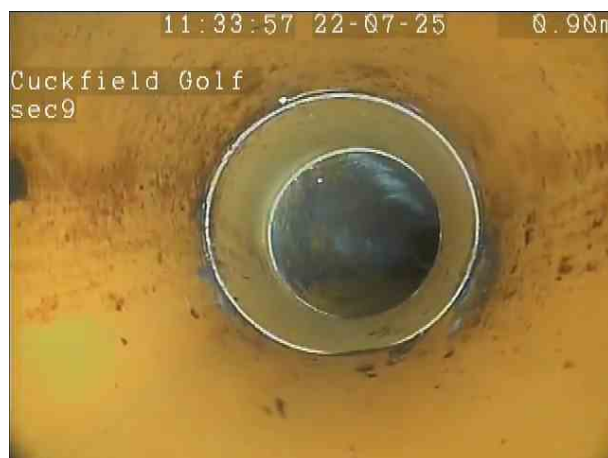
Line deviates right, slight bend

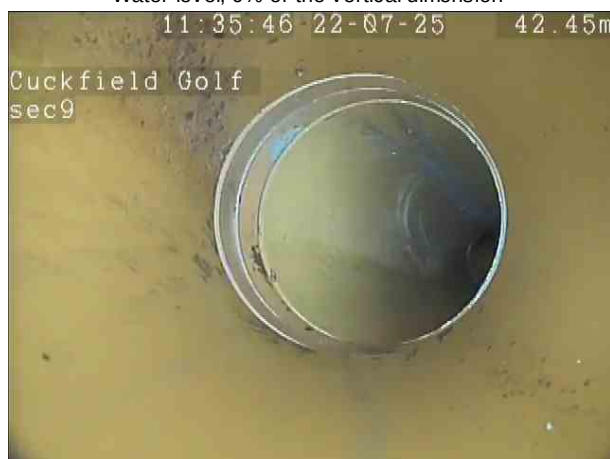
Line deviates right, slight bend

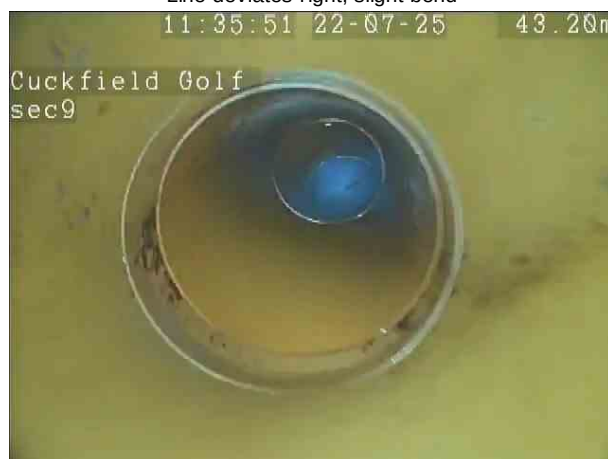
Line deviates up, slight bend

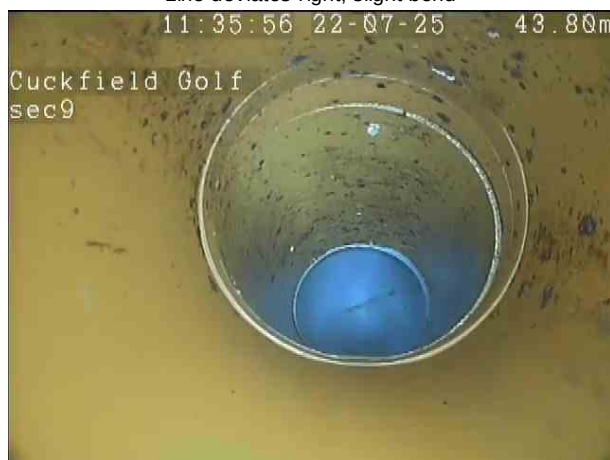
General photograph taken at this point, line straight

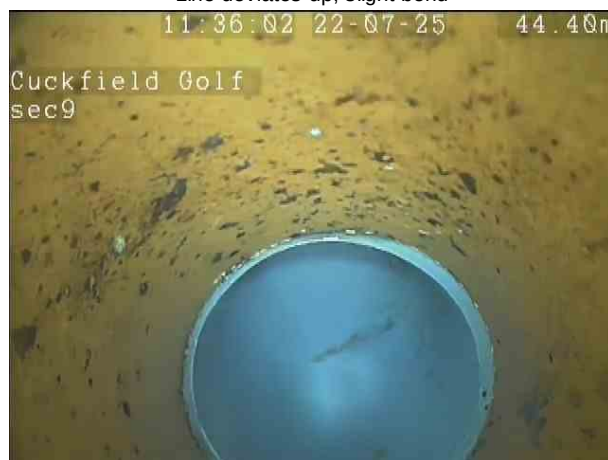
Line deviates up, base bend

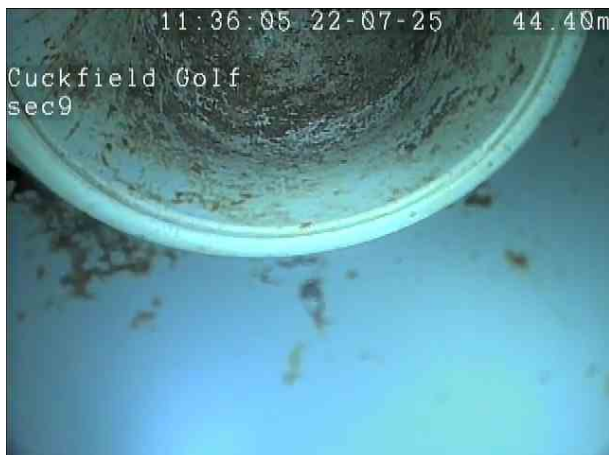
Finish node, manhole, reference: SVP Contai, pan connector
