Project Name: Penland Farm

Project Description: CCTV Survey, Trace & Plot

Inspection Standard: MSCC5 Sewers & Drainage GB (SRM5 Scoring)

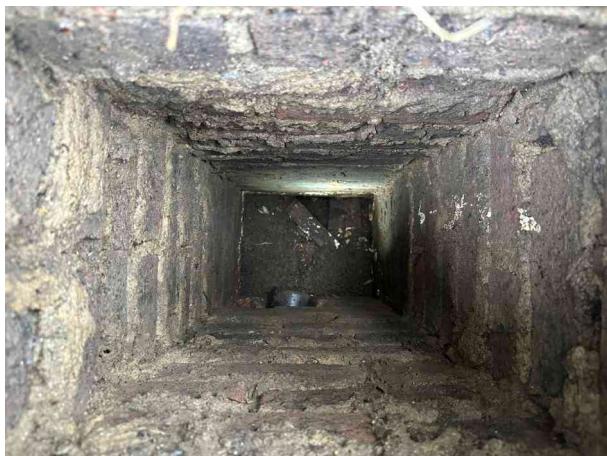
SW2 (no visible outlet)

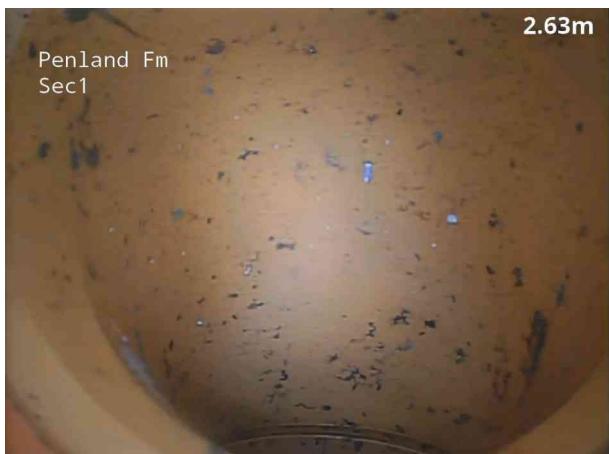
3, 00:00:32, 2.70 m
Finish node, gully, reference: RWG

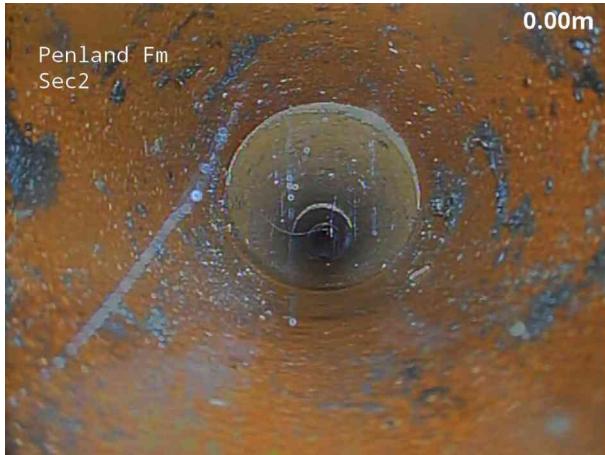
1, 00:00:00, 0.00 m
Water level, 0% of the vertical dimension

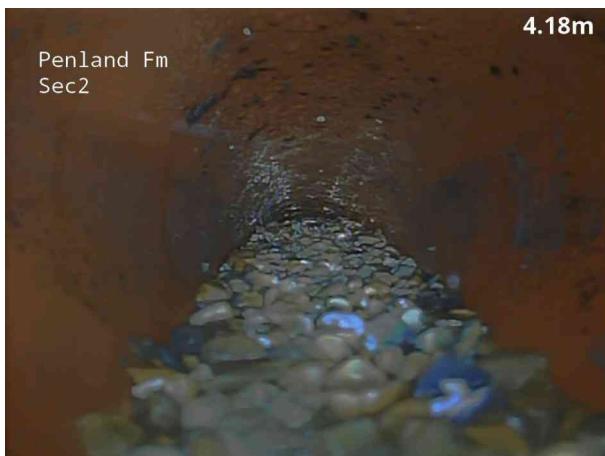
3, 00:00:21, 4.20 m
Settled deposits, coarse, 10% cross-sectional area loss, start

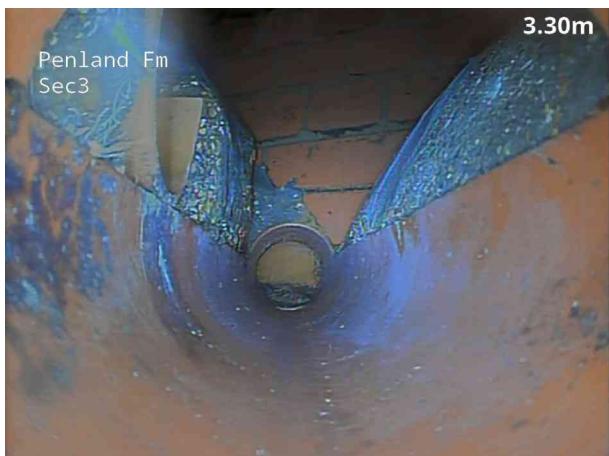
3, 00:00:26, 3.40 m
Finish node, manhole, reference: MH6

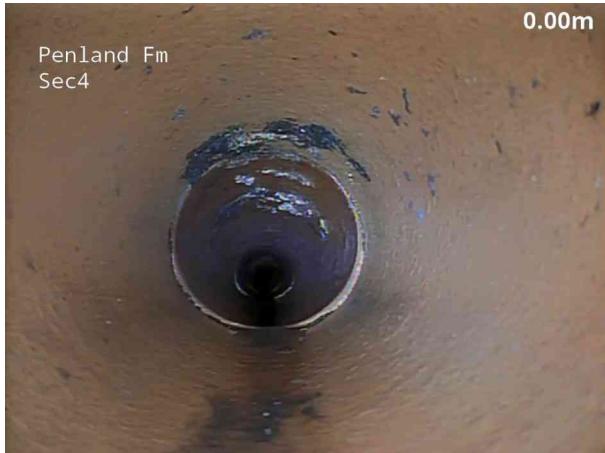
1, 00:00:01, 0.00 m
Water level, 0% of the vertical dimension

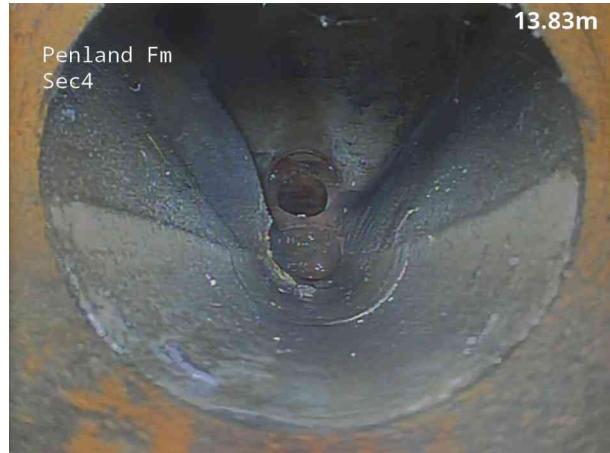
2, 00:00:54, 14.00 m
Finish node, manhole, reference: MH4

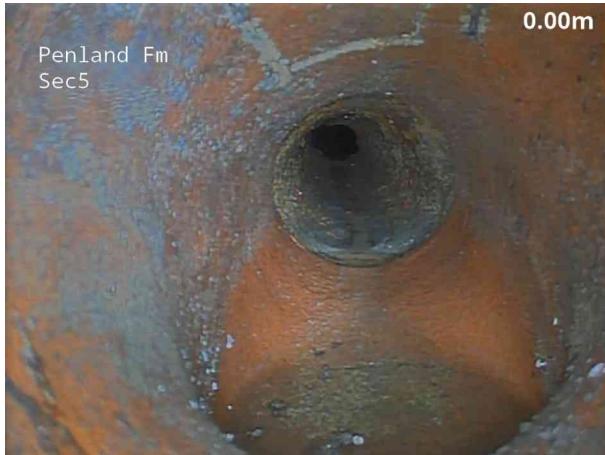
1, 00:00:05, 0.00 m
Water level, 0% of the vertical dimension

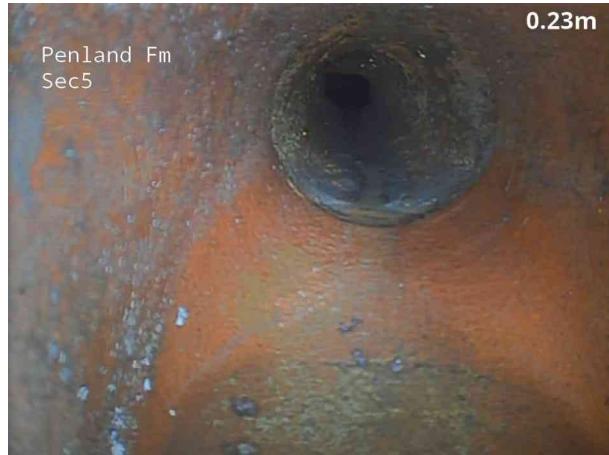
2, 00:00:07, 0.20 m
General remark, Trap

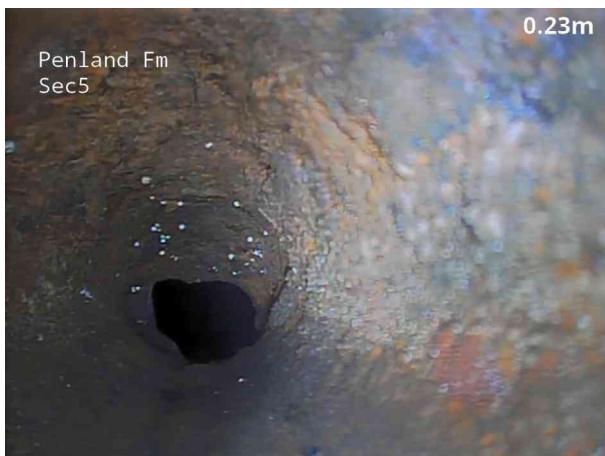
3, 00:00:07, 0.40 m
Pipe material changes to cast iron at this point

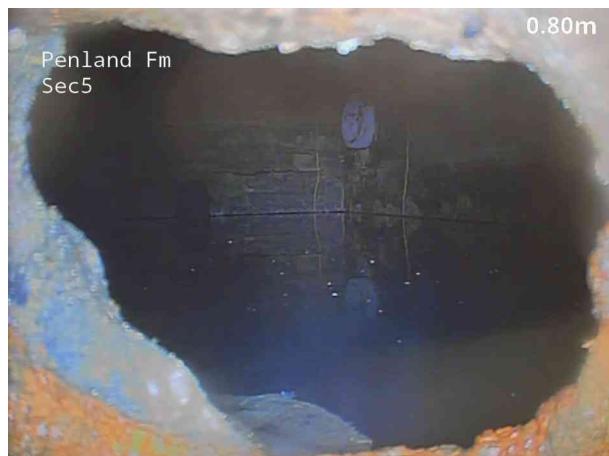
4, 00:00:34, 0.90 m
Finish node, other special chamber, reference: Tank, Septic
Tank

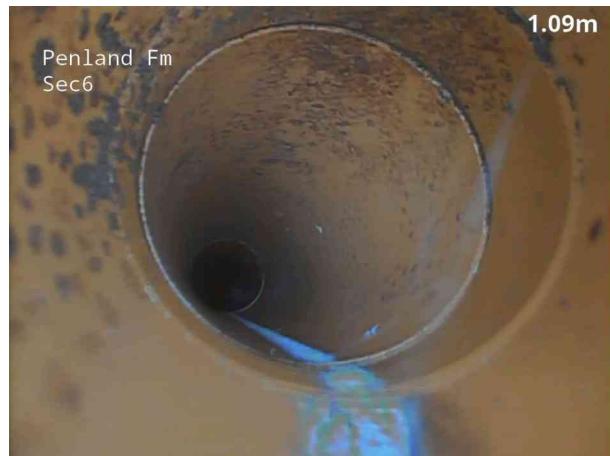
2, 00:00:14, 1.20 m
Line deviates left

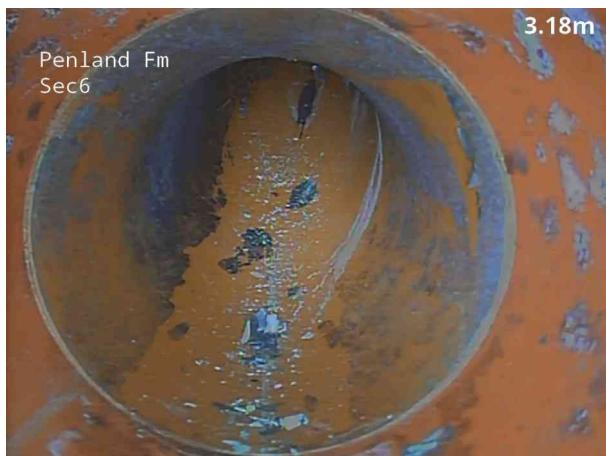
3, 00:00:24, 3.30 m
Line deviates up

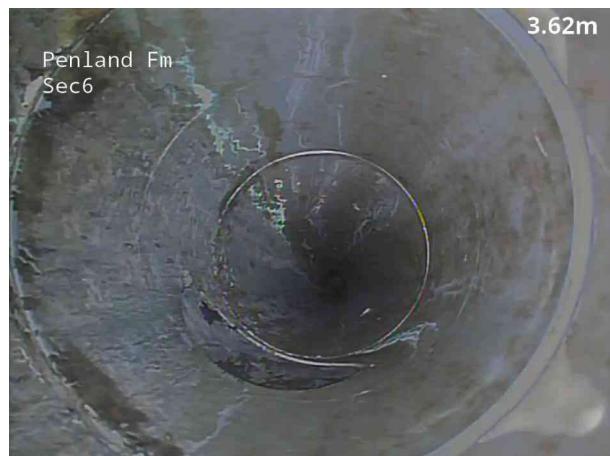
4, 00:00:32, 3.70 m
Finish node, manhole, reference: SVP, Assumed internal

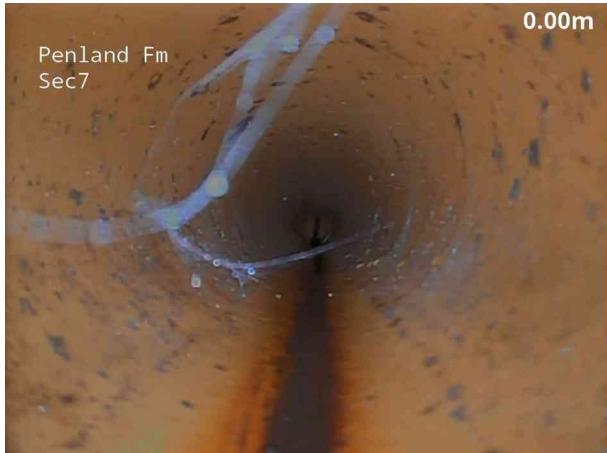
1, 00:00:00, 0.00 m
Water level, 0% of the vertical dimension

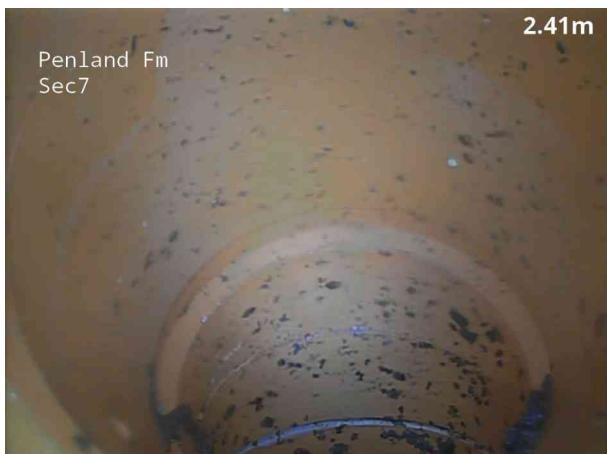
3, 00:00:21, 2.50 m
Finish node, gully, reference: RWG

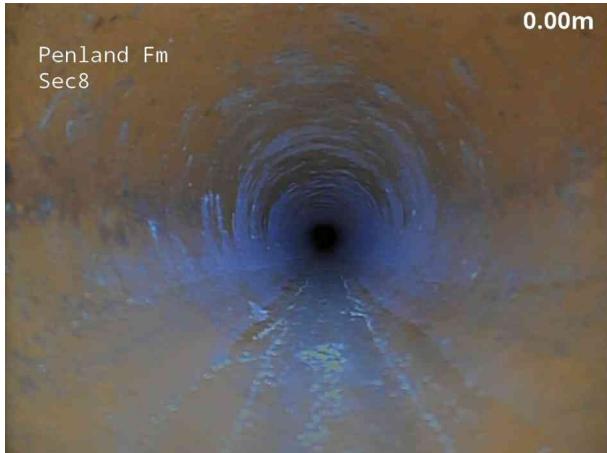
1, 00:00:03, 0.00 m
Water level, 0% of the vertical dimension

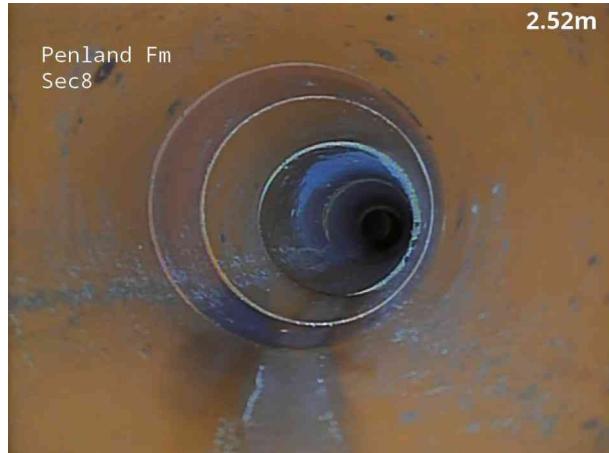
2, 00:00:15, 2.60 m
Line deviates right

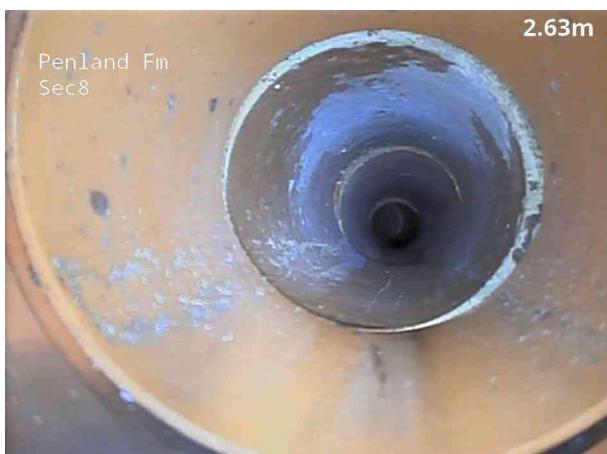
3, 00:00:25, 2.70 m
Pipe material changes to vitrified clay at this point

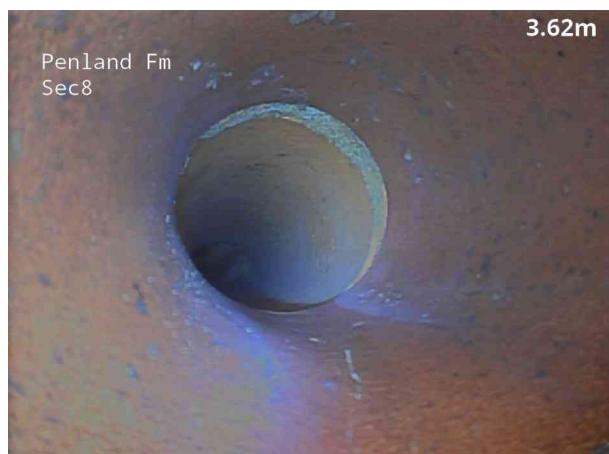
4, 00:00:37, 3.80 m
Line deviates left

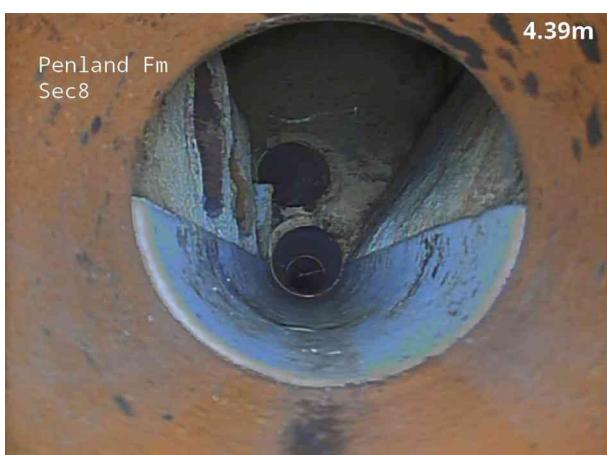
5, 00:00:47, 4.50 m
Finish node, manhole, reference: MH7

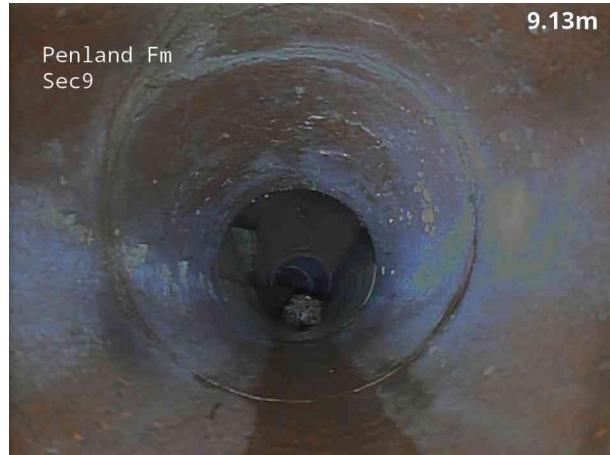
2, 00:01:04, 9.10 m
Fracture, circumferential from 12 o'clock to 12 o'clock

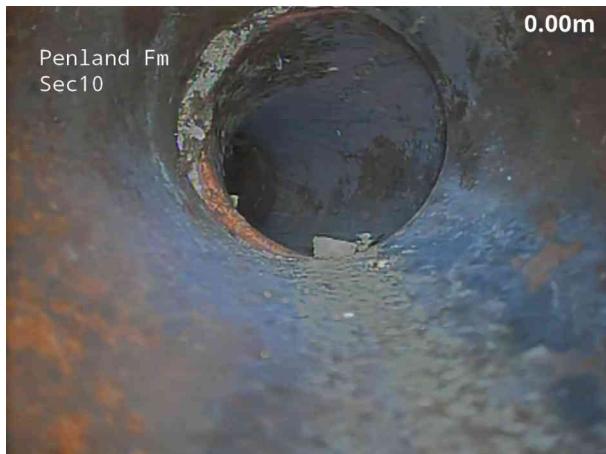
1, 00:00:06, 0.00 m
Water level, 0% of the vertical dimension

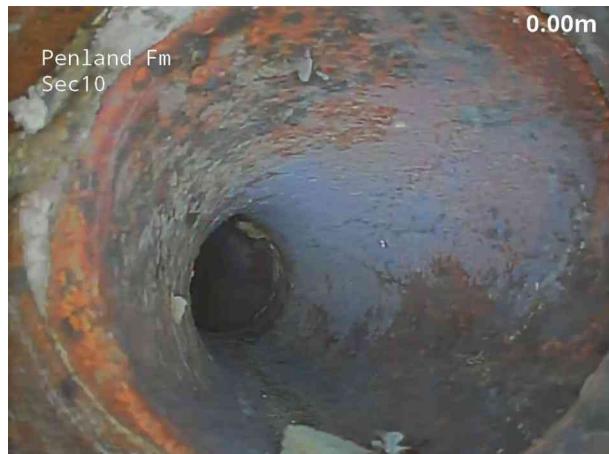
2, 00:00:10, 0.20 m
Line deviates left

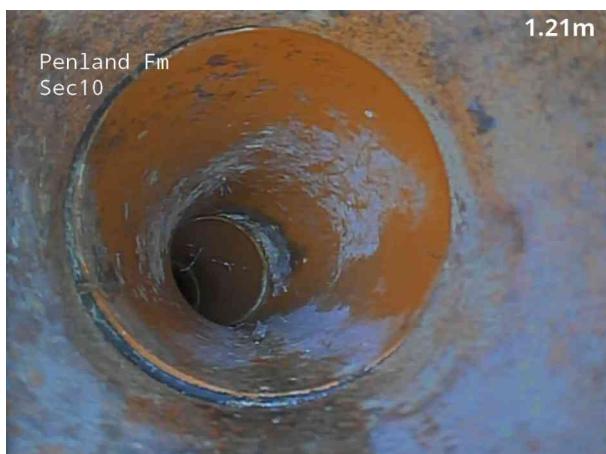
3, 00:00:25, 1.30 m
Pipe material changes to polyvinyl chloride at this point

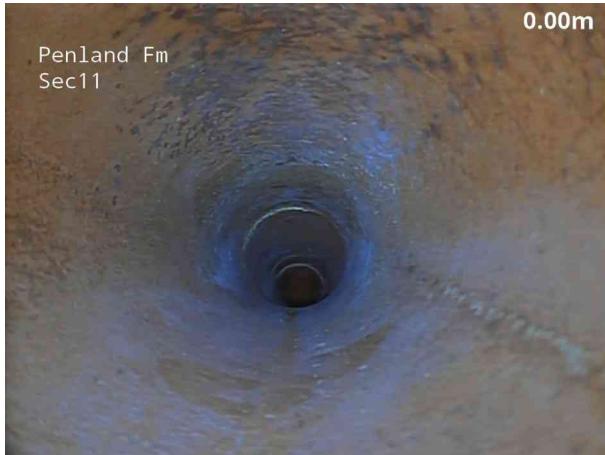
1, 00:00:09, 0.00 m
Water level, 0% of the vertical dimension

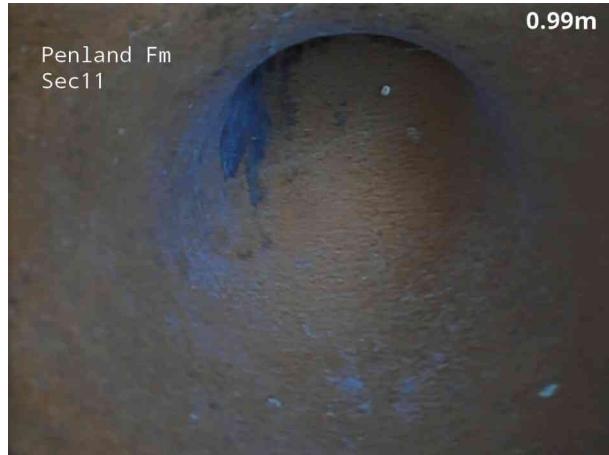
2, 00:00:23, 1.10 m
Line deviates up

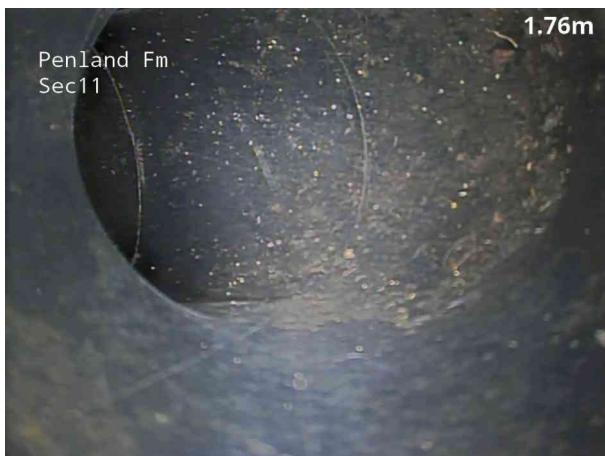
3, 00:00:27, 1.90 m
Finish node, manhole, reference: WC

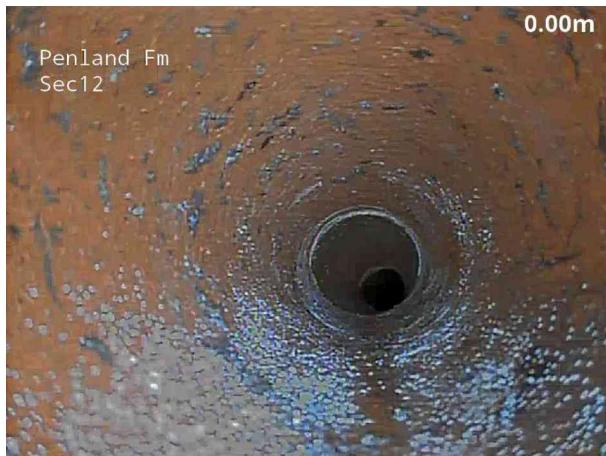
1, 00:00:02, 0.00 m
Water level, 0% of the vertical dimension

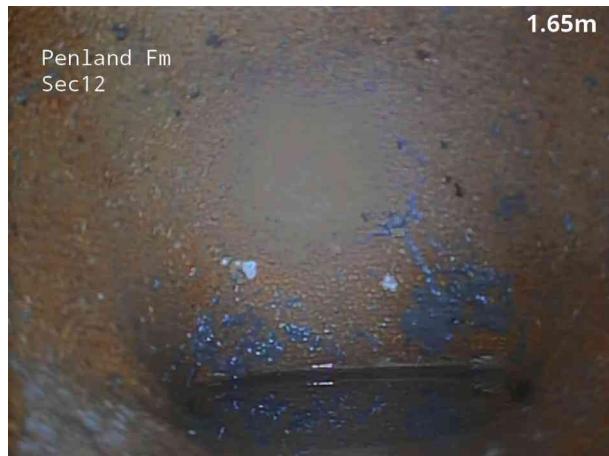
2, 00:00:21, 1.70 m
Finish node, gully, reference: RWG

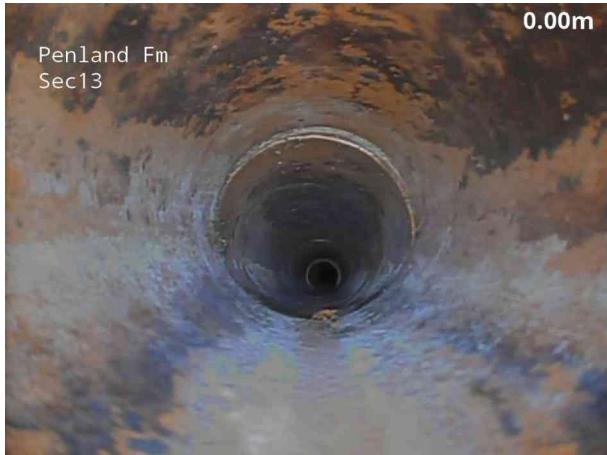
1, 00:00:08, 0.00 m
Water level, 0% of the vertical dimension

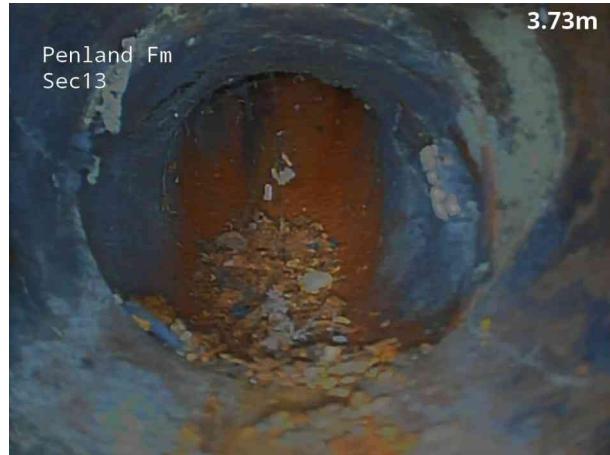
2, 00:00:23, 3.90 m
Line deviates up

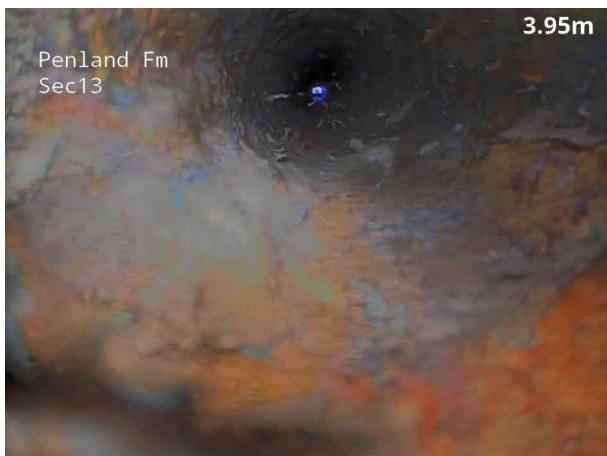
3, 00:00:39, 4.10 m
Finish node, manhole, reference: SVP2

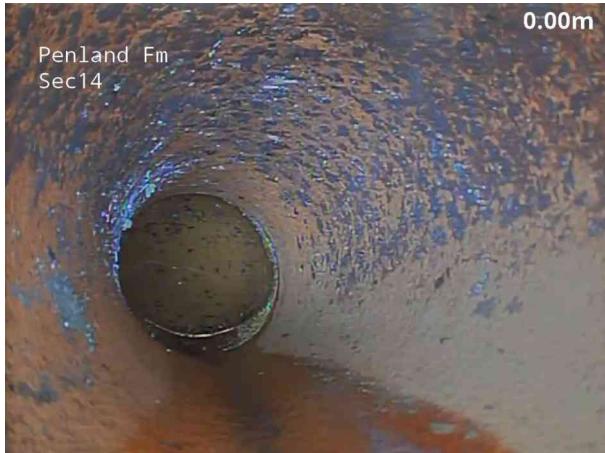
1, 00:00:01, 0.20 m
Line deviates left

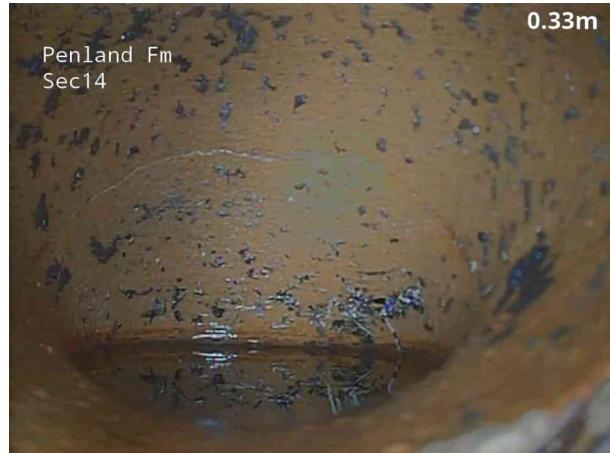
2, 00:00:10, 0.40 m
Finish node, gully, reference: FWG

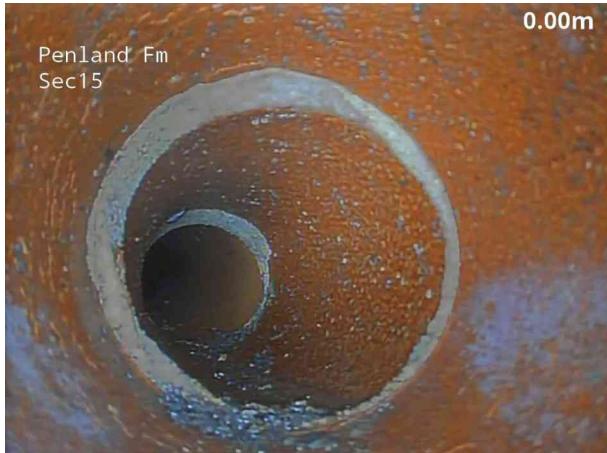
1, 00:00:00, 0.00 m
Water level, 0% of the vertical dimension

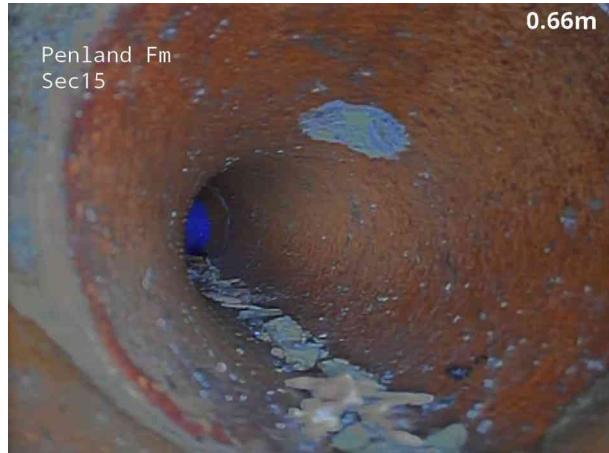
2, 00:00:10, 0.80 m
Line deviates left

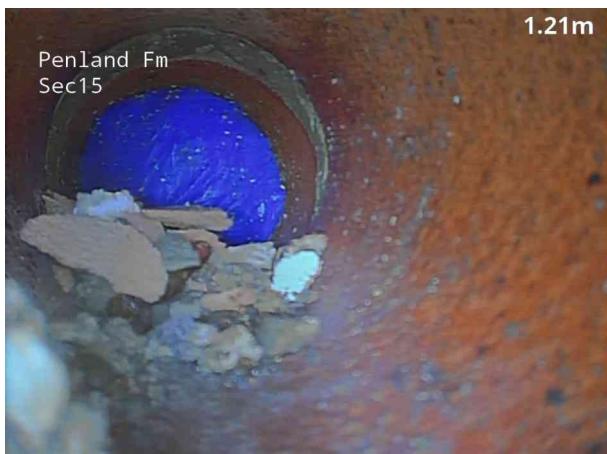
3, 00:00:16, 1.20 m
Finish node, manhole, reference: A, Capped

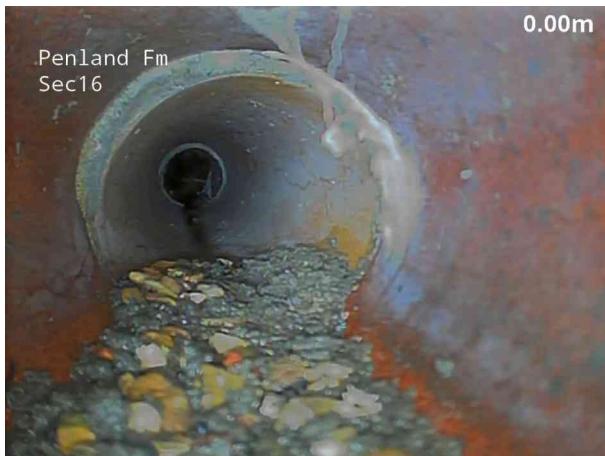
1, 00:00:04, 0.00 m
Settled deposits, coarse, 10% cross-sectional area loss

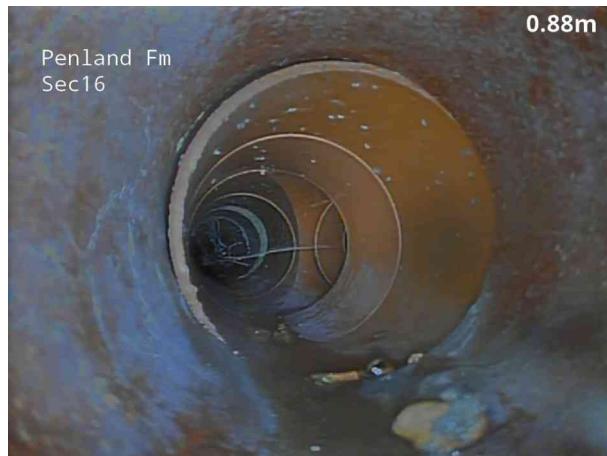
2, 00:00:14, 1.00 m
Pipe material changes to polyvinyl chloride at this point

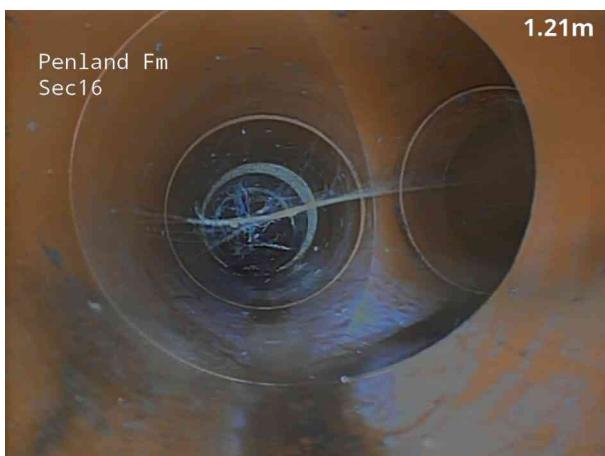
3, 00:00:18, 1.30 m
Junction at 3 o'clock, 100mm dia

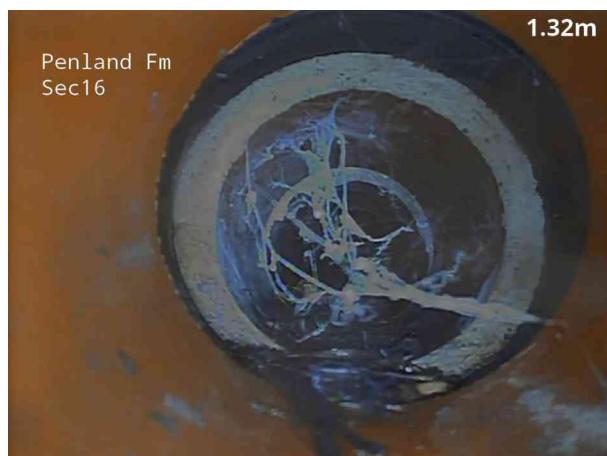
4, 00:00:21, 1.50 m
Pipe material changes to vitrified clay at this point

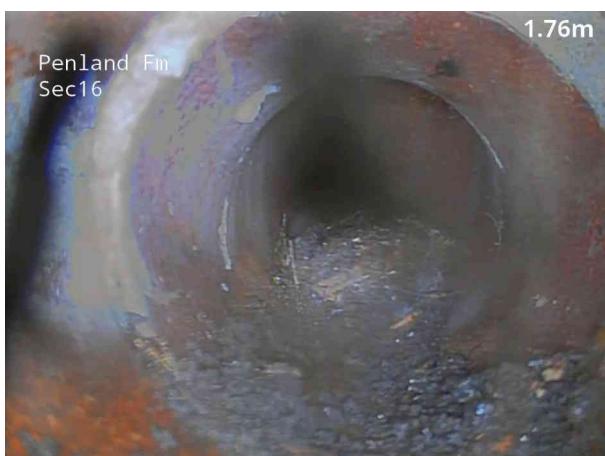
5, 00:00:32, 1.90 m
Line deviates up

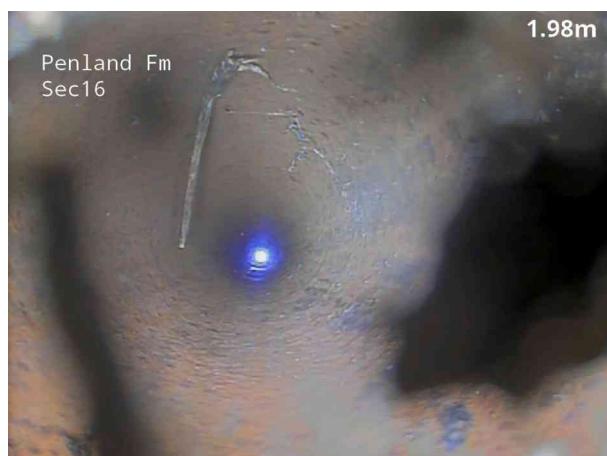
6, 00:00:37, 2.20 m
Finish node, manhole, reference: SVP

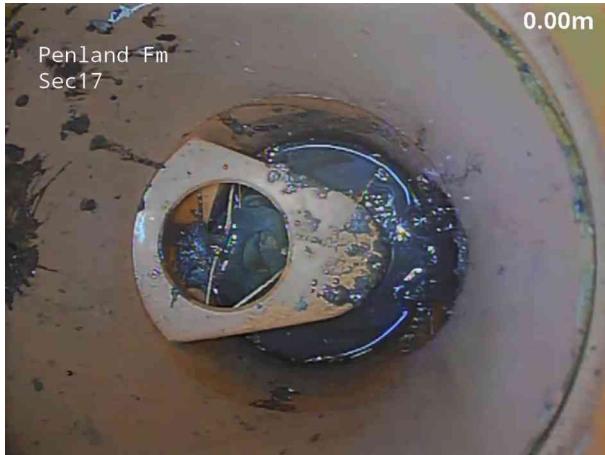
1, 00:00:00, 0.00 m
Start node, gully, reference: YG1

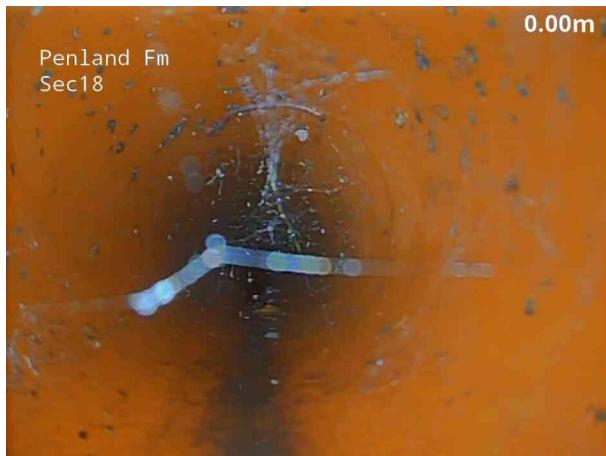
1, 00:00:01, 0.00 m
Water level, 0% of the vertical dimension

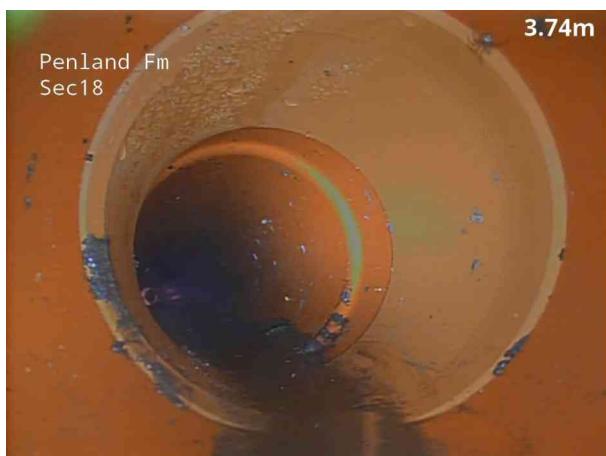
3, 00:00:36, 3.90 m
Line deviates left

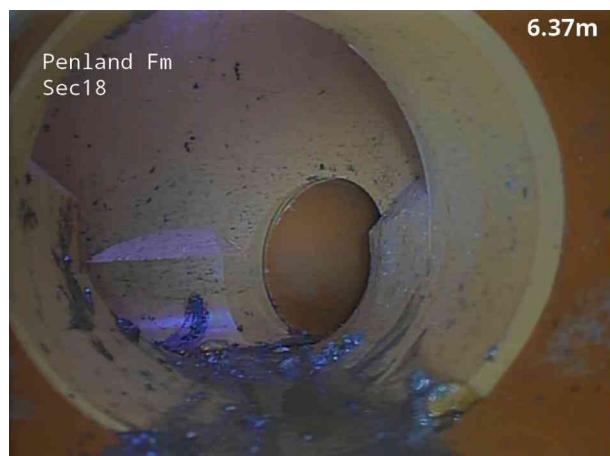
4, 00:00:25, 6.50 m
Finish node, manhole, reference: SW1

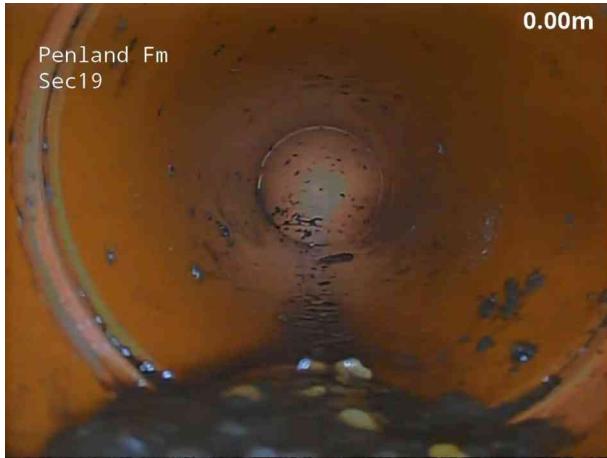
1, 00:00:01, 0.00 m
Water level, 0% of the vertical dimension

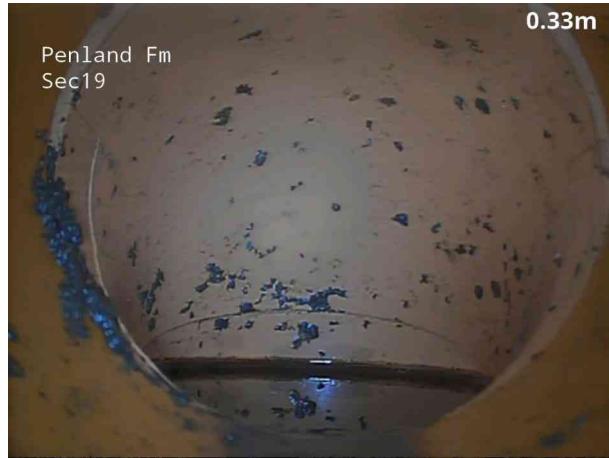
2, 00:00:06, 0.40 m
Finish node, gully, reference: RWG

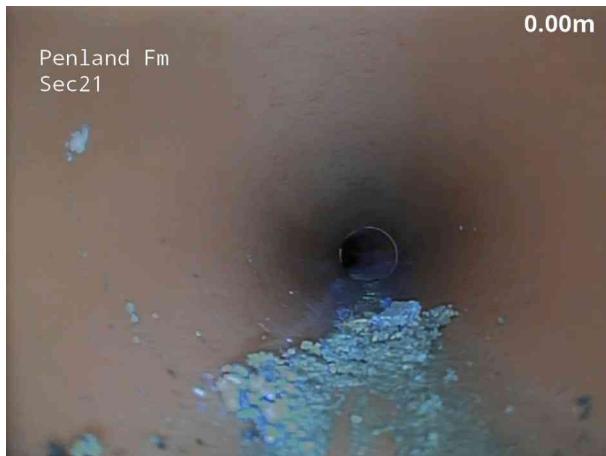
1, 00:00:00, 0.00 m
Water level, 0% of the vertical dimension

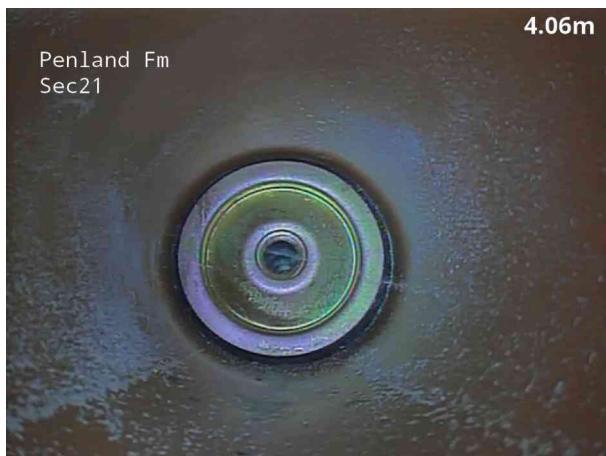
3, 00:00:27, 4.30 m
Finish node, manhole, reference: Cap1, For future use

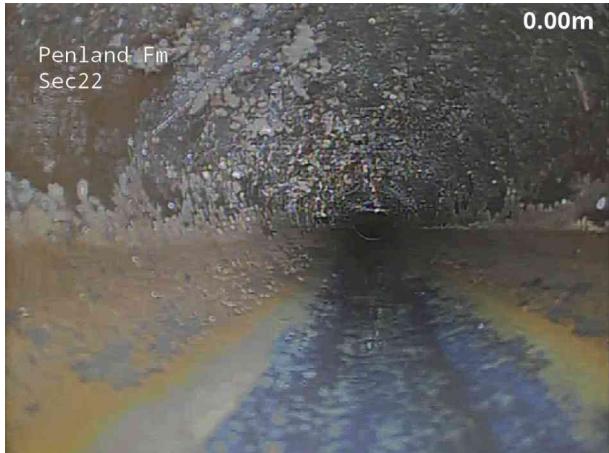
1, 00:00:01, 0.00 m
Water level, 0% of the vertical dimension

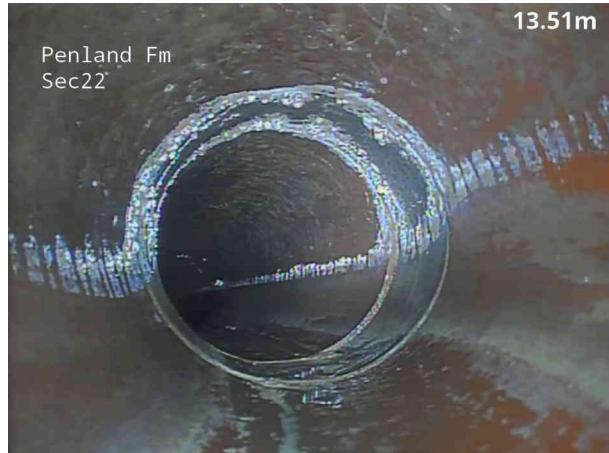
2, 00:00:30, 13.60 m
Line deviates left

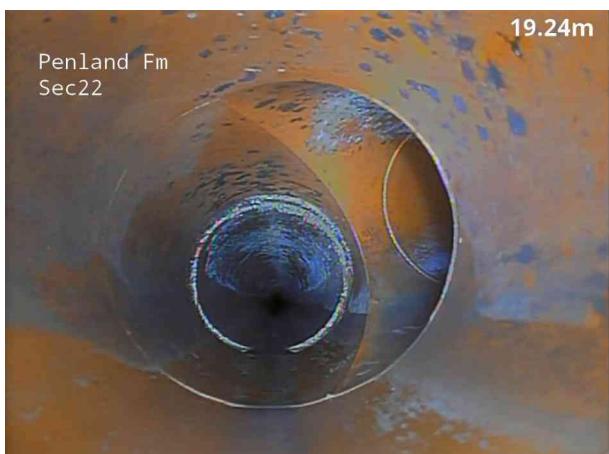
3, 00:00:42, 19.40 m
Junction at 3 o'clock, 100mm dia

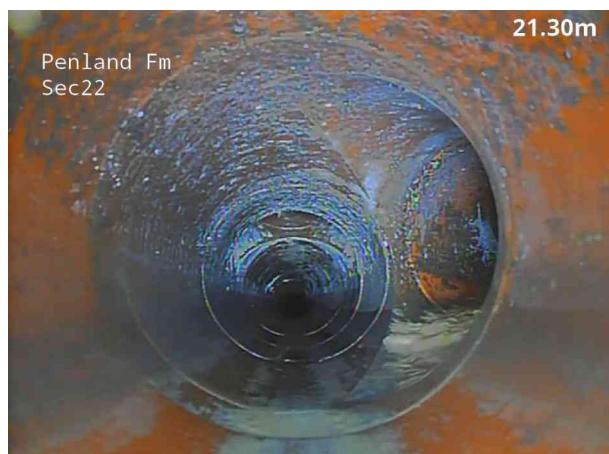
4, 00:00:51, 21.40 m
Junction at 3 o'clock, 100mm dia

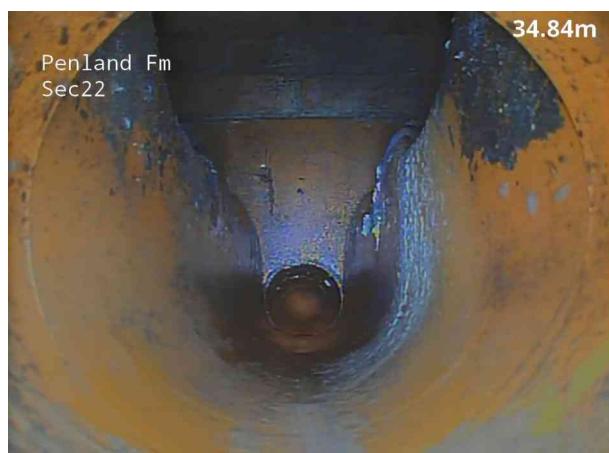
6, 00:01:21, 39.00 m
Finish node, manhole, reference: MH3

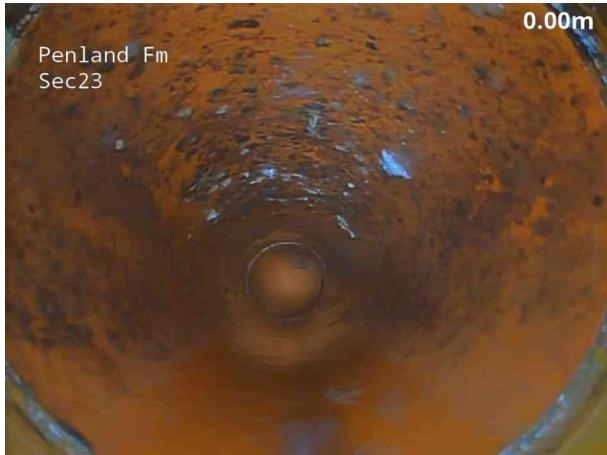
1, 00:00:01, 0.00 m
Water level, 0% of the vertical dimension

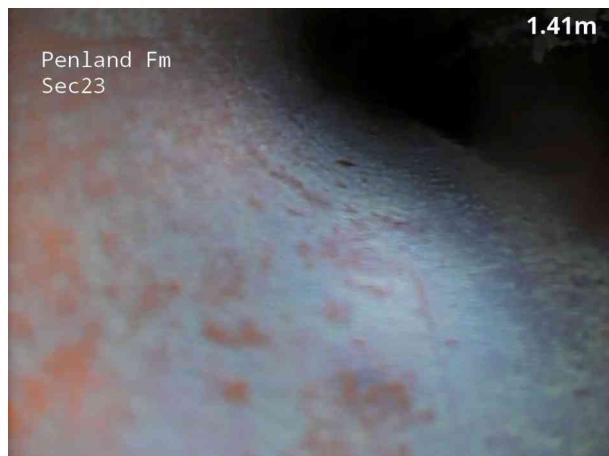
4, 00:00:17, 1.40 m
Finish node, manhole, reference: FP

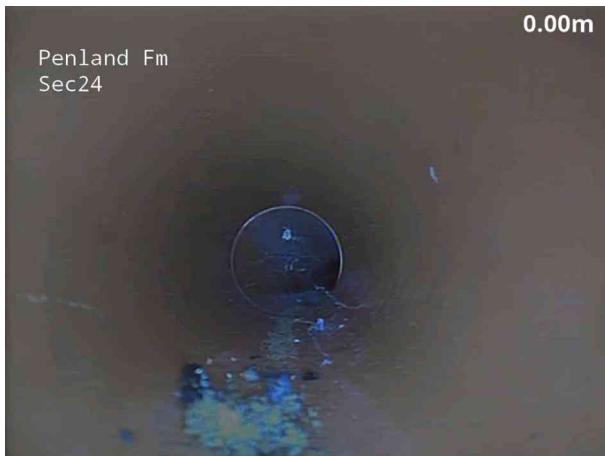
1, 00:00:01, 0.00 m
Water level, 0% of the vertical dimension

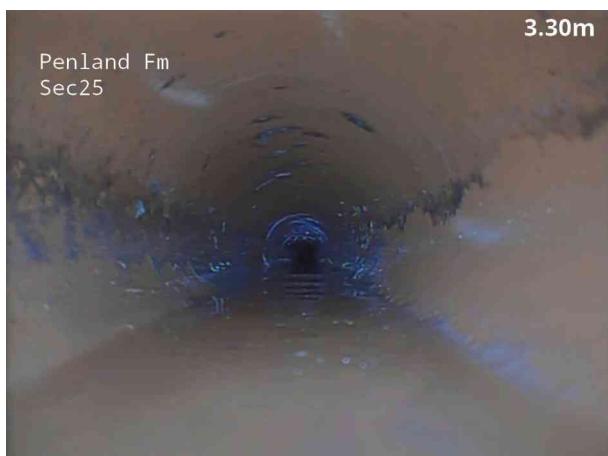
3, 00:00:20, 3.30 m
Water level, 10% of the vertical dimension, Continuous

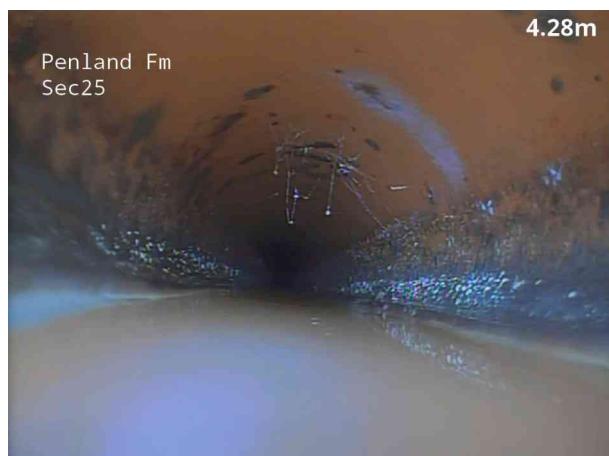
4, 00:00:43, 4.30 m
Water level, 20% of the vertical dimension, Continuous

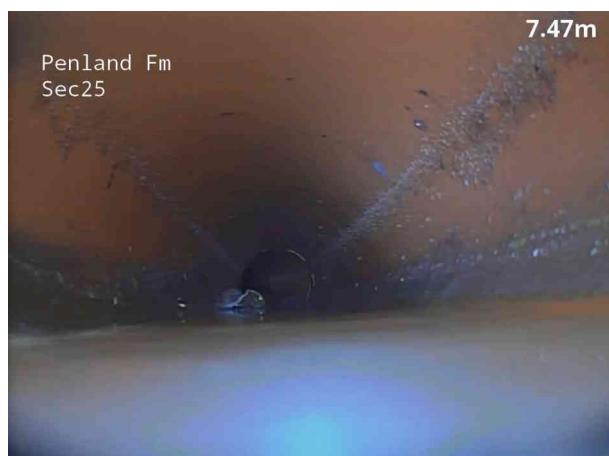
6, 00:01:21, 7.50 m
Water level, 20% of the vertical dimension

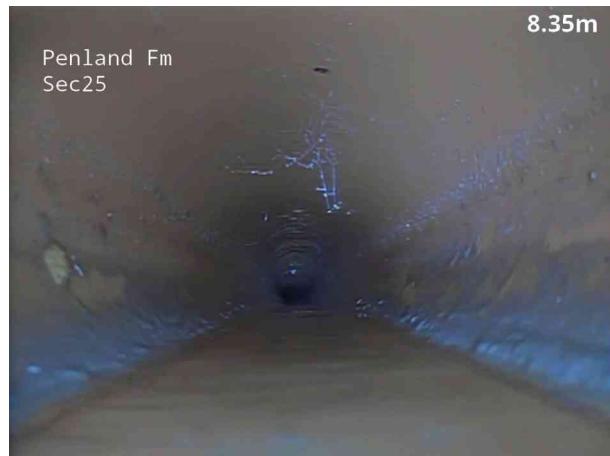
8, 00:01:14, 8.30 m
Water level, 10% of the vertical dimension

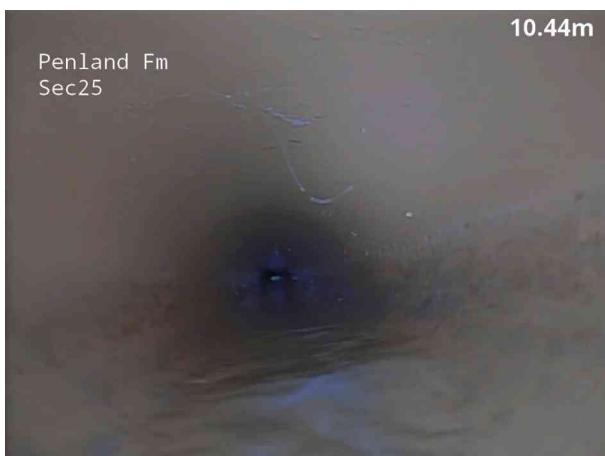
9, 00:01:55, 10.30 m
Water level, 10% of the vertical dimension, Continuous

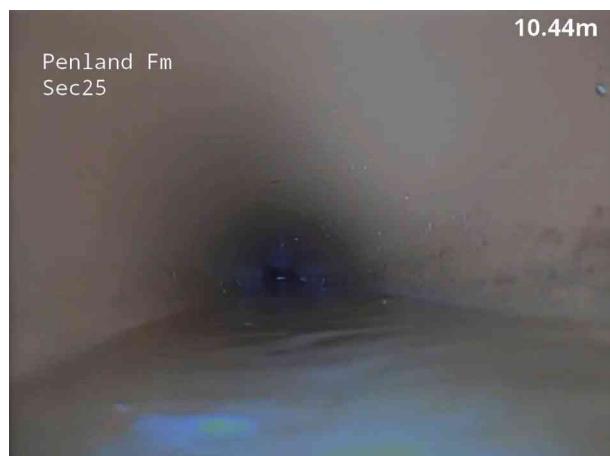
10, 00:01:55, 10.50 m
Water level, 20% of the vertical dimension, Continuous

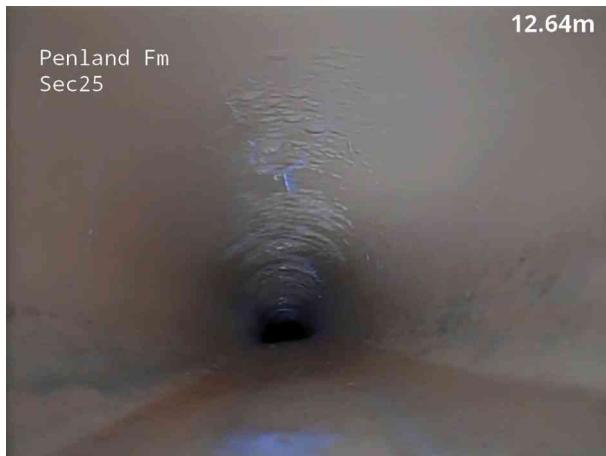
13, 00:02:15, 12.60 m
Water level, 10% of the vertical dimension

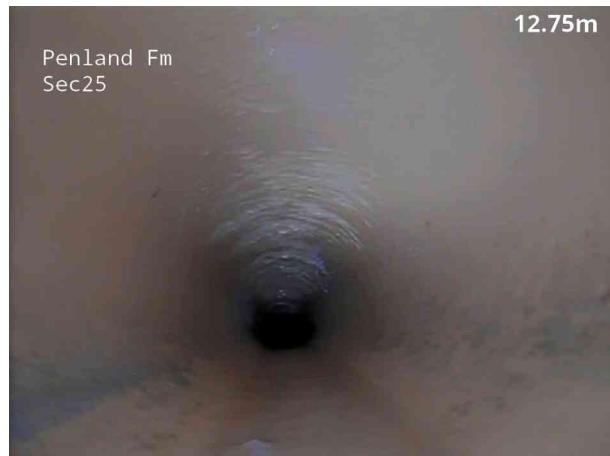
14, 00:02:37, 12.80 m
Water level, 0% of the vertical dimension

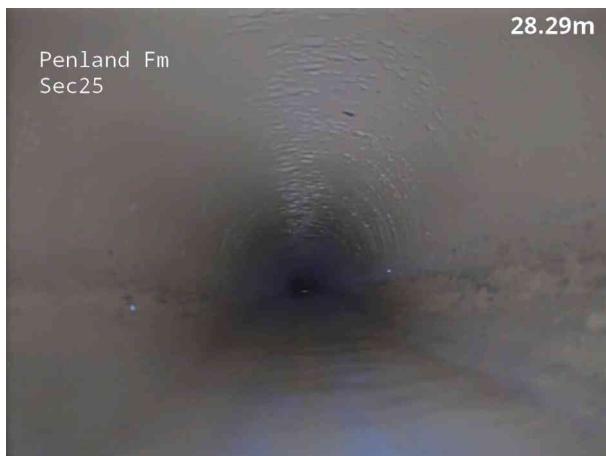
15, 00:03:04, 28.40 m
Water level, 10% of the vertical dimension

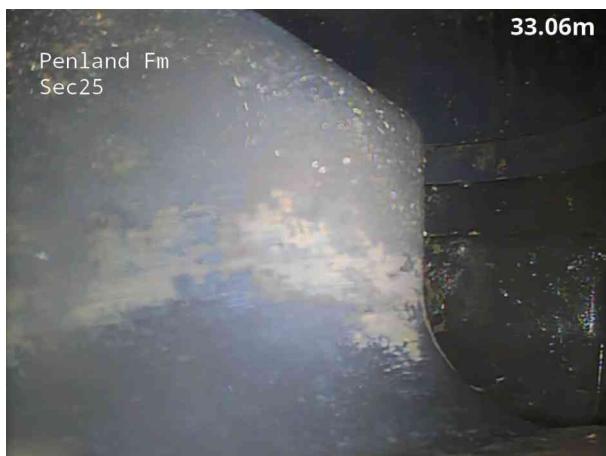
17, 00:03:25, 33.10 m
Finish node, manhole, reference: MH1

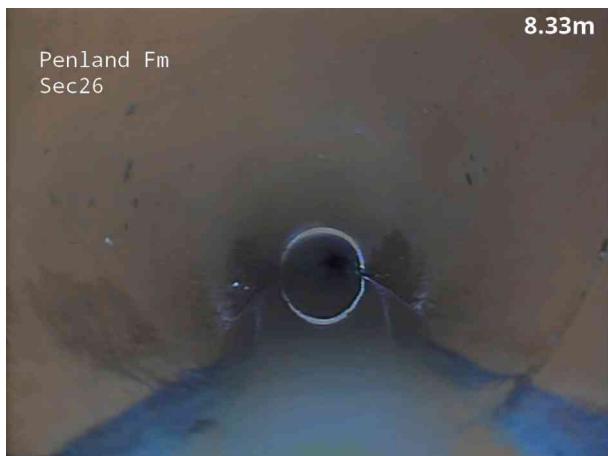
3, 00:01:00, 8.40 m
Water level, 10% of the vertical dimension

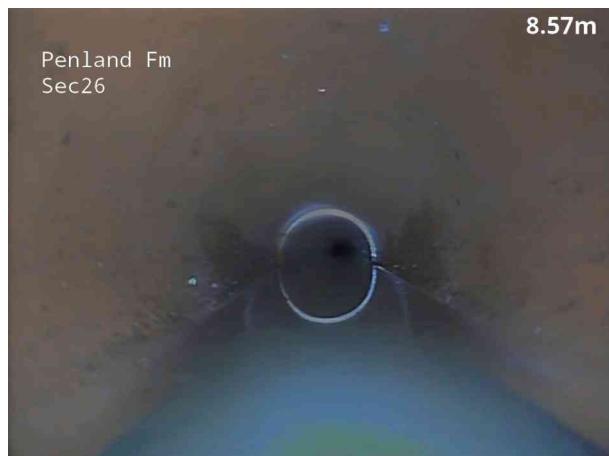
4, 00:01:03, 8.60 m
Water level, 20% of the vertical dimension

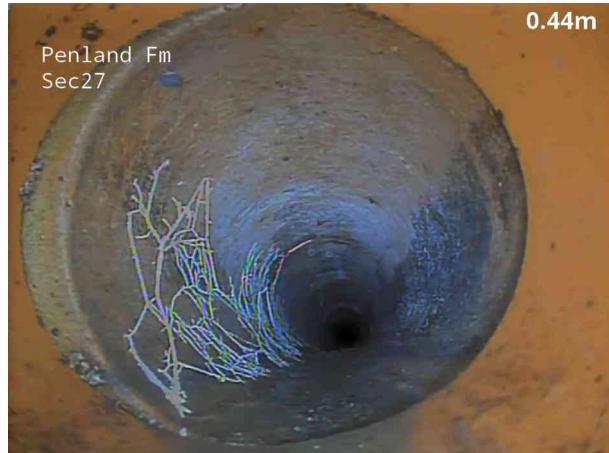
2, 00:00:08, 0.50 m
Pipe material changes to vitrified clay at this point

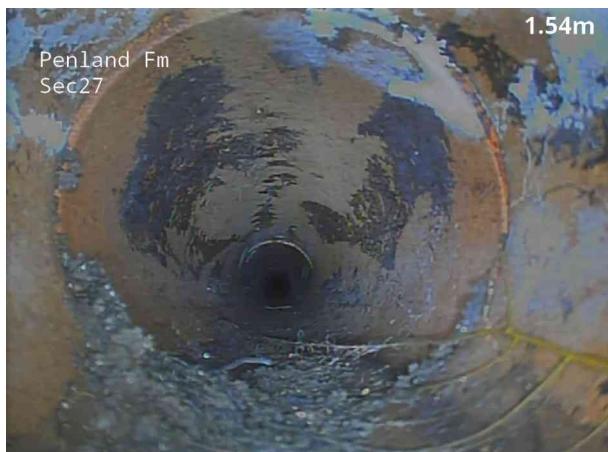
3, 00:00:15, 1.60 m
Roots, fine at joint

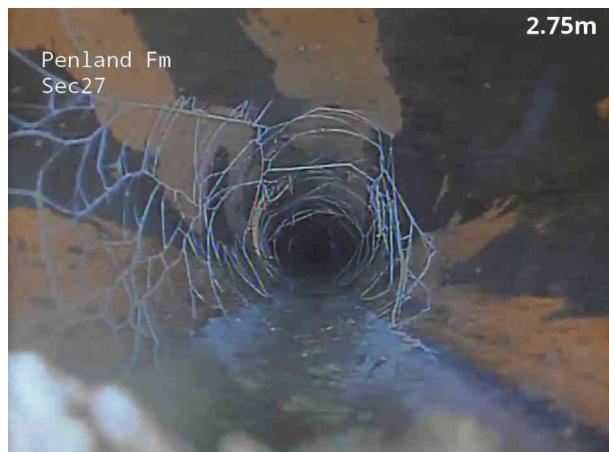
4, 00:00:22, 2.80 m
Roots, fine, start

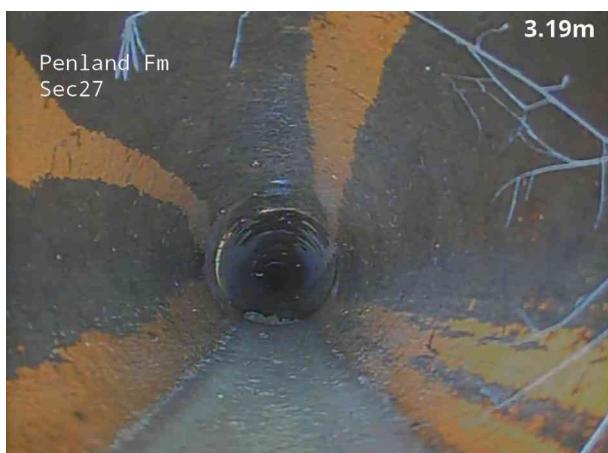
5, 00:00:27, 3.30 m
Roots, fine, finish

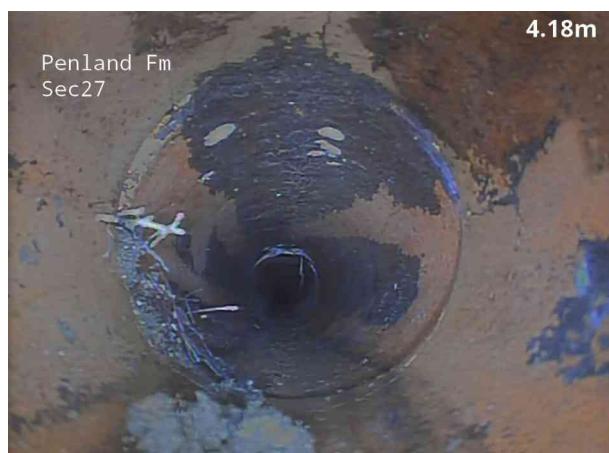
6, 00:00:33, 4.30 m
Roots, fine at joint, start

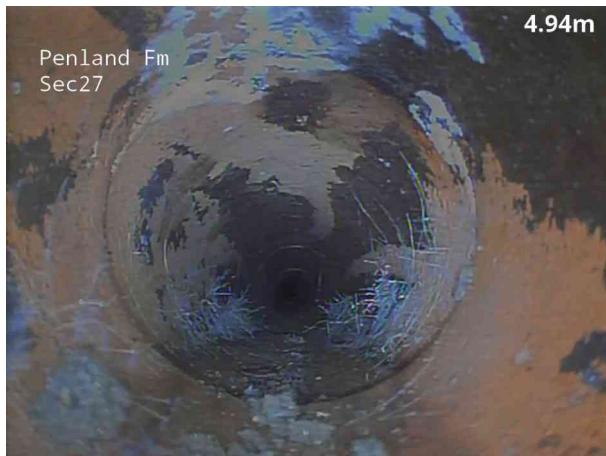
7, 00:00:33, 4.30 m
Roots, fine at joint, start

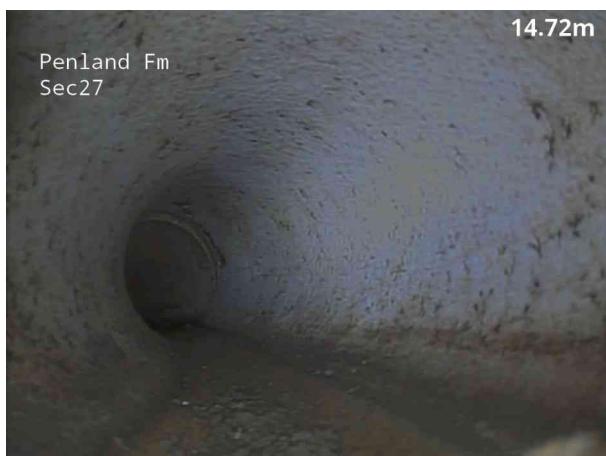
9, 00:01:35, 14.90 m
Line deviates left
