Project Name: Penland Farm

Project Description: CCTV Survey, Trace & Plot

Inspection Standard: MSCC5 Sewers & Drainage GB (SRM5 Scoring)

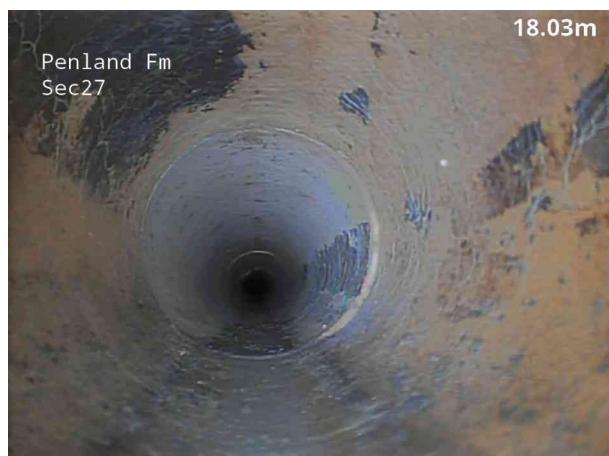
10, 00:01:48, 18.20 m
Roots, fine at joint, finish

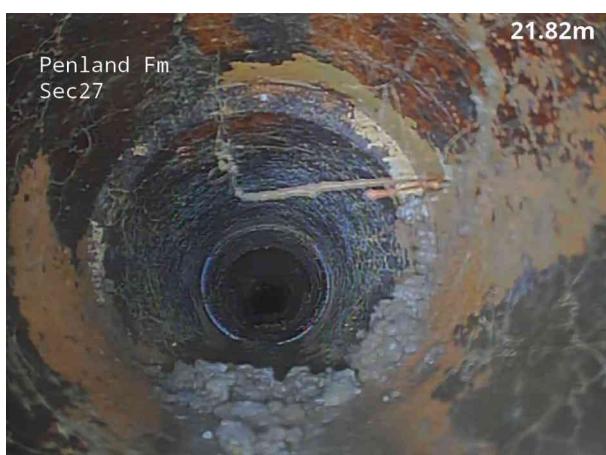
11, 00:02:11, 22.00 m
Roots, fine at joint

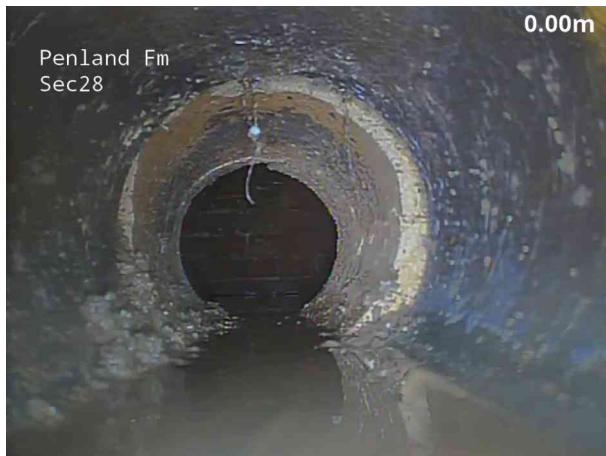
1, 00:00:01, 0.00 m
Water level, 5% of the vertical dimension

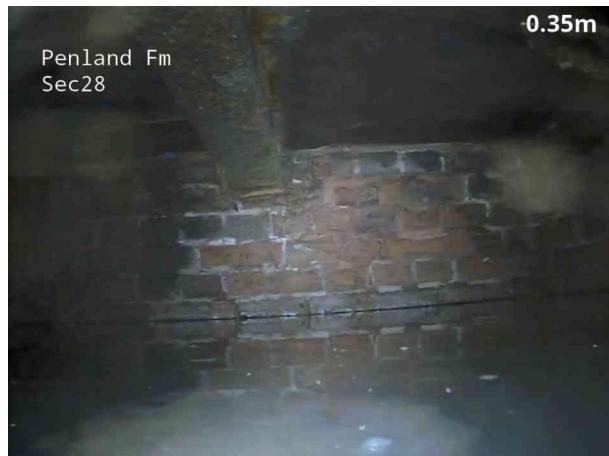
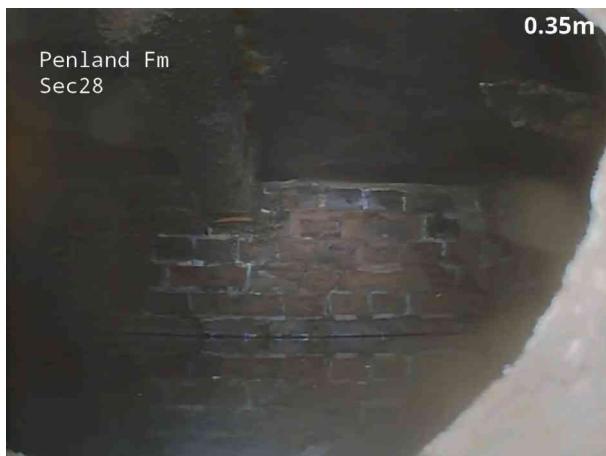
2, 00:00:08, 0.50 m
Finish node, other special chamber, reference: Tank, Septic
Tank

3, 00:00:08, 0.50 m
Finish node, other special chamber, reference: Tank, Septic
Tank

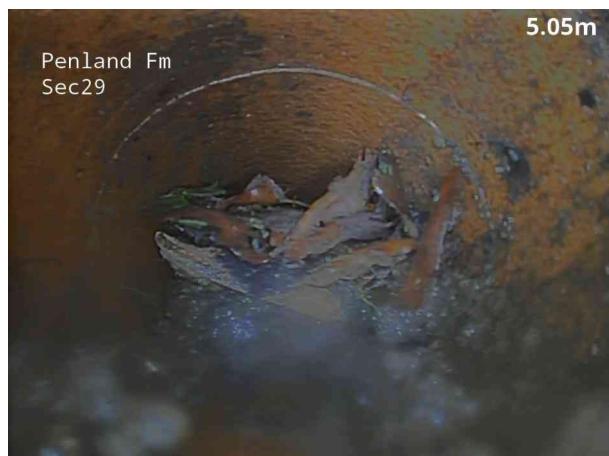
6, 00:00:35, 5.10 m
Survey abandoned, Camera compacting debris, possibly
serving Surface Water network

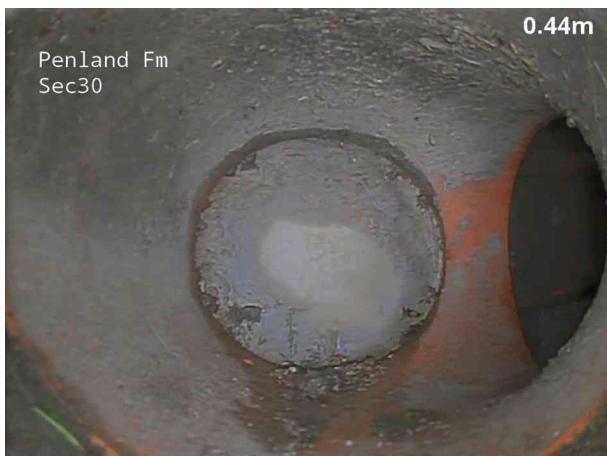
3, 00:00:24, 0.60 m
Junction at 3 o'clock, 100mm dia

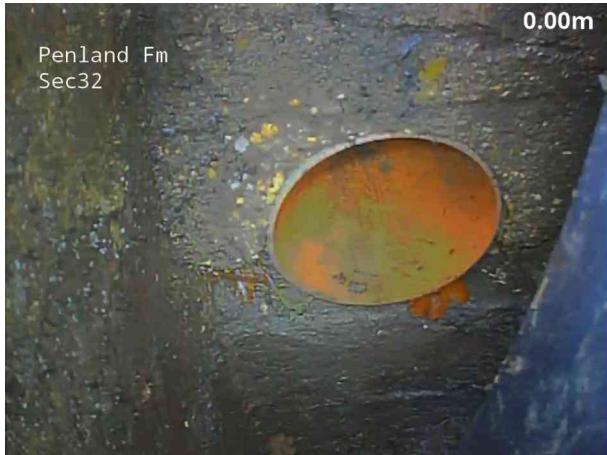
1, 00:00:00, 0.00 m
Start node, outfall, reference: OF1, Retro fitted relief pipe

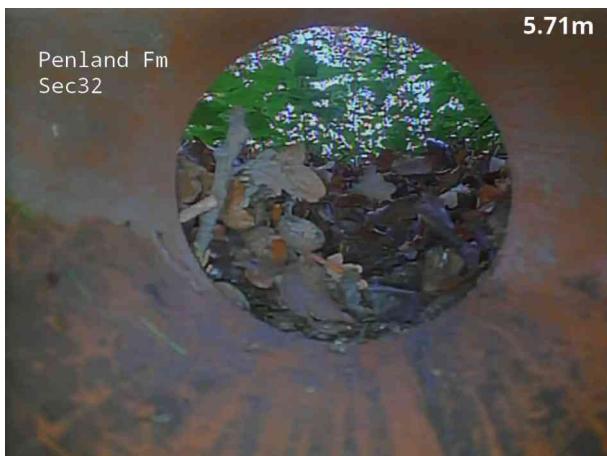
3, 00:00:43, 5.80 m
Finish node, outfall, reference: OF2, Into neighbouring land

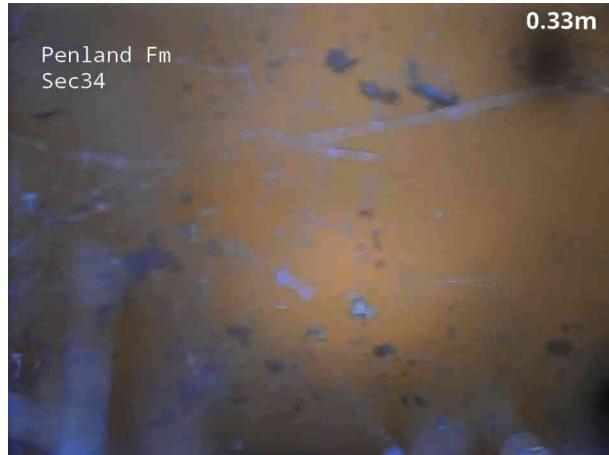
2, 00:00:11, 0.20 m
Line deviates down

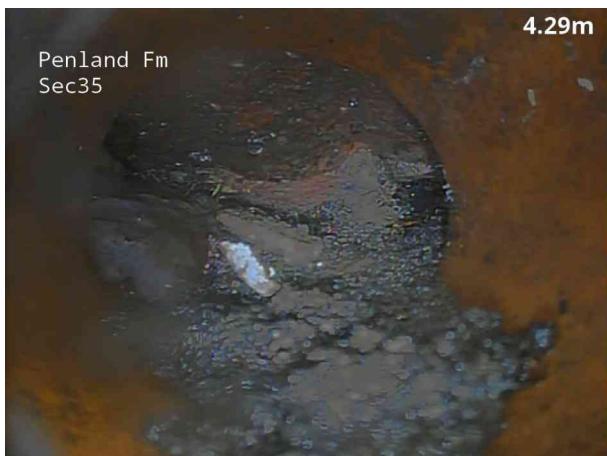
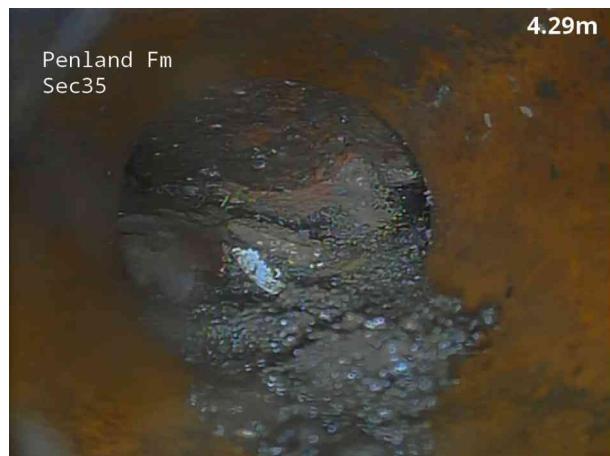
3, 00:00:48, 4.50 m
Finish node, soakaway, reference: SK, Assumed Soakaway

4, 00:00:48, 4.50 m
Finish node, soakaway, reference: SK, Assumed Soakaway

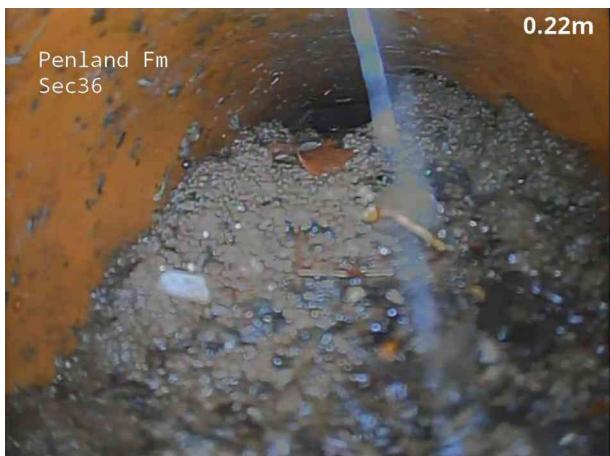
3, 00:00:11, 0.20 m
Survey abandoned, Unable to continue

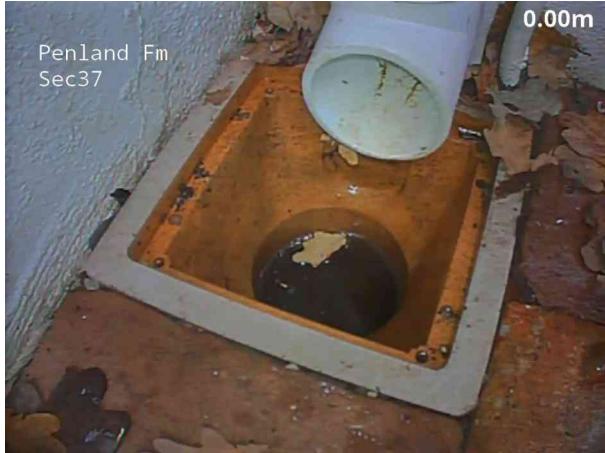
1, 00:00:03, 0.00 m
Survey abandoned, Trapped gully, unable to survey

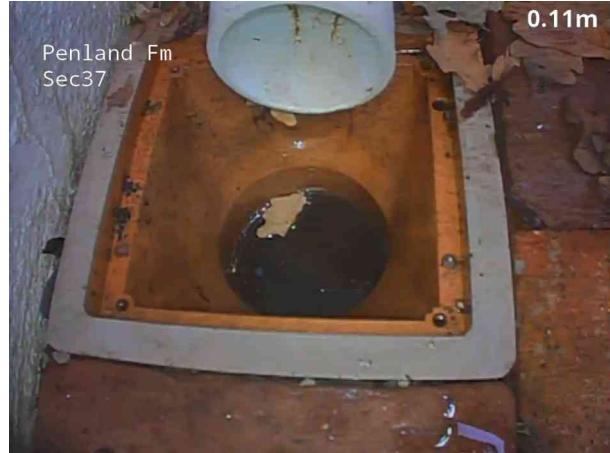
2, 00:00:03, 0.00 m
Survey abandoned, Trapped gully, unable to survey

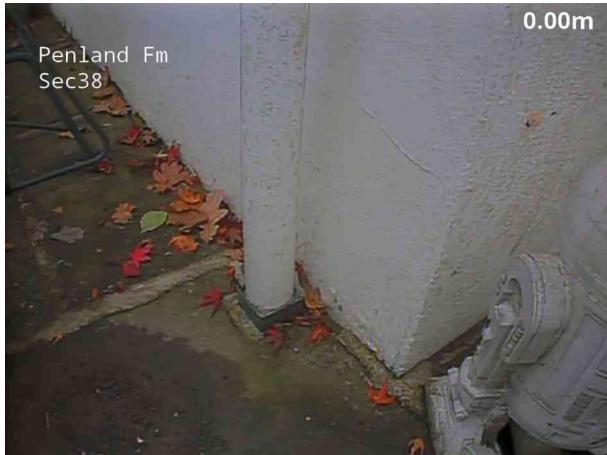
1, 00:00:00, 0.00 m
Start node, manhole, reference: RWP1

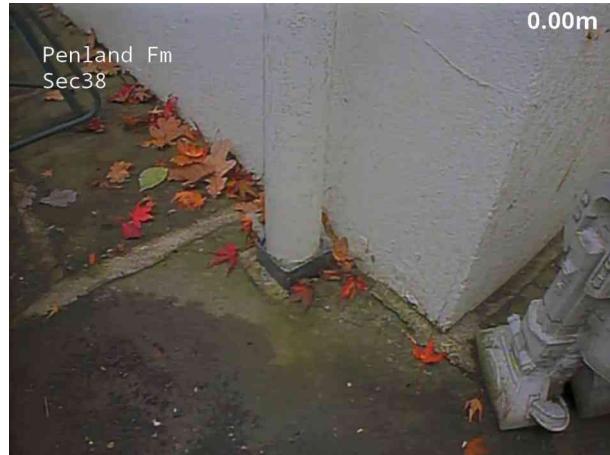
2, 00:00:05, 0.00 m
Survey abandoned, Sealed, no access

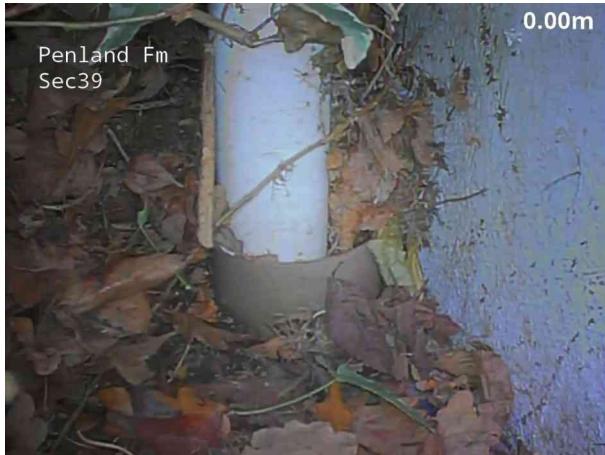
1, 00:00:00, 0.00 m
Start node, manhole, reference: RWP2

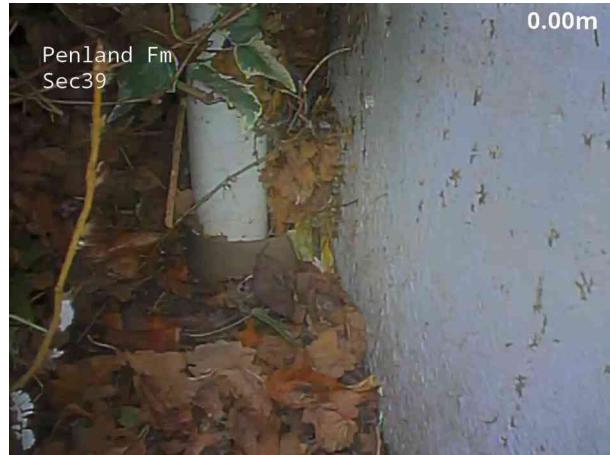
2, 00:00:06, 0.00 m
Survey abandoned, Sealed, no access

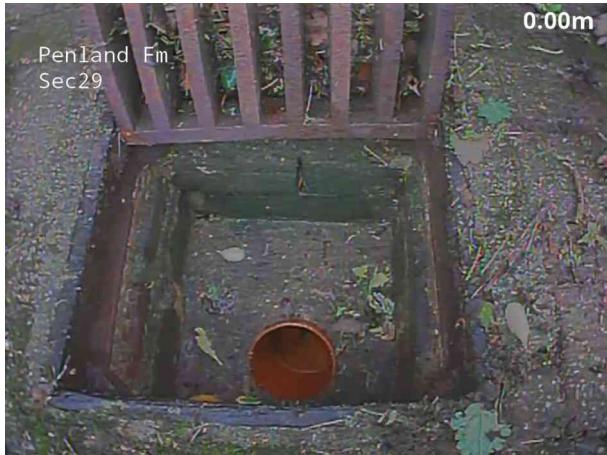
1, 00:00:00, 0.00 m
Start node, gully, reference: YG
