## TANYARD MANOR

Repair and Renewal of  
Roof Coverings

HERITAGE  
STATEMENT

July 2025  
v1

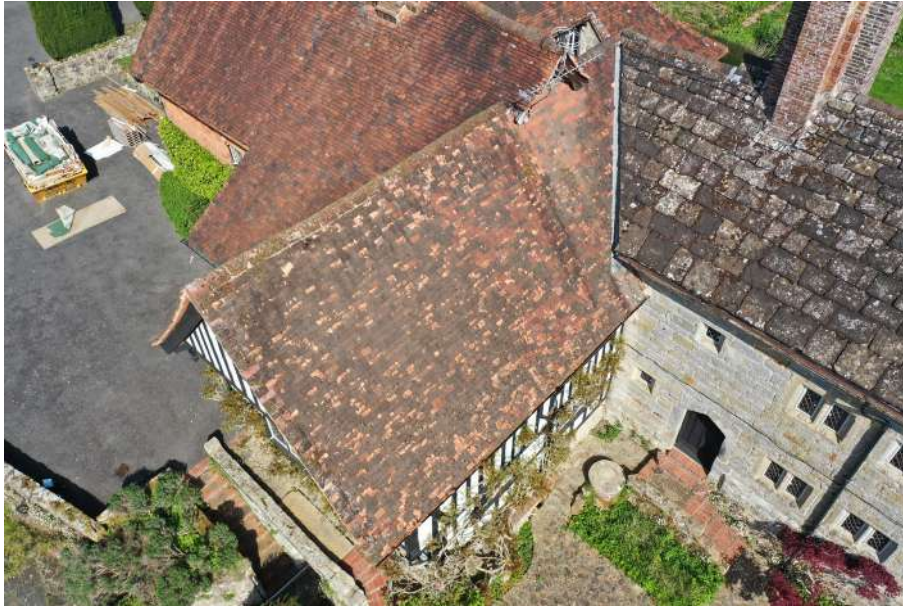
*lead valley to south slope*

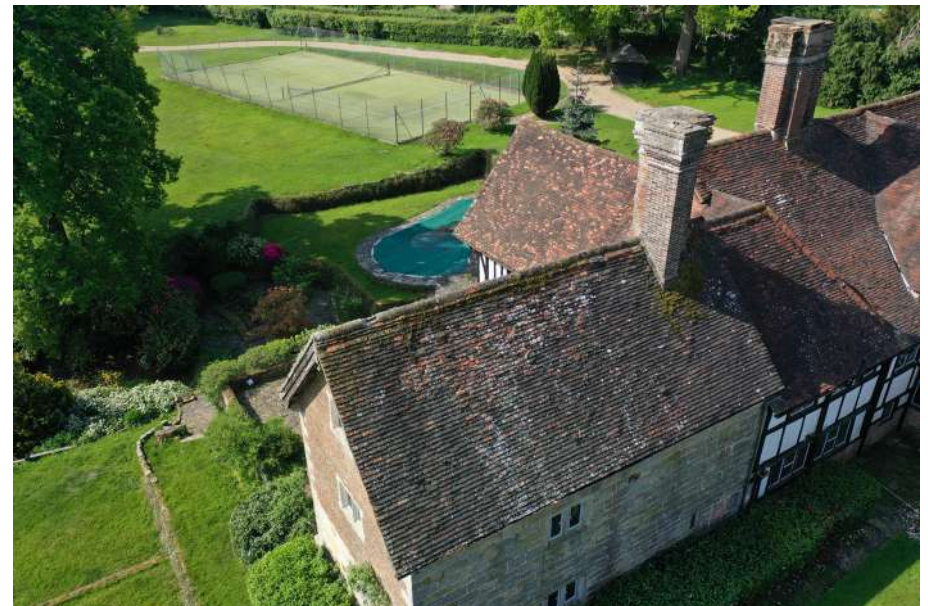
The north slope exhibits moss and lichen consistent with its shaded orientation and there is extensive evidence of spalling consistent with freeze thaw action due to water sitting on the relatively uncambered tiles, as well as cracked, broken, missing and slipped tiles. There is a missing ridge tile.

*clay plain tile to north slope*

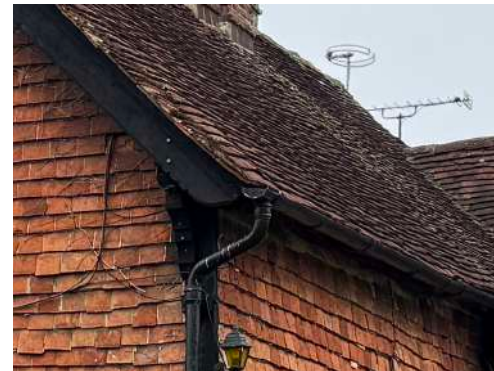
Notably the verge tiles to west end abutting the C17th range are tile and half rather than cut tiles. The verges and half round ridge tiles are bedded in mortar with tiled fillets to the chimney abutments bedded in mortar (cement content unknown). The north slope exhibits moss and lichen consistent with its shaded orientation and there is extensive evidence of spalling consistent with freeze thaw action due to water sitting on the relatively uncambered tiles, as well as cracked, broken, missing and slipped tiles. There are lead dressings consistent with modern good practice and all suggestive of a circa mid-early-late C20th reroofing.

*verge and eaves to west elevation of C17th range*
