# Flood Risk Assessment

Furlong House, Pitt Lane, Furlong House, Pitt Lane,  
Hurstpierpoint BN6 9QA

**Ref:** 10517

**Date:** September 2026

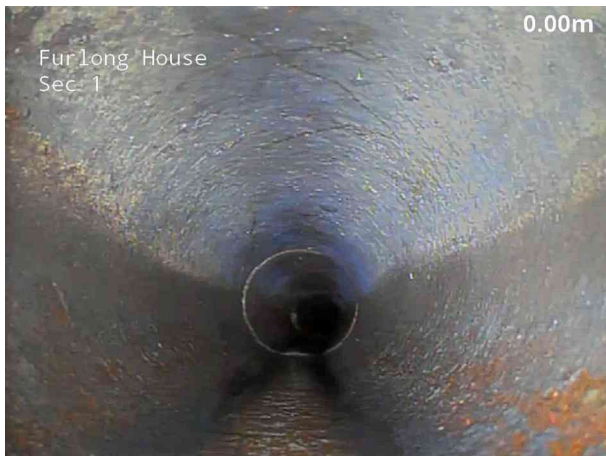
1, 00:00:00, 0.00 m  
Water level, 0% of the vertical dimension

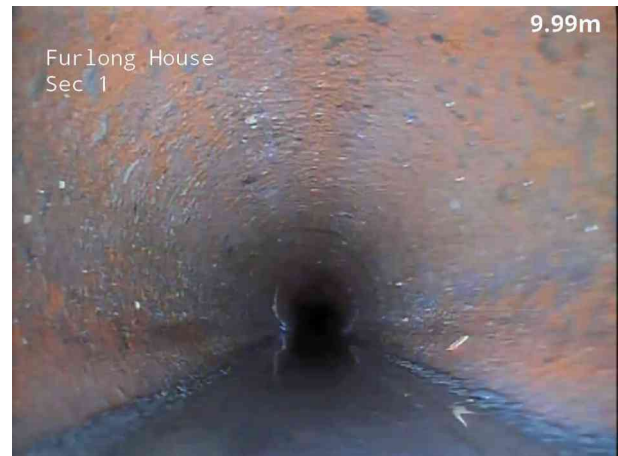
2, 00:01:48, 10.00 m  
Water level, 15% of the vertical dimension

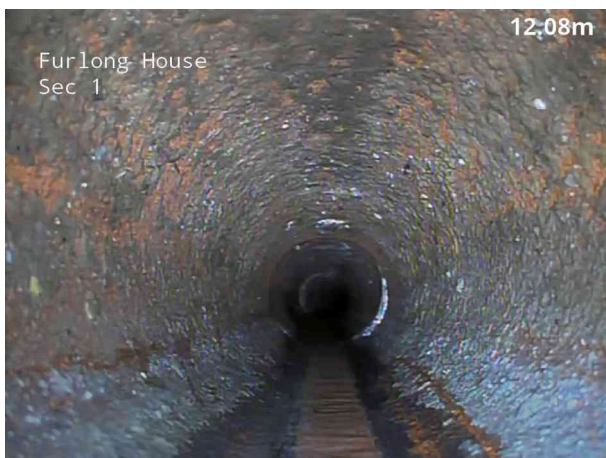
3, 00:02:11, 12.00 m  
Water level, 5% of the vertical dimension

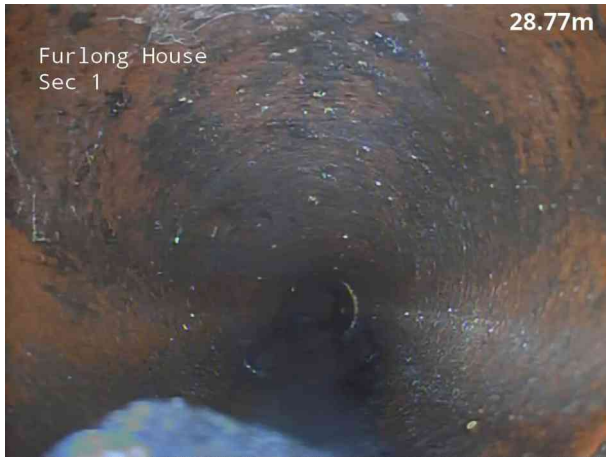
7, 00:05:24, 28.77 m  
Water level, 5% of the vertical dimension

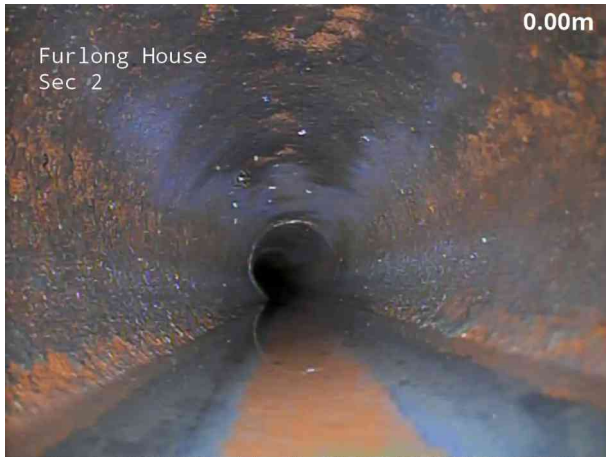
1, 00:00:01, 0.00 m  
Water level, 5% of the vertical dimension

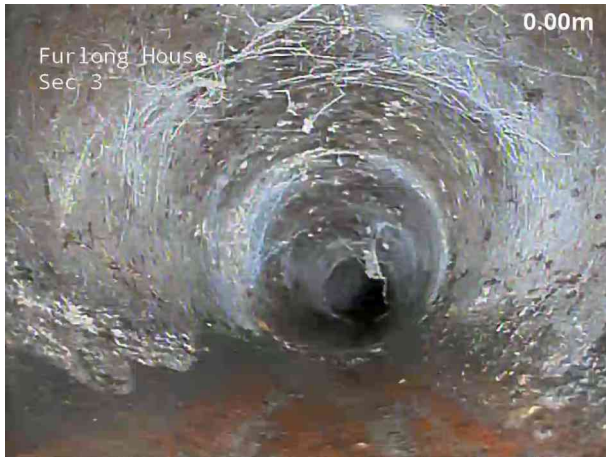
1, 00:00:01, 0.00 m  
Water level, 0% of the vertical dimension

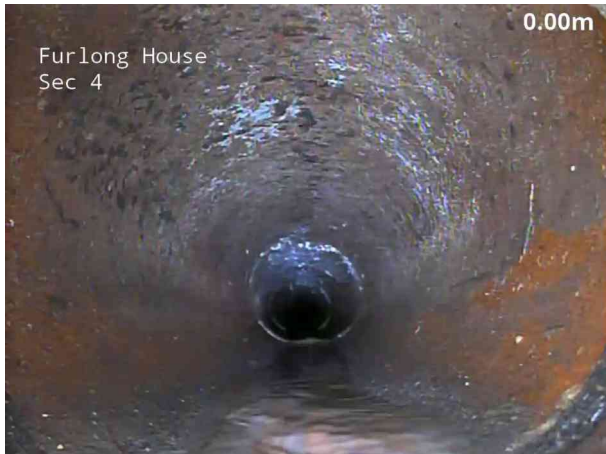
1, 00:00:00, 0.00 m  
Water level, 0% of the vertical dimension

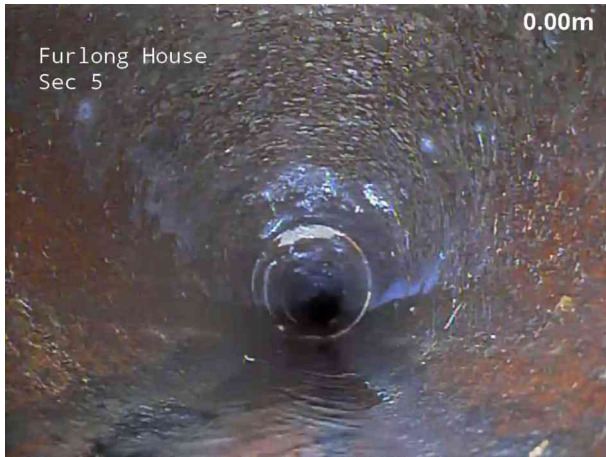
1, 00:00:01, 0.00 m  
Water level, 0% of the vertical dimension

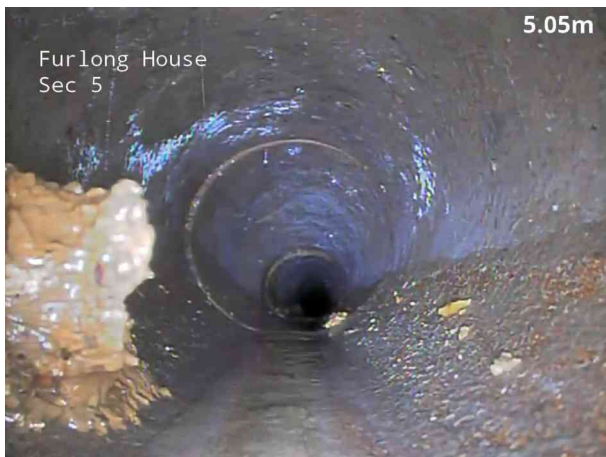
5, 00:00:51, 5.05 m  
Water level, 5% of the vertical dimension

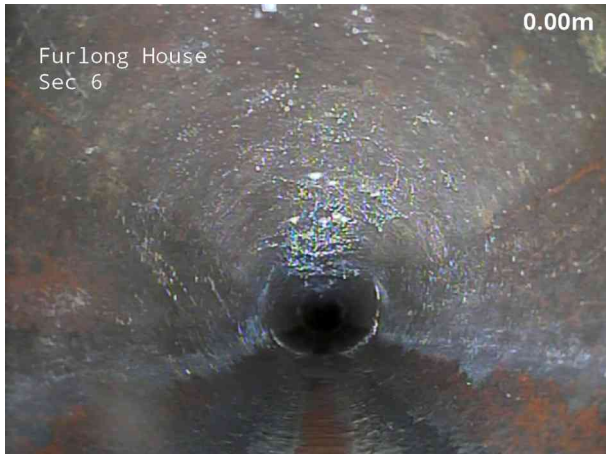
1, 00:00:00, 0.00 m  
Water level, 0% of the vertical dimension

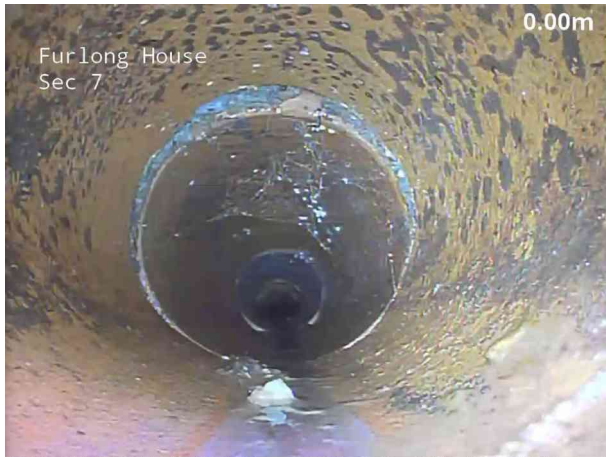
1, 00:00:00, 0.00 m  
Water level, 0% of the vertical dimension

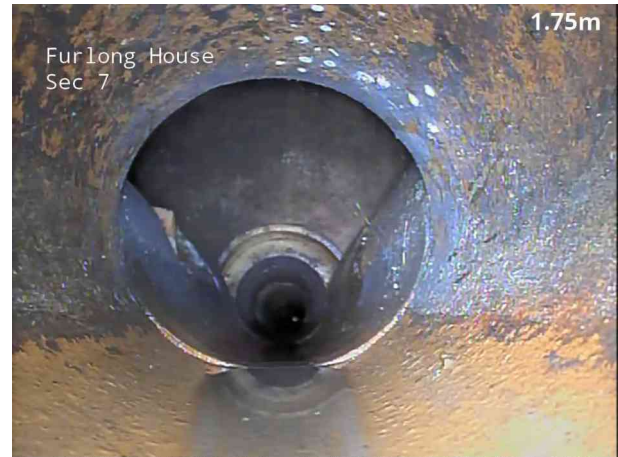
2, 00:00:16, 2.00 m  
Finish node, manhole, reference: FW2

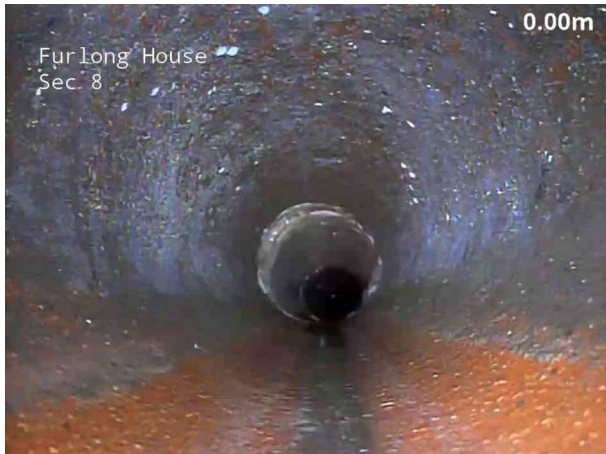
1, 00:00:01, 0.00 m  
Water level, 0% of the vertical dimension

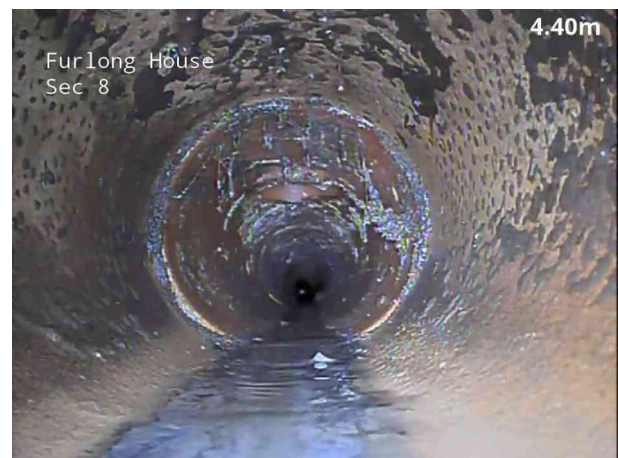
4, 00:00:49, 4.40 m  
Water level, 0% of the vertical dimension

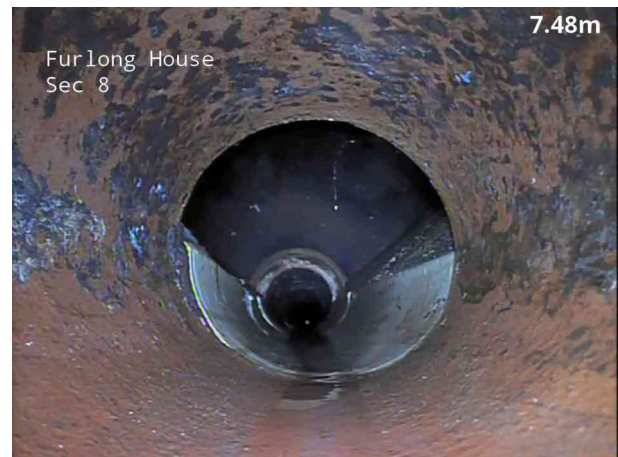
6, 00:01:19, 7.65 m  
Finish node, manhole, reference: FW3

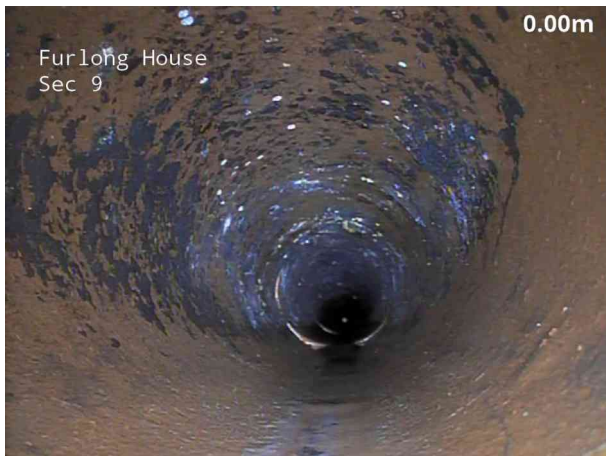
1, 00:00:00, 0.00 m  
Water level, 0% of the vertical dimension

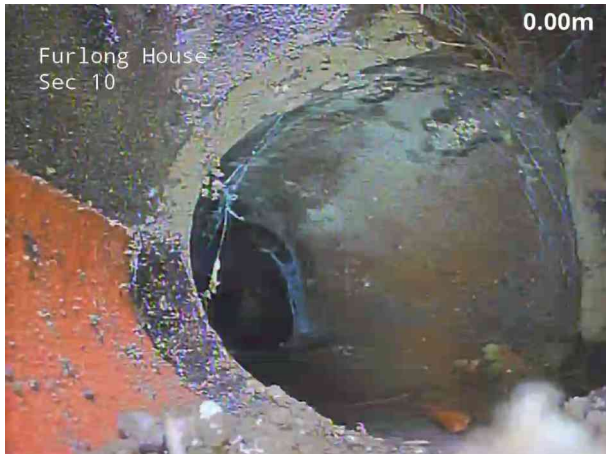
1, 00:00:01, 0.00 m  
Water level, 0% of the vertical dimension

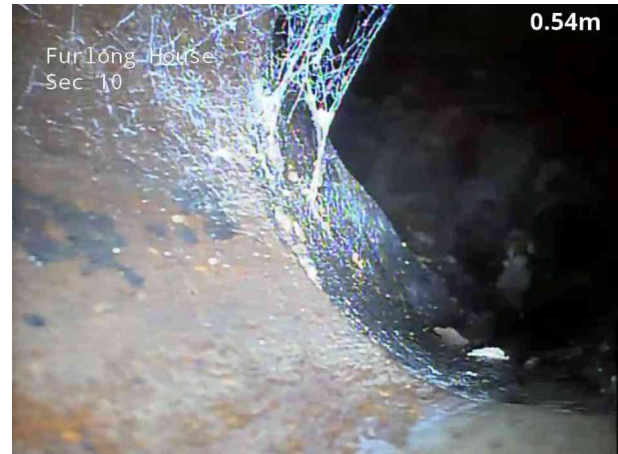
2, 00:00:13, 0.54 m  
Line deviates right

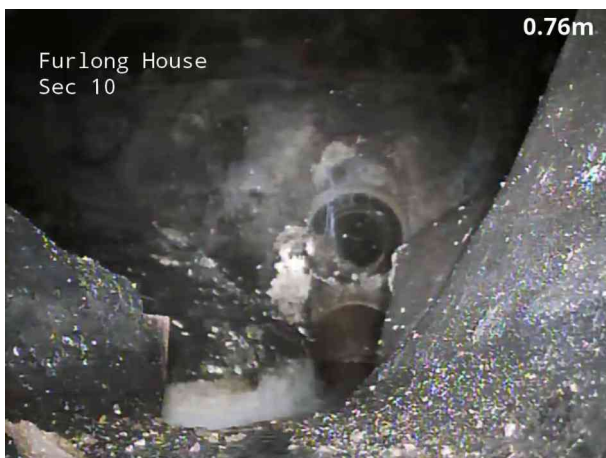
3, 00:00:17, 0.76 m  
Finish node, manhole, reference: FW4

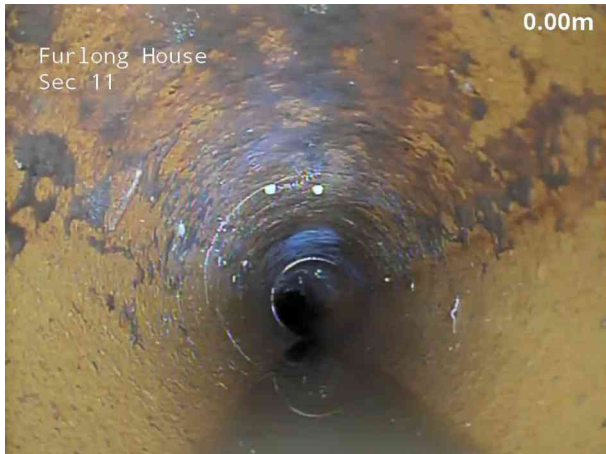
1, 00:00:02, 0.00 m  
Water level, 5% of the vertical dimension

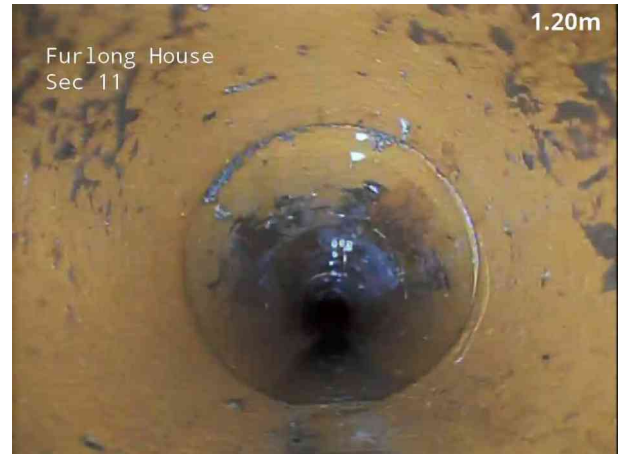
2, 00:00:18, 1.20 m  
Water level, 0% of the vertical dimension
