## **Sunte House & Outbuildings: Initial Structural Assessment**

22 11 24 .V1

Prepared By: Elizabeth Cattle MEng GMICE  
Checked By: Steve Atkinson BEng CEngMIStructE

**BUILT ENGINEERS**

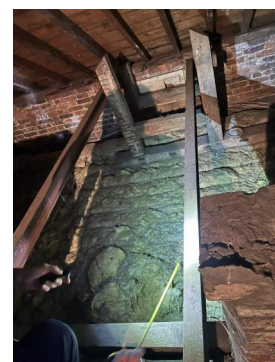
14 Suspected support structure to early clock

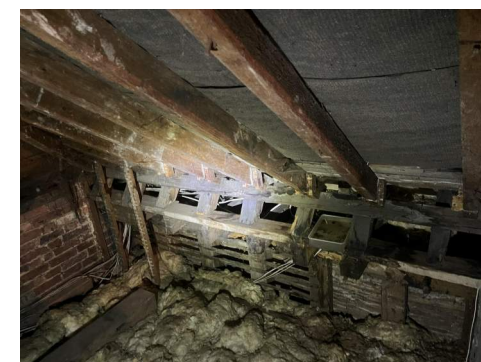
16 C19th infill section adjoining existing

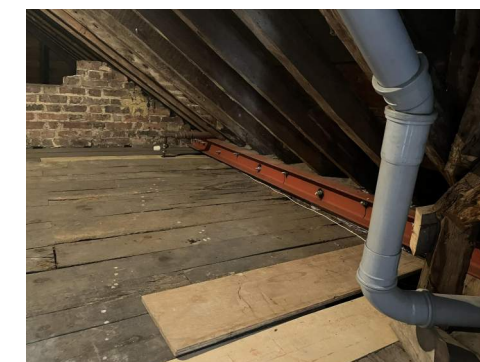
17 Previous strengthening with PFCs

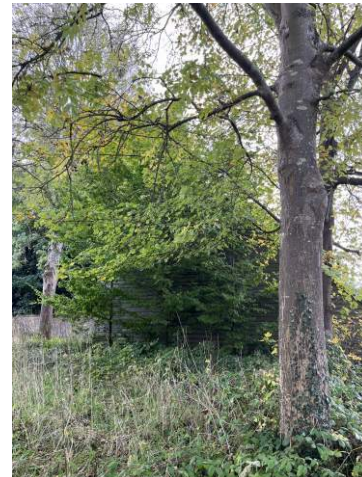
2 Rear East Elevation - concealed by vegetation, planting is too close to building face

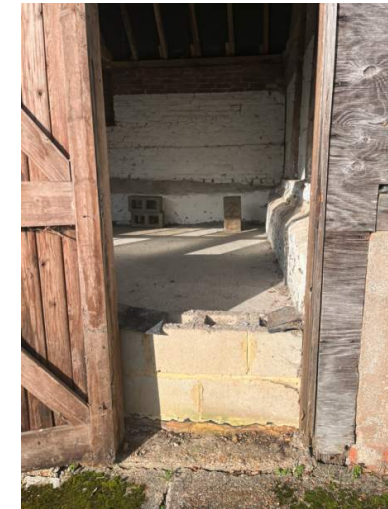
4 Step up to new slab

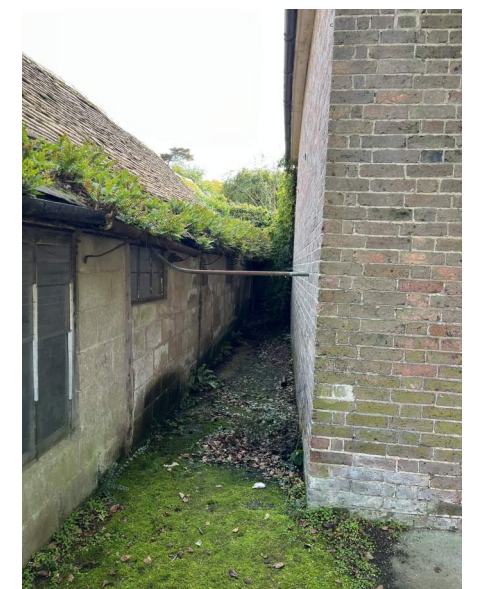
6 Vegetation on western elevation

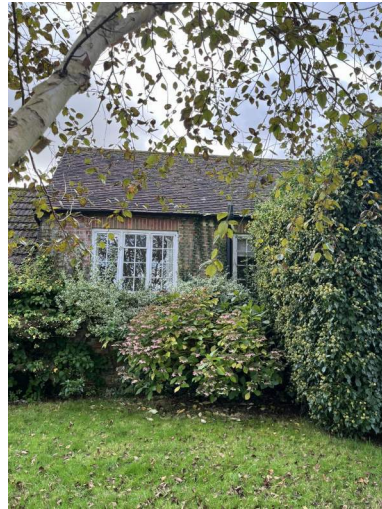
2 Northern elevation

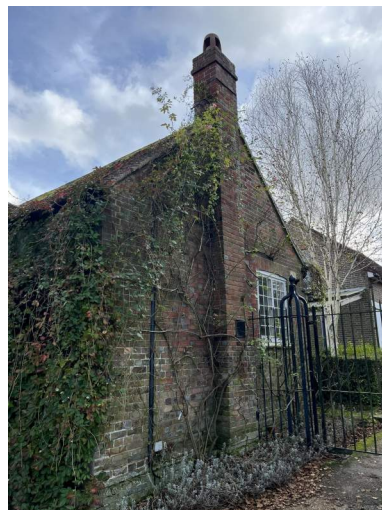
6 Gable end with chimney

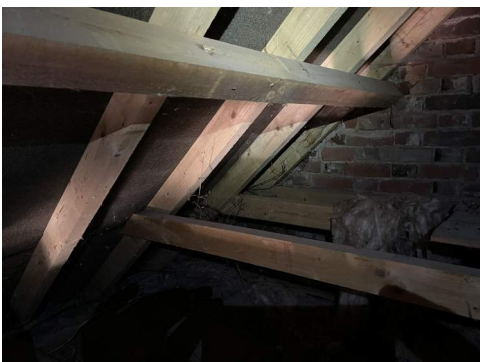
9 Roof framing

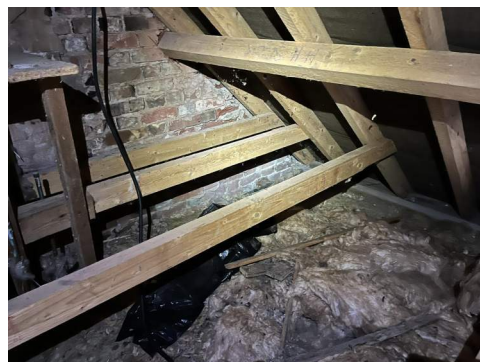
10 Purlin

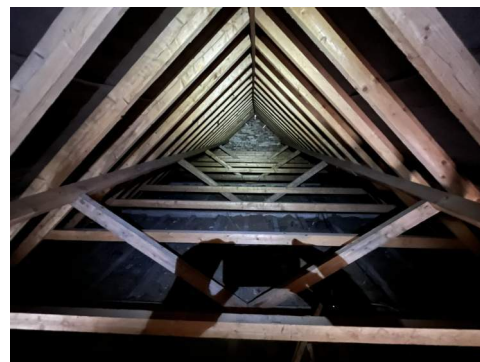
11 Collars to every other rafter

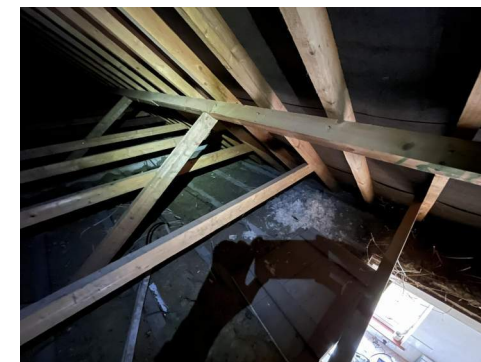
12 Props to purlin

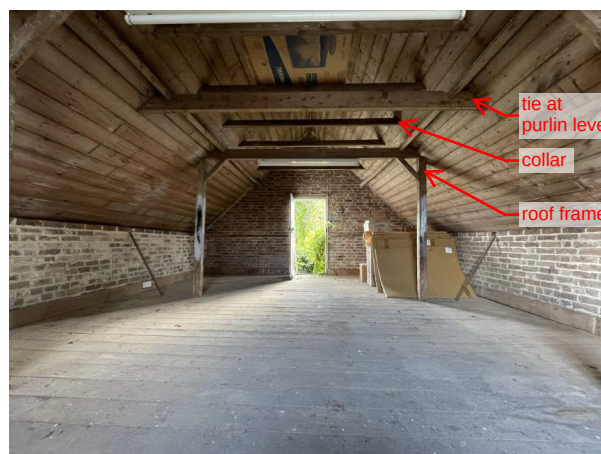
10 1st floor & roof framing

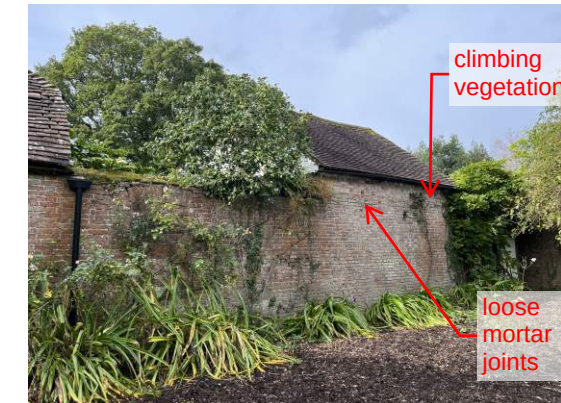
4 Rear elevation

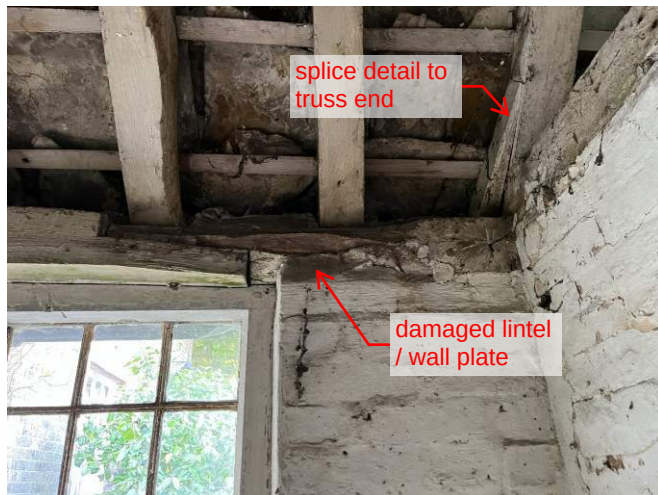
4 Timber wallplate

localised repointing required, new insulated timber framing inboard of existing masonry walls - details to be developed with Architect, damaged wall plate / lintel to western wall, to be repaired and reinstated with seasoned oak

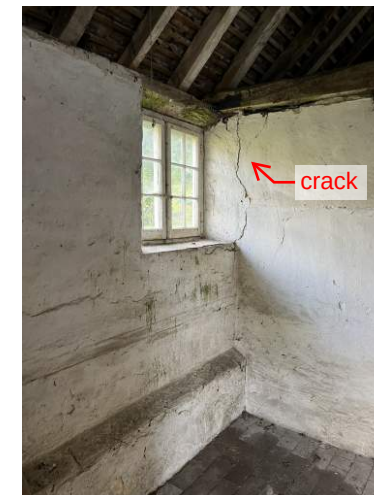
6 Internal wall

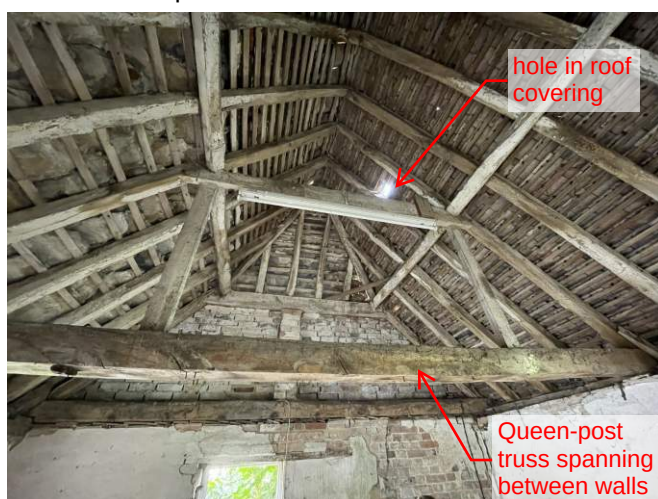
8 Internal timber queen post truss

denotes positions of original Queen-post truss spanning onto flank masonry walls, during later remodelling / repositioning of building gables, truss has been modified by addition of a dysfunctional corbelled central half brick pier, restoration of correct timber truss function should be developed during next stages  
rafters and framing in some areas requires repair and reinstatement, purlin and rafter structural capacity to be checked for increased applied loads due to new ceilings, insulation and ply sarking board etc

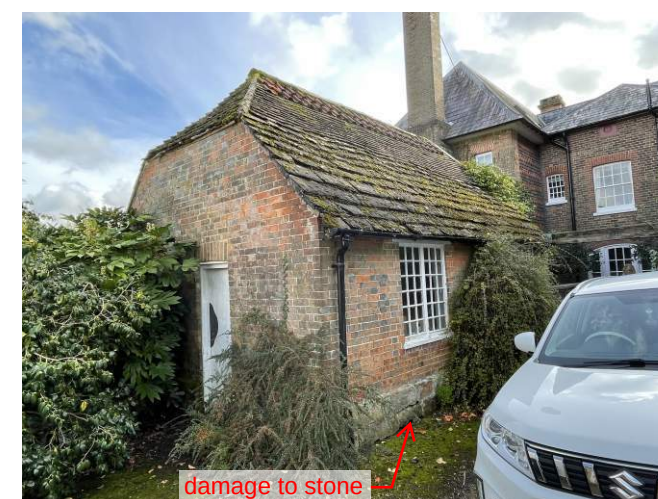
10 External view

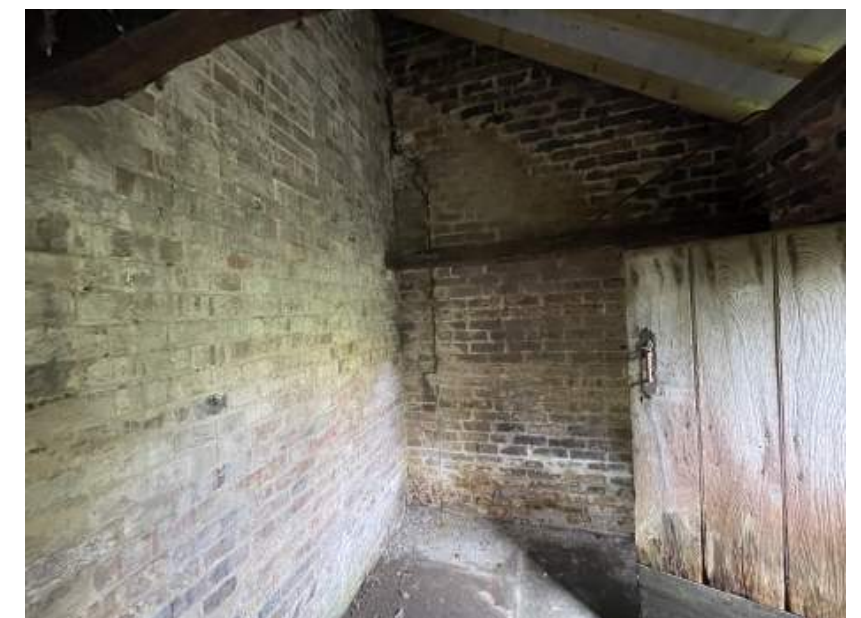
3.3 Garden store

appears to be historically altered, with evidence of previously altered rooflines, generally in fair condition, with roof rafters recently replaced:

rafters recently replaced, appears in generally good condition
