**Project Name:** Cuckfield Rd - Ansty  
**Project Description:** CCTV Survey, Trace & Plot  
**Project Status:** Complete  
**Project Date:** 04/06/2026  
**Inspection Standard:** MSCC5 Sewers & Drainage GB (SRM5 Scoring)

# **EYES ON DRAINAGE**

## **CCTV-Trace-Plot-Map-Repair**

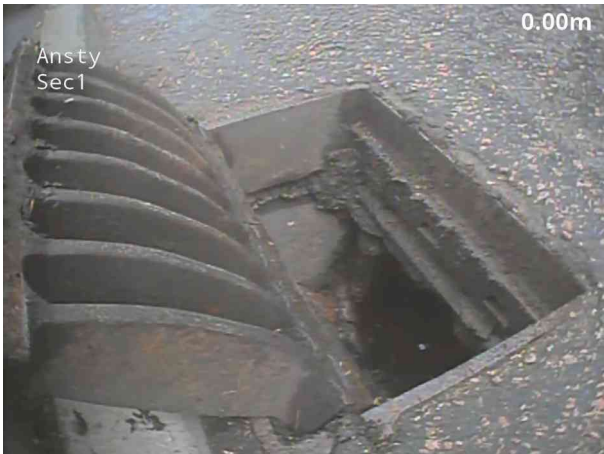
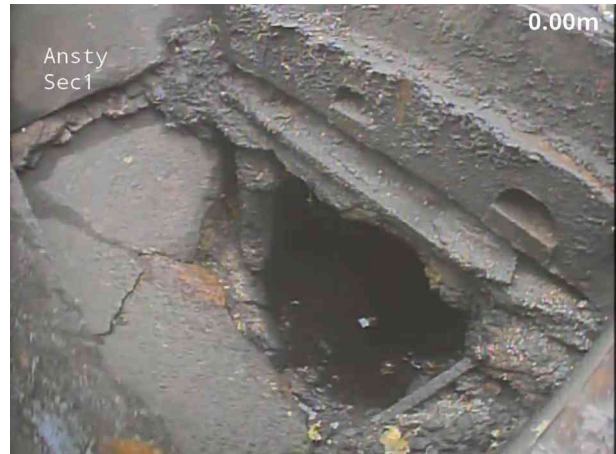
1, 00:00:00, 0.00 m  
Start node, gully, reference: RG1

2, 00:00:00, 0.00 m  
Start node, gully, reference: RG1

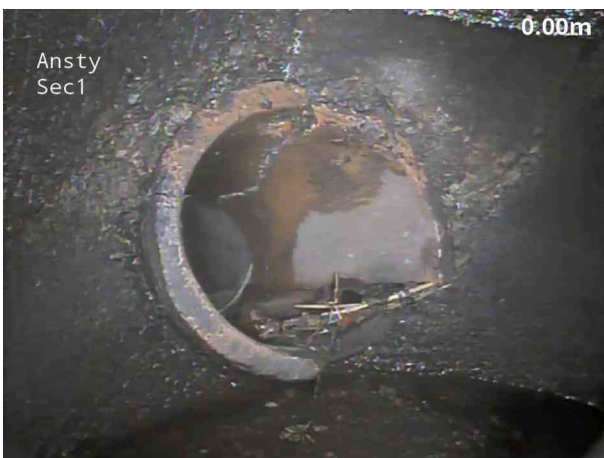
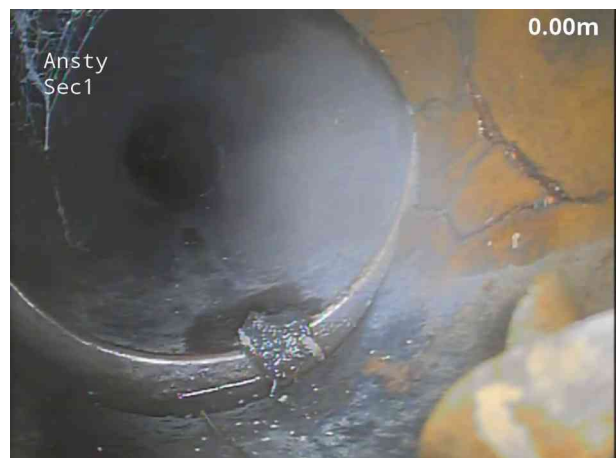
3, 00:00:29, 0.00 m  
Water level, 0% of the vertical dimension

4, 00:00:29, 0.00 m  
Water level, 0% of the vertical dimension

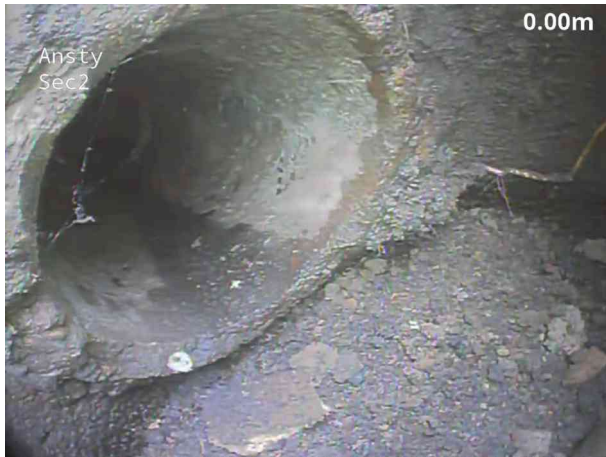
1, 00:00:00, 0.00 m  
Start node, gully, reference: RG2

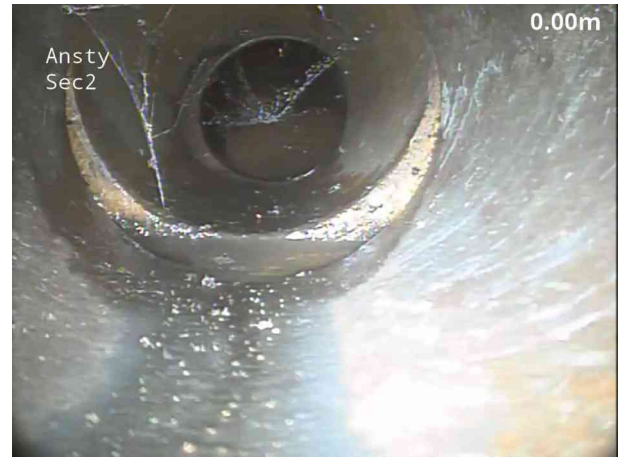
2, 00:00:00, 0.00 m  
Water level, 0% of the vertical dimension

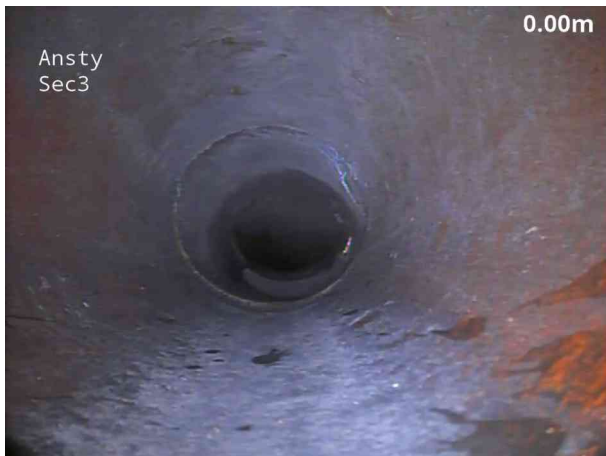
1, 00:00:11, 0.00 m  
Water level, 0% of the vertical dimension

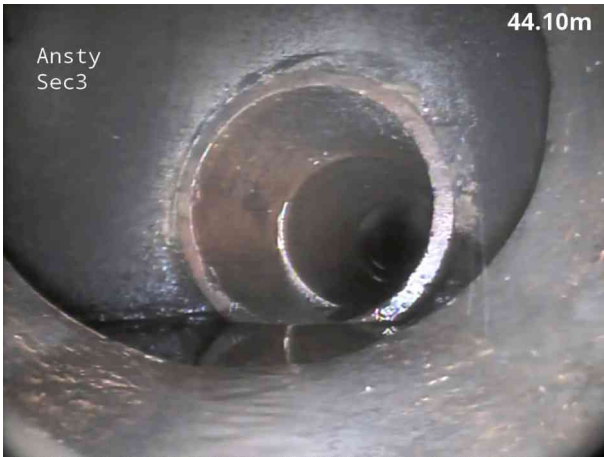
19, 00:04:07, 44.40 m  
Finish node, catchpit, reference: CP3, Buried
