## TANYARD MANOR

Repair and Renewal of  
Roof Coverings

HERITAGE  
STATEMENT

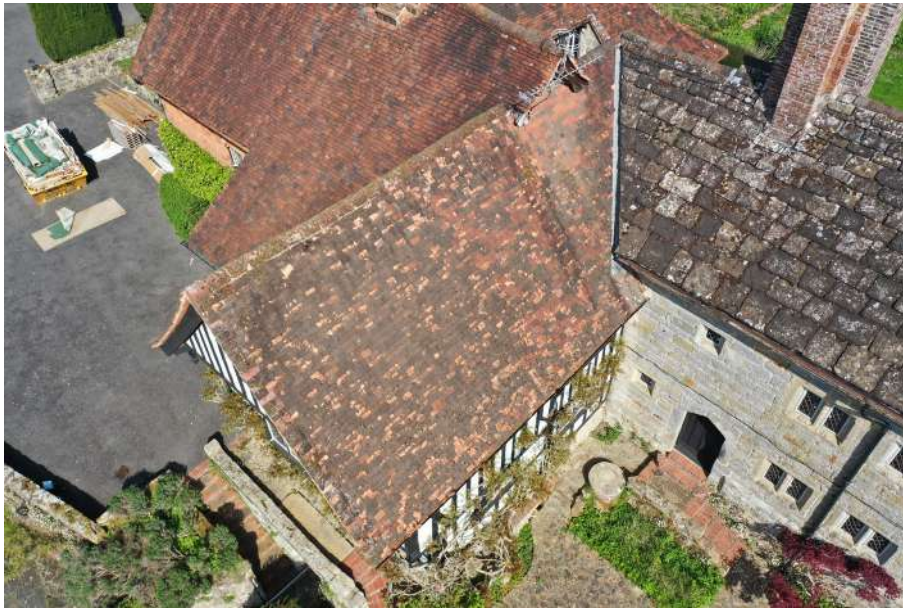
*lead valley to south slope*

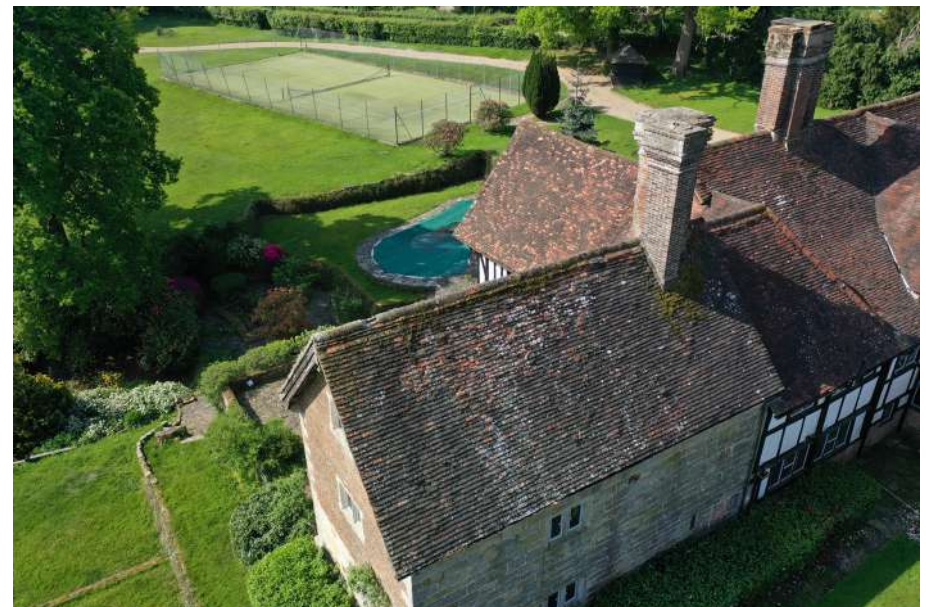
The north slope exhibits moss and lichen consistent with its shaded orientation and there is extensive evidence of spalling consistent with freeze thaw action due to water sitting on the relatively uncambered tiles, as well as cracked, broken, missing and slipped tiles. There is a missing ridge tile.

*clay plain tile to north slope*

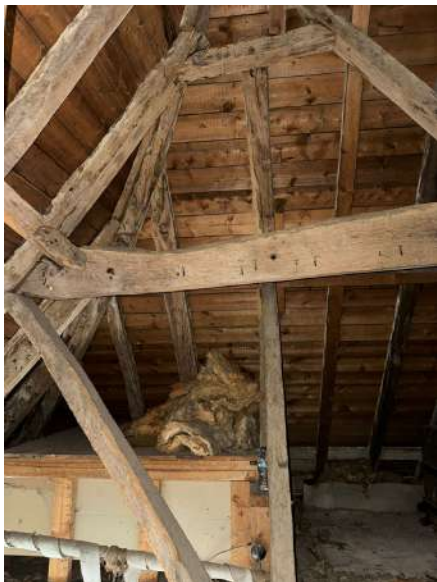
*interior of north hip of C17th range  
showing sarking boards*

further inspection) presumably hung over roofing battens nailed to the boards. The boards presumably confer lateral restraint to the roof as part of historic repairs. The nails may be ferrous and corroded but this was not evident from the available drone survey information or inspection of the roof void. The line of the tails of the tiles exhibit considerable variation suggestive of the use of peg tiles secured through the varying position of peg holes rather than nib tiles, which would exhibit a more uniform appearance.

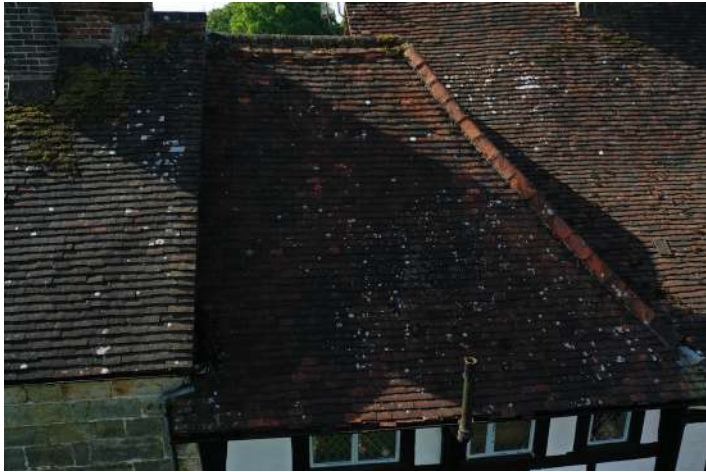
*hip to north elevation of C17th range*

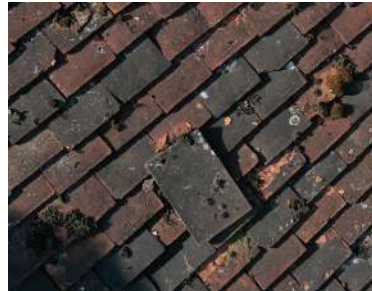
The tiles do not exhibit much camber and appear to be a mix of red and darker brown tiles and may comprise a mix of handmade and machine made tiles (handmade typically displaying a characteristic smile at the tail of the tile). The odd slipped tiles evidence the tiles are peg rather than nib tiles.

*slipped peg tile to C17th range*

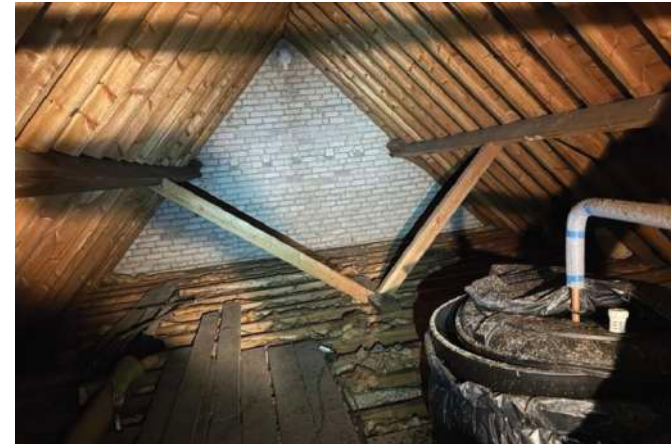
*loft space*

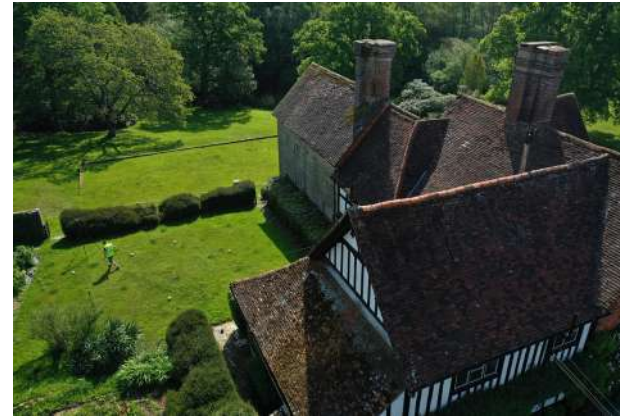
The usual defects are apparent including spalled, cracked, missing and slipped tiles, especially to the eaves suggestive of decayed tilt fillet due to failed rainwater goods. There is evidence of the loss of mortar beds to bonnet tiles and ridge tiles.

*west elevation of C20th range*

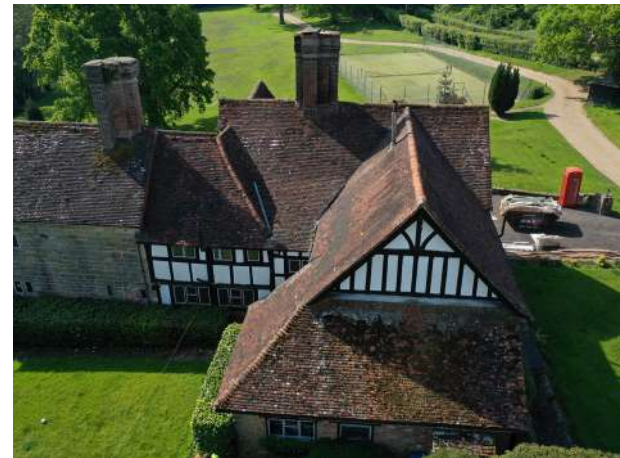
*north elevation of C20th range*

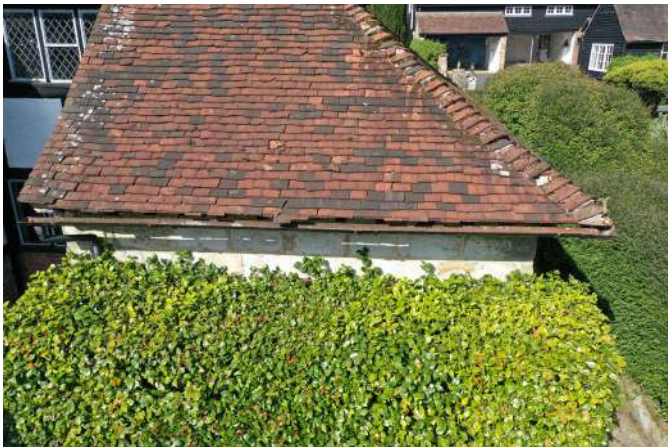
*wraparound roof to the east*

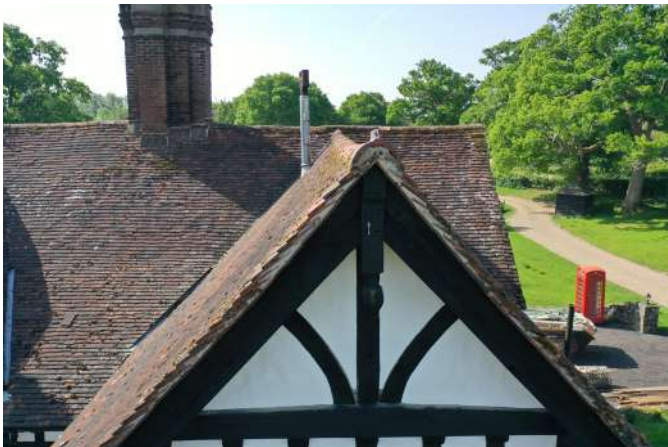
*traditional mortar bedded verge with tiled undercloak*

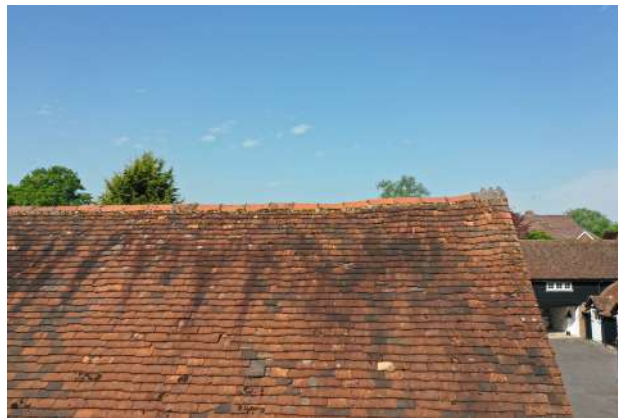
*north elevation of C20th range*

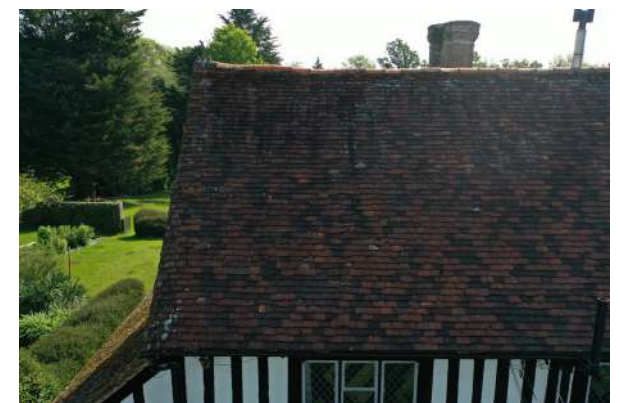
*characteristic variation in pattern and gauge to west slope*

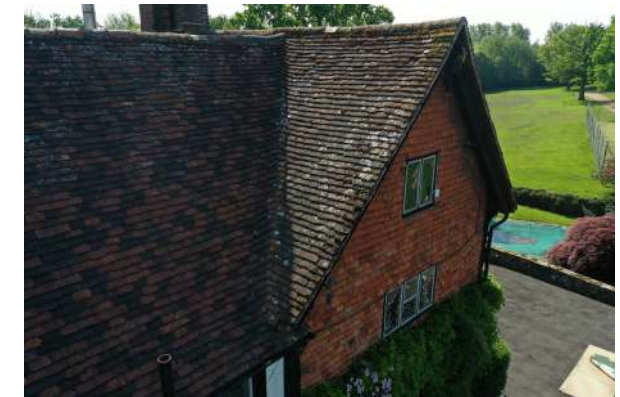
*traditional laced tiled valley to west slope adjoining C17th range*

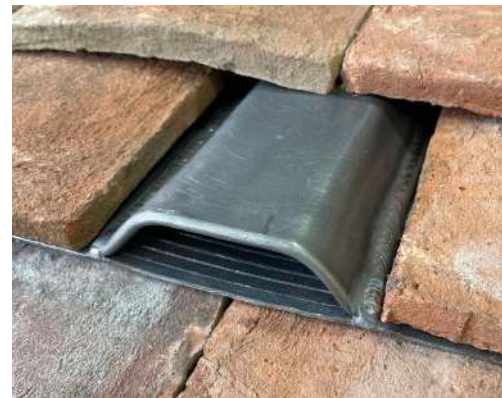
*lead bat arch installed in plain clay tile and slate roof*

- The PEA and bat emergence surveys revealed the presence of potential roosts and although the spaces will be retained for roosts, the following mitigation measures will be incorporated in the proposals:
  - partitioning of the unconverted loft spaces in the roof apex with panels to provide roost opportunities.
  - installation of 2no. crevice style bat boxes within the loft spaces
  - insulation in the unconverted loft spaces to be at floor level only
  - access to the unconverted loft spaces to be via lead bat arches to each slope.
  - a new external crevice box fixed to the west facing gable
  - replacement/installation of roofing membrane with type 1F felt only.
