Foul and Surface Water Drainage Report

2 Reservoir Place, Ashurst

Reference **C3547**

Project Name: 2 Reservoir Place
Project Description: CCTV survey, trace and plot
Project Status: Complete
Project Date: 14/02/2025
Inspection Standard: MSCC5 Sewers & Drainage GB (SRM5 Scoring)

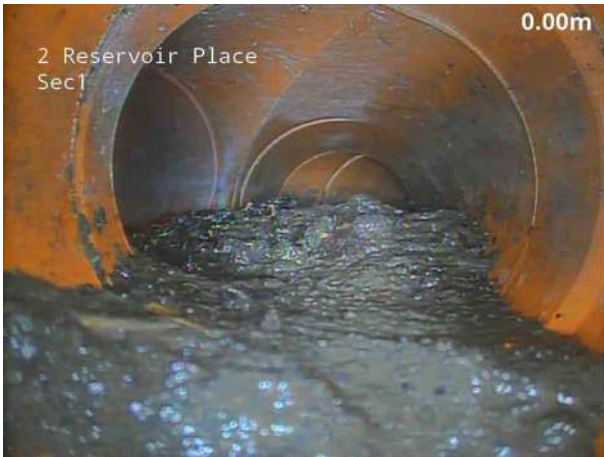
1, 00:00:03, 0.00 m
Water level, 0% of the vertical dimension

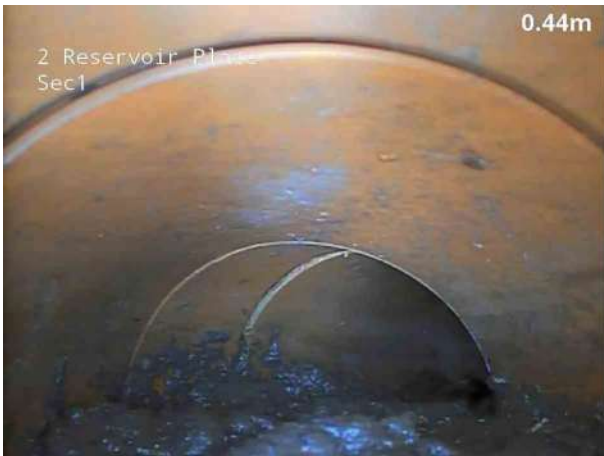
3, 00:00:17, 0.50 m
Line deviates right

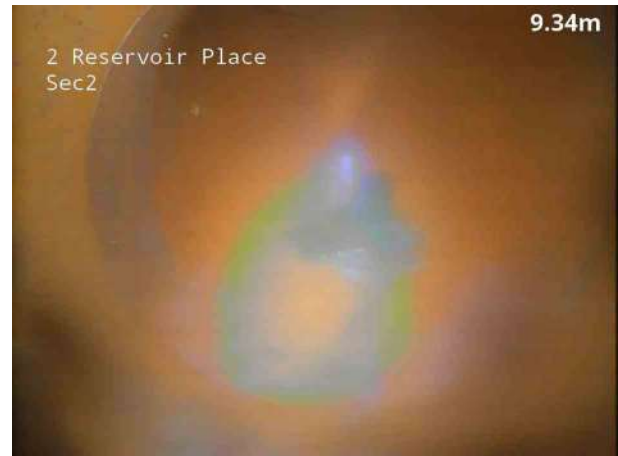
4, 00:01:20, 9.50 m
Line deviates up

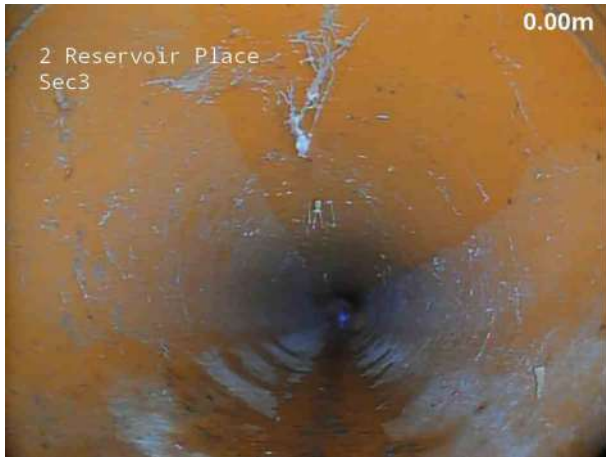
1, 00:00:04, 0.00 m
Water level, 0% of the vertical dimension

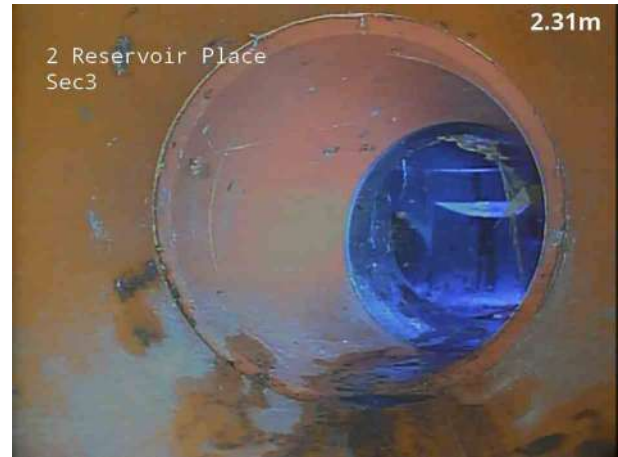
2, 00:00:21, 2.40 m
Line deviates right

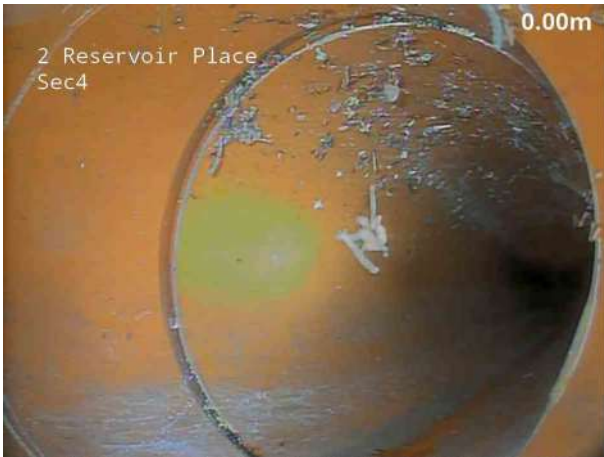
1, 00:00:04, 0.00 m
Water level, 0% of the vertical dimension

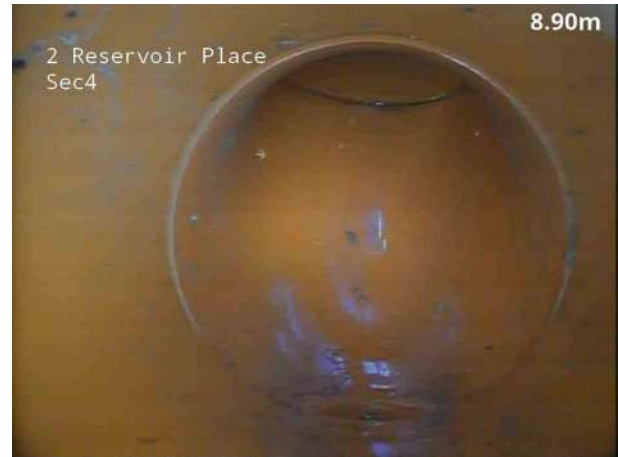
2, 00:00:30, 9.00 m
Line deviates up

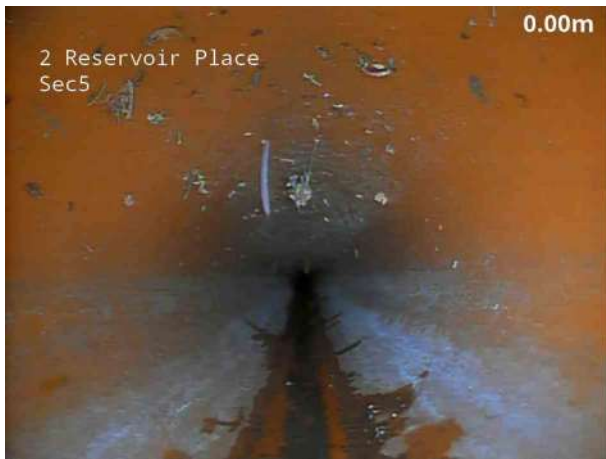
1, 00:00:03, 0.00 m
Water level, 0% of the vertical dimension
