*Project ref: TV241020*

SITE: 45 The Broadway  
Haywards Heath  
West Sussex  
RH16 3AS

# ***CCTV Survey Report***

*Sewer Inspection, Cleaning and Repair*

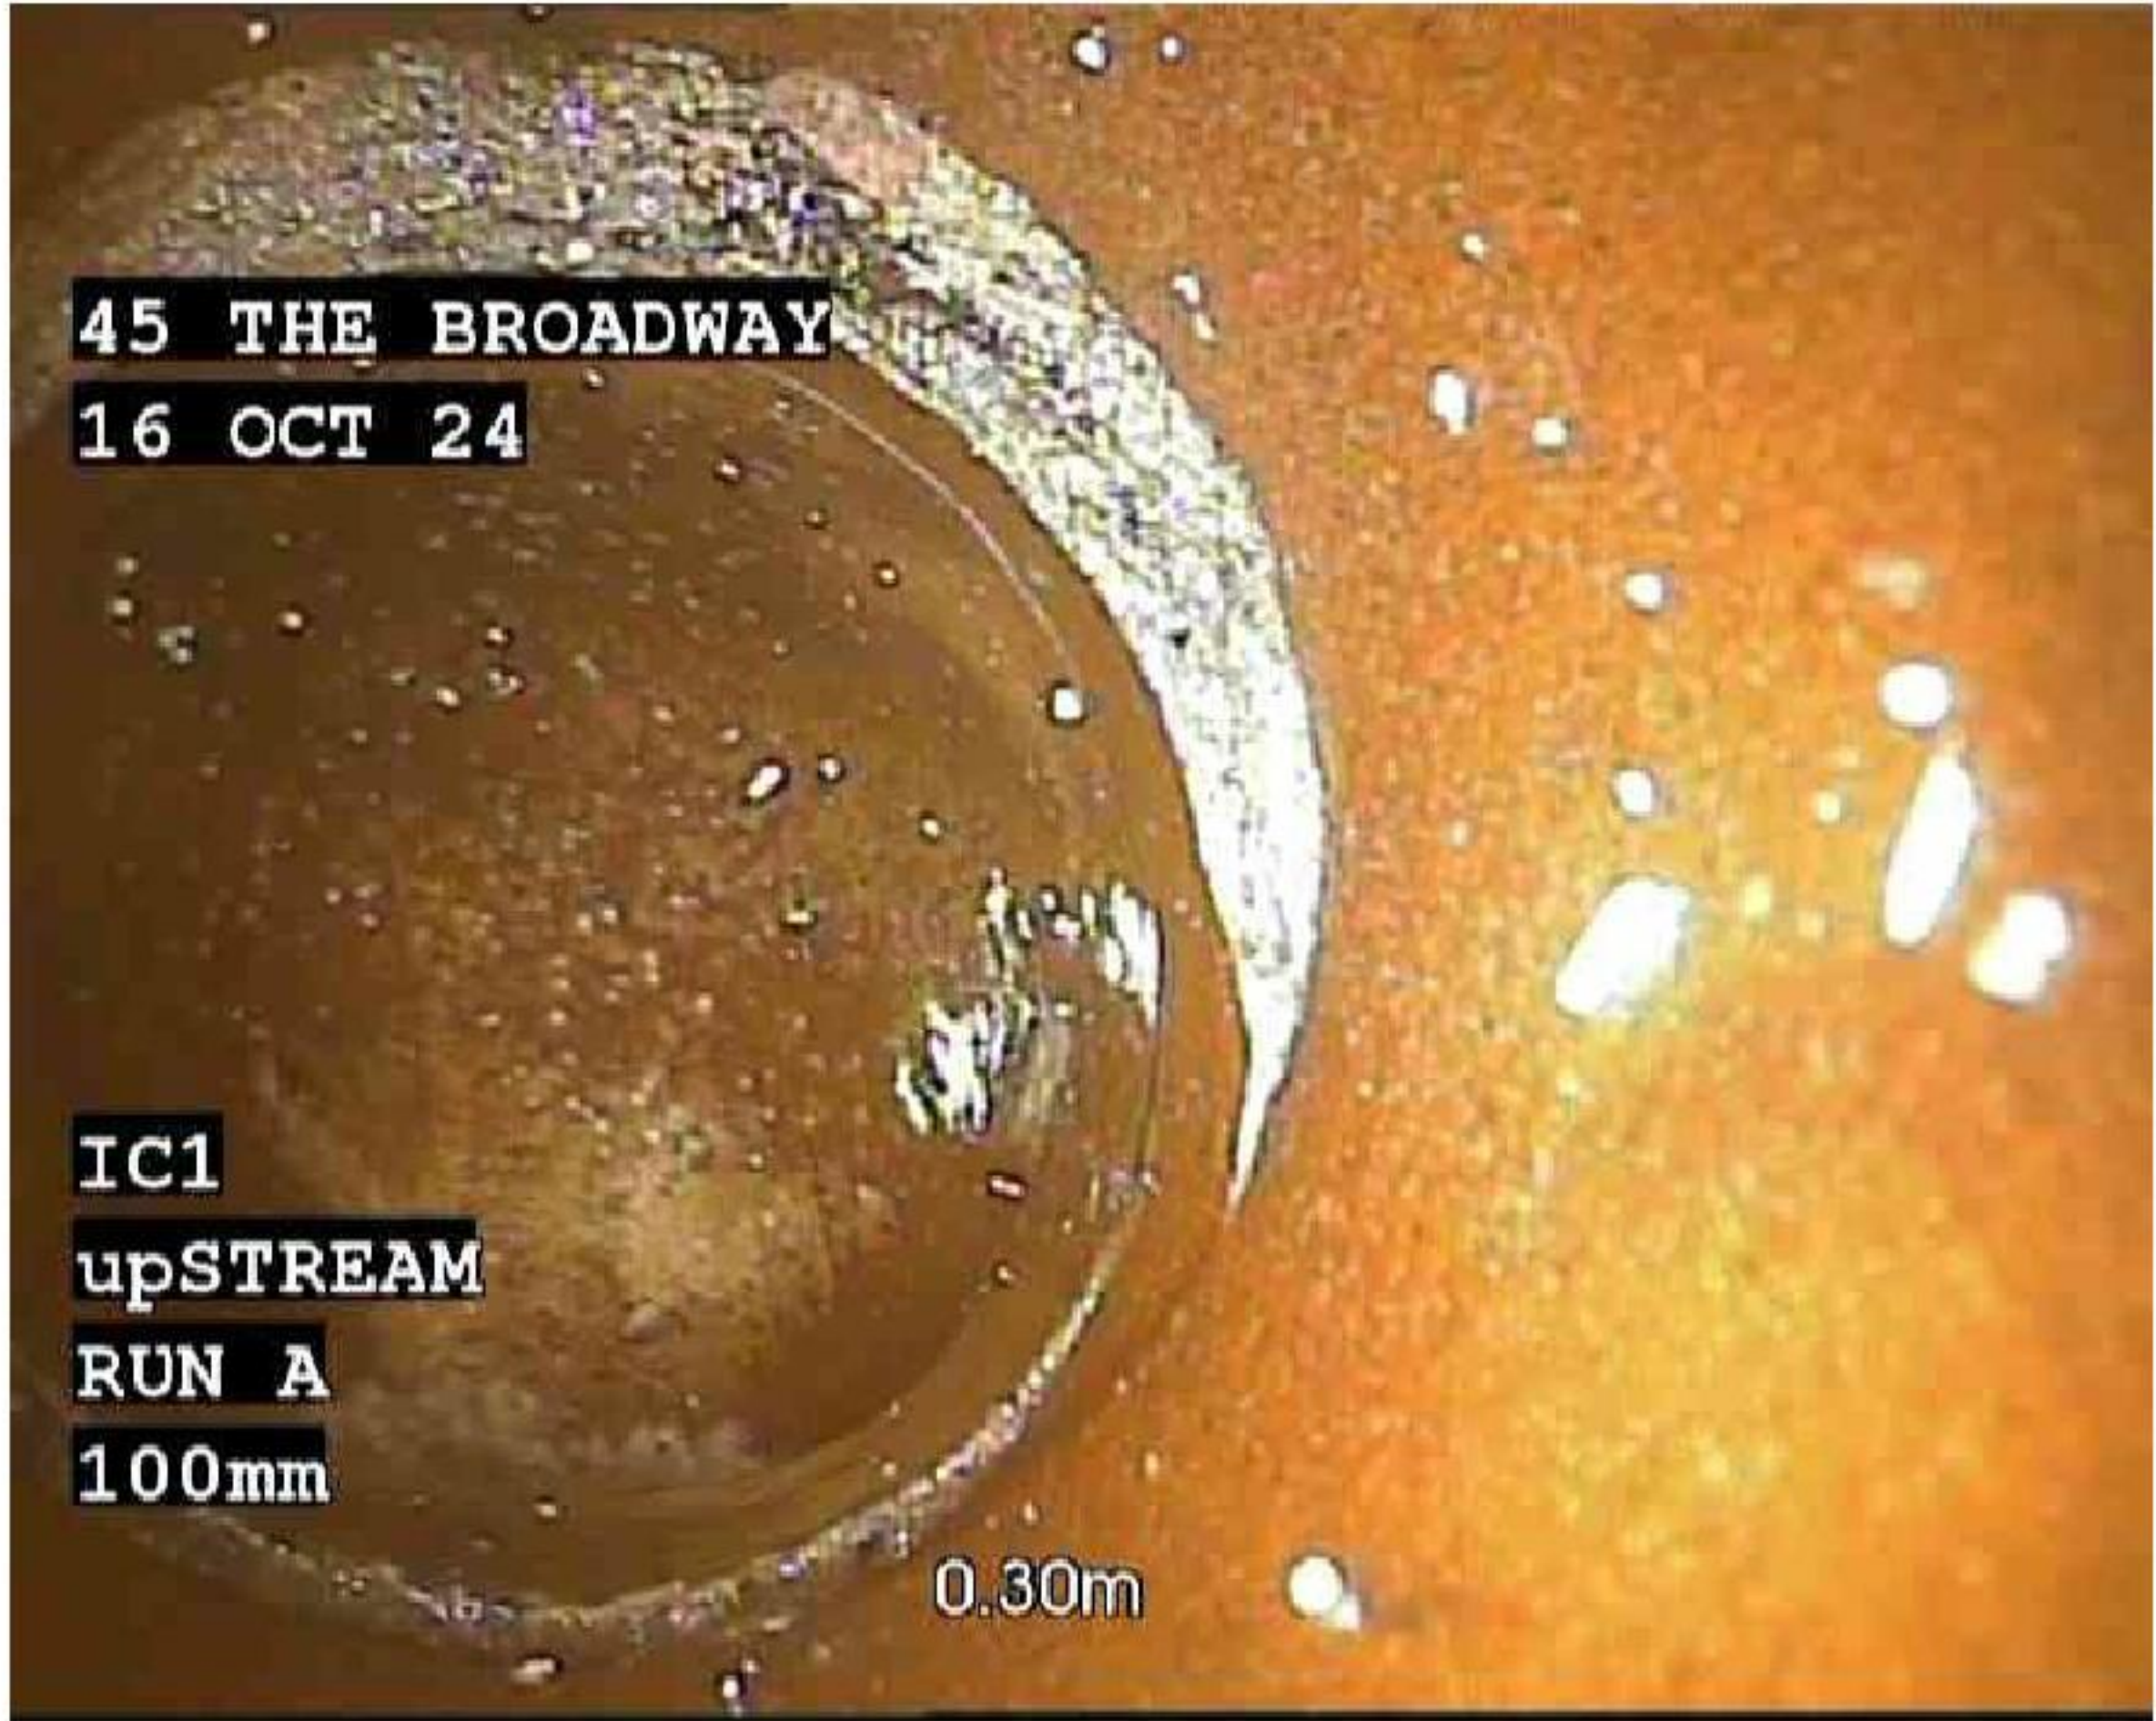
1, 00:00:02, 0.00 m  
Water level, 5% of the vertical dimension

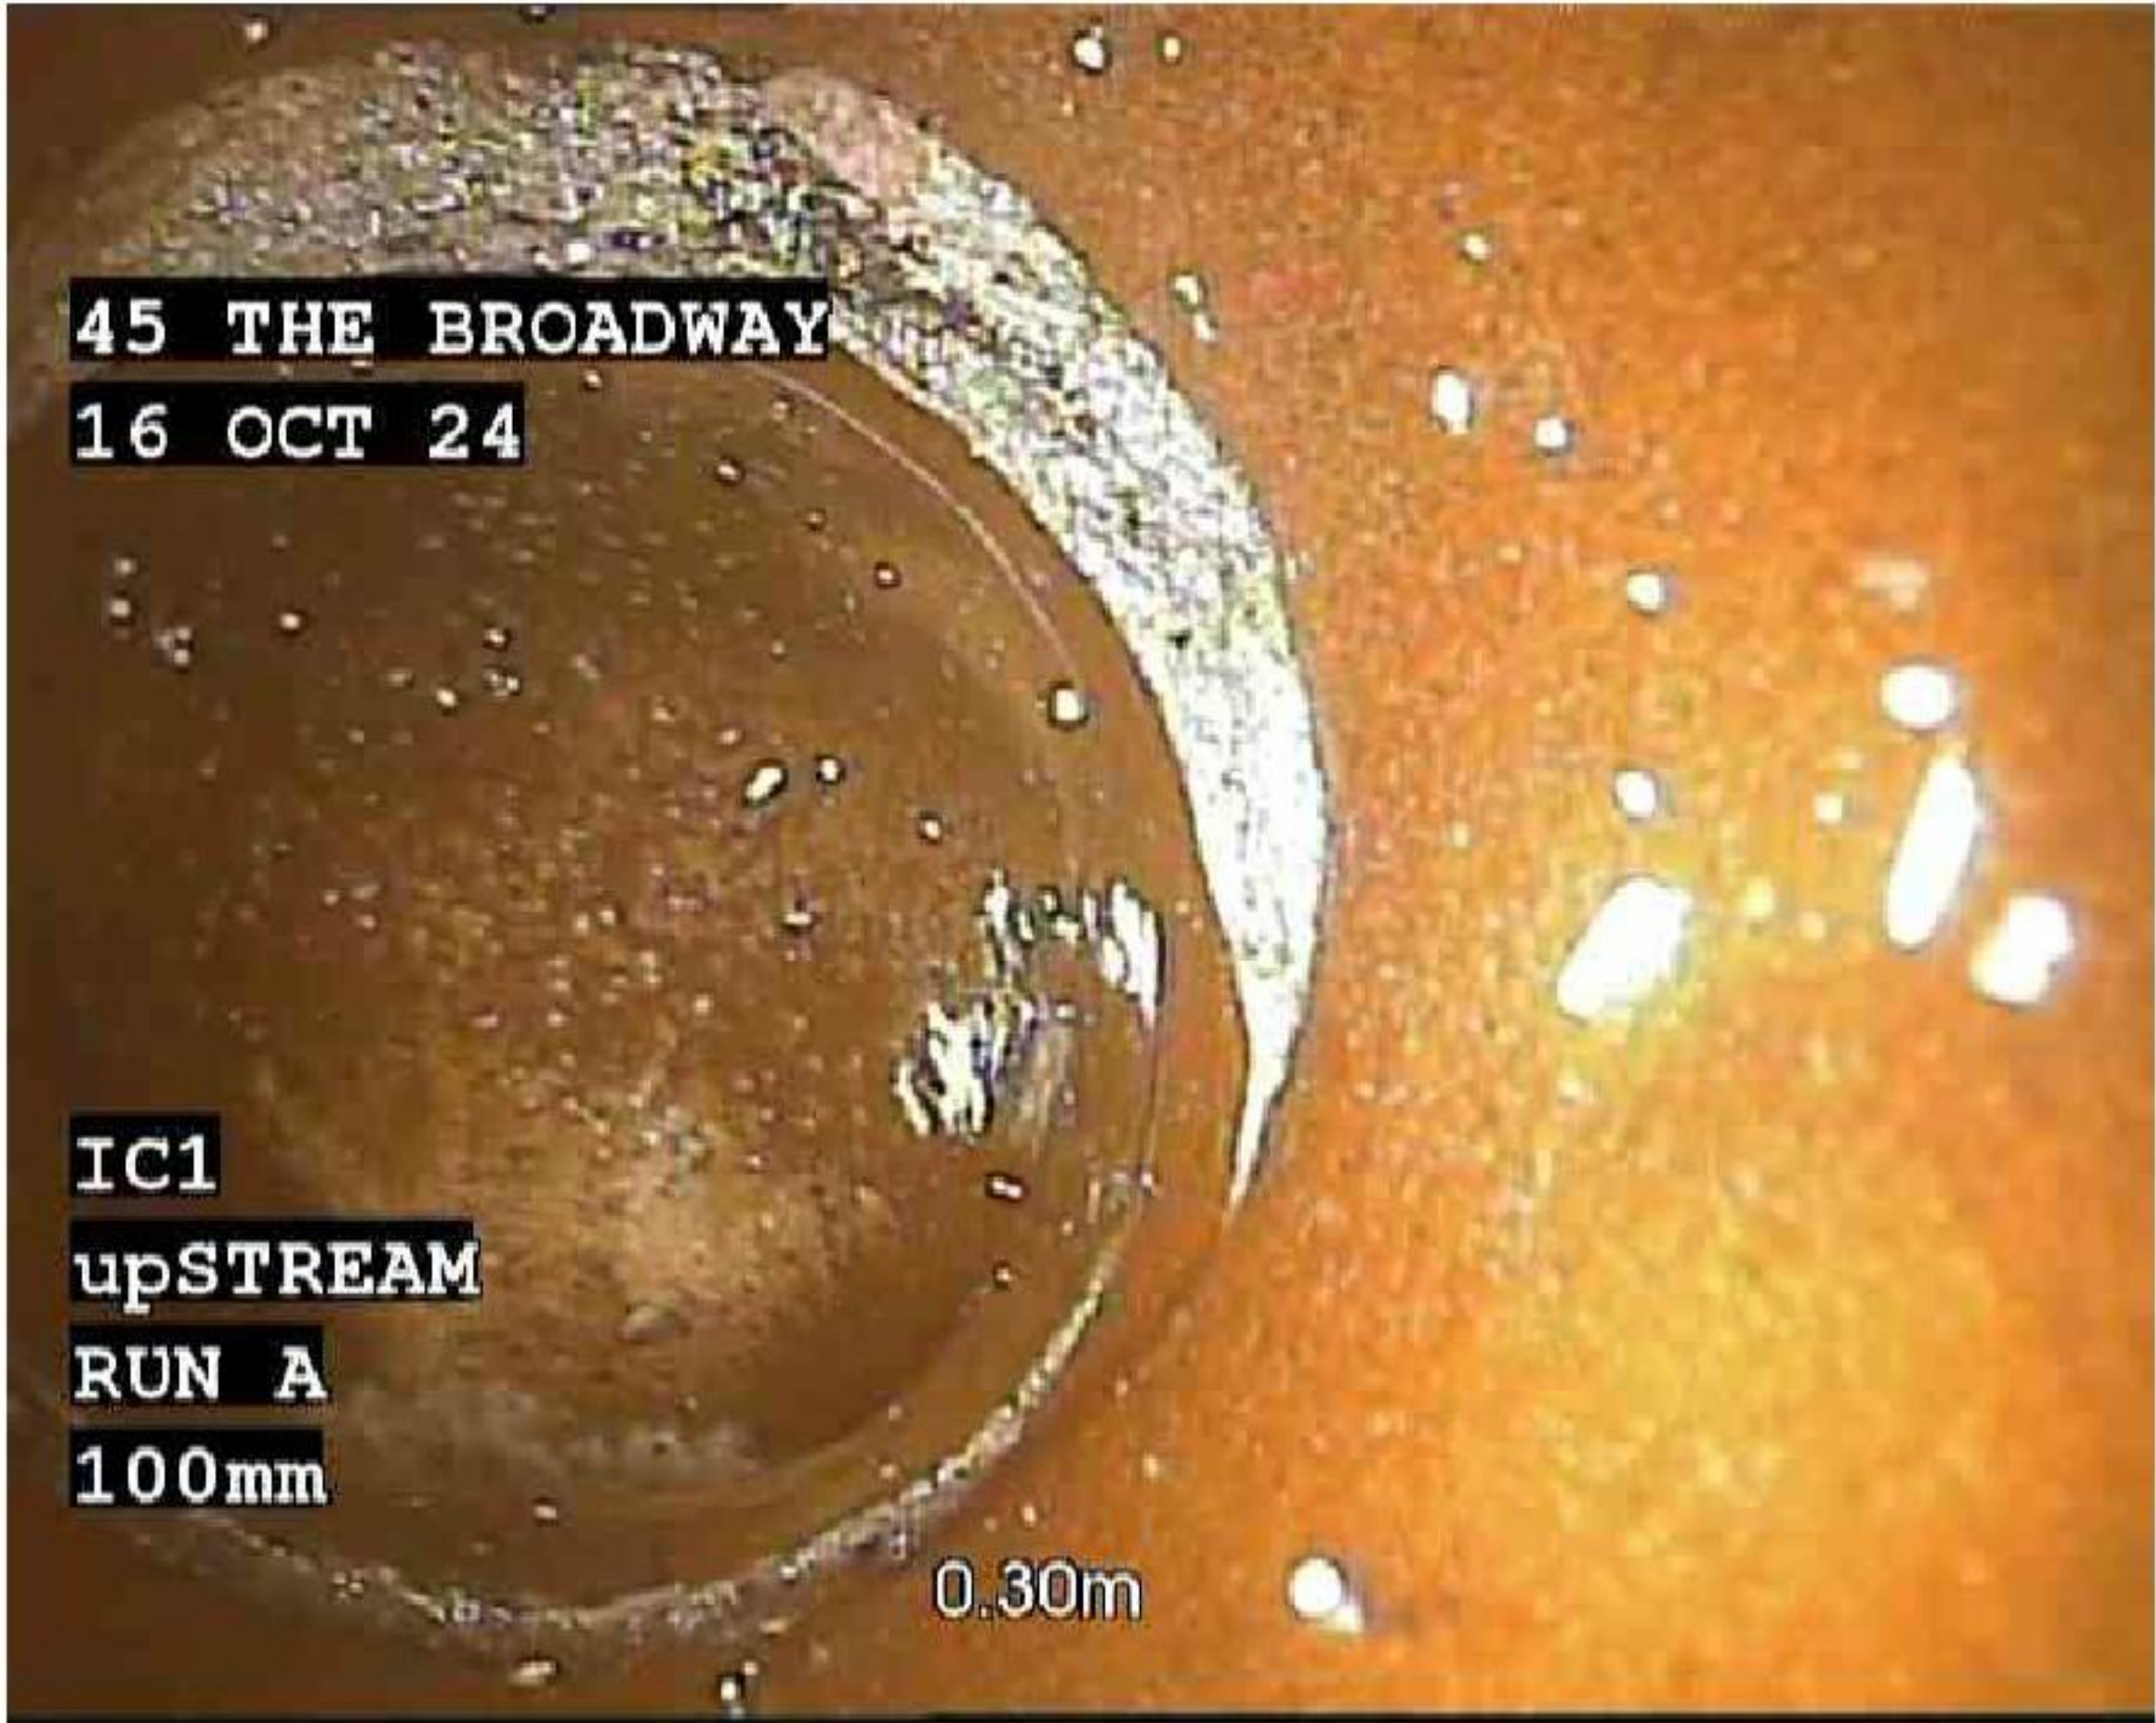
2, 00:00:02, 0.30 m  
Finish node, gully, reference: RUN A, At gully

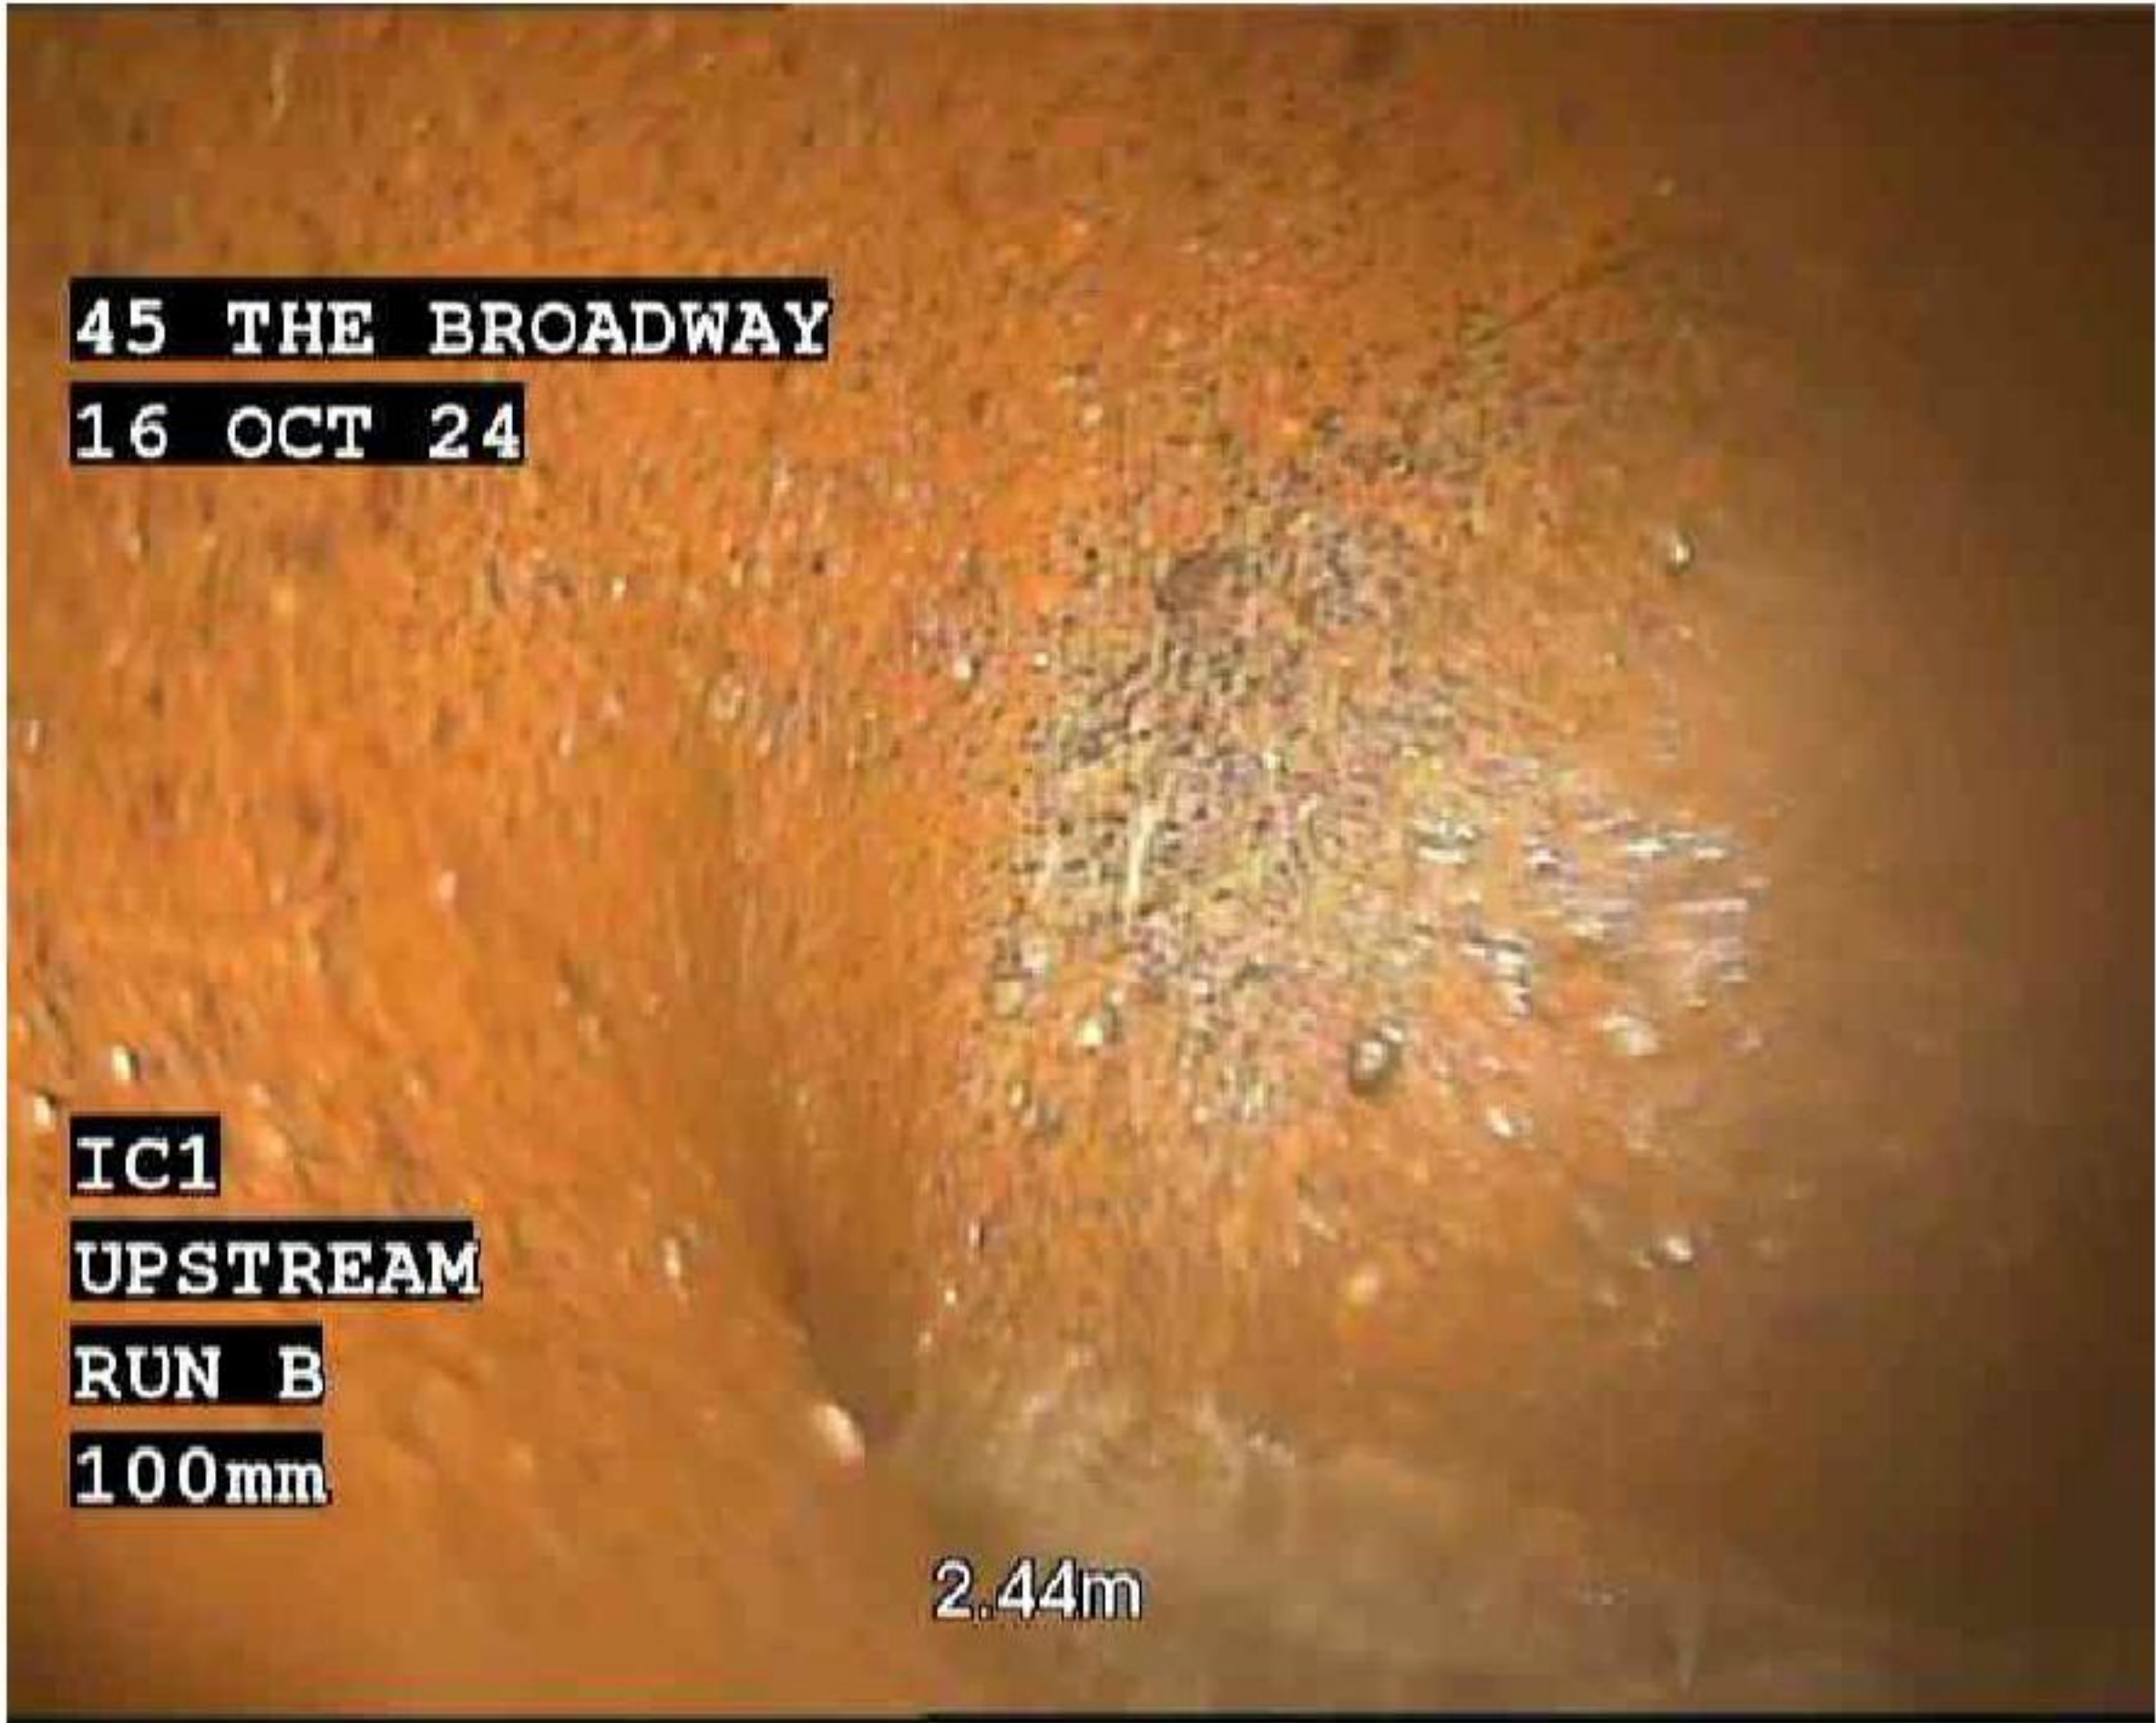
2, 00:00:18, 2.44 m  
Finish node, gully, reference: IC1-B, At gully

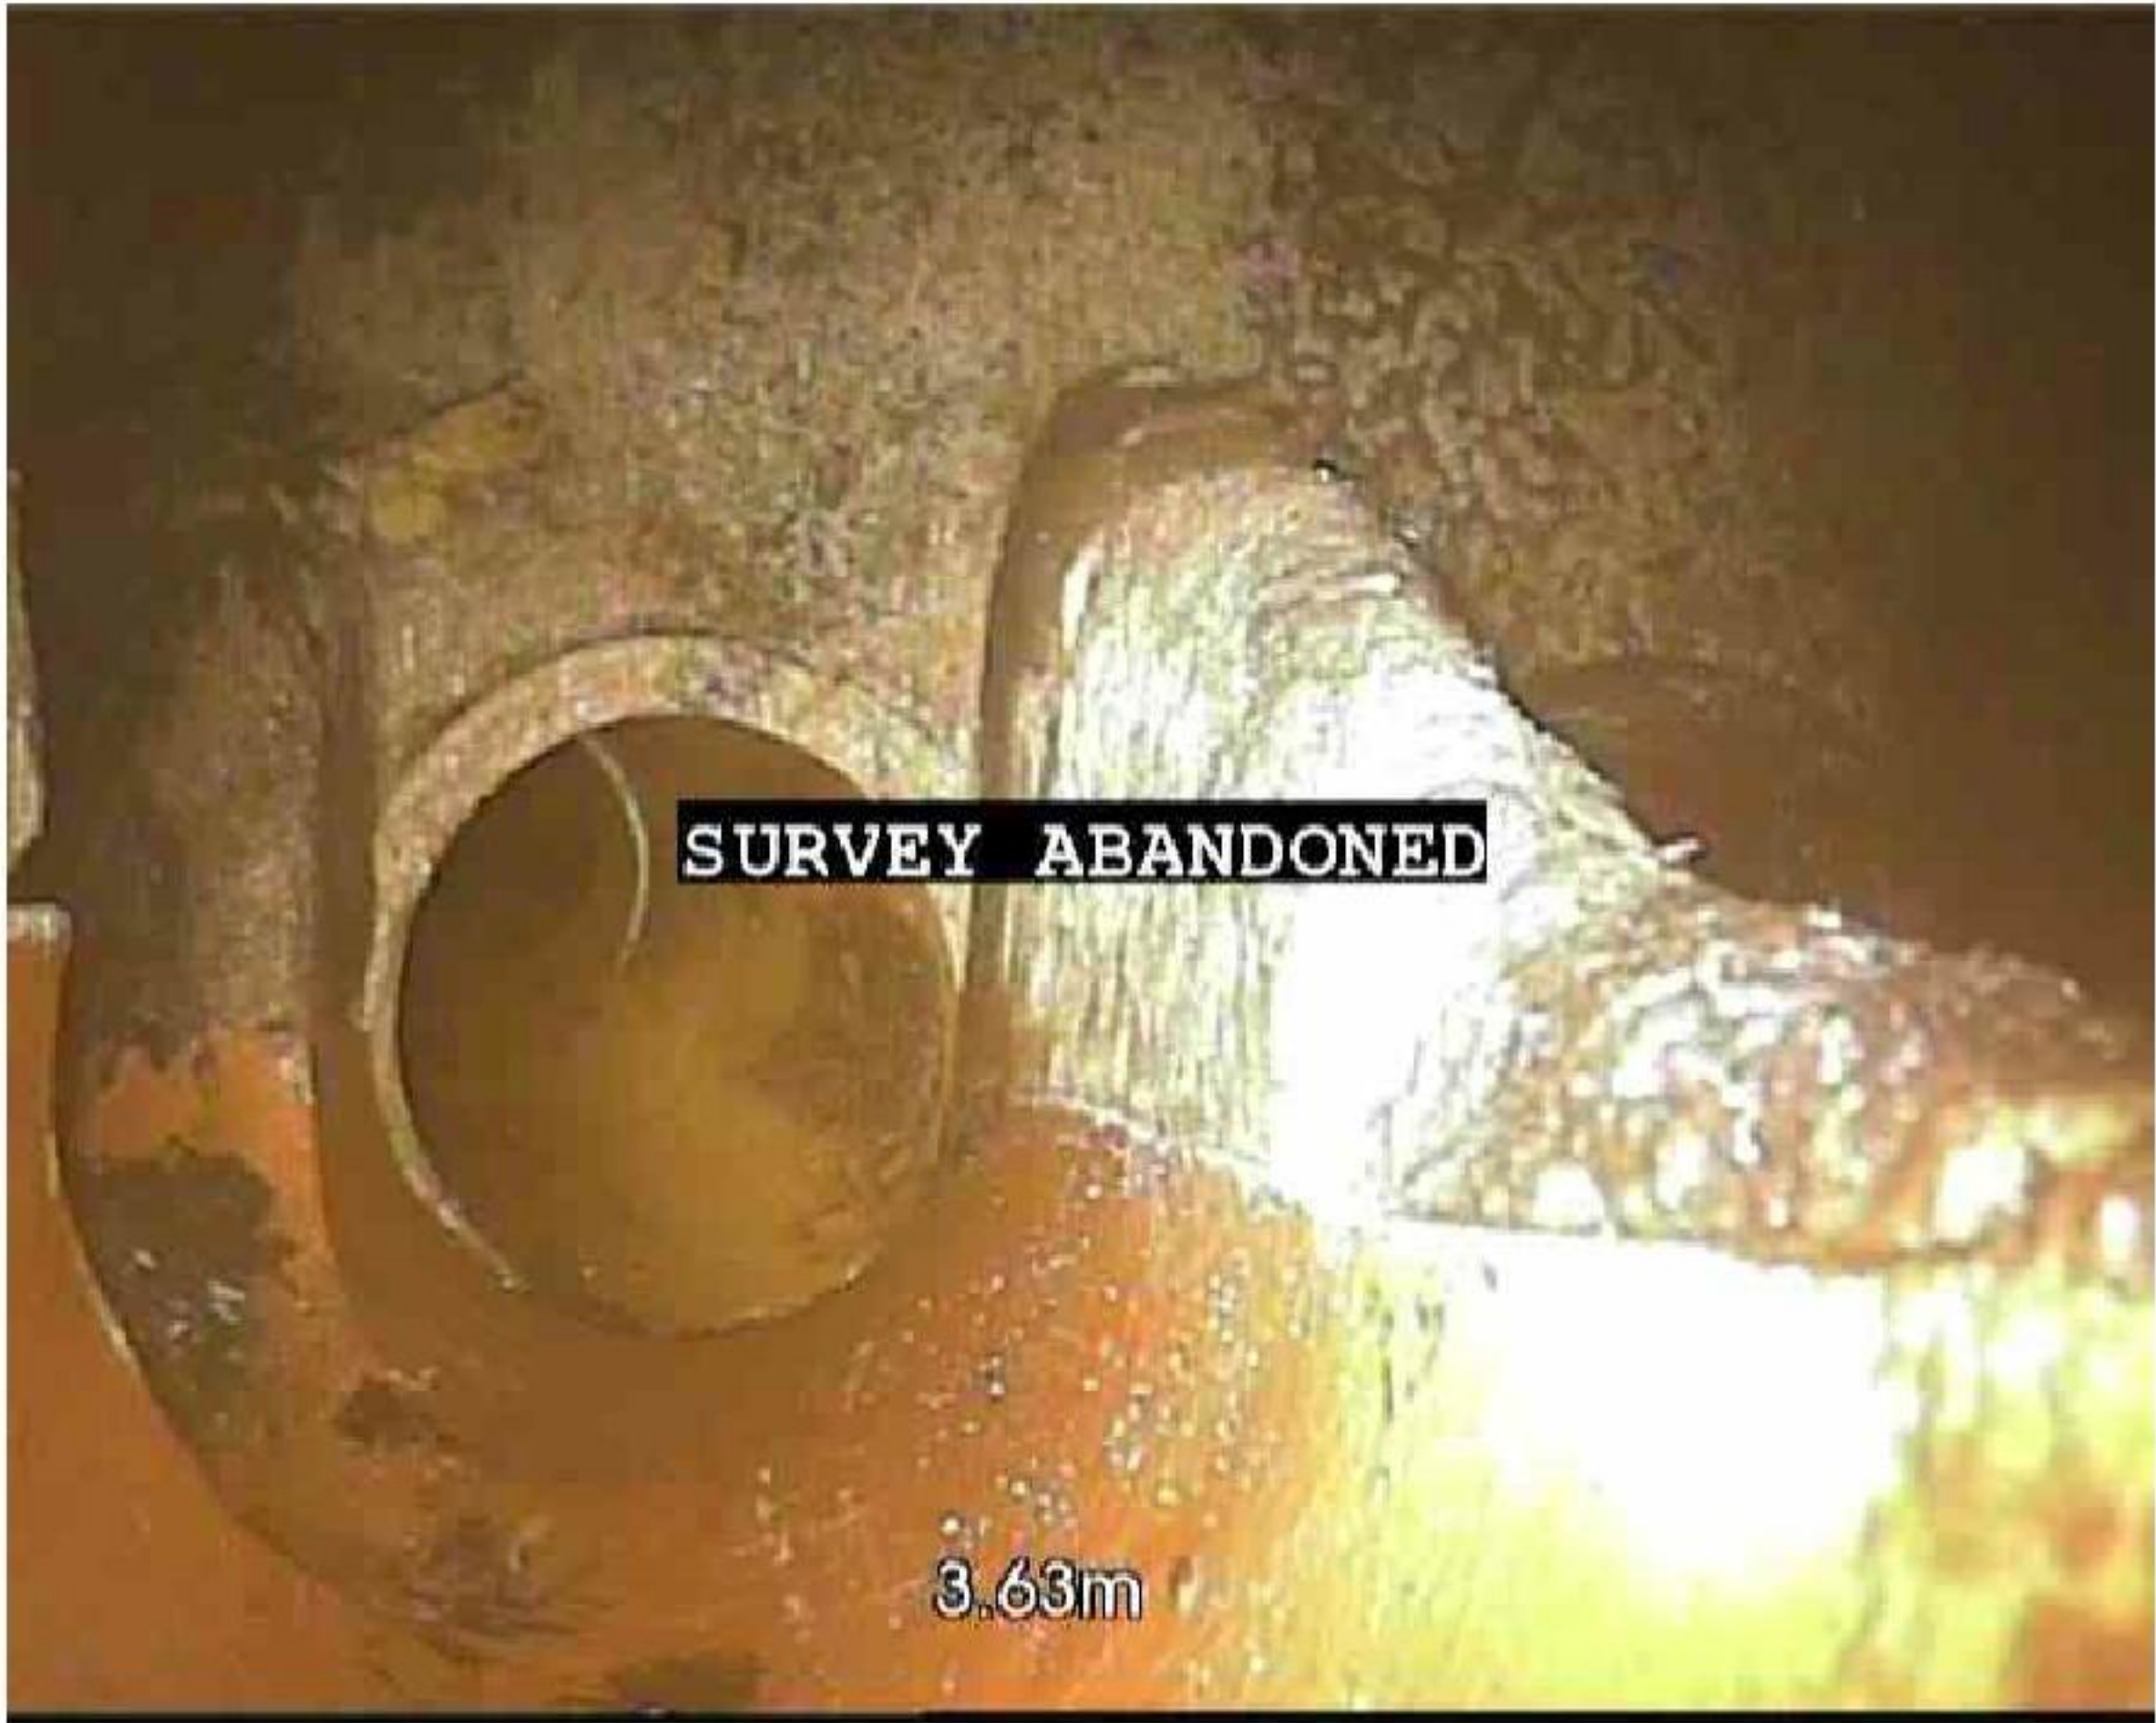
2, 00:00:16, 3.63 m  
Finish node, manhole, reference: IC2

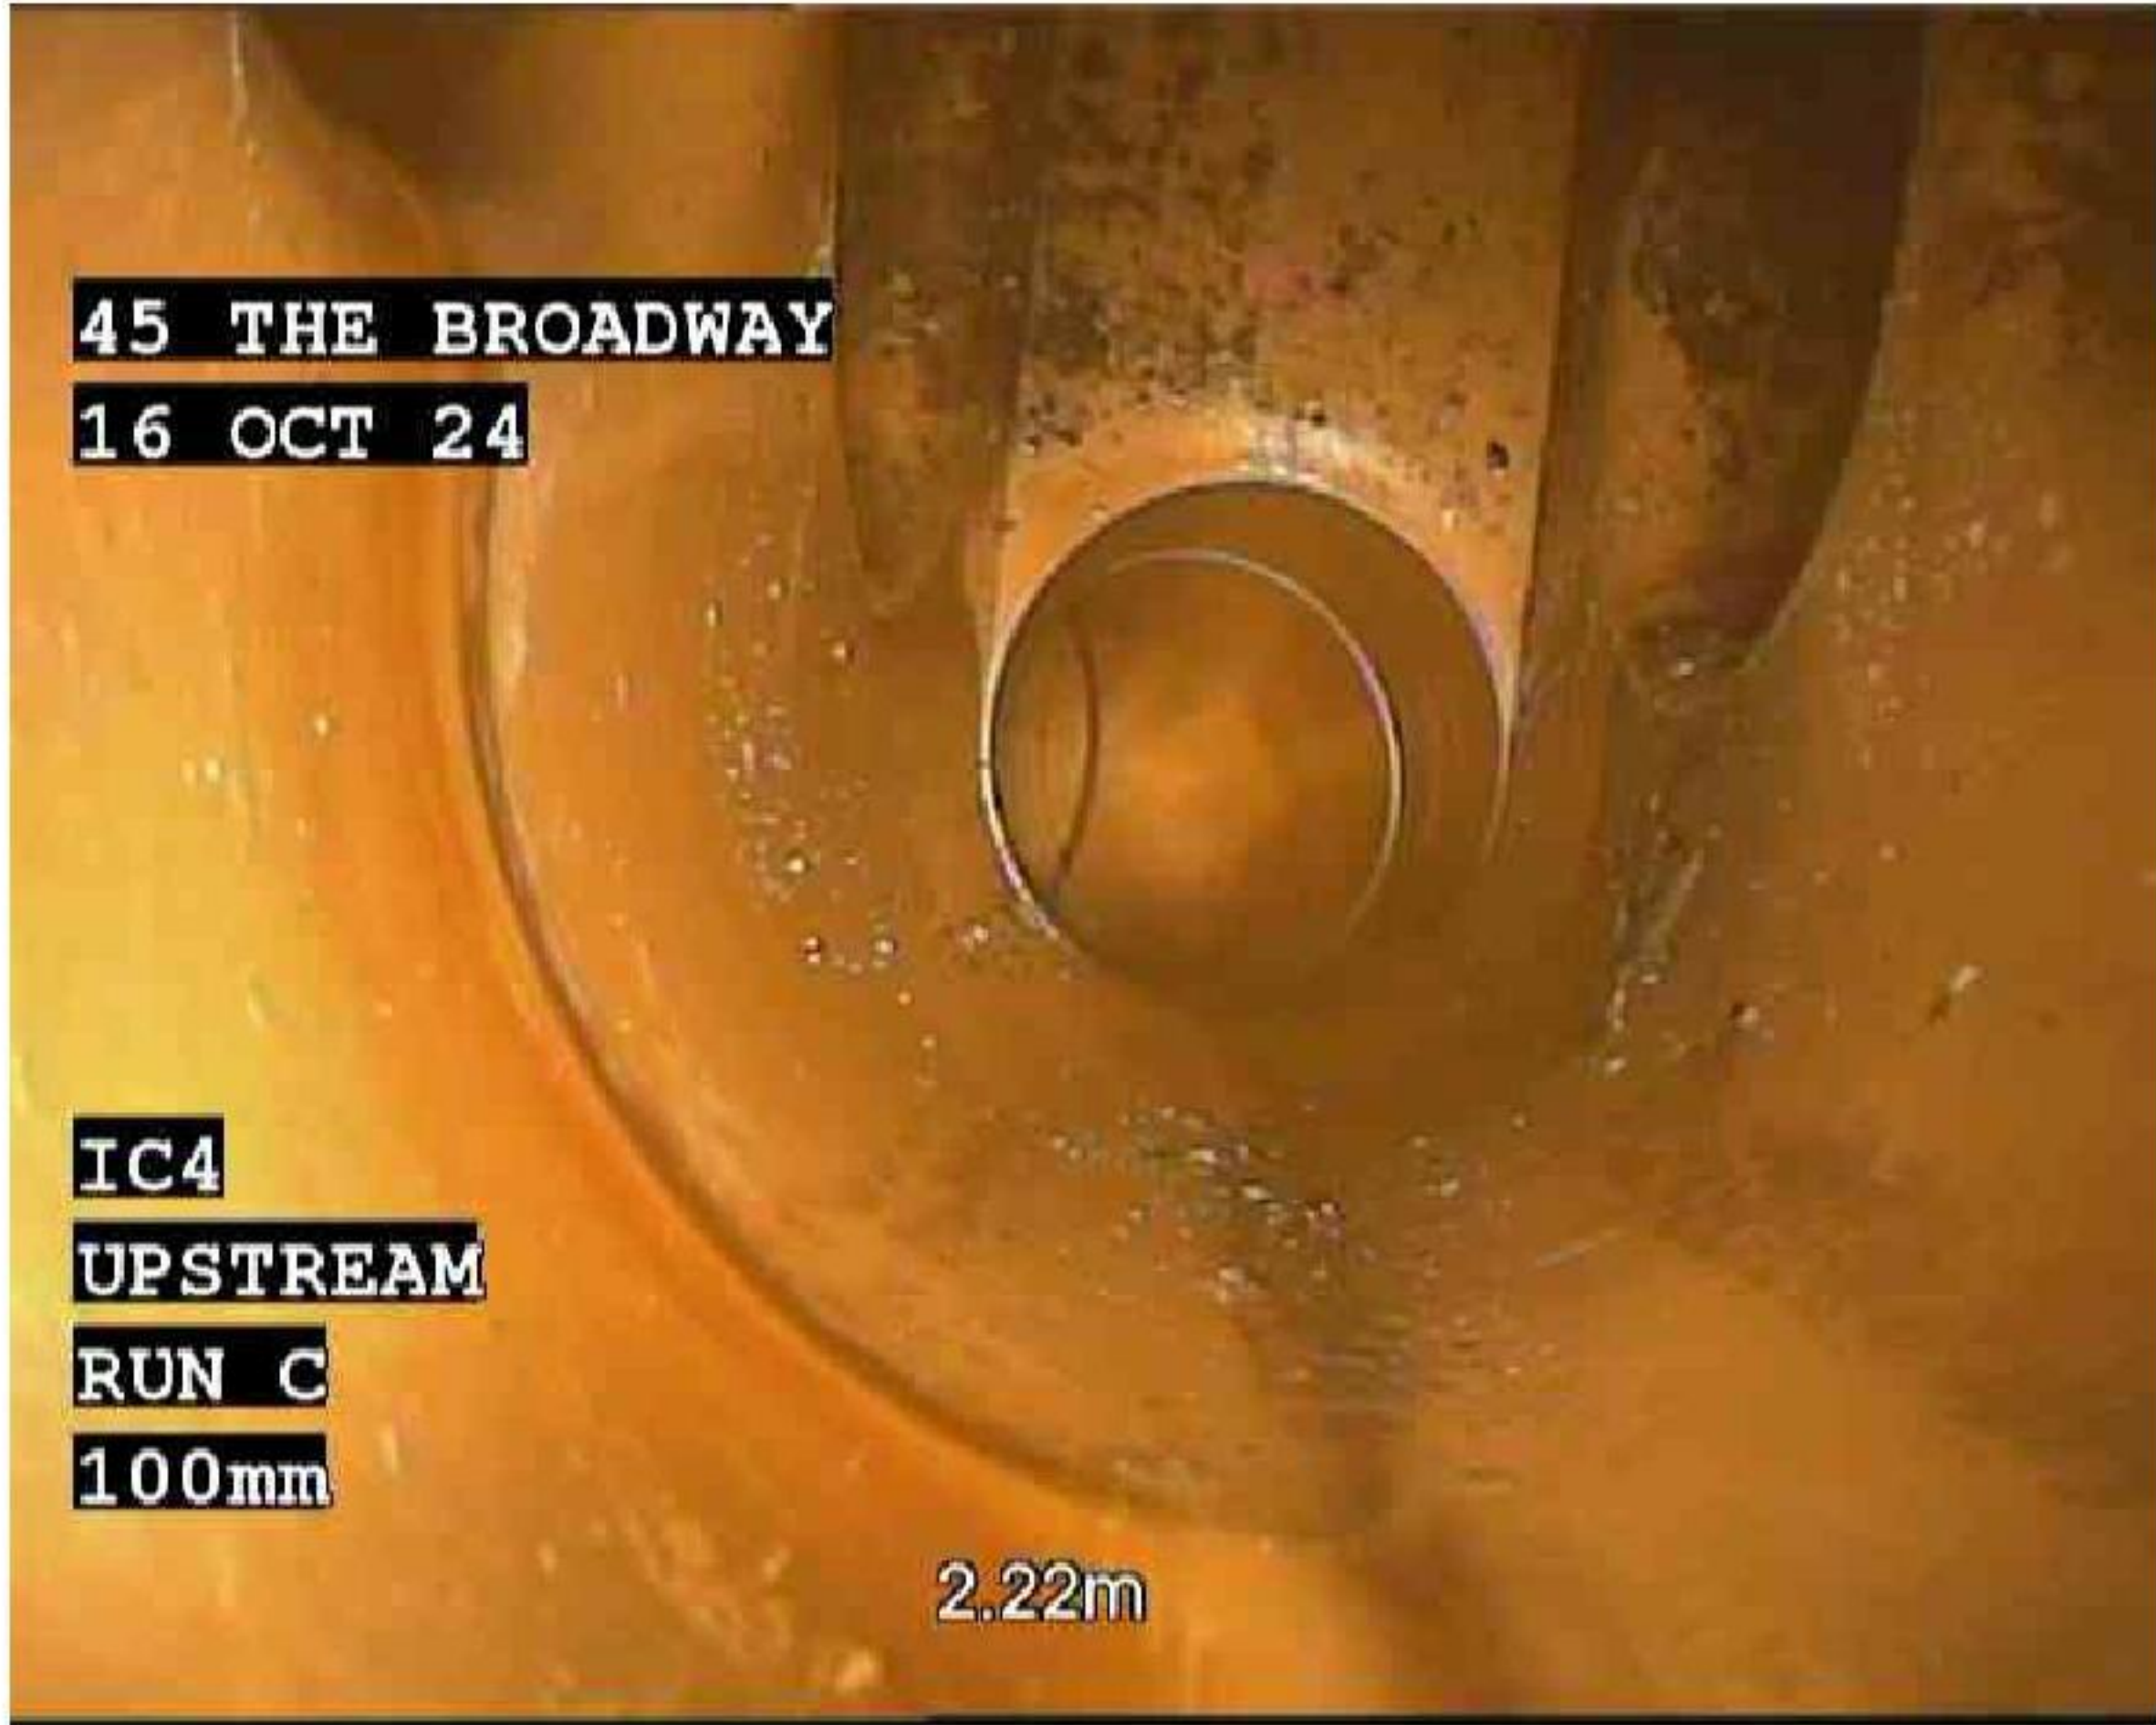
1, 00:00:16, 2.23 m  
Finish node, manhole, reference: IC3

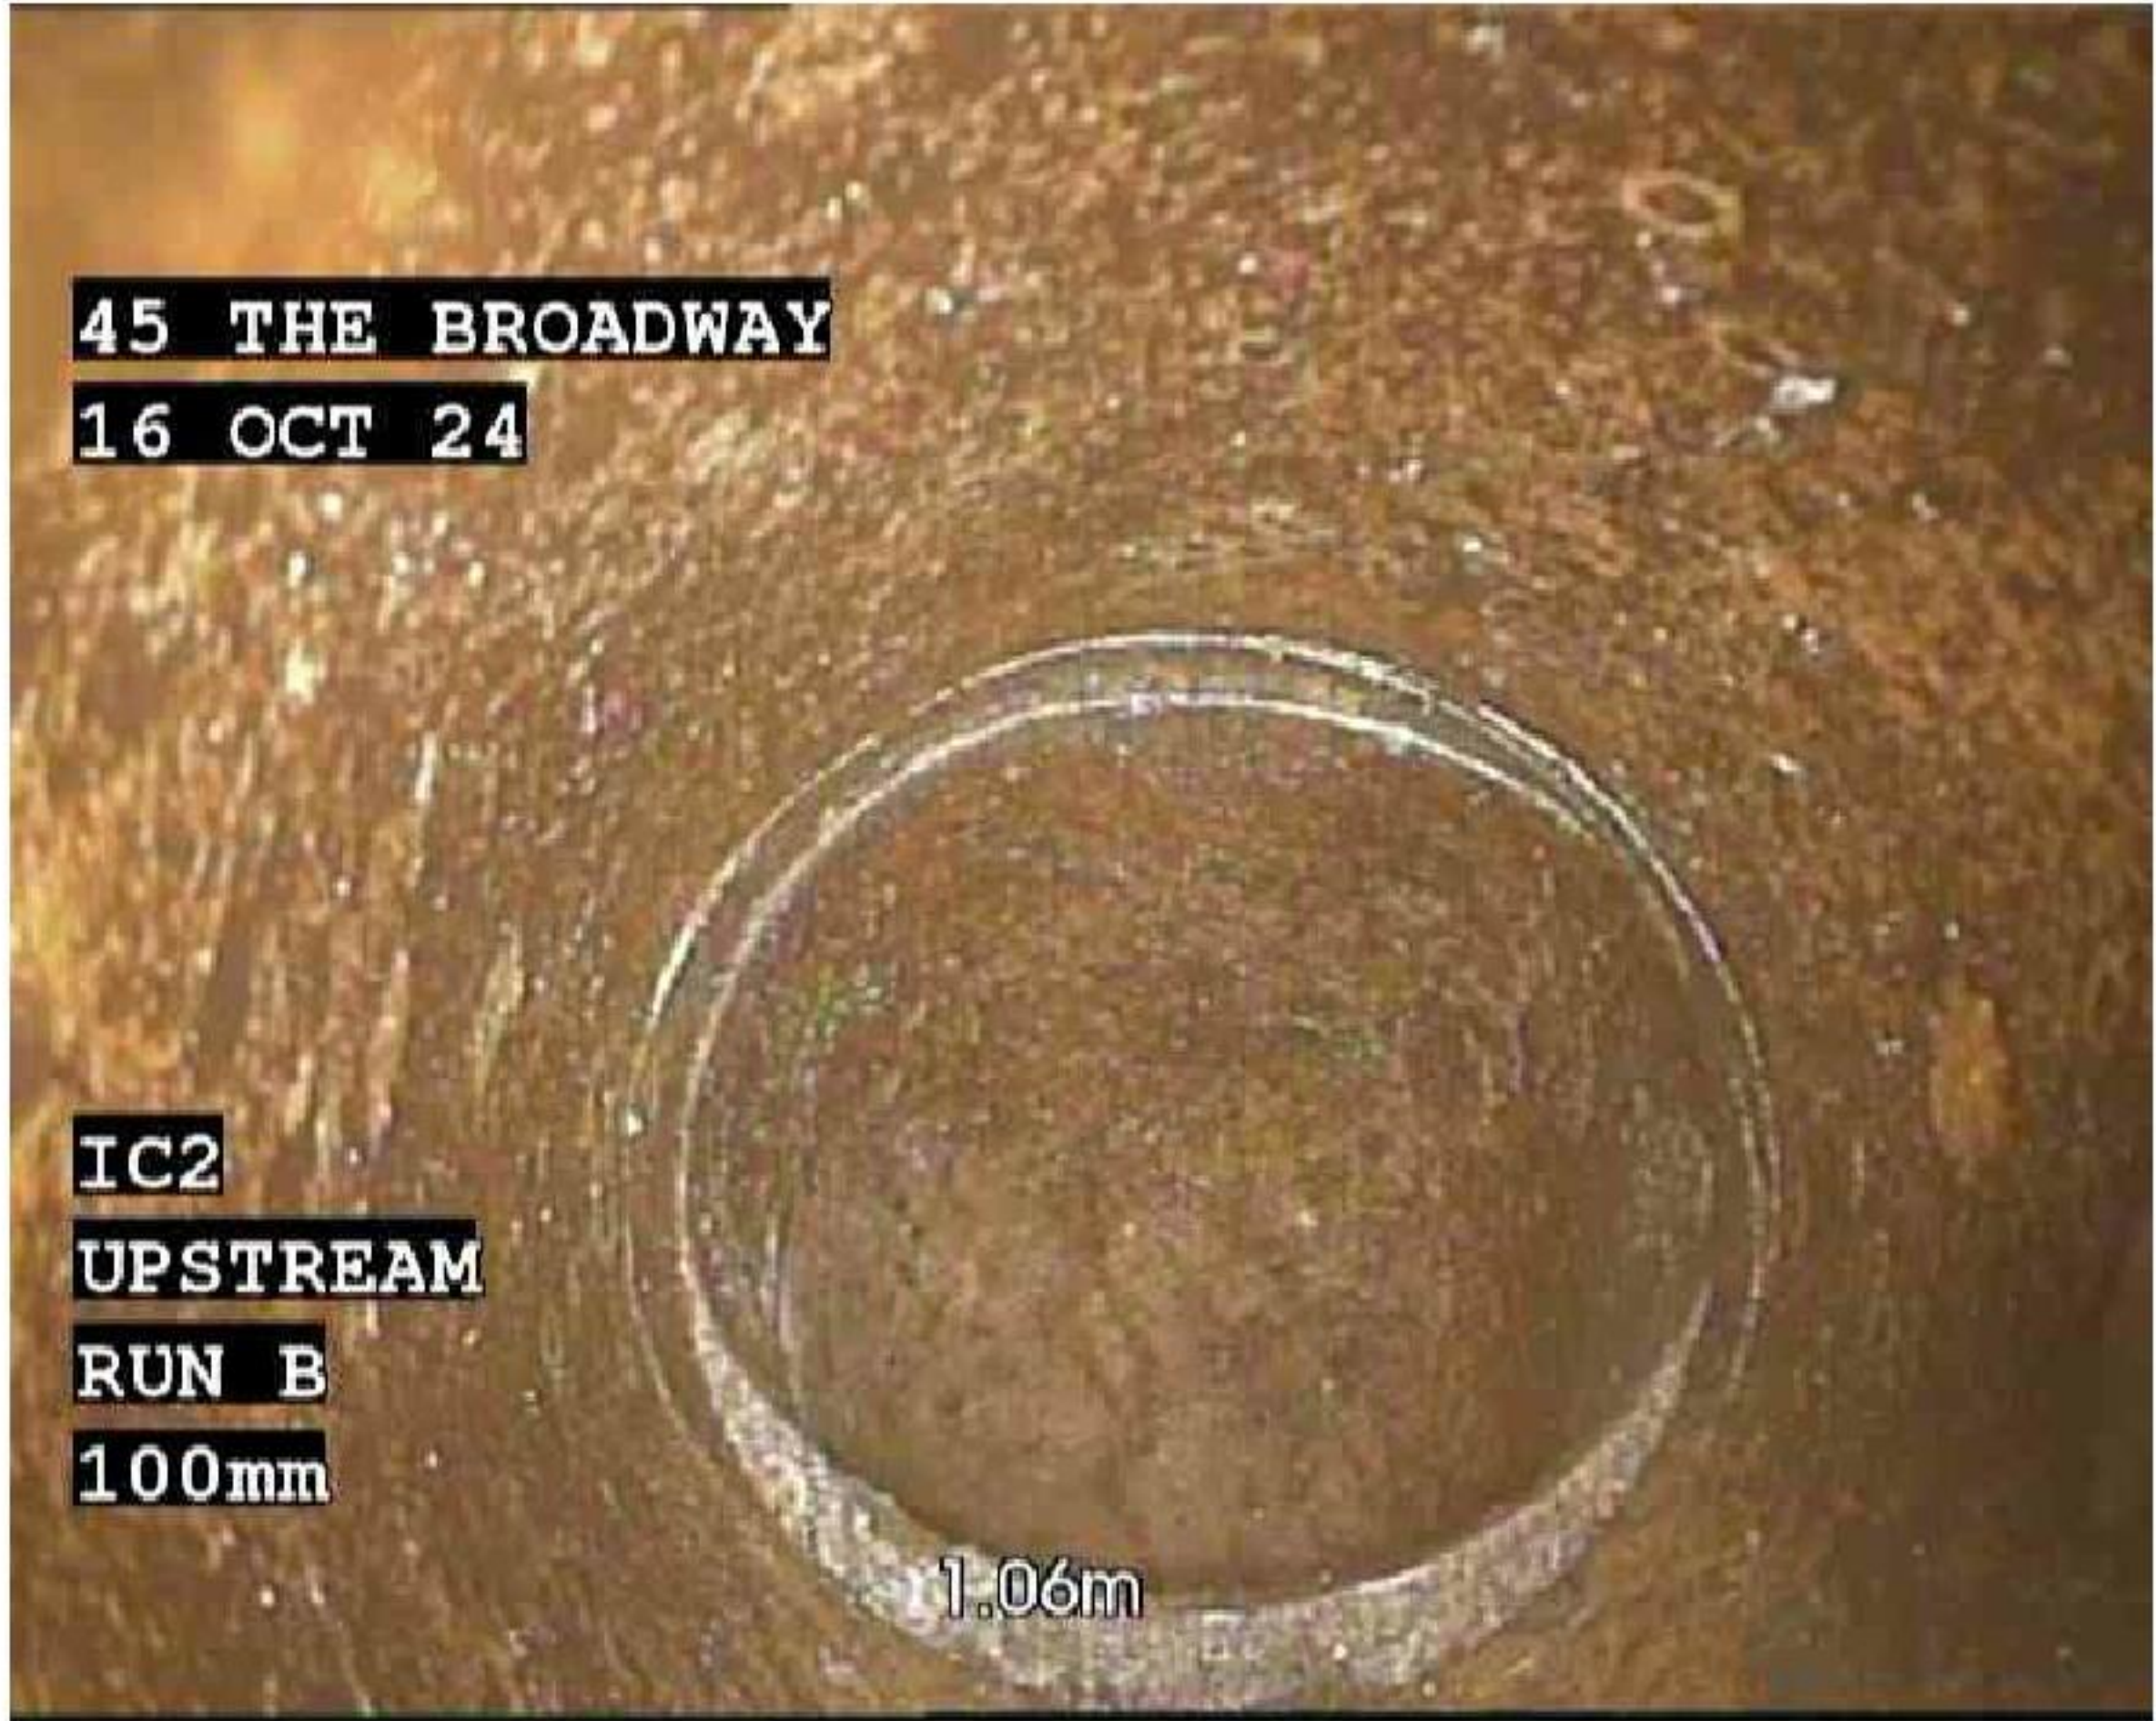
1, 00:00:12, 1.06 m  
Finish node, manhole, reference: IC2-B, At unknown gully  
assumed to be redundant
